How and to what extent can Historical Ship Structural Components be Observed in a Shallow Dynamic Environment?

The Case Study of SS *Admella*

A thesis submitted in fulfilment of the requirements for the degree of: Masters of
Maritime Archaeology.

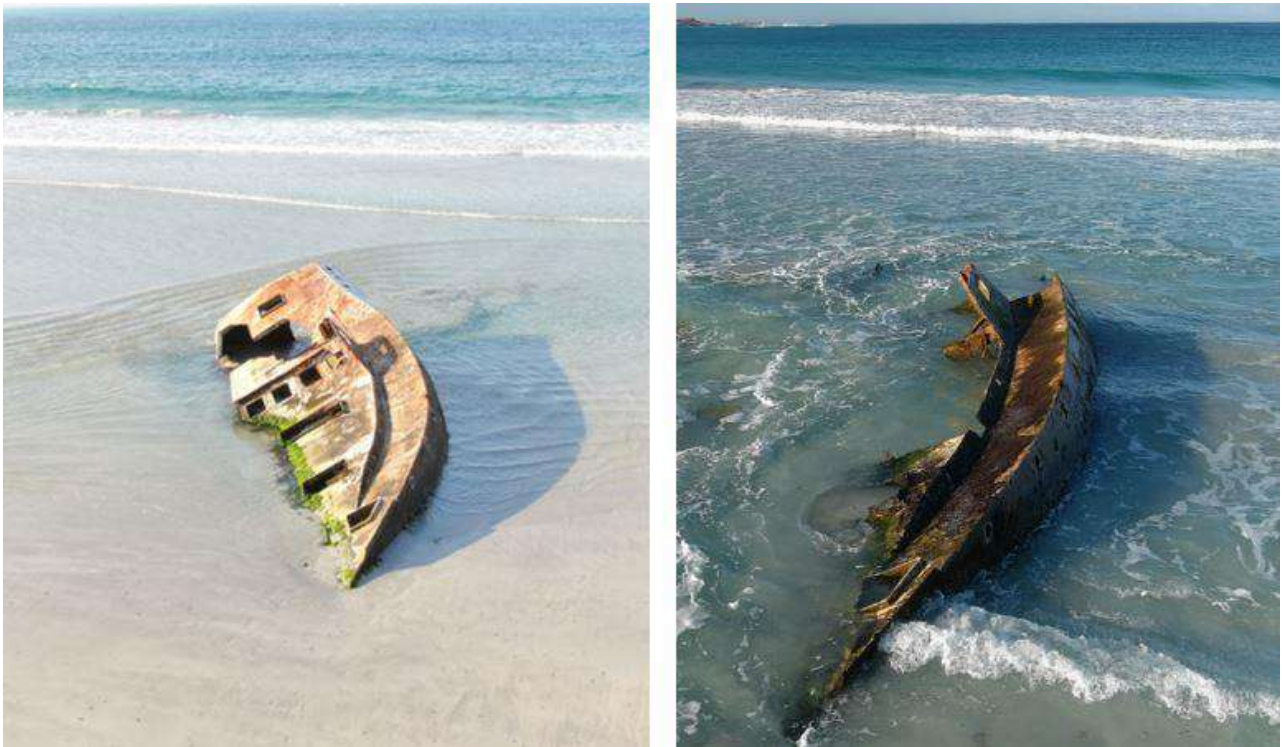
Figure 4.8. *Pisces Star* 2021 (left) and 2022 (right) deterioration process (2022-06-22)

Pisces Star, from 1997 to present has been constantly deteriorating in the intertidal zone at a faster speed than expected. The vessel is impacted by constant swell, sediment movement (listing to starboard), southerly and south-westerly winds, corrosion, and marine growth. Interpreting *Pisces Star*'s deterioration rate and applying that framework onto *Admella*, provides an understanding of taphonomic processes on ship material in high energy environments and preservation results over 25 years. The M2P was used in spiral rotation to complete a video transect of the vessel in 2021 and a second video transect in 2022, and both videos were used to create 3D models through Agisoft Metashape (2021) to show the variational change in deterioration rate (Fig. 4.9).

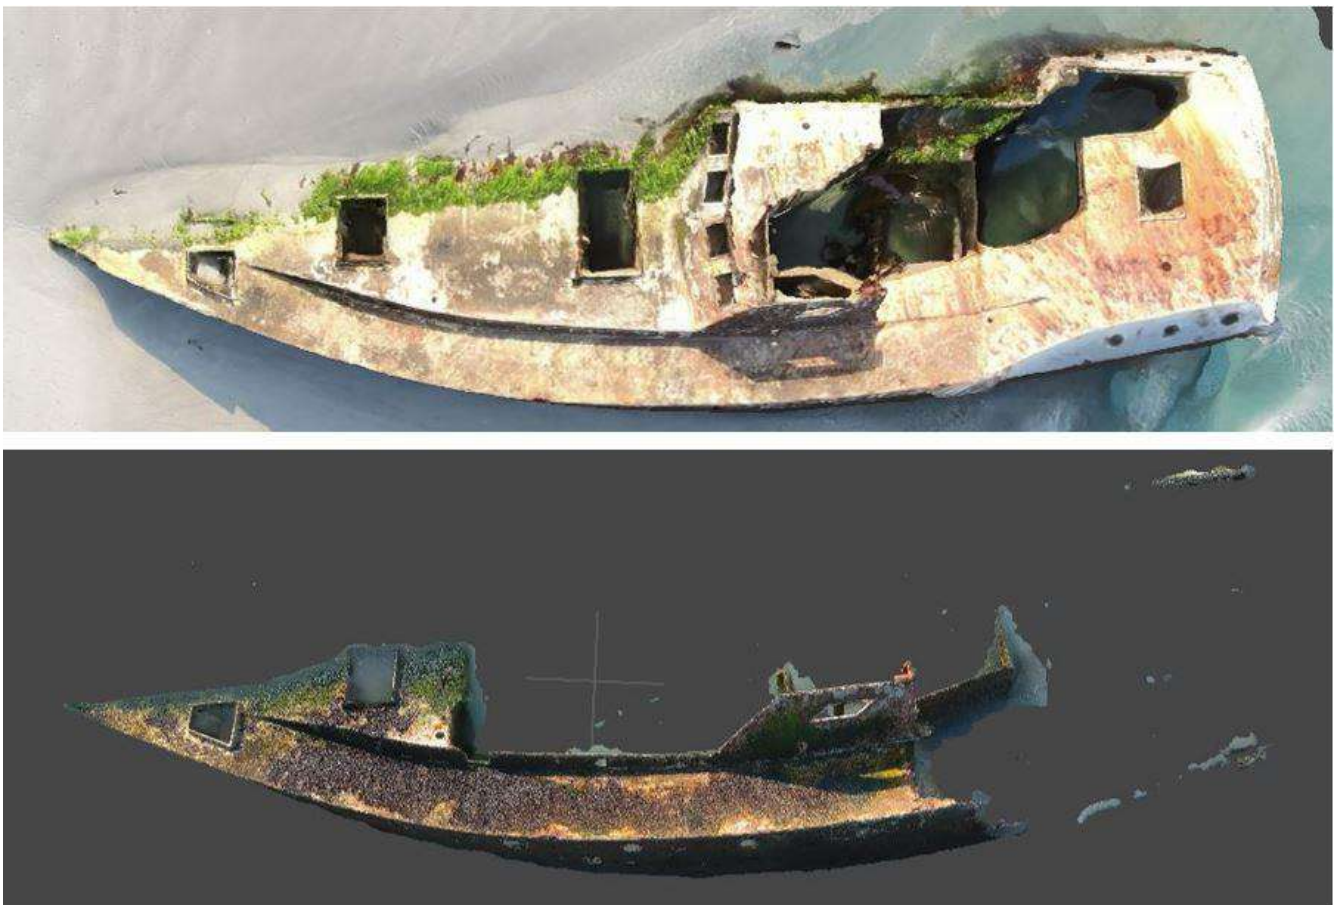
Figure 4.9. 3D photogrammetry comparison of missing main cabin roof and overgrowth of algae (Agisoft Metashape, 2022-07-30)

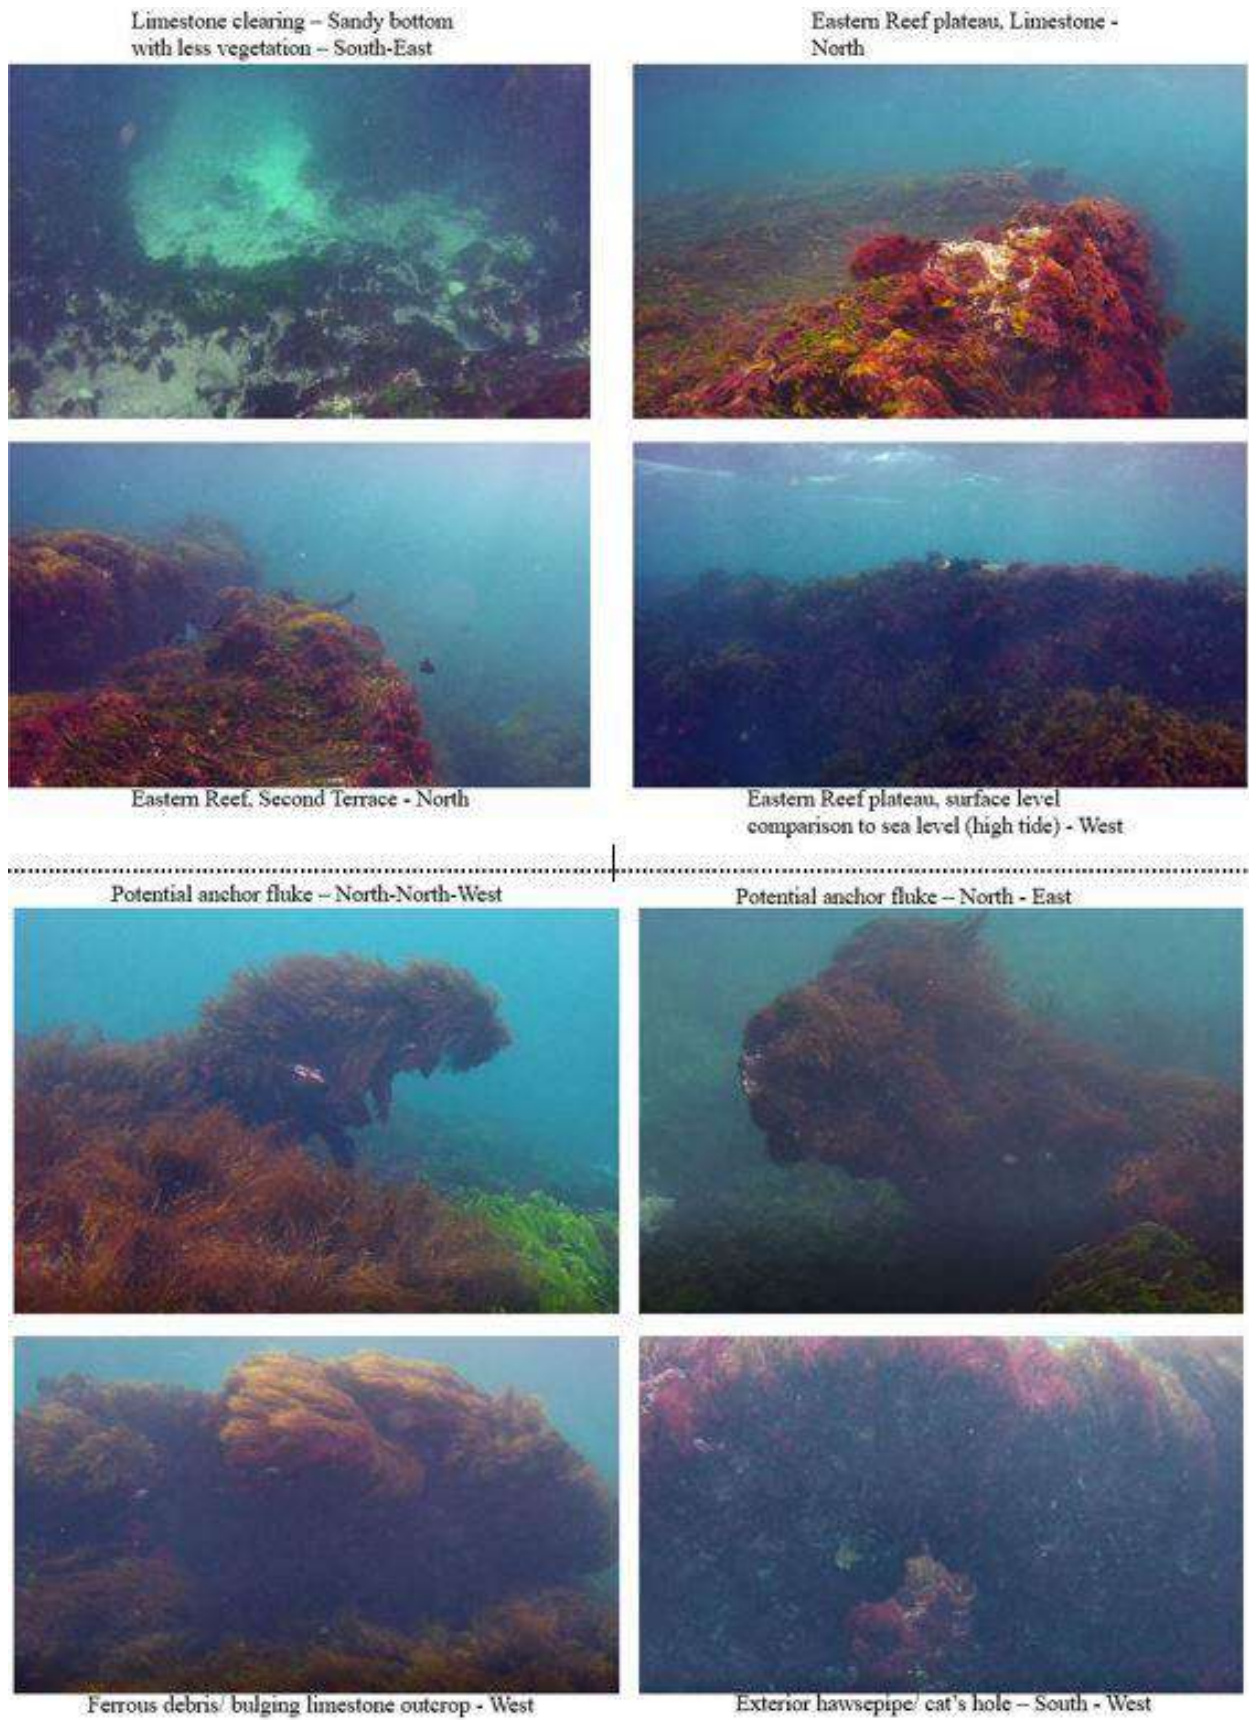
Surf was minimal, yet the submerged conditions recorded by the ROV indicated that the force of the surge was above 3 knots at the height of each interval. The various odd-shaped anomalies were recorded thoroughly to document and assess for the potential of ship-related material. Having launched two missions in ideal conditions, site extent was able to be narrowed to less than two hundred metres that would need to be investigated further by diver survey. The landscape provided evidence of a rocky eastern reef system covered by seagrass and kelp. Between the rocky alcoves within the reef, clearings were observed as having bare white limestone pebbles in areas with little vegetation present. The clearings had peculiar-shaped objects nestled in the centre with seagrass overgrowth (Fig. 4.24). Without a magnetometer or underwater metal detector, the objects with overgrowth could not be positively associated as being ship related. The Western section of reef was not observed due to sea surface level from reef seafloor recorded at 600 mm, creating a hydrodynamic fluvial bottleneck exceeding ROV's speed of 3 knots.

Figure 4.24. ROV recorded data of natural limestone reef structure (top) in comparison to irregular structure littered throughout ADM1 (Chasing M2, 2022-08-05)

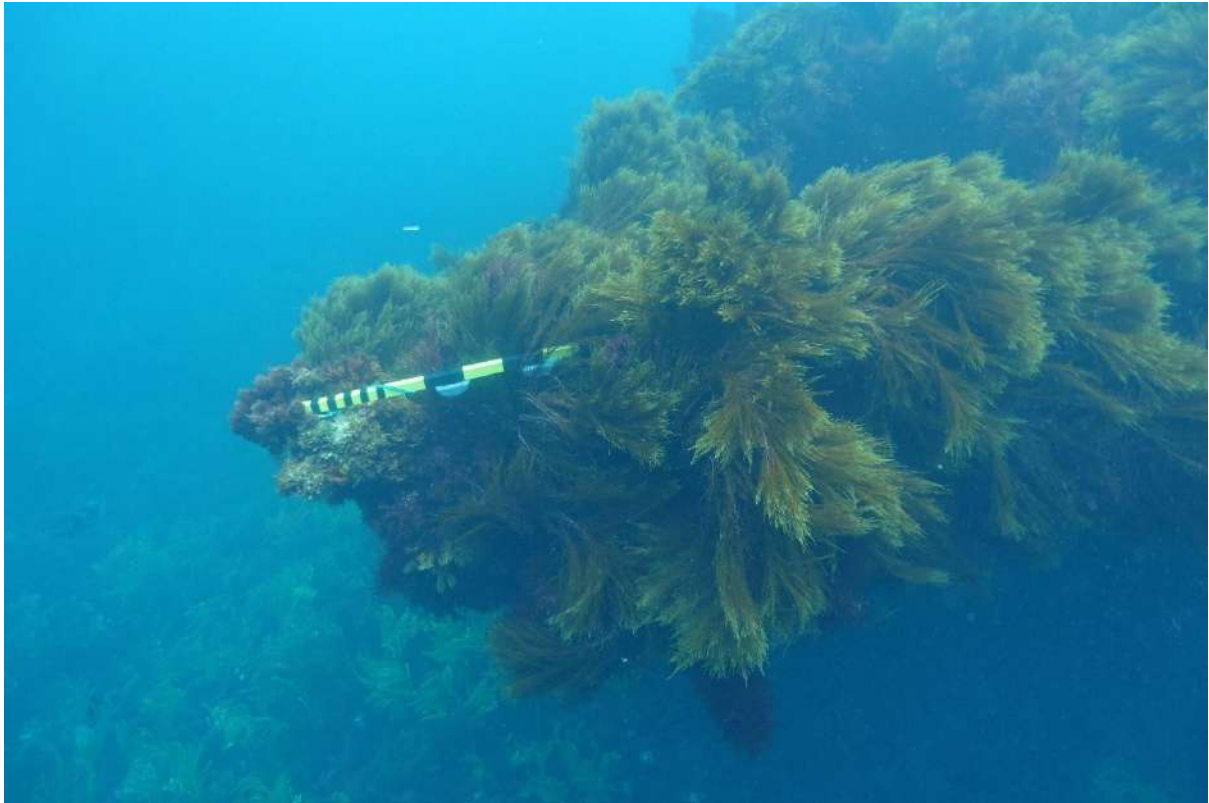
From plan-view the object resembles an 'A' frame with a triangular hole in the middle. The structure creates an overhang on the outer-western reef, rising forward out of the reef by 3.5 m and standing 2.8 m above the seafloor (Fig. 4.31). A round concreted shape can be observed at the intersection of the frame making the structure stand out from the limestone reef (Fig 4.32). Furthermore, at approximately 1.7 m below the 'A' frame structure, a long rectangular shape is found jutting-out of the reef on the western side, directly underneath the western side of the 'A' (Fig. 4.33). This structure is severely deteriorated; however, the thickness (0.6 m x 0.5 m) matches the 'A' frame and is observed to be jutting out in the same direction. At the time of wrecking this structure would have been positioned at the stern, making up part of the rudder trunk frame (Fig. 4.34) (Paasch 1885:53–58). The structure underneath the 'A' frame came into perspective during the dive and could be observed at length from the seafloor. The tilted upward-angle of the bottom beam suggests that it would connect to a fixed spot near or on the circular point depicted in figure 4.32 (Fig. 4.35). The standing 'A' frame had likely held in place the rudder trunk underneath the rudder-tiller (Paasch 1885:57). The 'A' frame was recorded by photographs and videos; no photogrammetry could be processed due to the movement of seagrass.

Figure 4.31. The 'A' frame structure facing (northwest, 2022-01-12)

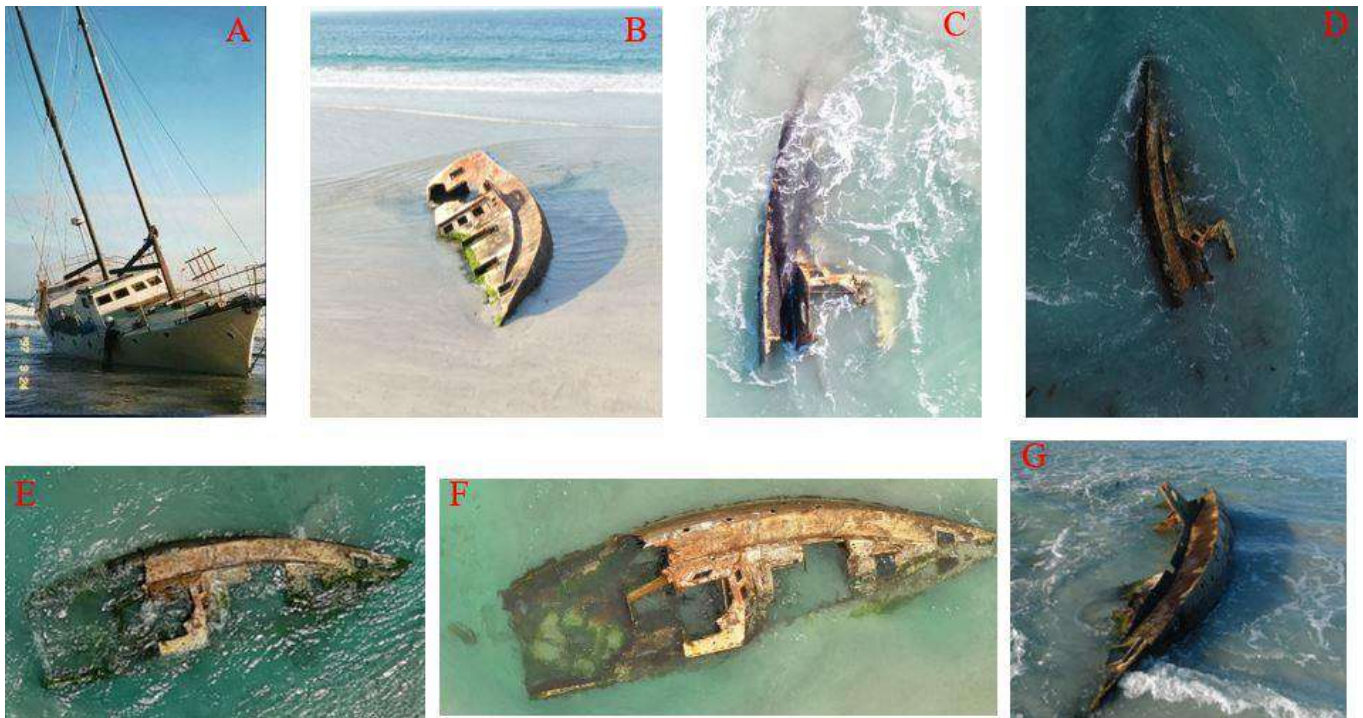
The vessel was first recorded in March 2021, using a drone to capture 95% of the vessel's structure and rendering it through Agisoft Metashape. A storm had passed through the area in late July 2021, travelling from the north-west down to Portland, Victoria. By August 2021, the vessel was observed as having lost the entire stern, evidently breaking off and sinking below the surface into the sediment except for a few visible steel-cord fixtures. By late-July 2022, the vessel is completely missing the roof of the main cabin area, and the starboard side is evidently being buried beneath the sediment (Fig. 5.6).

Figure 5.6. Deterioration process from A) August 1997, B) March 2021, C) August 2021, D) September 2021, E) December 2021, F) January 2022, and G) July 2022.

Considering *Pisces Star* is in more stable conditions than most vessels in the area, it still needs to be stressed that the vessel from 1997 to July 2022 has effectively deteriorated down to the structural components, which are now deteriorating with heavy storms and high 25 knot winds becoming commonplace. Furthermore, the area that *Pisces Star* is located, it was evident that the vessel was only affected by winds coming from the southerly and south-easterly directions. The south-westerly swell is reduced in force by the southern reef structure that can be observed adjacent to the signal marker rocks. The reduction of swell helps to reduce the overall impact force that *Pisces Star* experiences, aiding in the shipwreck's overall preservation. The vessel is observed to have significant marine growth in July 2022 and implies that the structure is now more frequently submerged than in previous years, which is attributed to the listing to starboard and envelopment by sediment (Fig. 5.7).

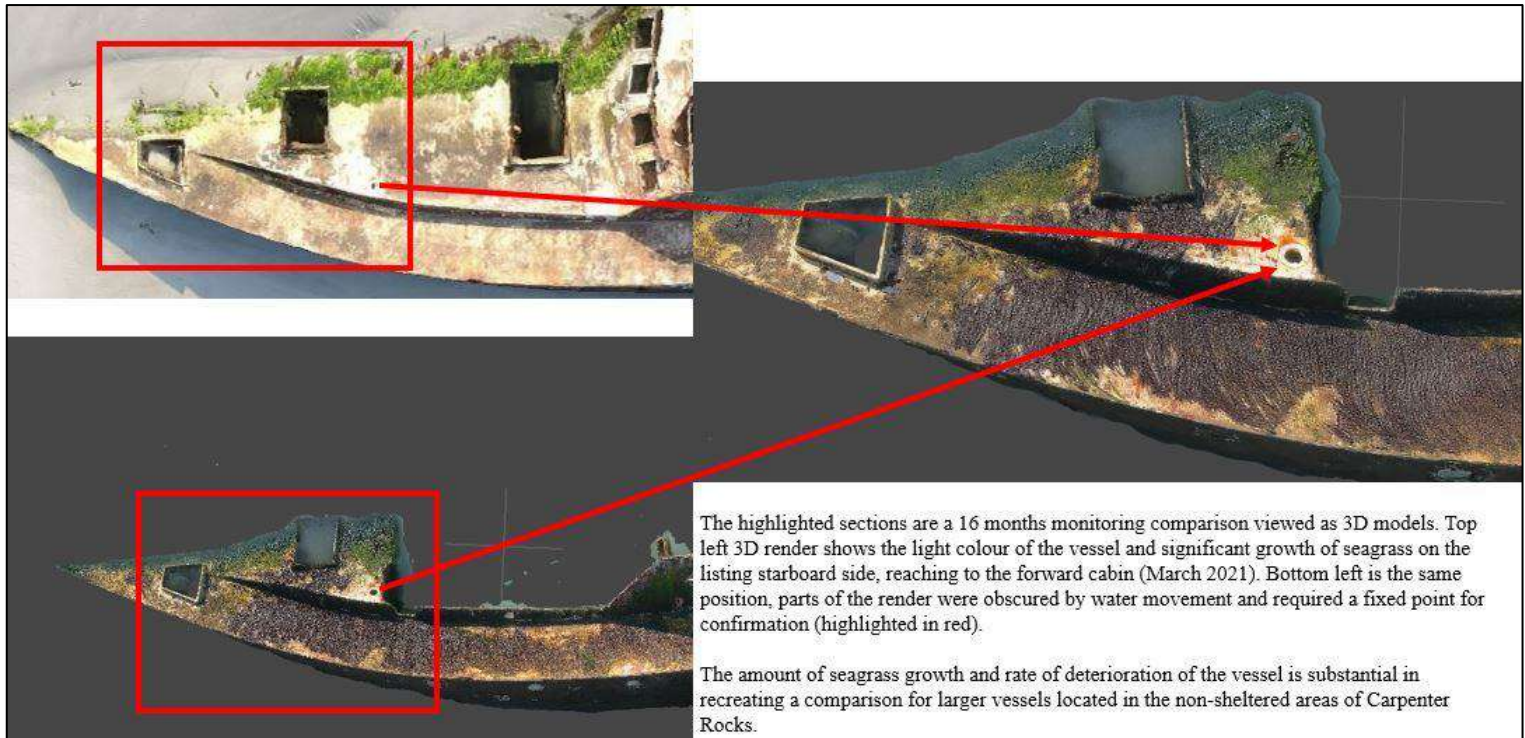
Figure 5.7. 3D model rendering *Pisces Star* for visual taphonomic dissemination (Agisoft Metashape, 2022-07-30)

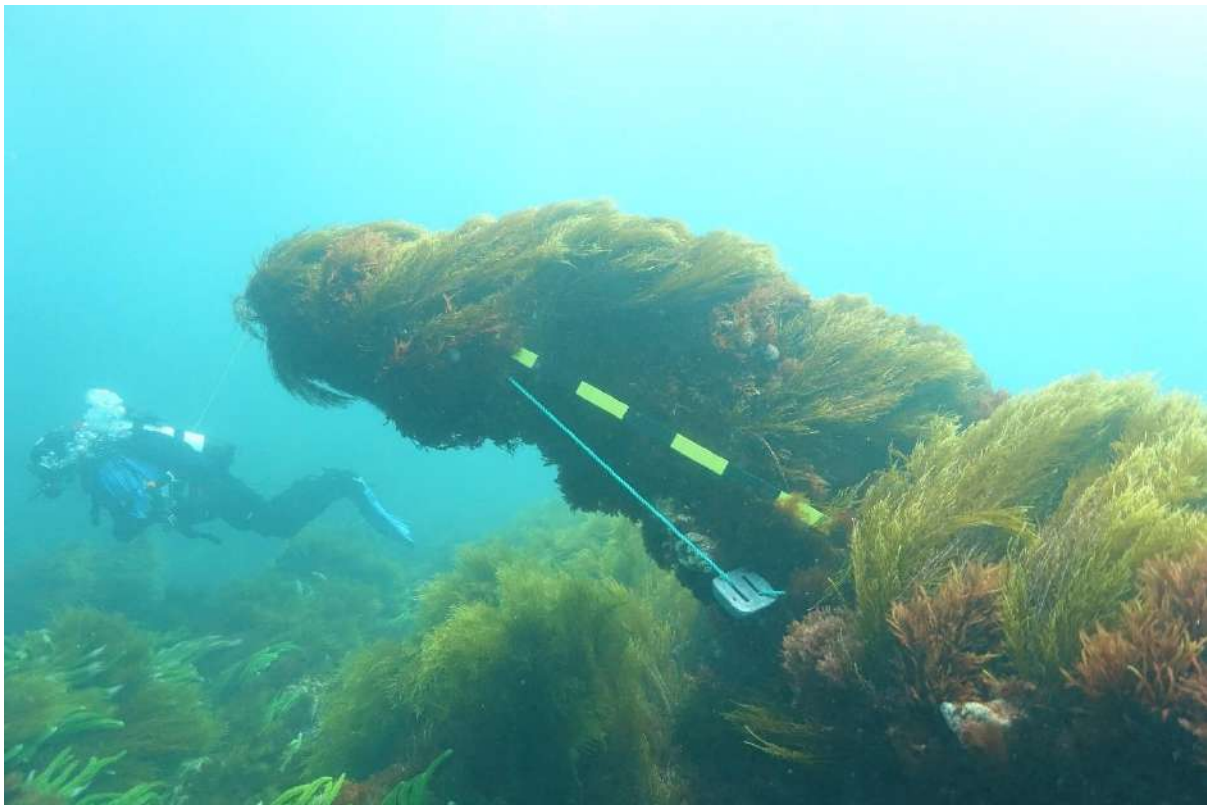
1G.2. ADM1-002 Potential anchor with fluke protruding out from limestone seafloor, C. Lewis in background (2022-01-13, P. Kermeen)

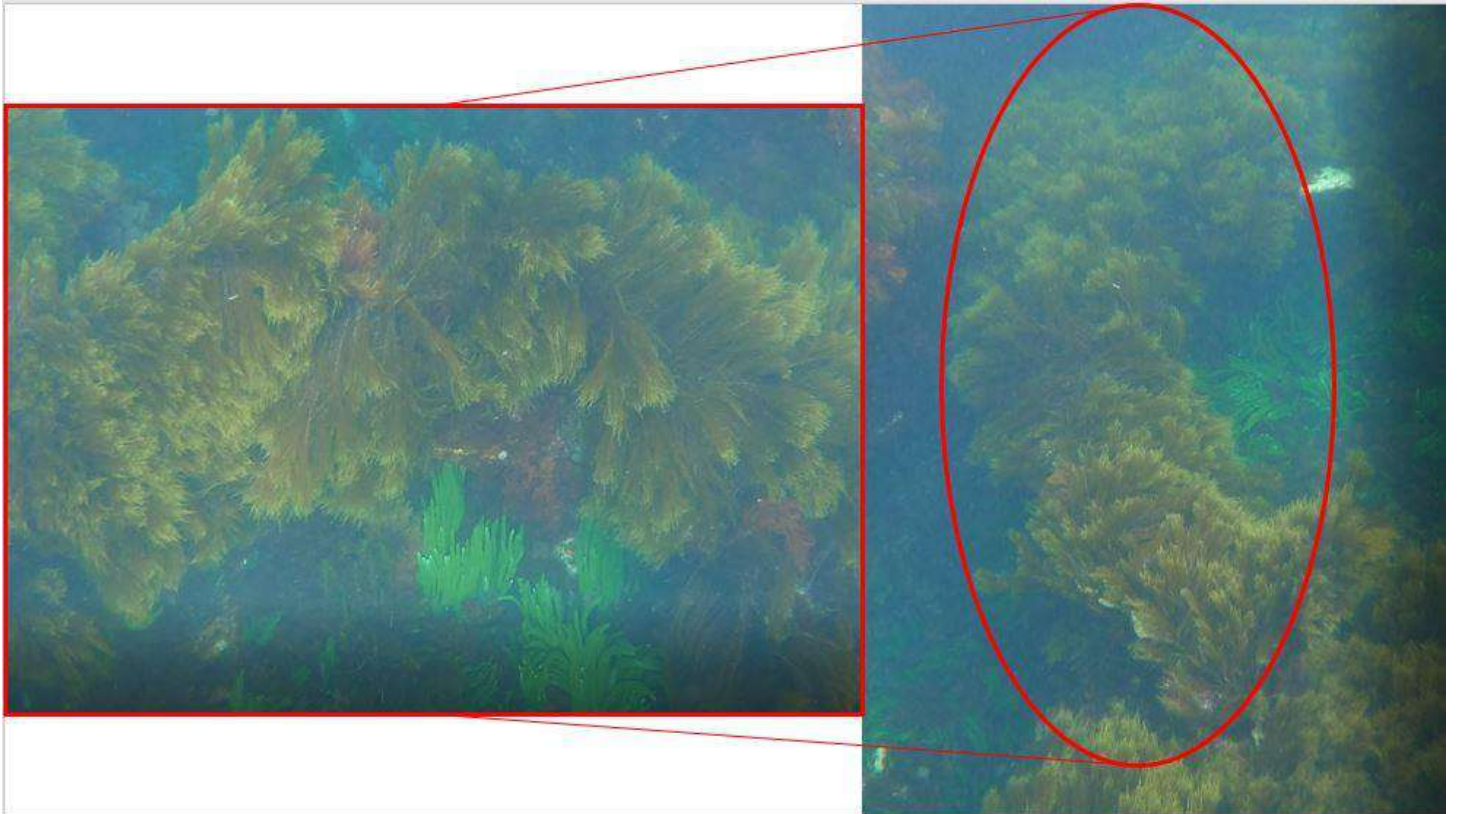
1G.3. ADM1-003 potential base for iron funnel (2022-01-12, P. Kermeen)

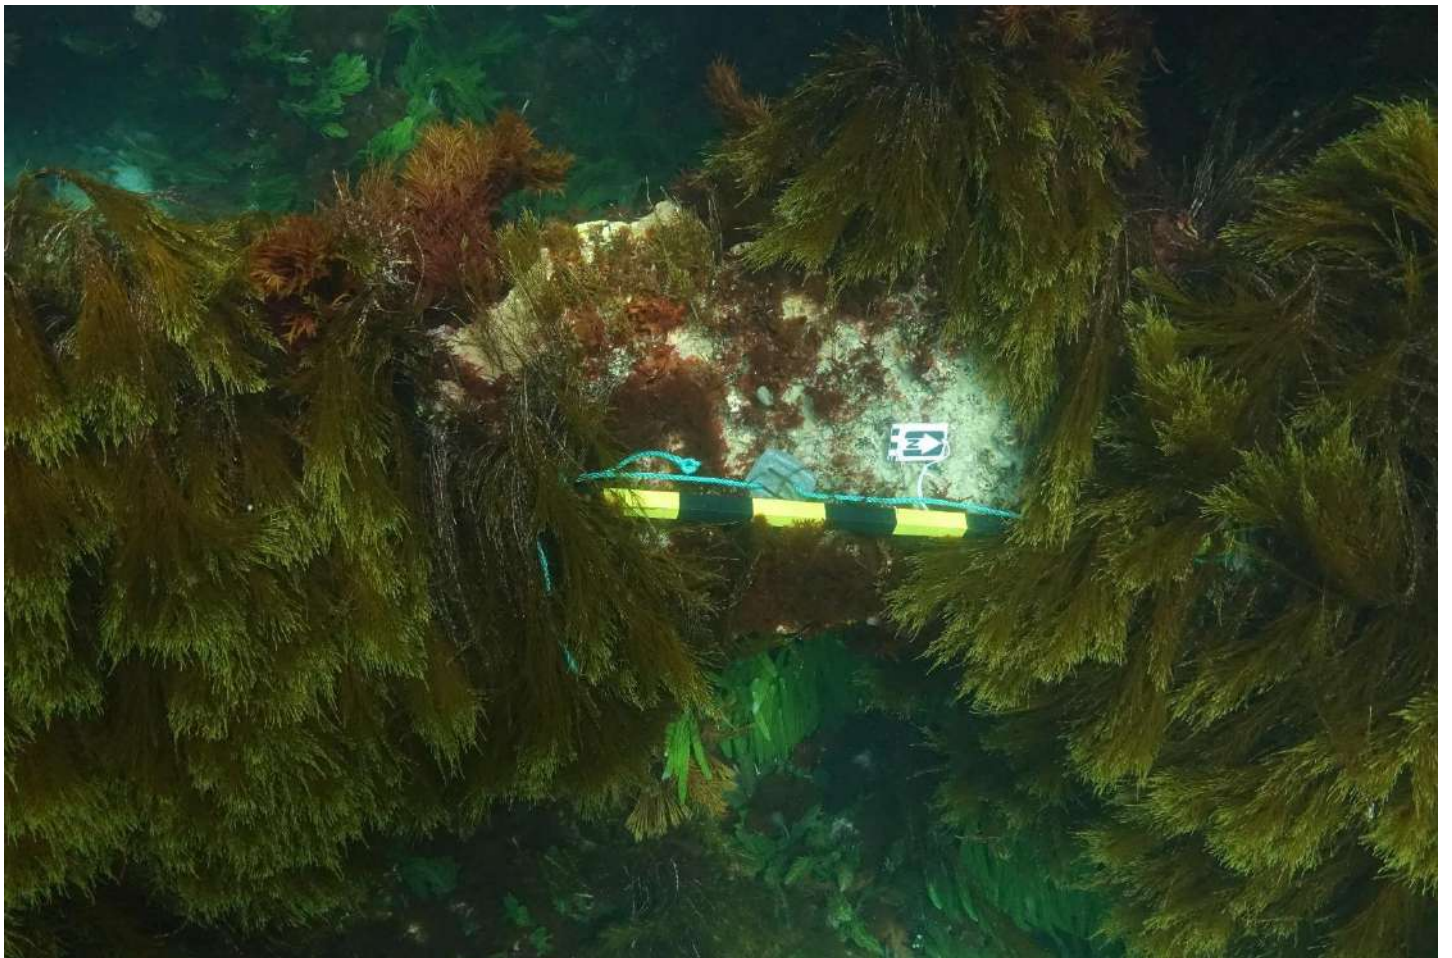
1G.4. ADM1-004 second recorded potential funnel base (2022-01-12, P. Kermeen)

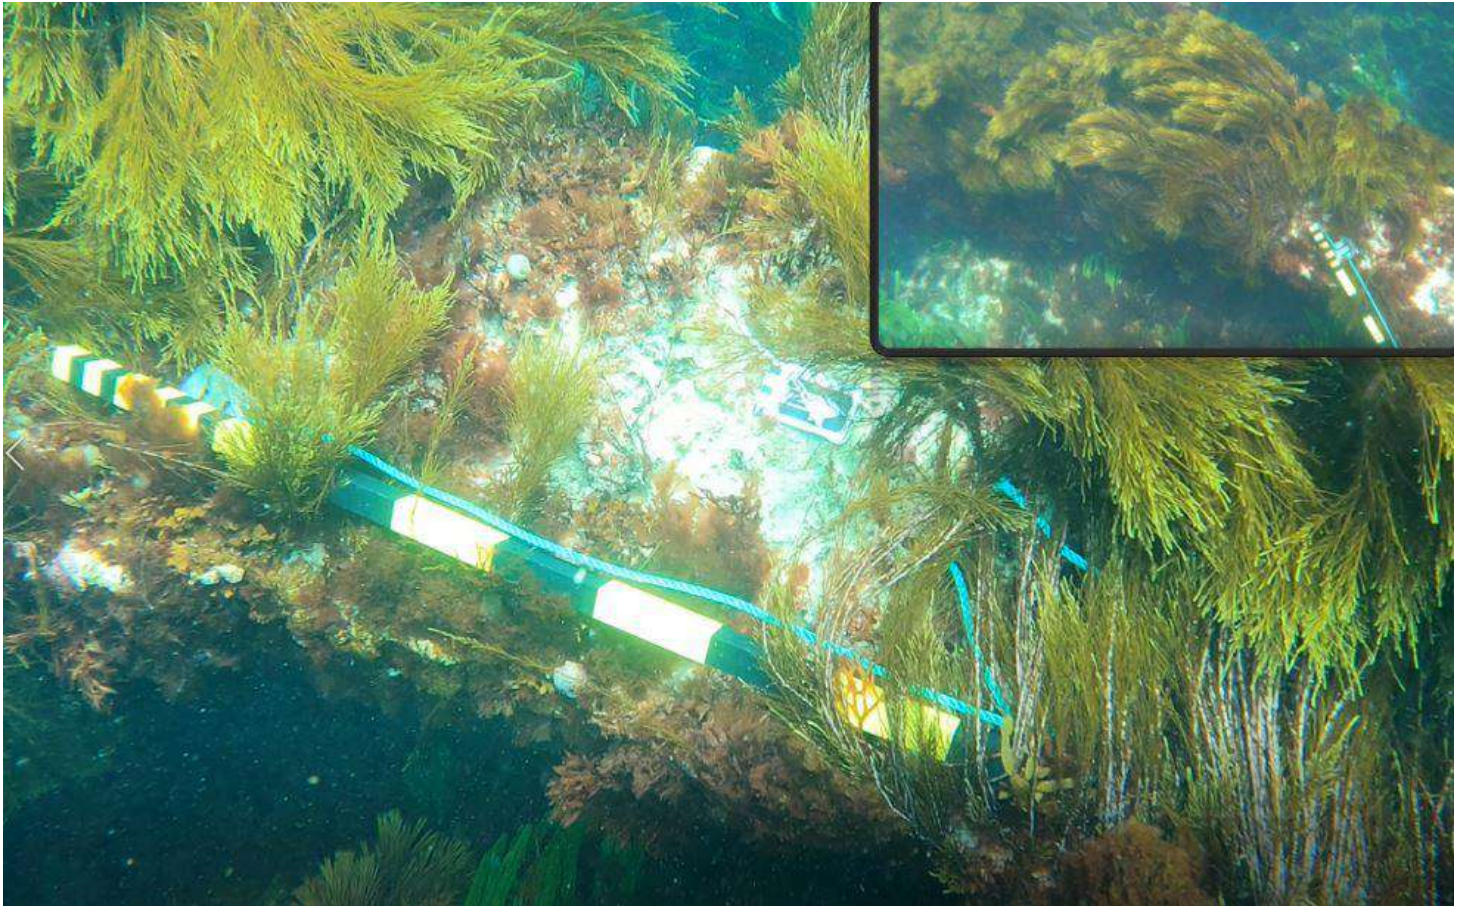
1G.5. ADM1-004 oblique view of ring that sits 10 m from ADM1-003 (2022-01-12, P. Kermeen)

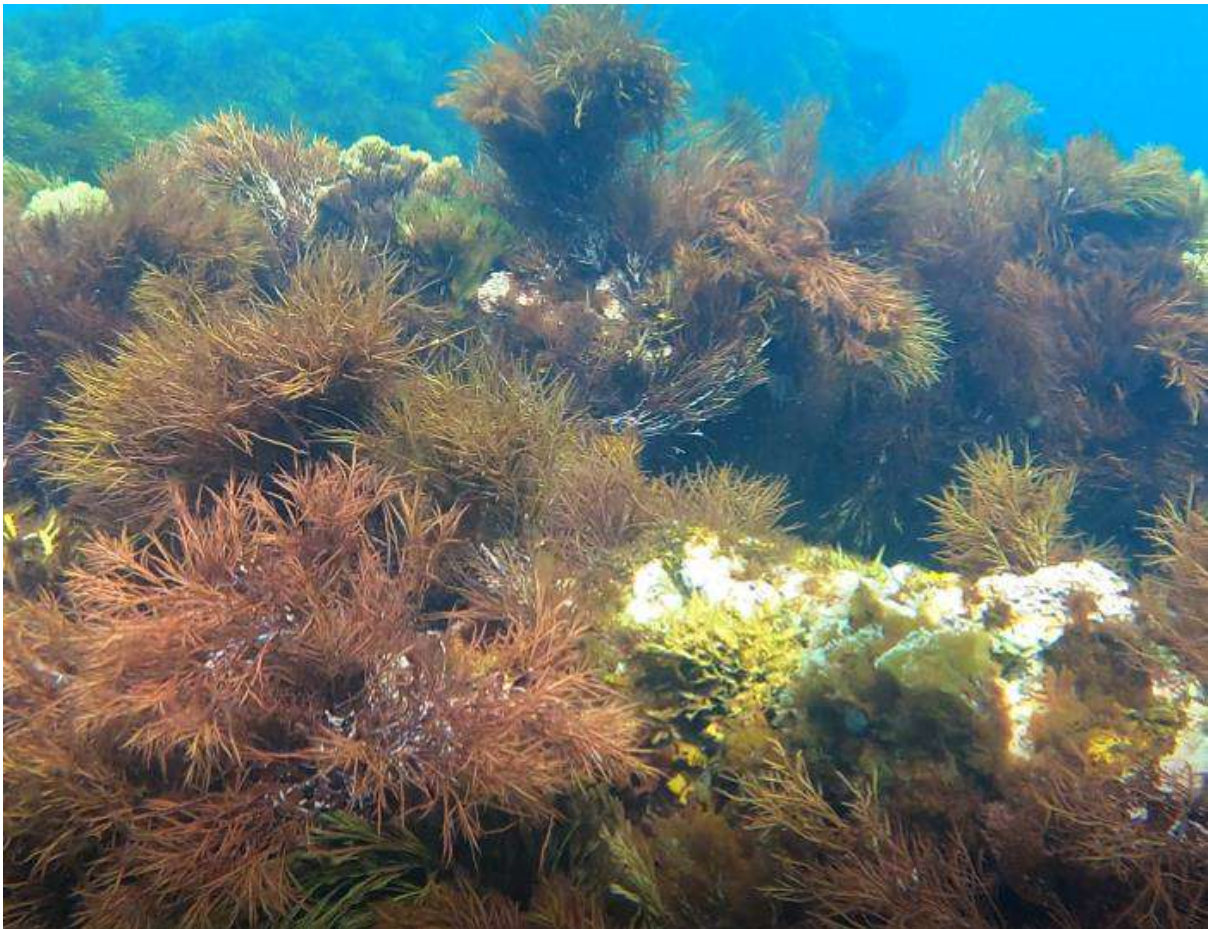
1G.8. ADM1-006 oblique perspective to observe depth of 'U' shape making part of the mainline keelson (2022-01-12, P. Kermeen)

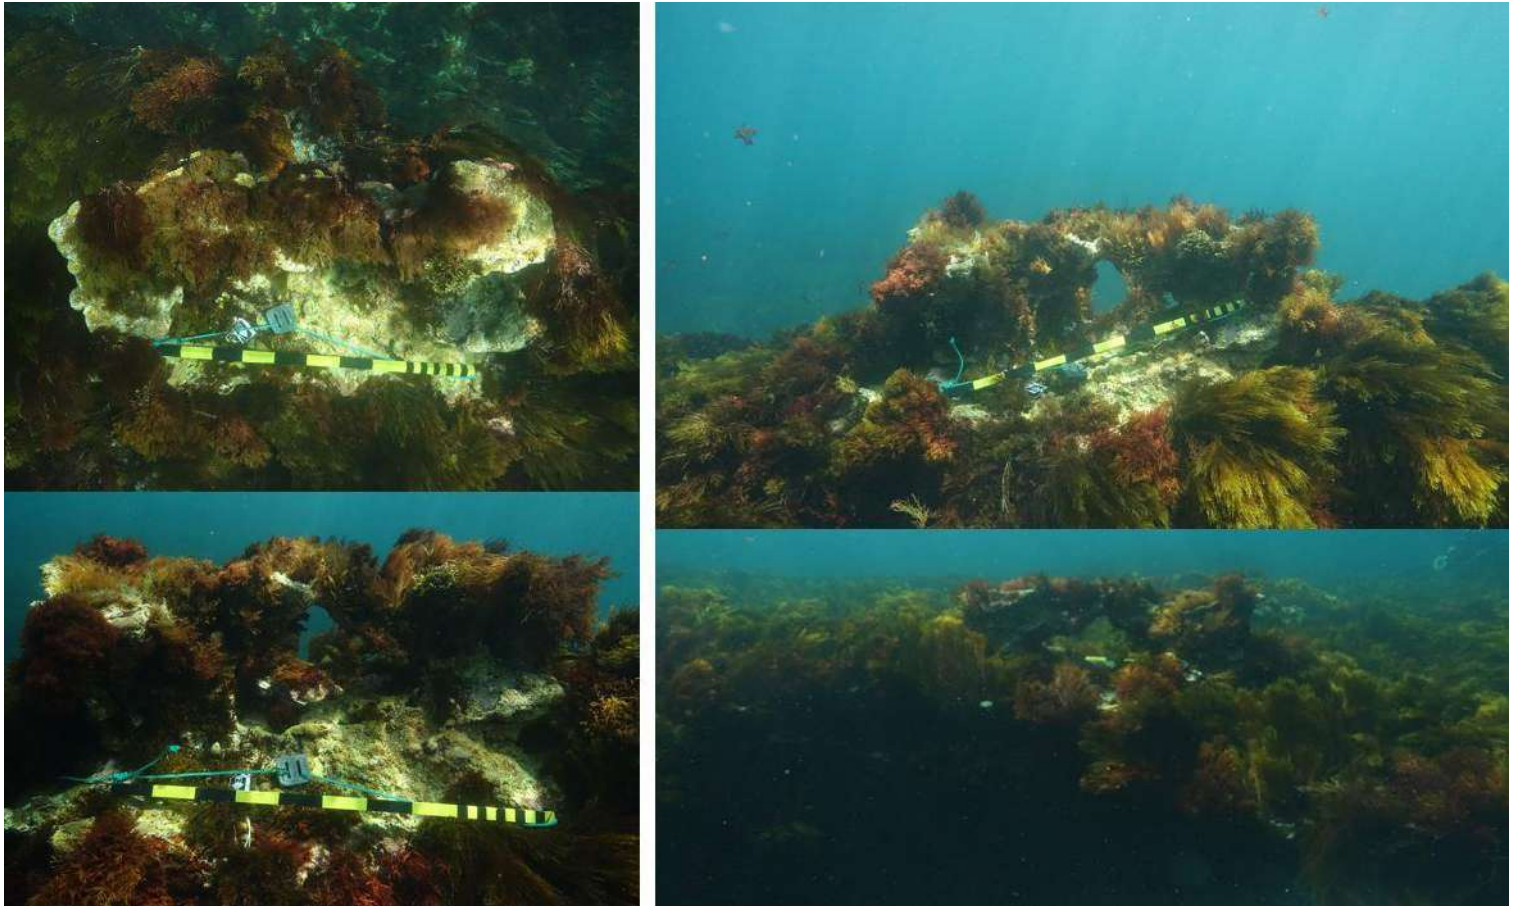
1G.9. ADM1-007 two concreted 'Bitts' from vessel (2022-01-13, P. Kermeen)

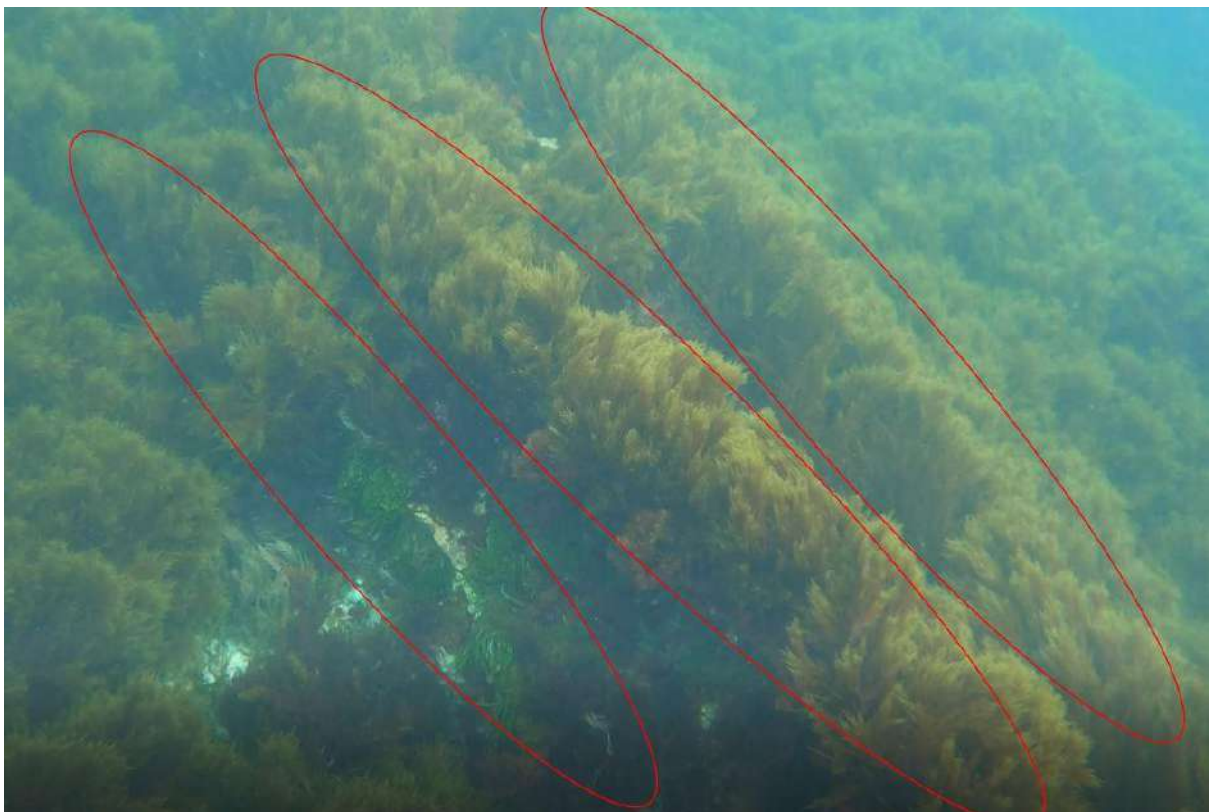
1G.11. ADM1-009, 010, 011 Three elongated ridges potentially bulb iron or single angle iron beams (2022-01-13, P. Kermeen)

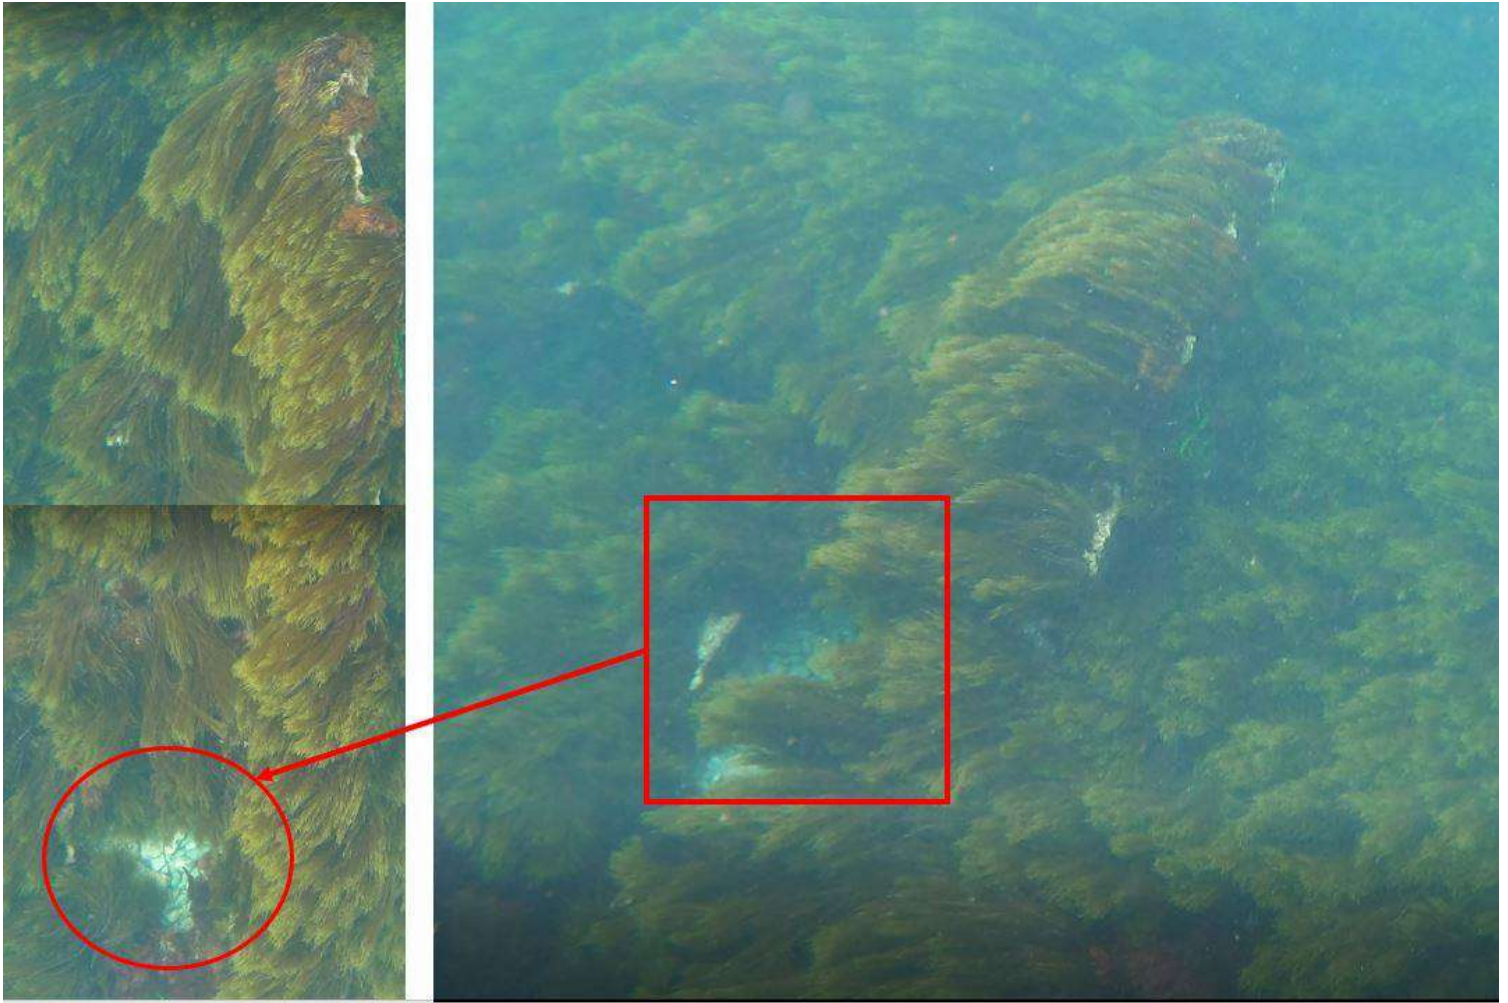
1G.14. ADM1-013 potential remaining hull structure with cats-eye (2022-01-13, P. Kermeen)

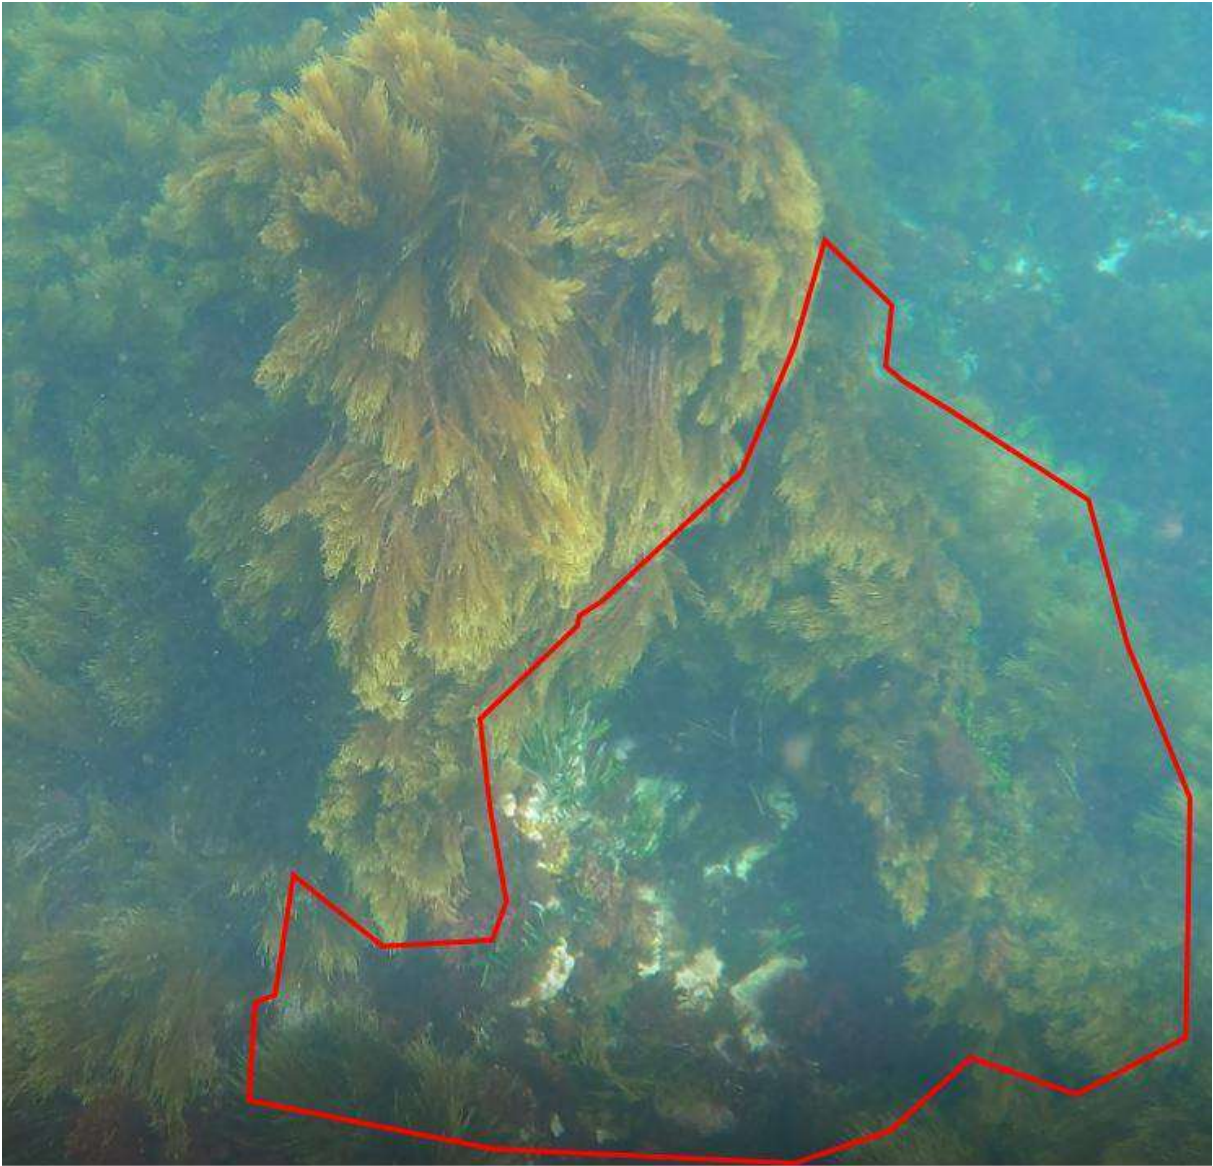
1G.16. ADM1-015 potentially concreted anchor chain (2022-01-13, P. Kermeen)

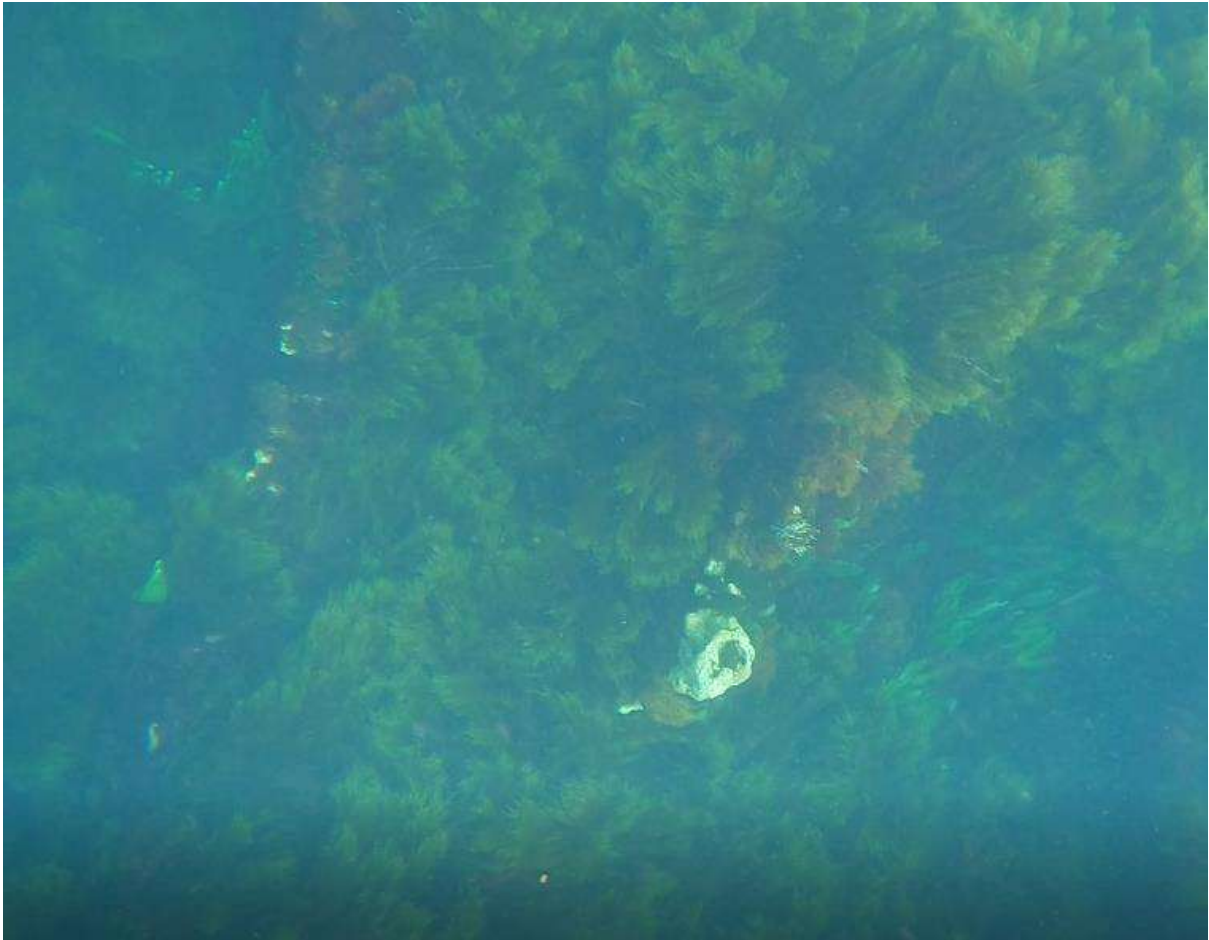
1G.17. ADM1-016 potential semi-box beam (2022-01-13, P. Kermeen)

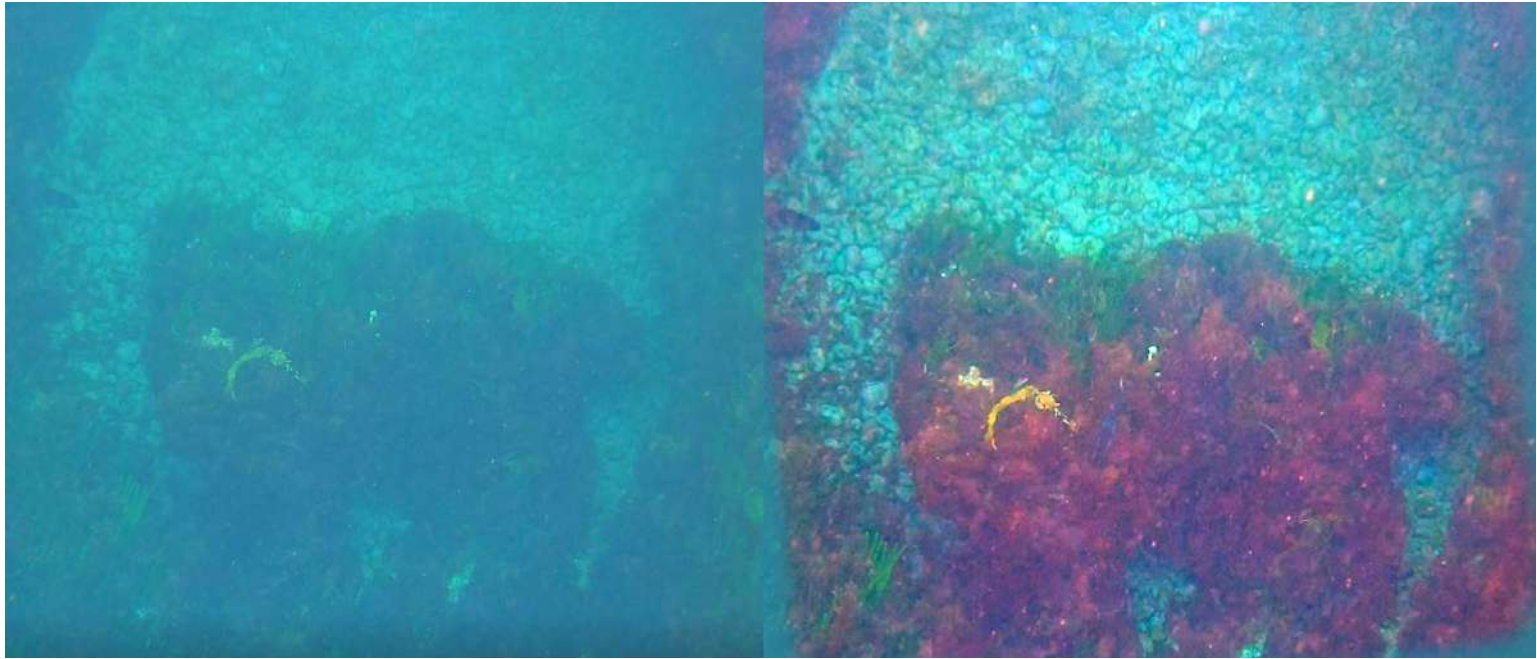
1G.19. ADM1-018 large, concreted structure (2.6 m Length) in fissure at 4.8 m depth (2022-01-12, P. Kermeen)
