How and to what extent can Historical Ship Structural Components be Observed in a Shallow Dynamic Environment?

The Case Study of SS *Admella*

A thesis submitted in fulfilment of the requirements for the degree of: Masters of
Maritime Archaeology.

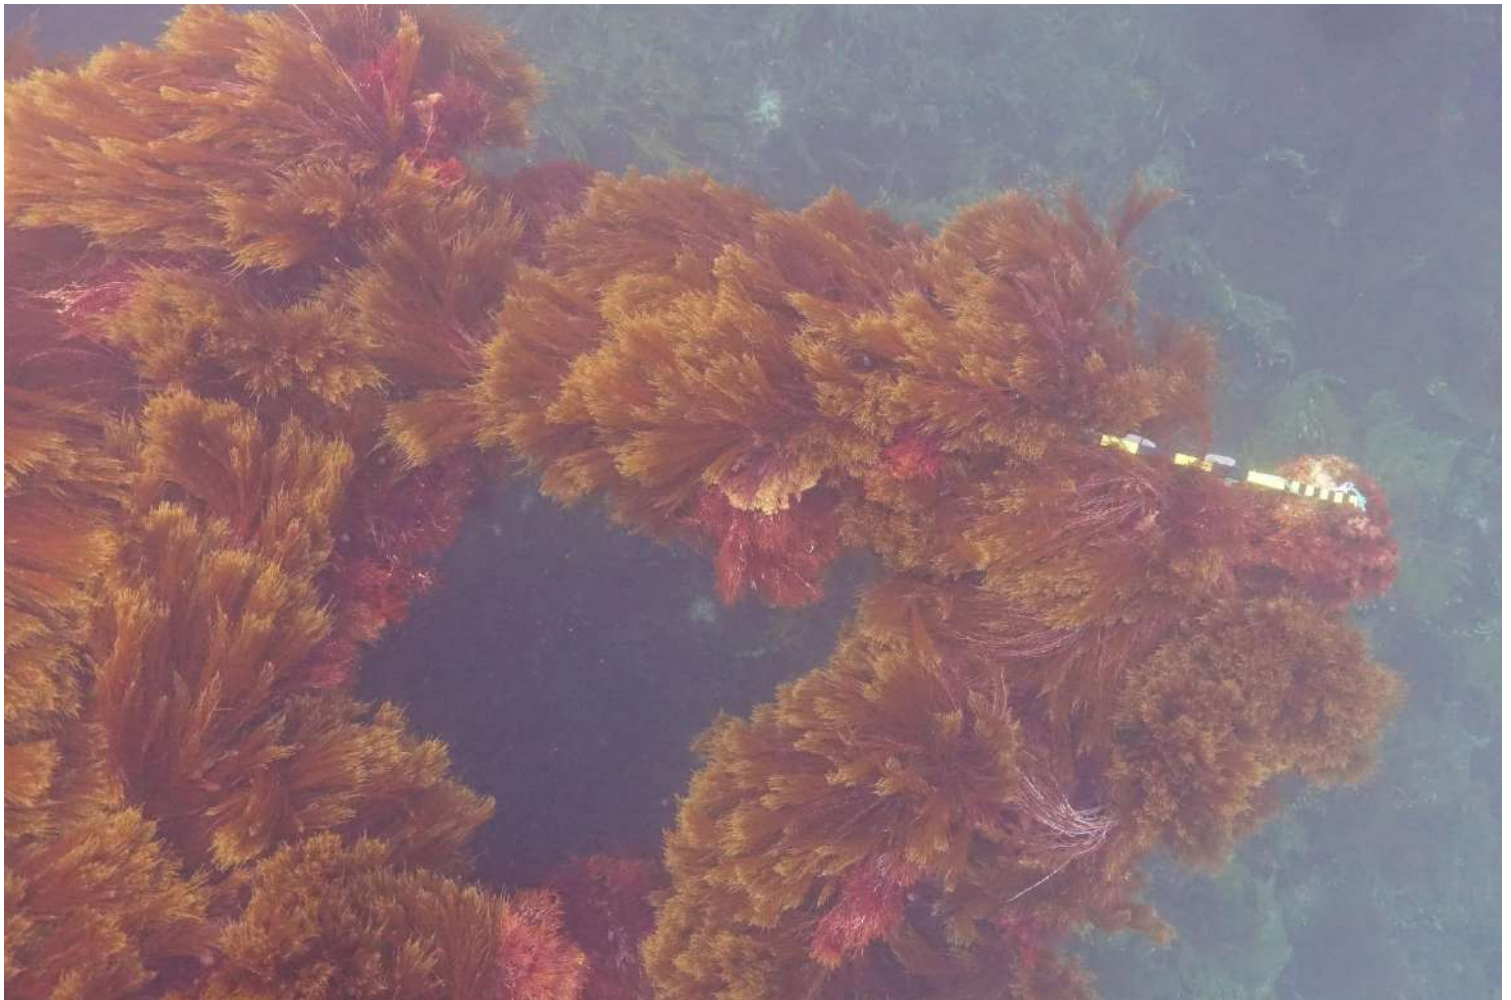
1G.20. ADM1-019 Rudder truck support frame plan view (2022-01-12, P. Kermeen)

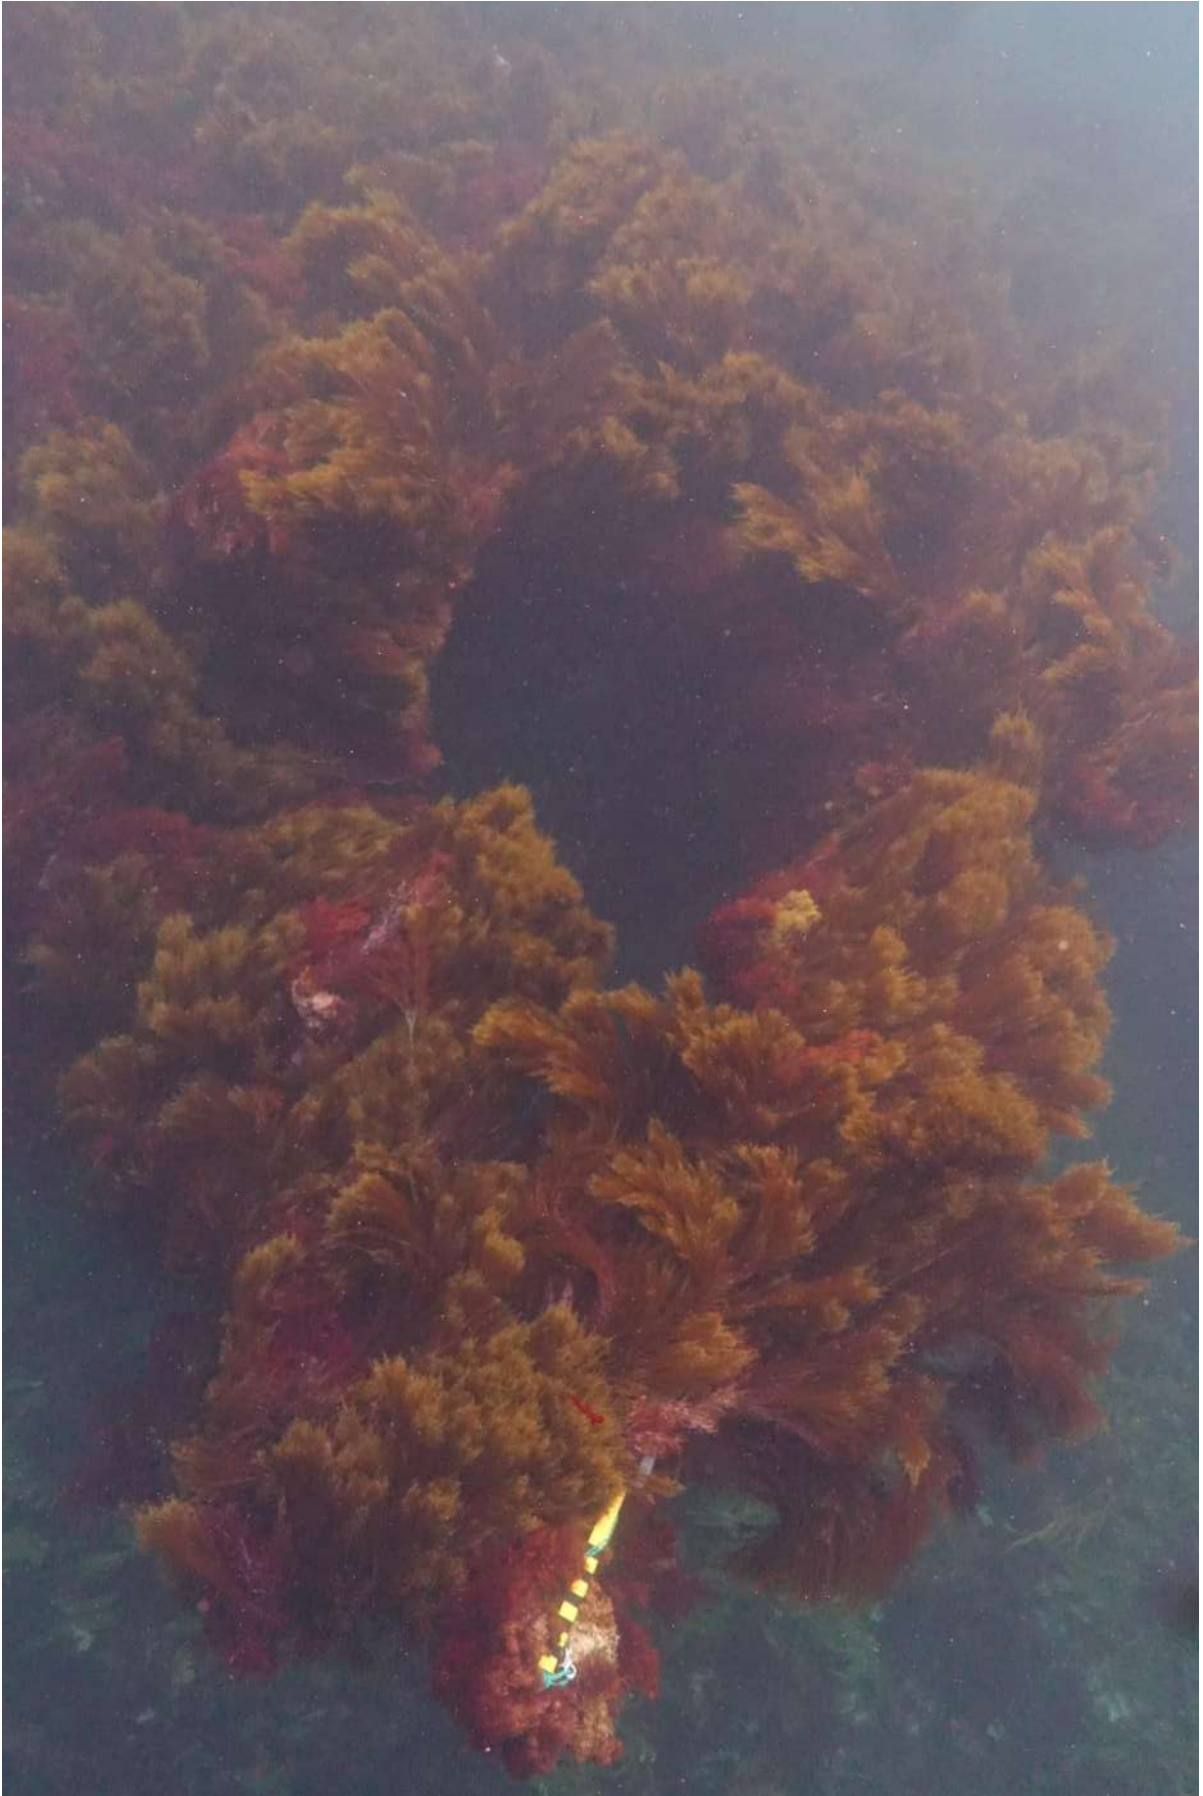
1G.21. ADM1-019 Oblique view of rudder trunk support frame to show extent (2022-01-12)

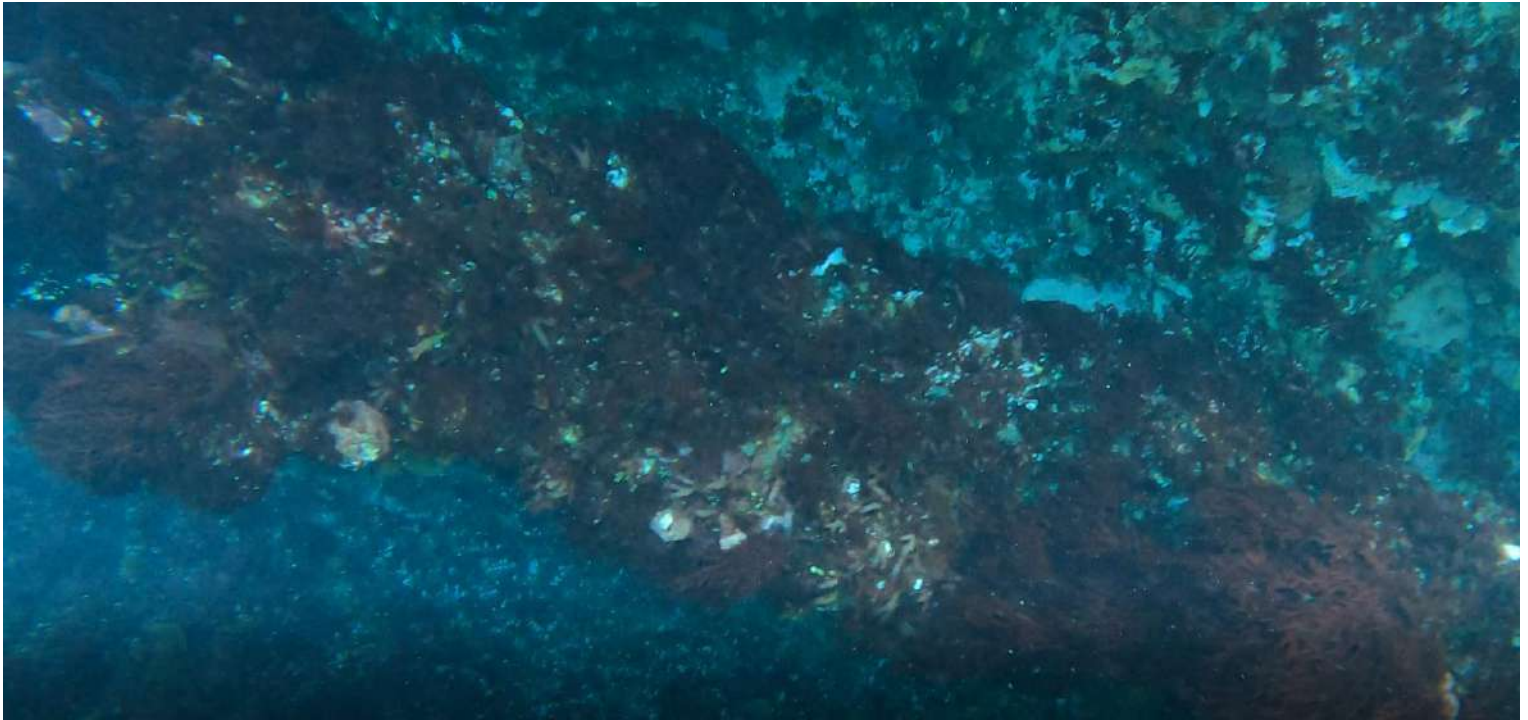
1G.22. ADM1-020 rudder trunk angled support frame heavily deteriorated underneath main 'A' frame (2022-01-12, P. Kermeen)

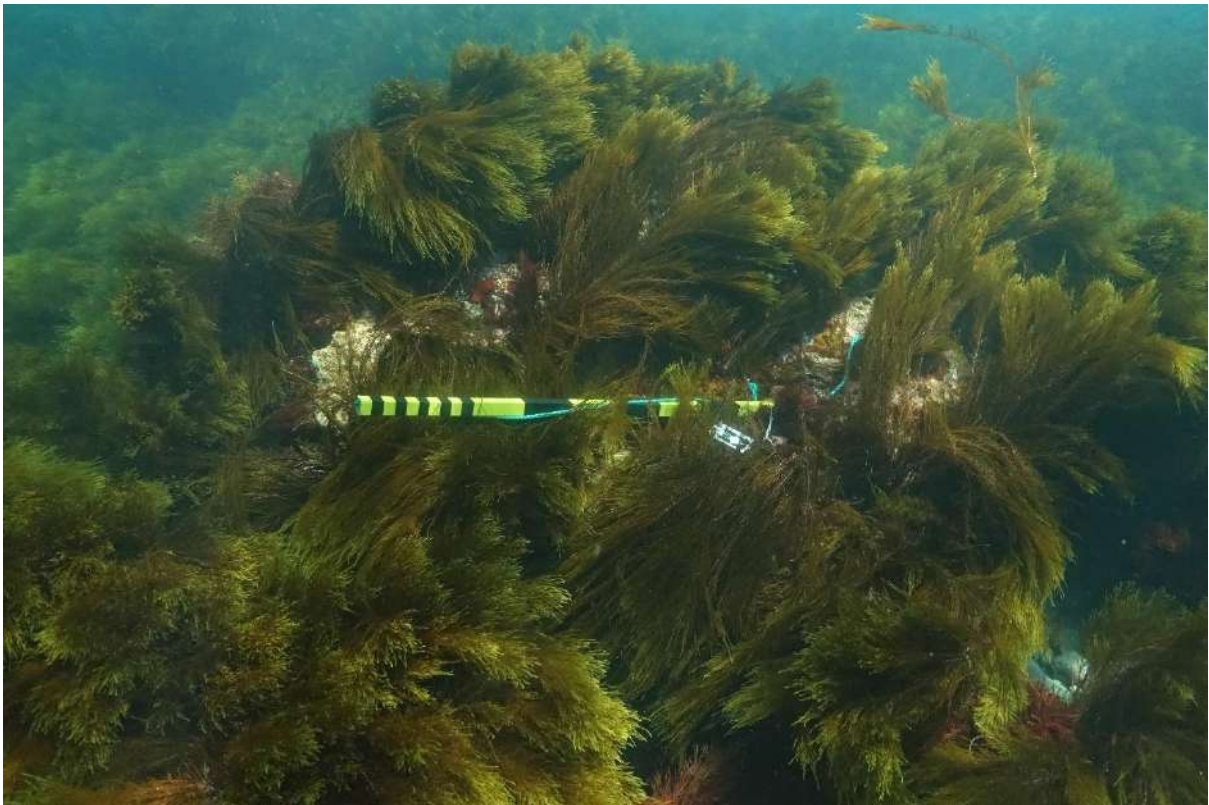
1G.23. ADM1-021 potential arms from anchor with concreted chain (2022-01-13, P. Kermeen)

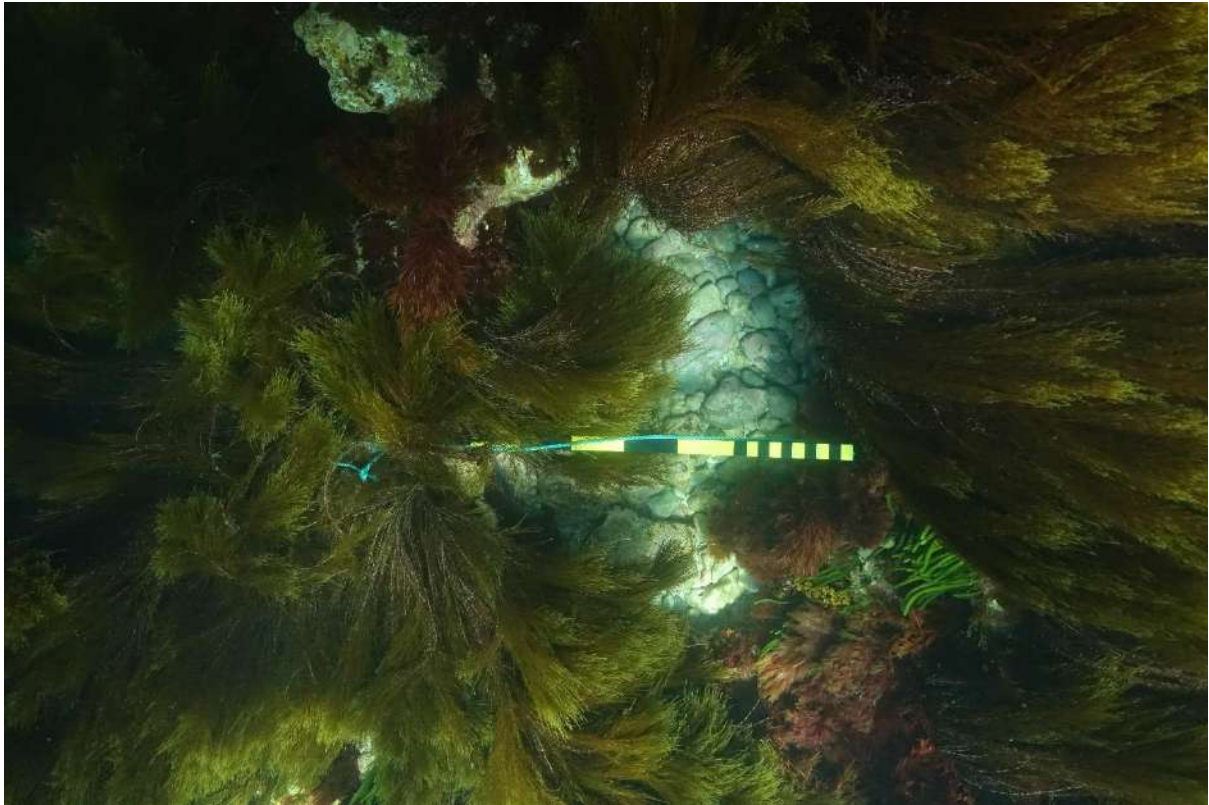
1G.24. ADM1-22 potential cats-eye with concreted hull remains (2022-01-13, P. Kermeen)
