**Shipwright artistry: cultural
transmission of British colonial ship
design and construction during the
eighteenth and nineteenth centuries**

*Thesis
Submitted to Flinders University
for the degree of*

Doctor of Philosophy

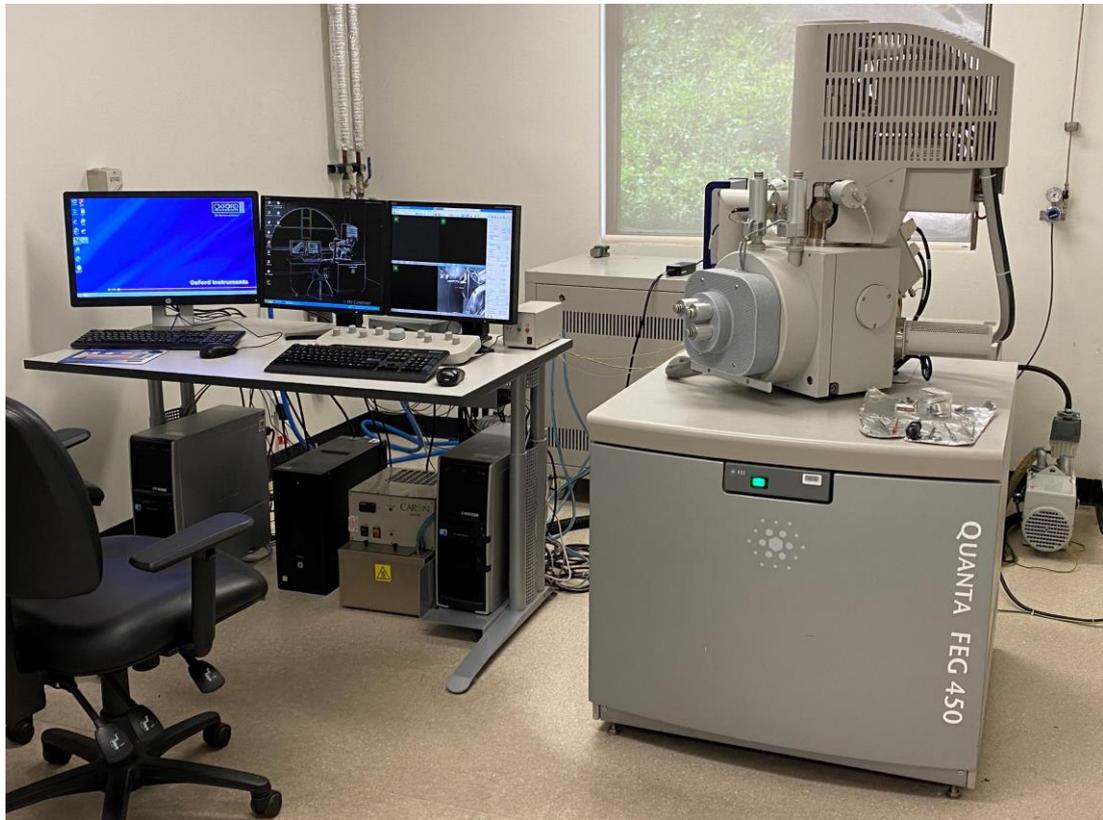
representative in composition of an entire sample. It was aimed to test three areas per sample to ensure similar compositions as a representative sample. Areas from the polished sample that were free of corrosion product and displayed solid metal were chosen for elemental determination.

Figure 43. FEG Quanta 450 with SDD EDS detector (Photograph: Wendy van Duivenvoorde, 2019).

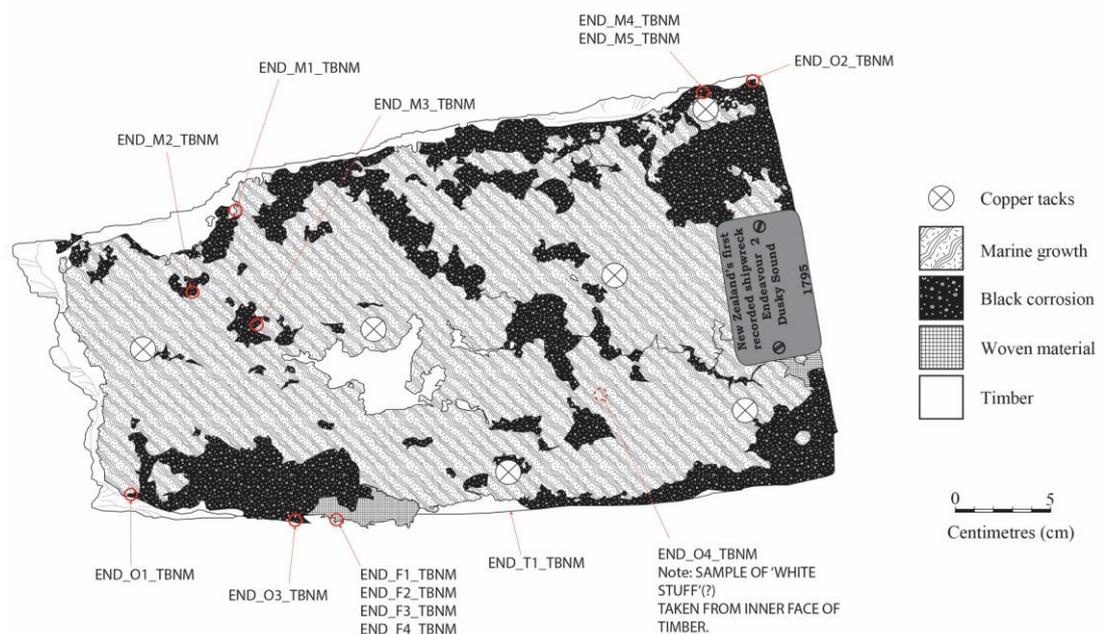
This identified sheathing plank fragment measured 385 mm in length by 203 mm in width and 30 mm thick. It retained evidence of a fabric layer and copper sheathing on the outer face of the timber (Figures 46 and 47). One end shows clear sawing activity demonstrated by saw marks which is likely caused by the modern removal from the original structure. The other end is badly degraded due to the effects of marine organisms and the copper sheathing is heavily corroded.

Figure 46. Outer face of the *Endeavour* timber fragment recorded at the National Museum of the Royal New Zealand Navy.

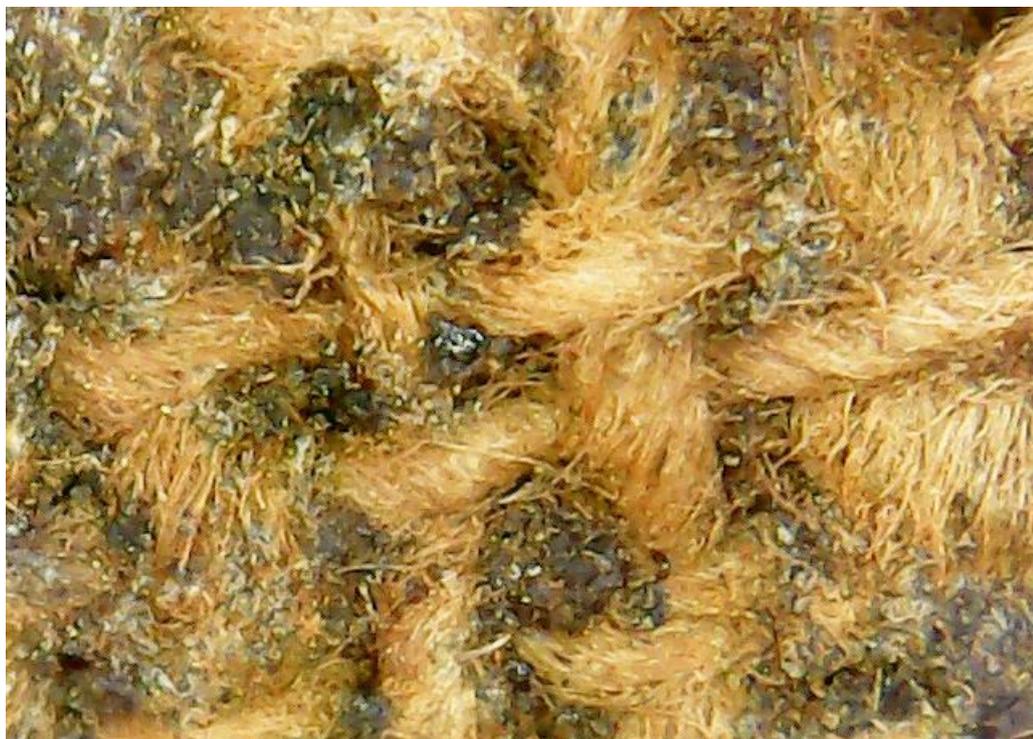
On the outer face of the timber is a layered antifouling structure. This includes a woven matting in a crisscross pattern with each thread measuring 0.1 mm in diameter (Figure 48). The fabric is adhered to the timber using an organic compound. This organic layer was applied directly below the metal sheathing. The sheathing is highly degraded and contains little to no original metal; however, sheathing tacks are present with copper oxidation indicating the area of sheathing coverage. A total of nine sheathing tacks were observed on the inner surface and 10 tacks on the outer surface of the timber. The shanks measured an overall length of 27.5 mm with the head diameters measuring between 13 mm and 14 mm. The positioning of the tacks in the timber resembled a crisscross pattern.

Figure 48. Woven matting recorded on *Endeavour*'s sacrificial timber fragment (2006.1631.14; SYA 0014) held in collection at the National Museum of the Royal New Zealand Navy (thread = 1 mm).

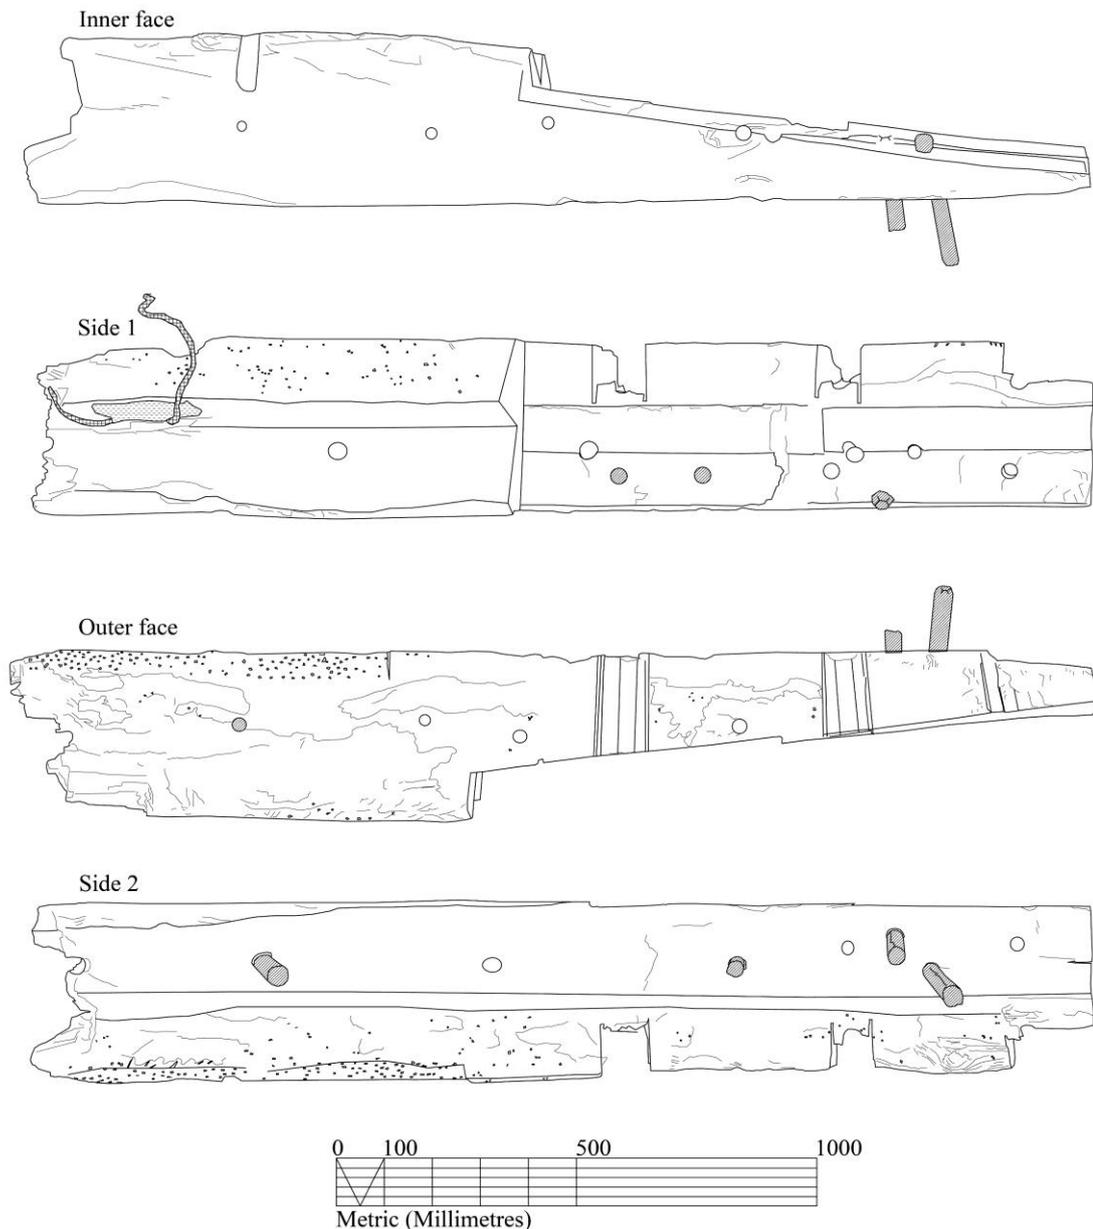
This timber is a broken longitudinal piece of keel (Figure 50). One end is broken, and the break is similar to the broken end on END_002. The timber is slightly weathered and is in a fair condition. The timber measured a preserved length of 2,215 mm. The maximum moulded face measured 365 mm by a maximum 364 mm sided. The original tree was converted as a whole with no bark or sap wood remaining. A diagnostic feature on this timber is evidence of a tabled scarf joint orientated vertically and extending longitudinally along the keel timber. The presence of rabbet lines further suggests this timber fragment is a continuation of END_002. The distance from the bottom of the keel to the outer rabbet line measured an approximate height of 187 mm. Angled recesses were evident at both ends of the timber on face 1 and were measured to determine changes in inclination. The rabbet angles of face 1 measured 23.3 degrees at end 2 and 33.5 degrees at end 1 (broken end). The back rabbet angles measured 72 degrees at end 2 and 58 degrees at end 1. The angles on face 3 were measured on one end of the timber and to where the scarf joint started. At end 1, the rabbet angle measured 34 degrees and 32 degrees at end 2. The back rabbet angles measured 59 degrees at end 1 and 65.6 degrees towards end 2. The depths of the rabbet cut into the keel measured approximately 107 mm and the depths of back rabbet measured approximately 175 mm. Treenails and metal fastenings were present in the timber. A total of five treenails were present and measured 43 mm in diameter. Their lengths could not be measured due to being stuck in the timber. No treenail wedges were present because the ends were either broken off or degraded. Empty bolts holes are positioned vertically through the inner face to the outer face. The diameters of the holes measured 35 mm and are similar in their characteristics to the alloy keel bolts recorded on END_001 and END_002. The magnet detected iron metal in the form of possible iron spikes. While tool marks were present, no construction marks were recorded. Impressions left by a tool measured 27 mm by 11 mm in area and are associated with round tool marks which arc through two of the impressions. It could not be determined if these tool marks were from the original construction or from contemporary salvage activity. In addition, there is evidence of adze workings along the entire length of the inner face.

Figure 50. END_003 keel fragment drawing.

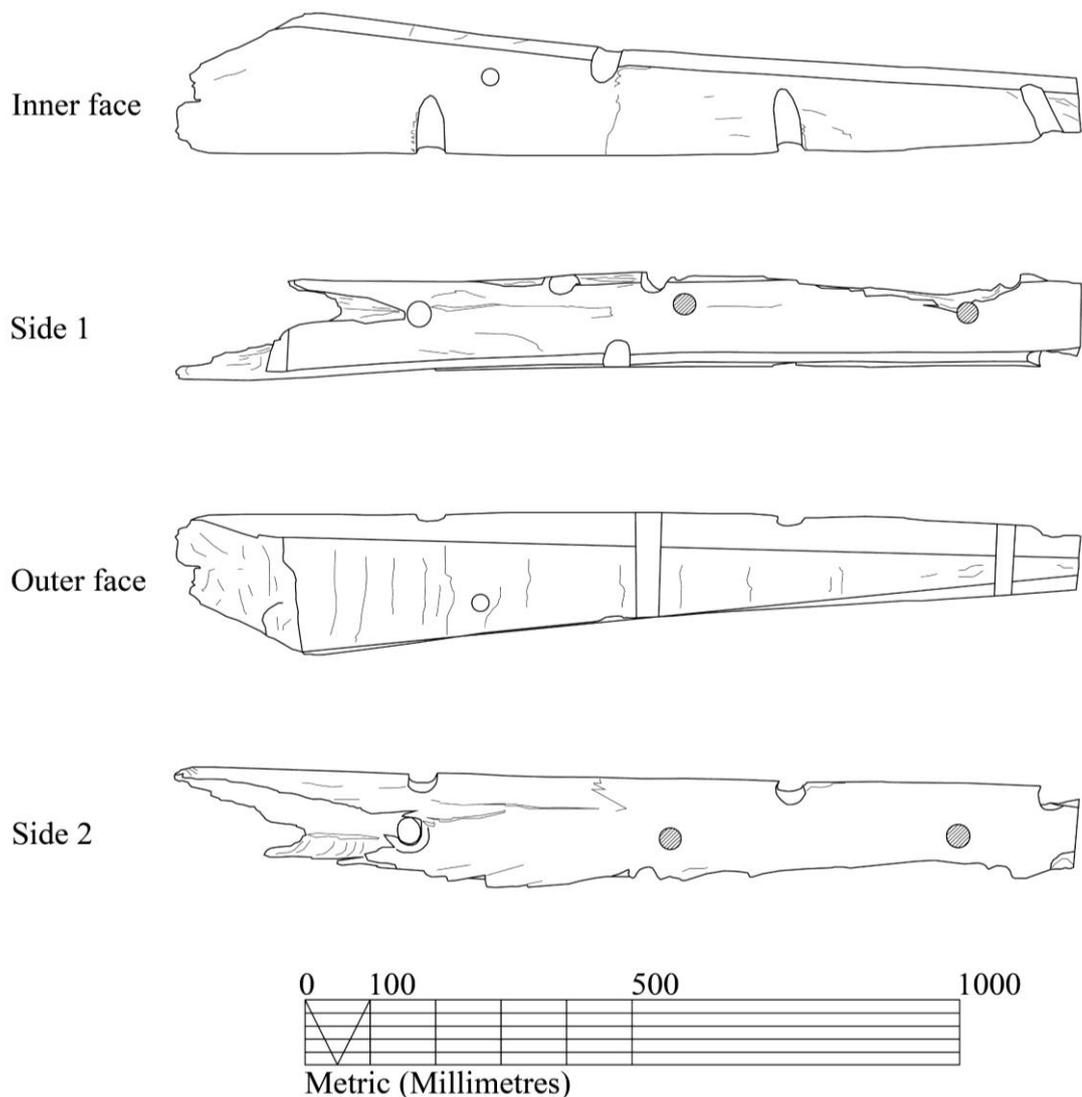
a result of modern salvage activity. The condition of the timber is in a poor state of preservation. Due to the timber having broken and worked edges it was not possible to identify how the timber was converted. The preserved dimensions of the timber measured 1381 mm in length by 183 mm moulded and 179 mm sided. A rabbet line is present on one face of the timber and measured between 64.8 degrees to 73 degrees. The length of the rabbet line could not be measured because neither side was preserved. Treenails and evidence of metal fasteners are present in the timber. The one extant treenail measured 40 mm in diameter with no wedge present. The timber contains one round ferrous metal fastener that measures 33 mm in diameter. The exact length of the fastener was not measured as it was corroded at both ends. No surface coverings were present on the timber and no evidence of sheathing tack holes were observed. The recesses on the scarf joint were recorded as construction marks. The recesses measured 23 mm deep by 13 mm. No samples were collected.

Figure 51. END_015 keel fragment drawing.

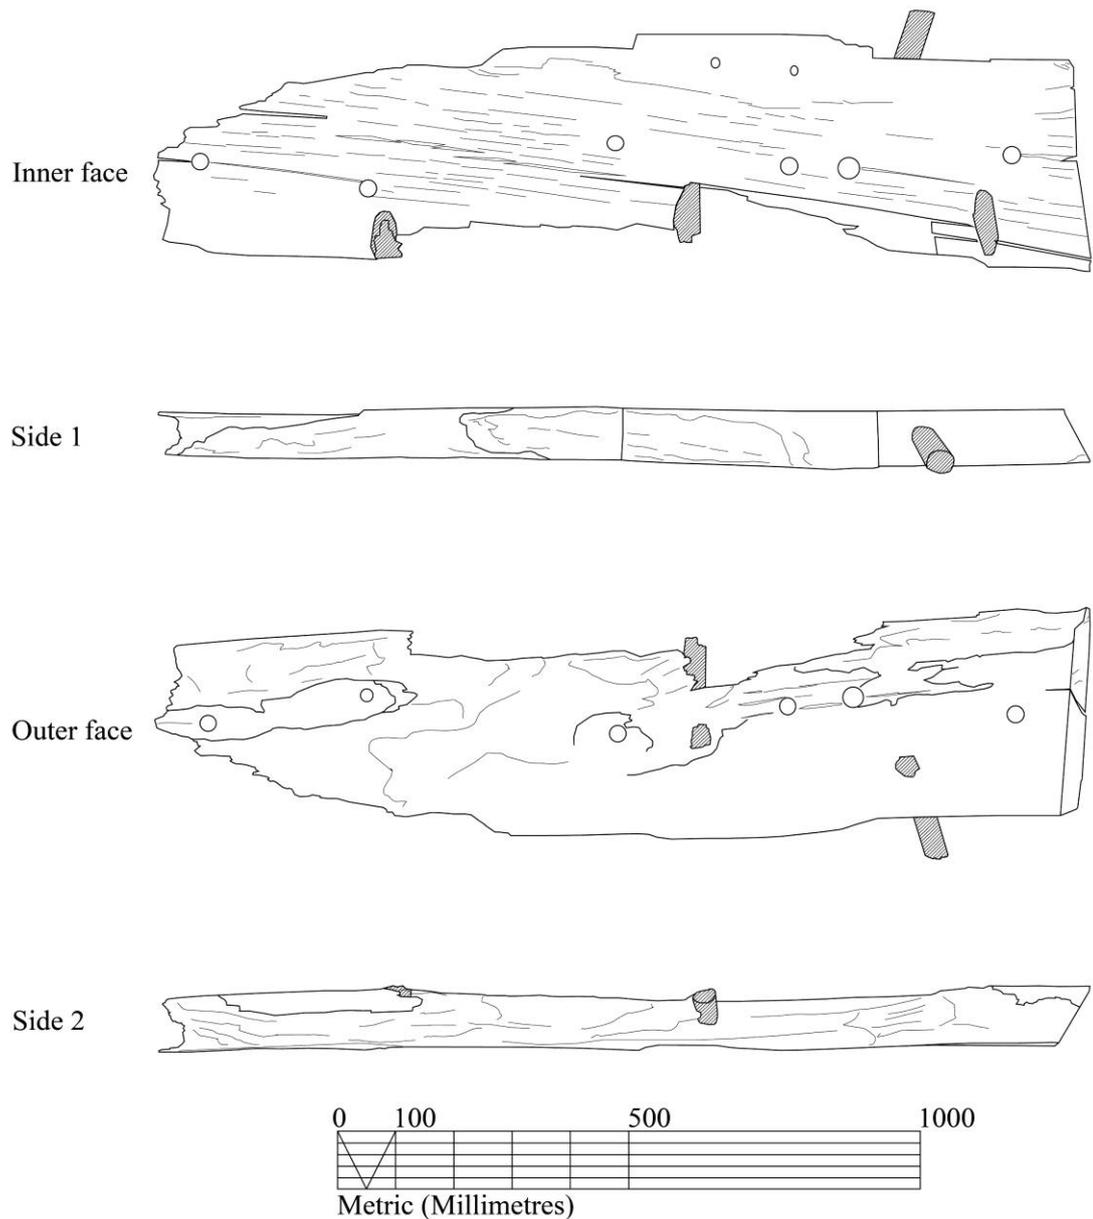
This timber fragment is identified as a possible part of the keel or keelson and as a possible continuation of END_006 (Figure 52). It appears to be an interior face of the same type of timber used as the keel. There are also notches cut into the inner face. The current condition of the timber is poor and therefore the timber joints are undiagnostic at the time of recording. The parent tree was halved during the conversion process. The preserved dimensions measure 1,598 mm in length, 327 mm moulded and 98 mm sided. Although the timber is probably part of the keel, there is no evidence of a rabbet line. The timber contains wooden and metal fasteners. Four extant treenails measured 41 mm in diameter; however, there is no evidence of wedges in the treenails. The magnet confirmed ferrous round fasteners and measured 31 mm in diameter. Due to the absence of original lengths, their extent was not measured. No evidence of surface coverings was present nor any sheathing tack impressions. The timber displayed both construction and tool marks, the construction marks shown in the form of possible scoring marks and divots, and tool marks were identified as possible saw marks. Two wood samples were collected for identification. These were T01 from the main timber fragment and T02 from a treenail.

Figure 52. END_017 keel fragment drawing.

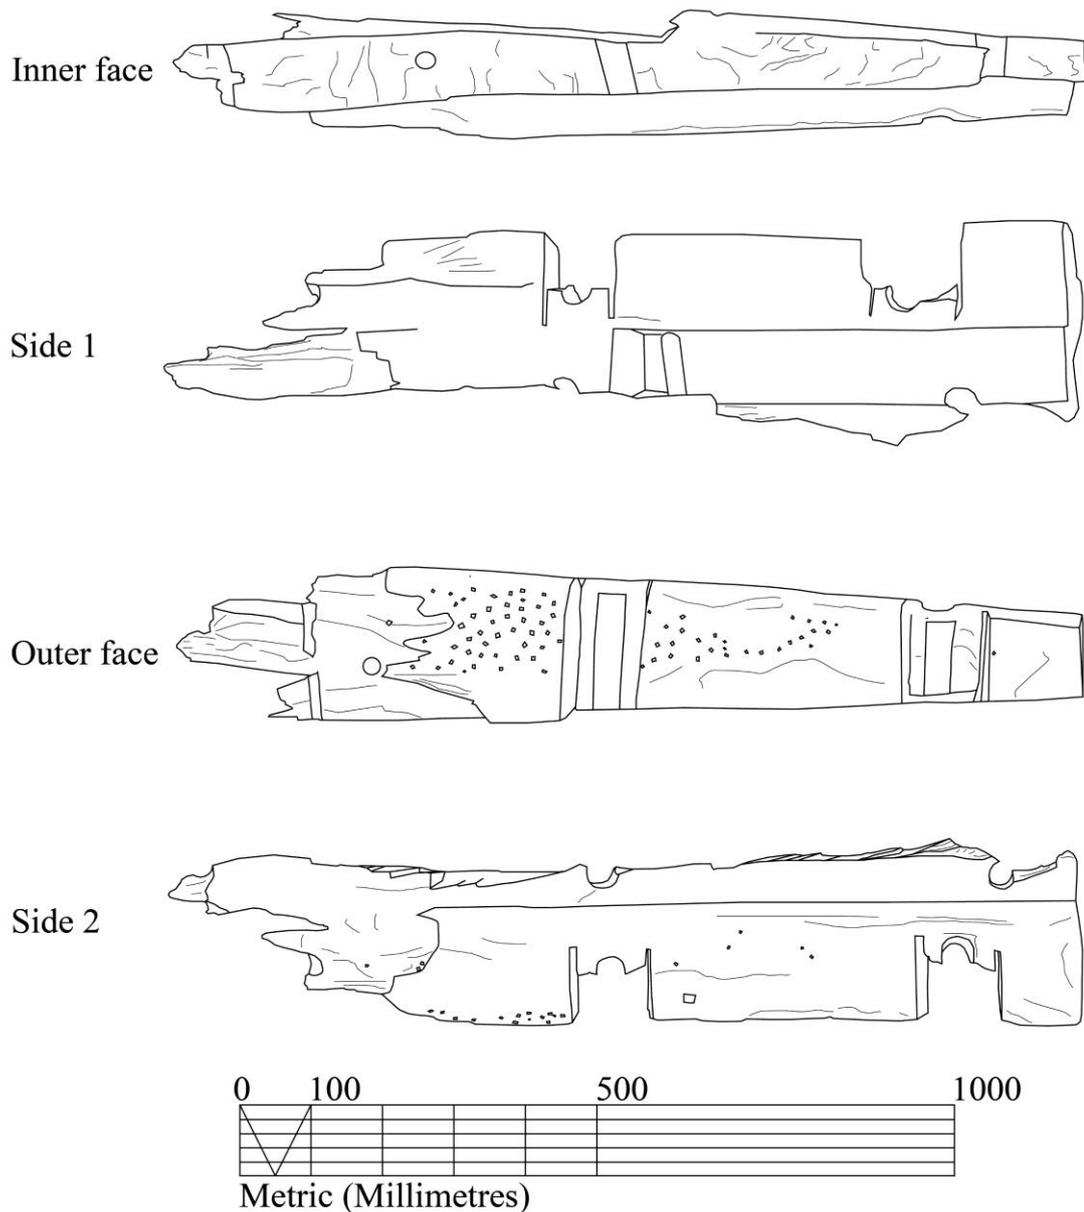
line measured 89 mm and intersected the bottom recess. The bottom recess measured 77 mm from the outer rabbet line to the back rabbet line. All rabbet measurements were to broken edges and therefore, do not reflect the maximum measurements of the original dimensions. The timber has no extant remains of metal or timber fastenings, although there are holes that suggest fasteners were originally fixed in the timber. The treenail holes measured 41 mm in diameter and the metal fastener holes measured 38 mm in diameter. The suspected metal fastener holes have copper alloy residue around the perimeter and extend through the entire thickness of the timber. It is likely these holes match those recorded in END_007 that housed copper alloy keel bolts. The timber only contains wooden and copper fasteners. No extant surface coverings were on the timber, although there was evidence of a possible fibrous substance along the rabbet. Tack impressions, however, are visible on the outer face of the timber. These tack holes measured up to 5 mm by 7 mm in area on the surface and up to 27 mm in depth in the voids. No construction or tool marks were recorded on the timber. One wood sample was collected for identification. The fibre substance was not sampled because END_002 provided a better-preserved fibre sample for analysing caulking along the rabbet line.

Figure 53. END_026 keel fragment drawing.

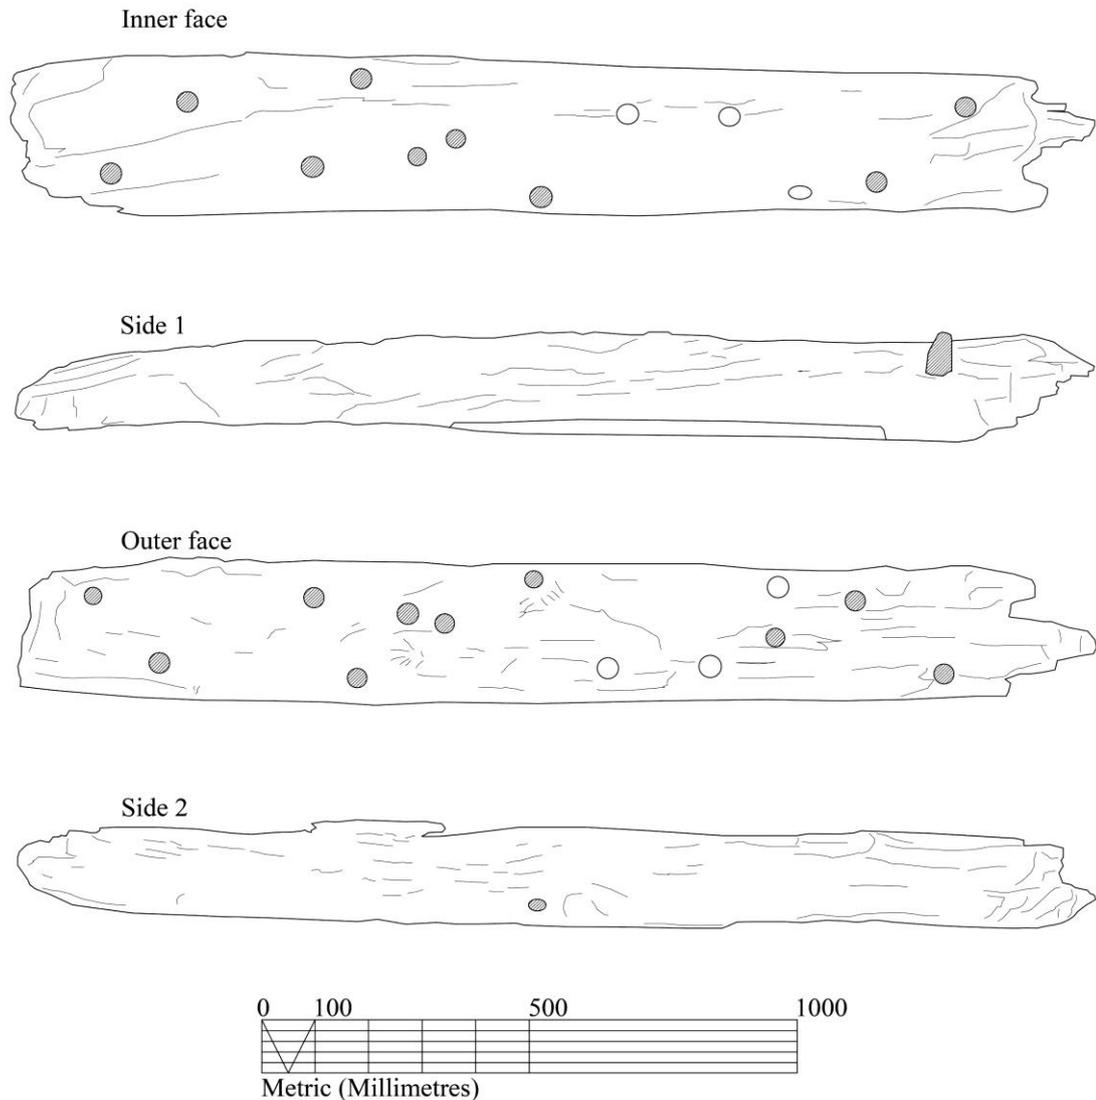
Figure 54. END_007 futtock drawing.

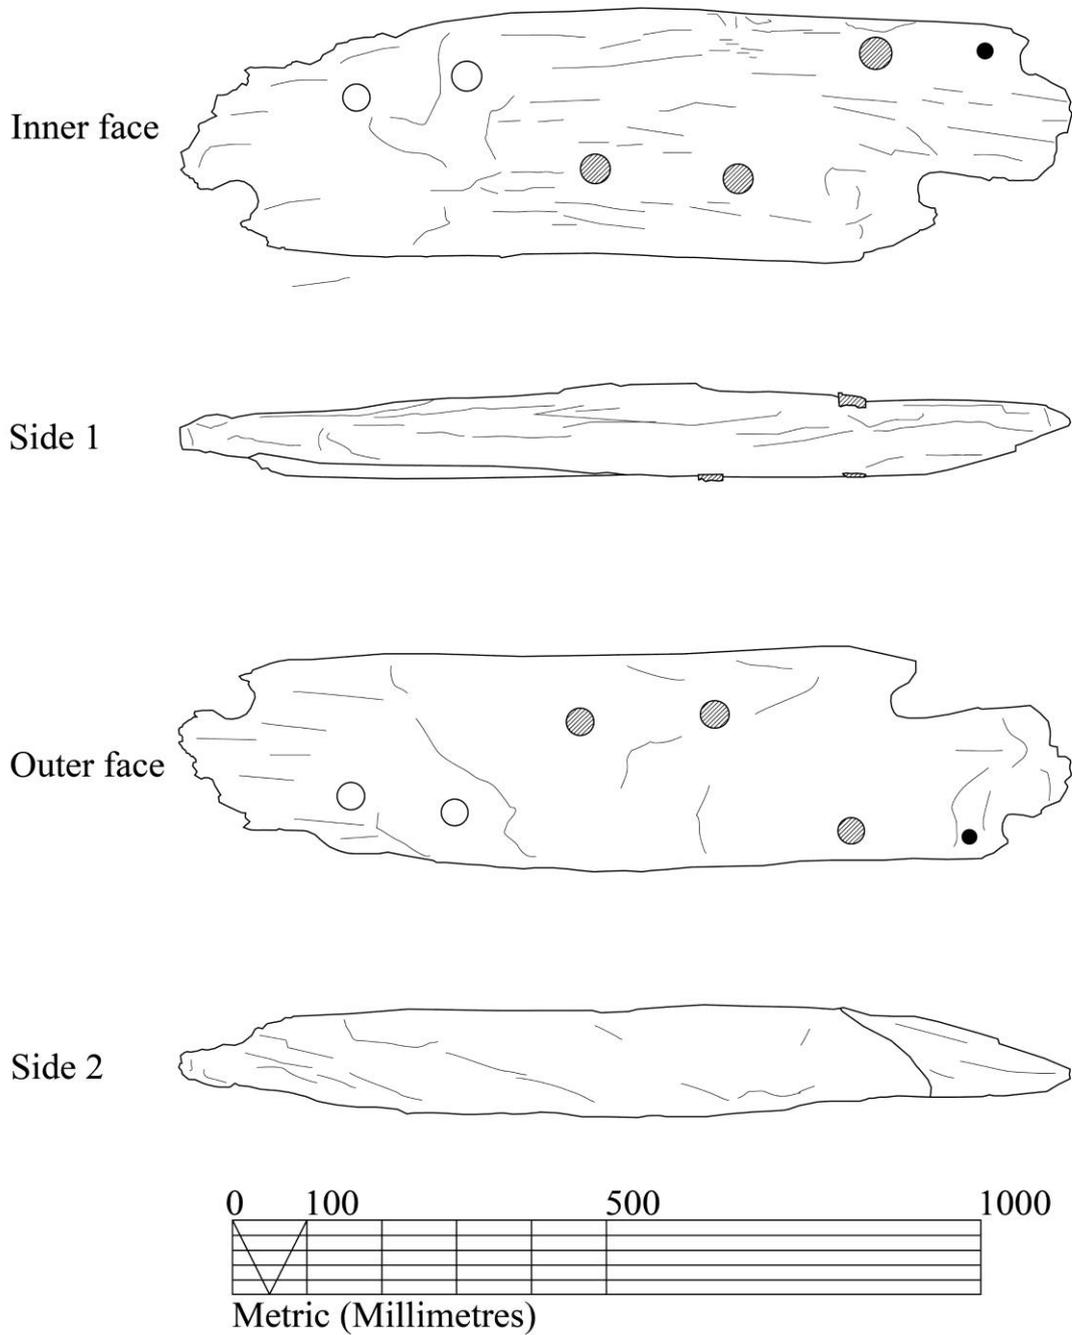
Figure 55. END_013 futtock drawing.

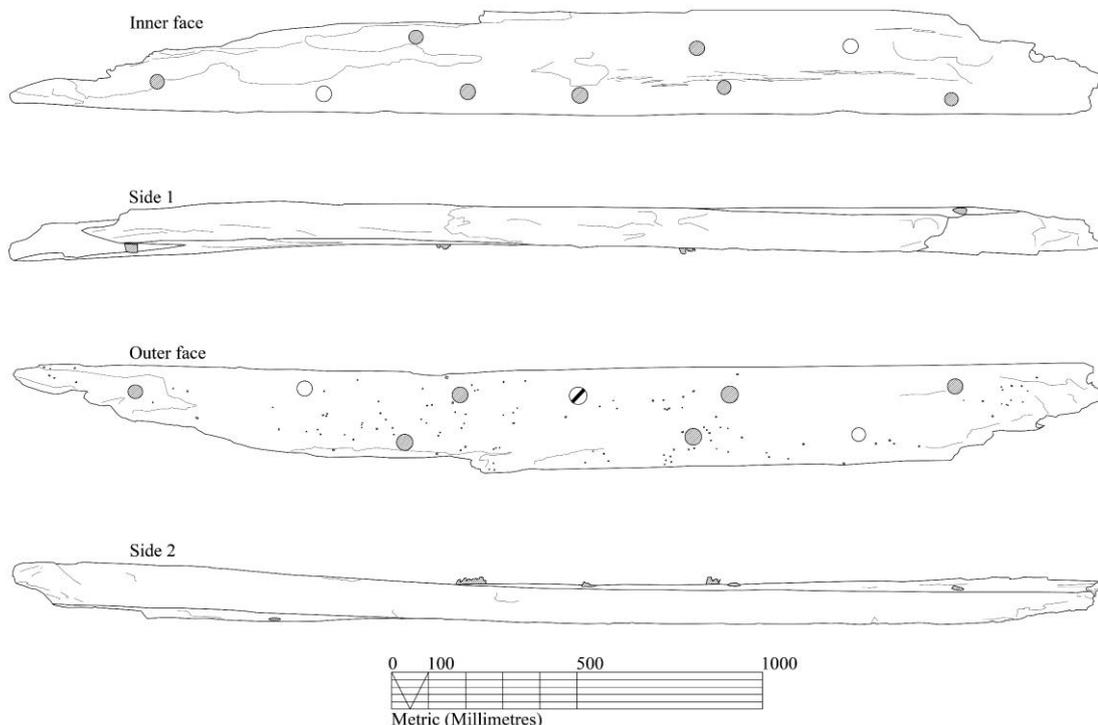
Figure 56. END_019 garboard strake drawing.

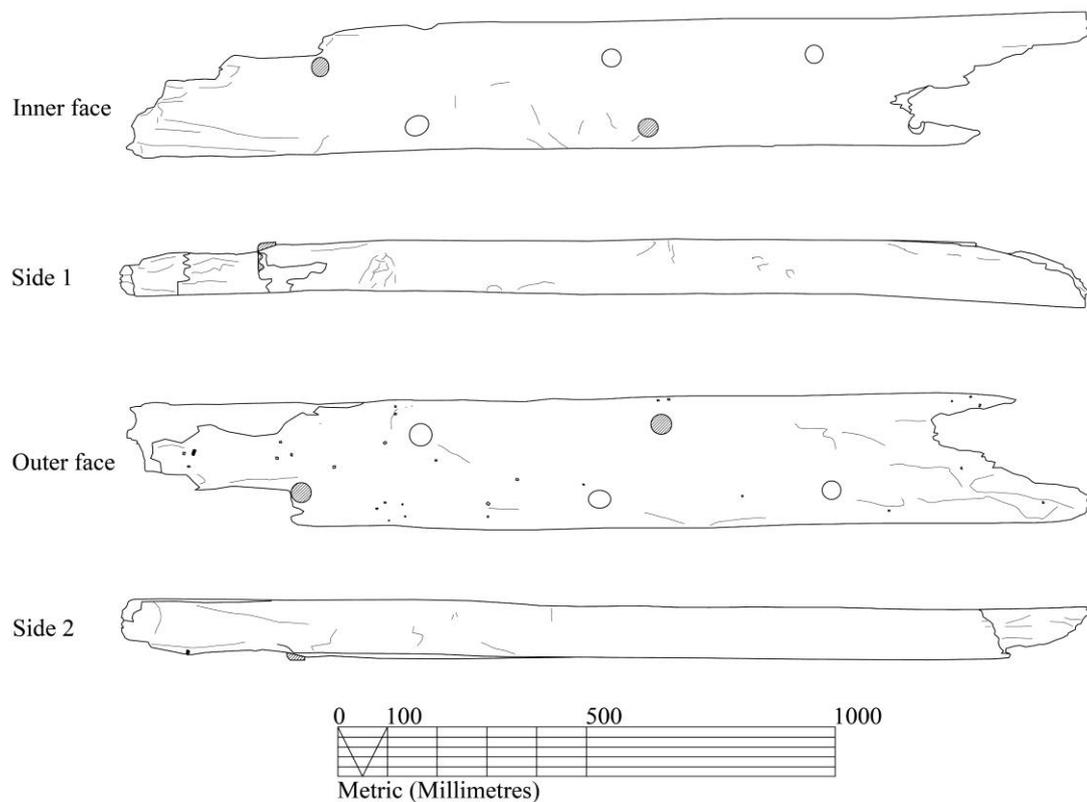
Figure 57. END_010 outer hull plank fragment drawing.

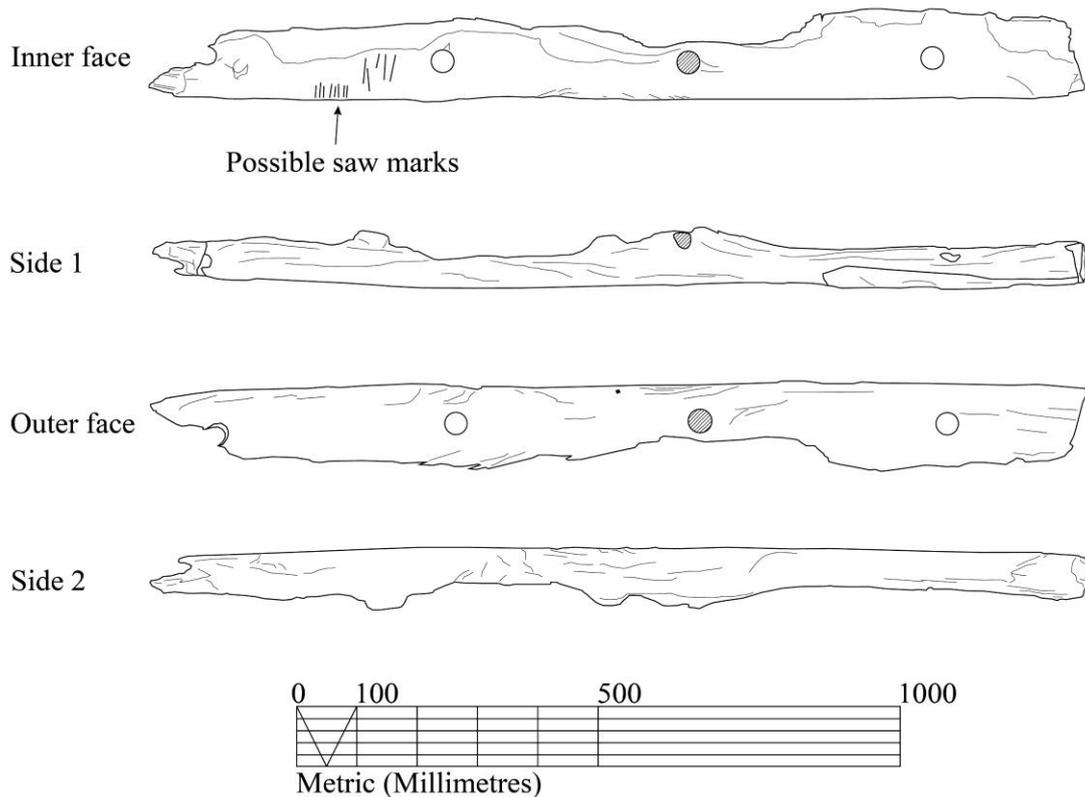
Figure 58. END_011 outer hull plank fragment drawing.

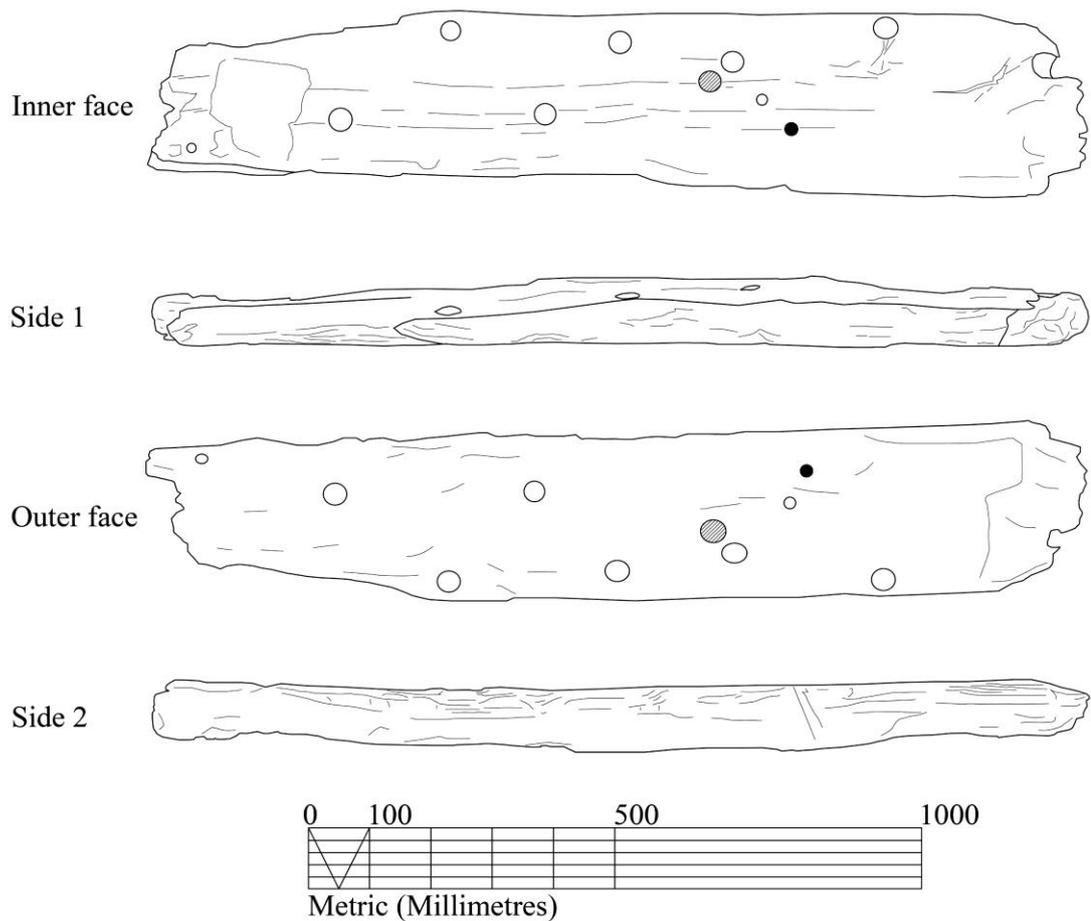
Figure 59. END_012 outer hull plank fragment drawing.

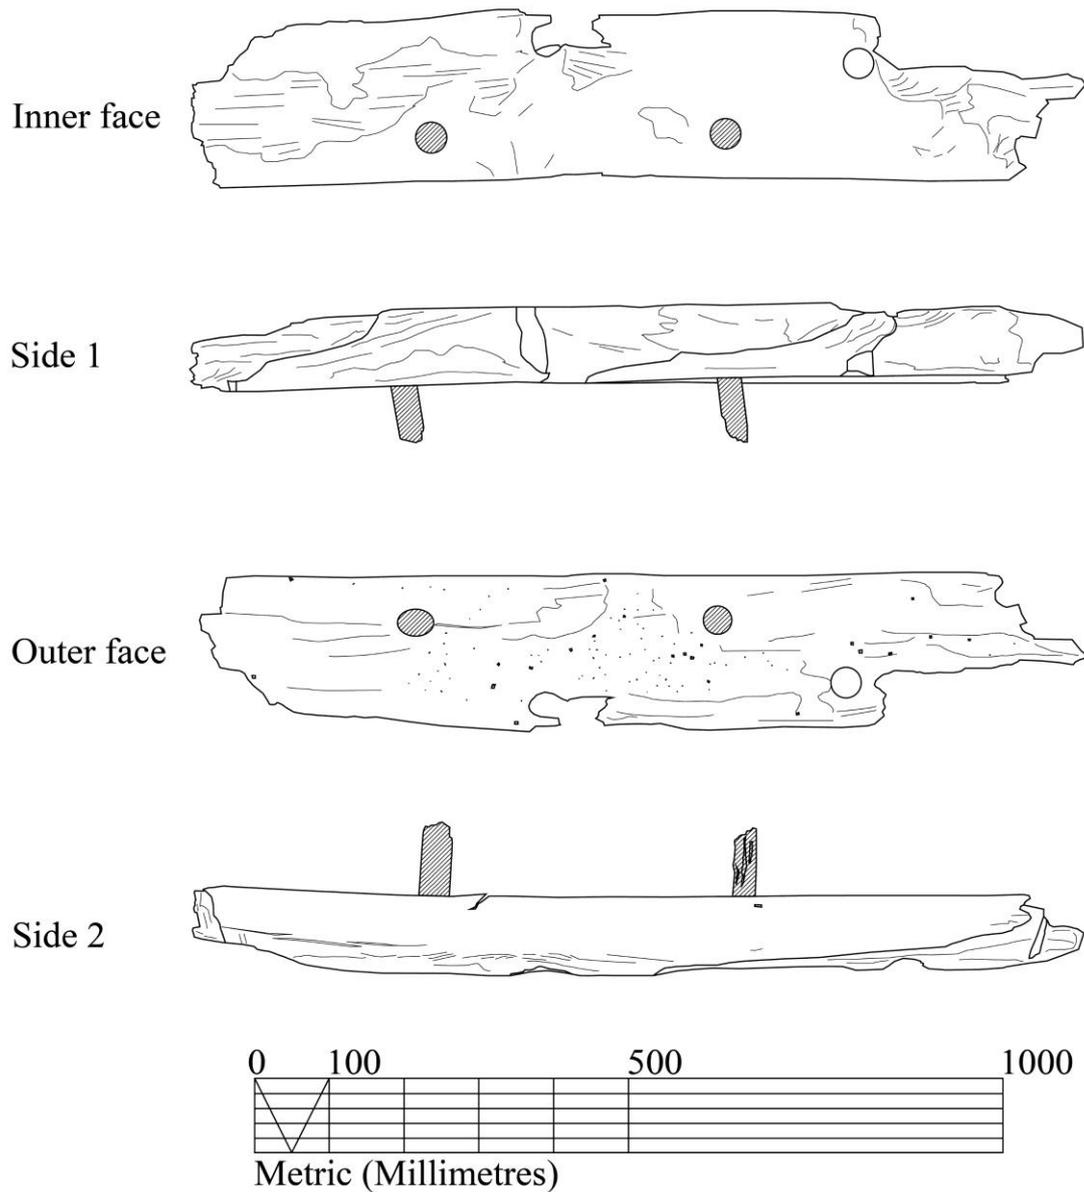
Figure 60. END_014 outer hull plank fragment drawing.

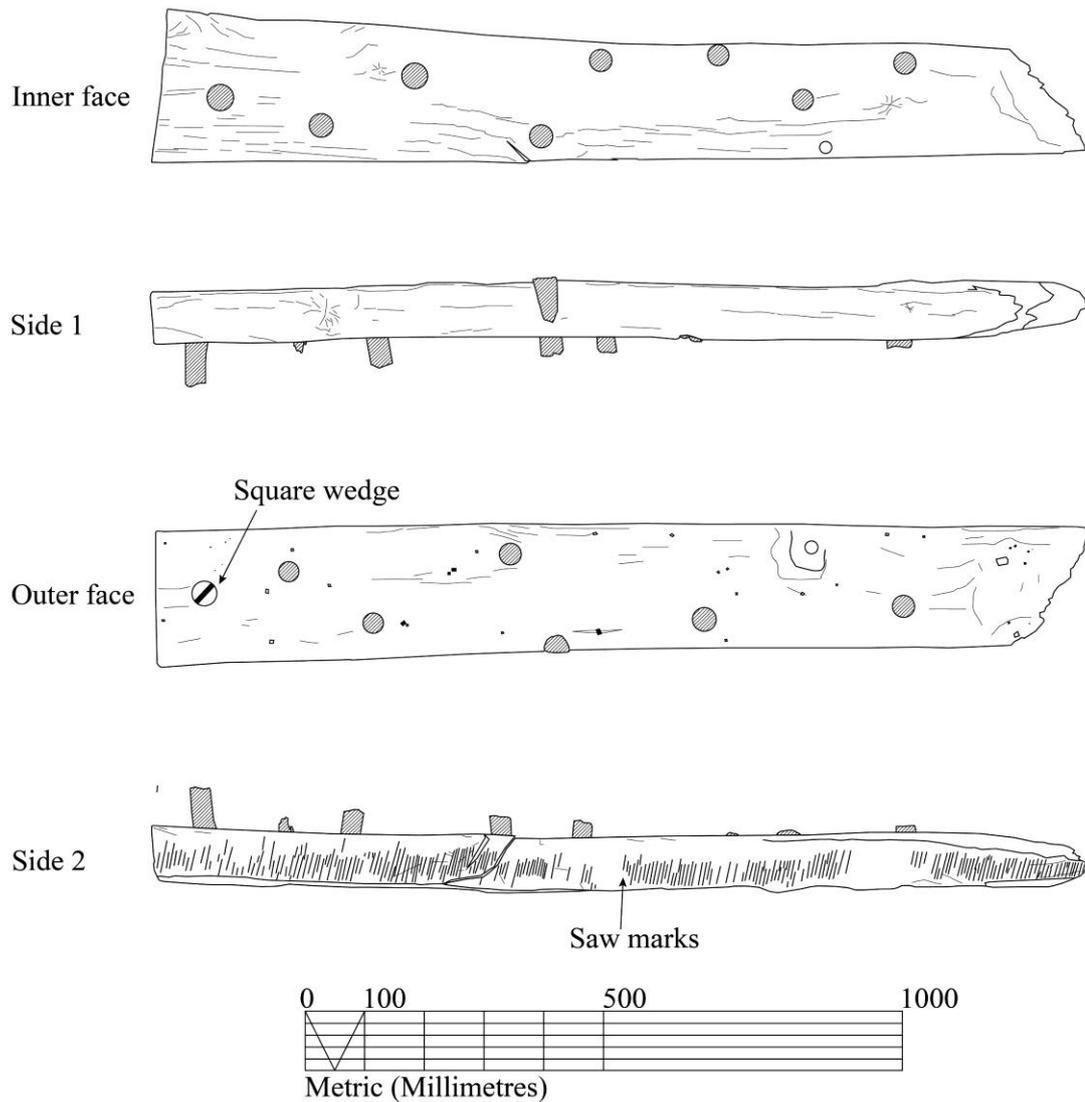
Figure 61. END_016 outer hull plank fragment drawing.

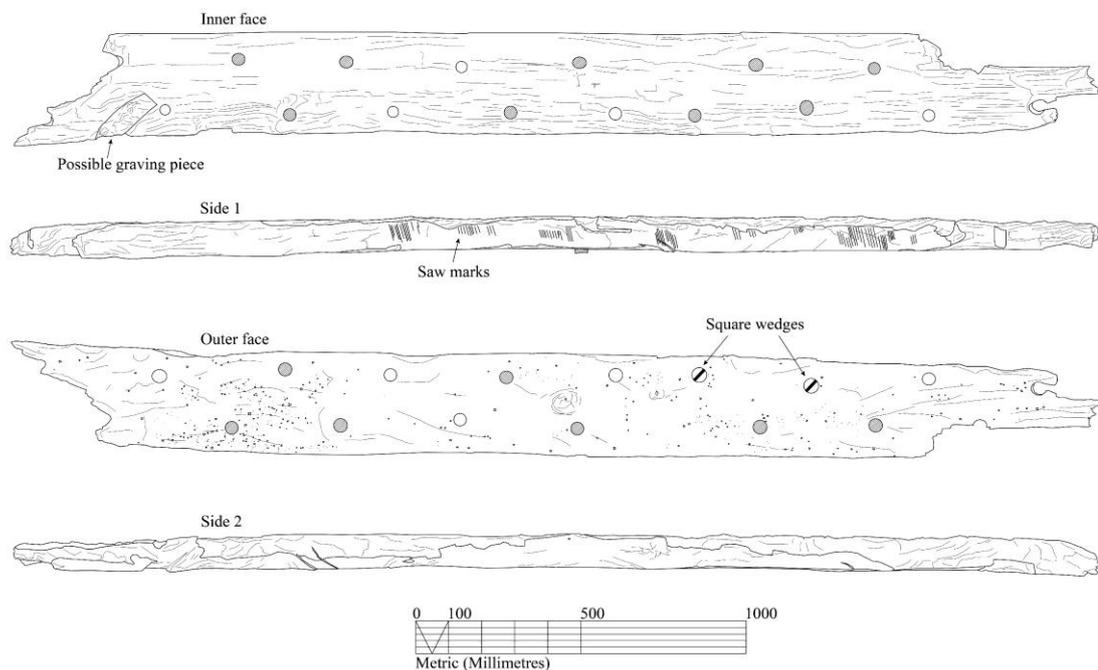
Figure 62. END_018 outer hull plank fragment drawing.

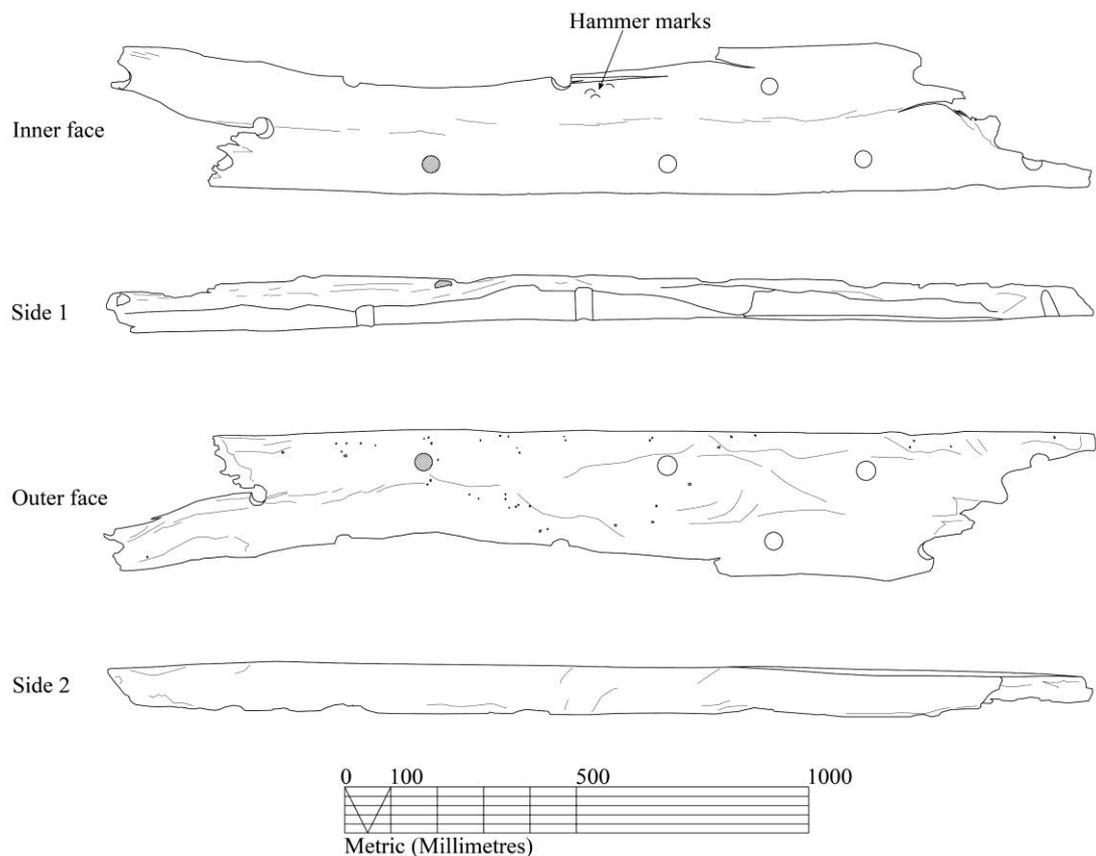
Figure 63. END_020 outer hull plank fragment drawing.

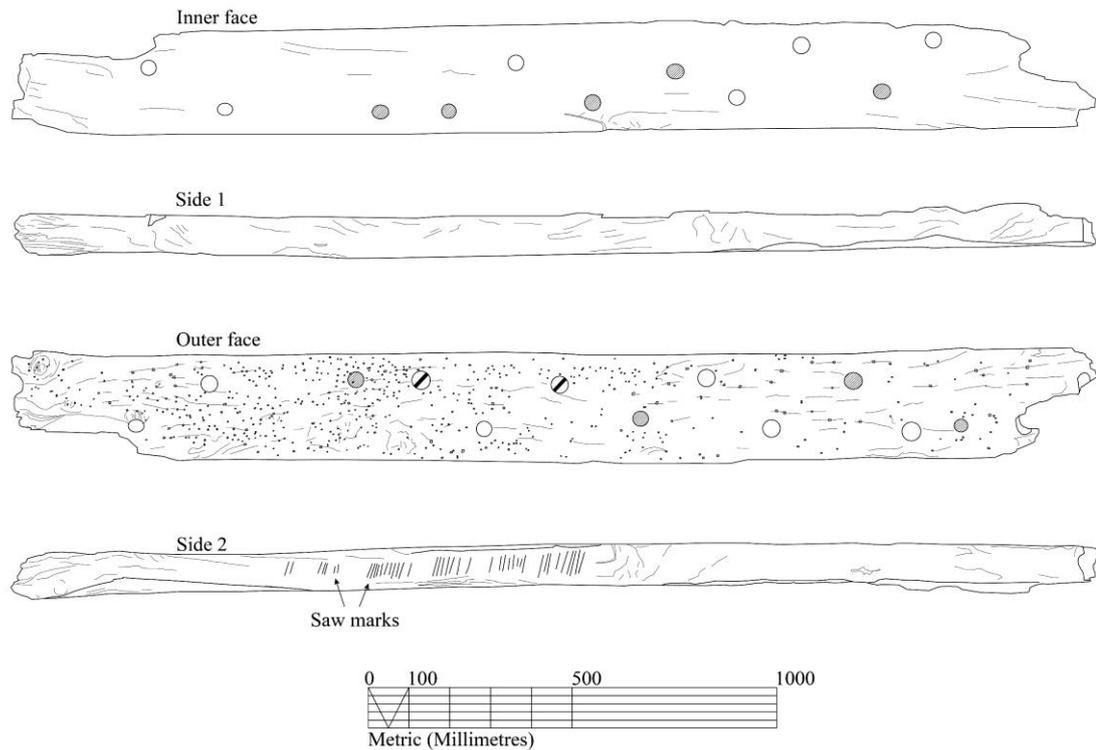
Figure 64. END_021 outer hull plank fragment drawing.

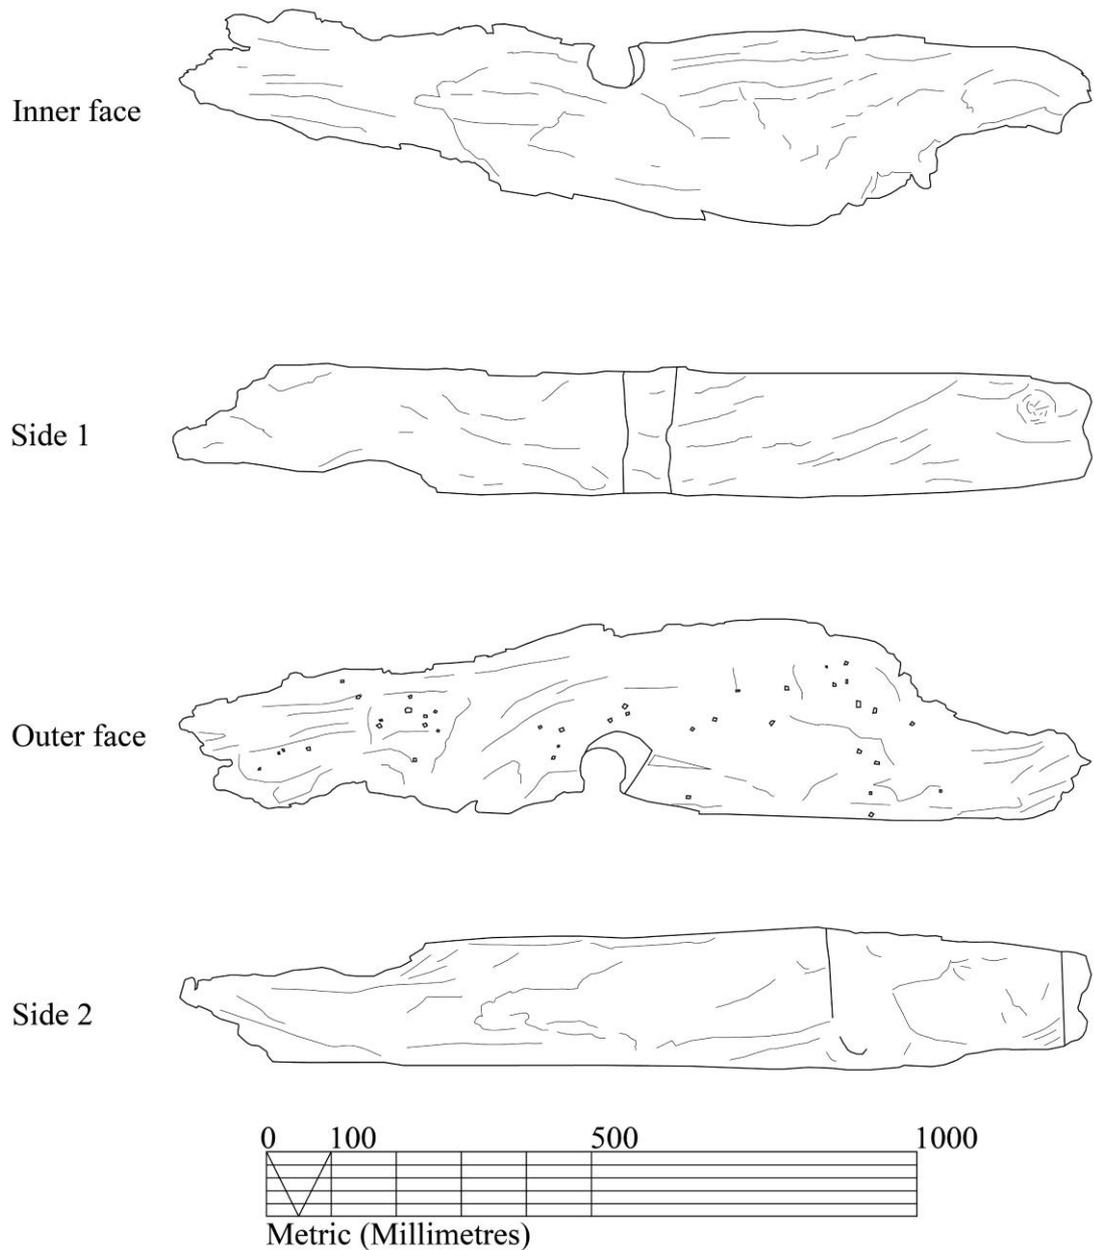
Figure 65. END_022 outer hull plank fragment drawing.
