**Shipwright artistry: cultural
transmission of British colonial ship
design and construction during the
eighteenth and nineteenth centuries**

*Thesis
Submitted to Flinders University
for the degree of*

Doctor of Philosophy

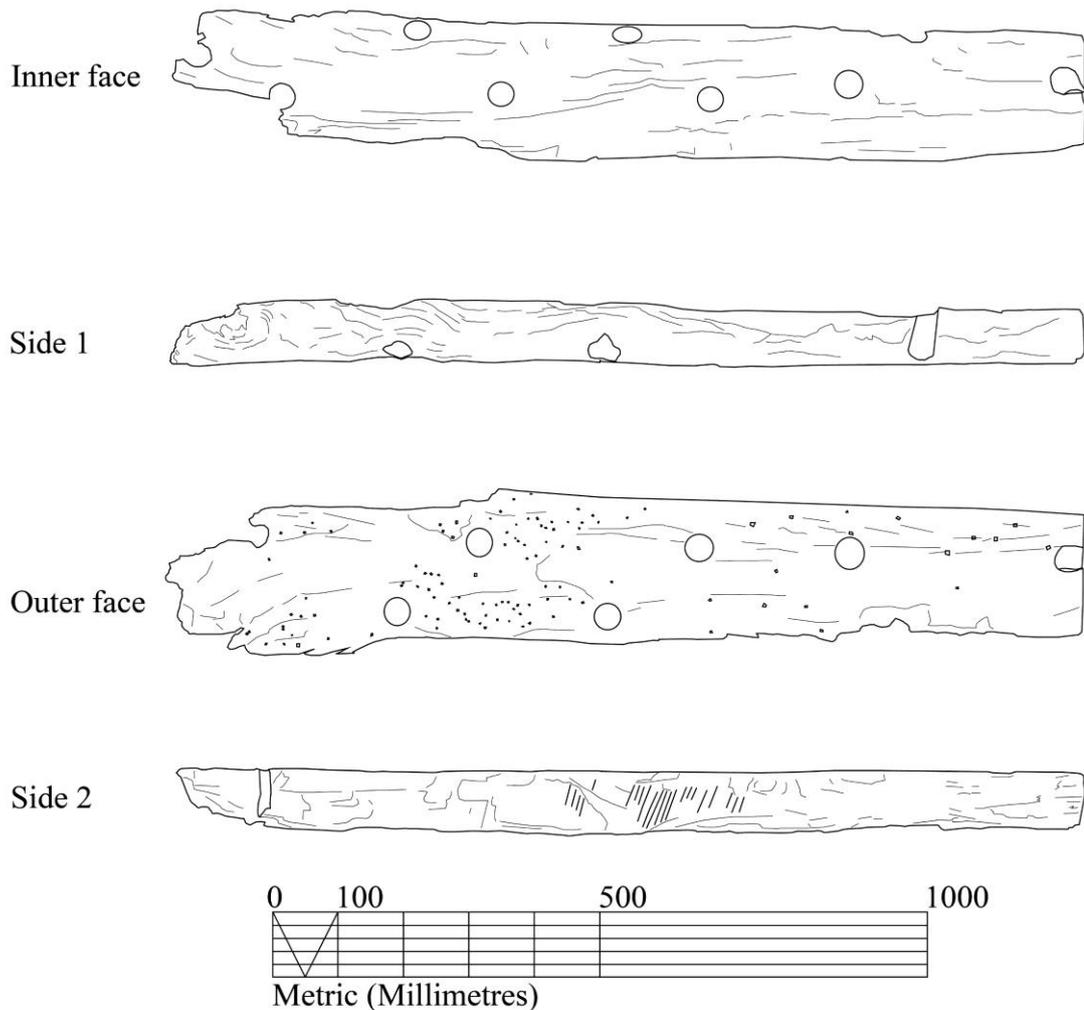
Figure 66. END_023 outer hull plank fragment drawing.

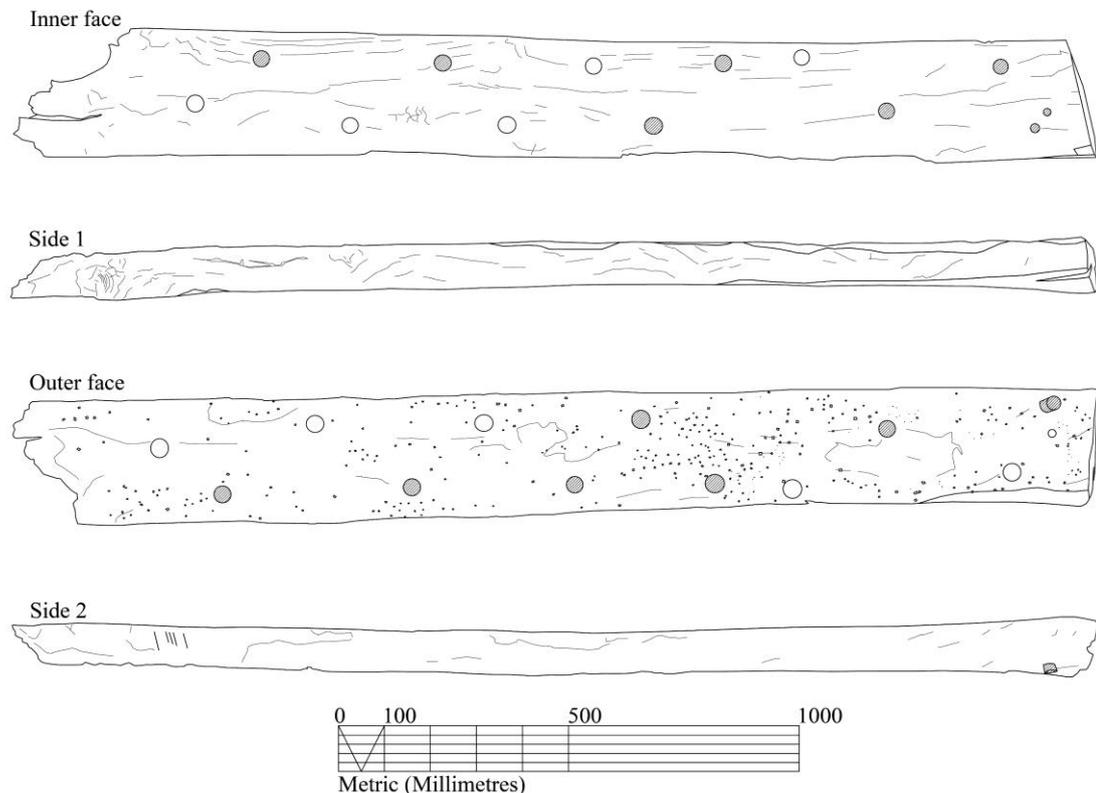
Figure 67. END_024 outer hull plank fragment drawing.

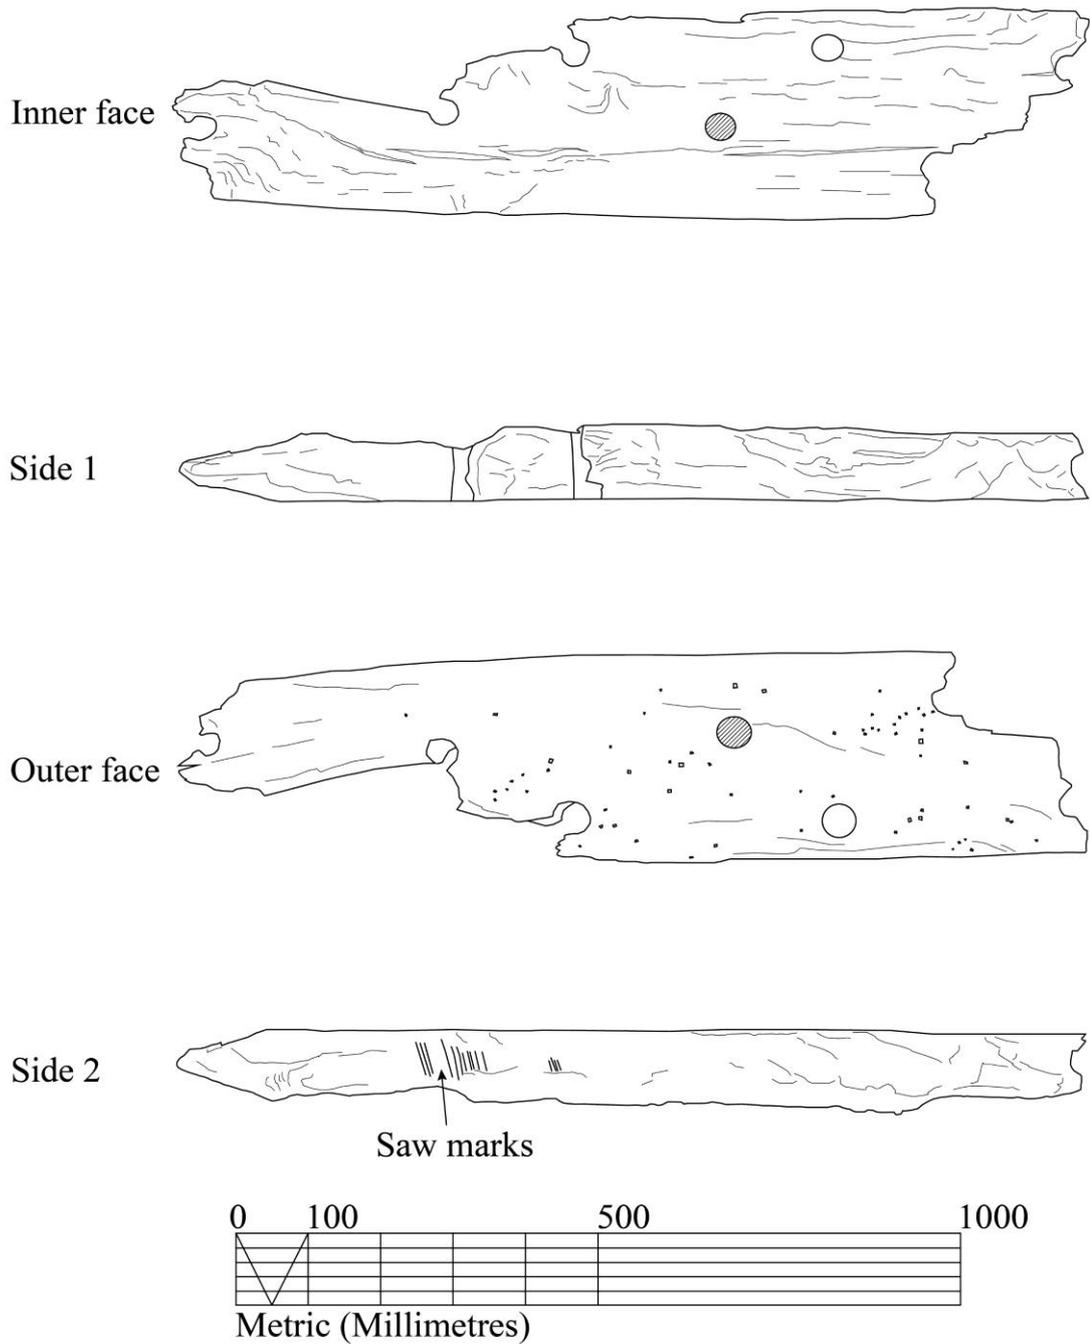
Figure 68. END_025 outer hull plank fragment drawing.

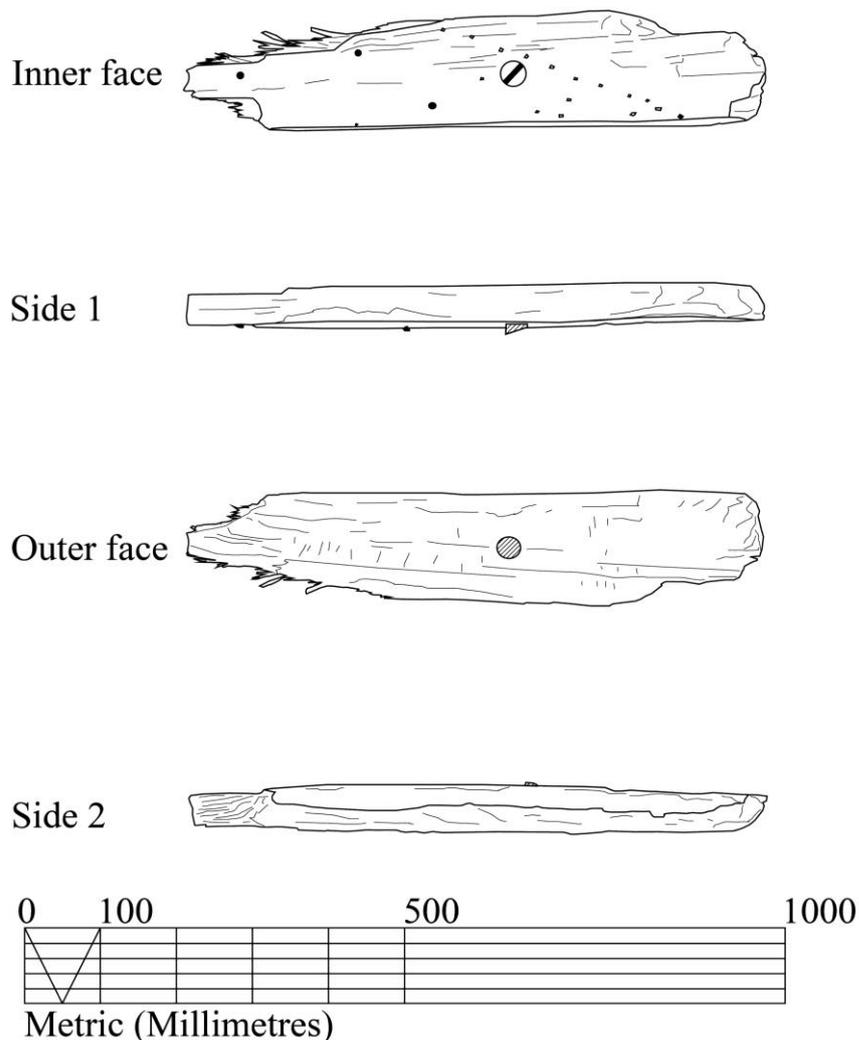
Figure 69. END_028 outer hull plank fragment drawing.

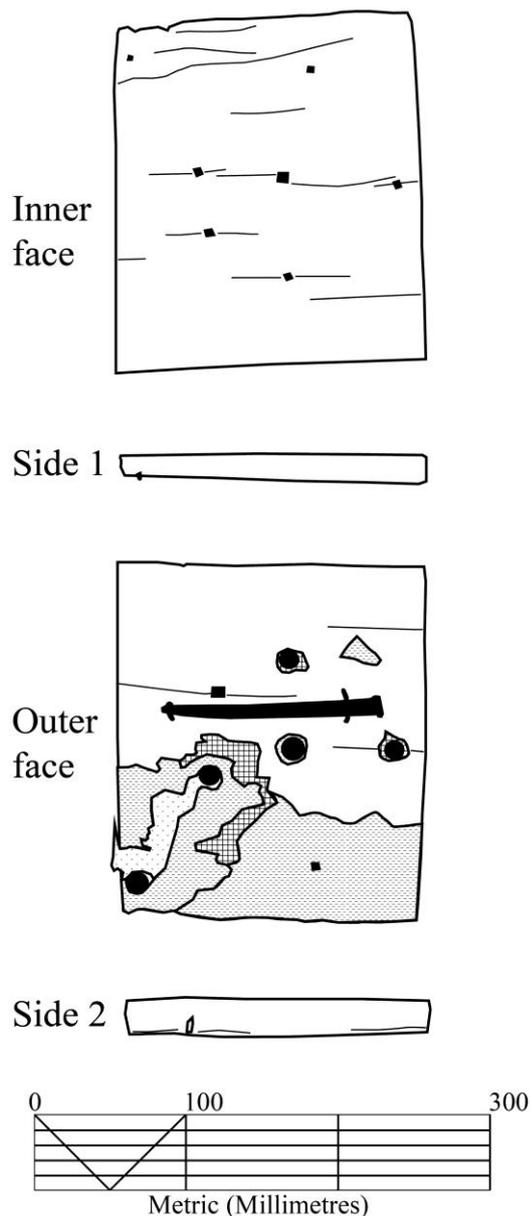
Figure 71. END_029 sacrificial timber drawing.

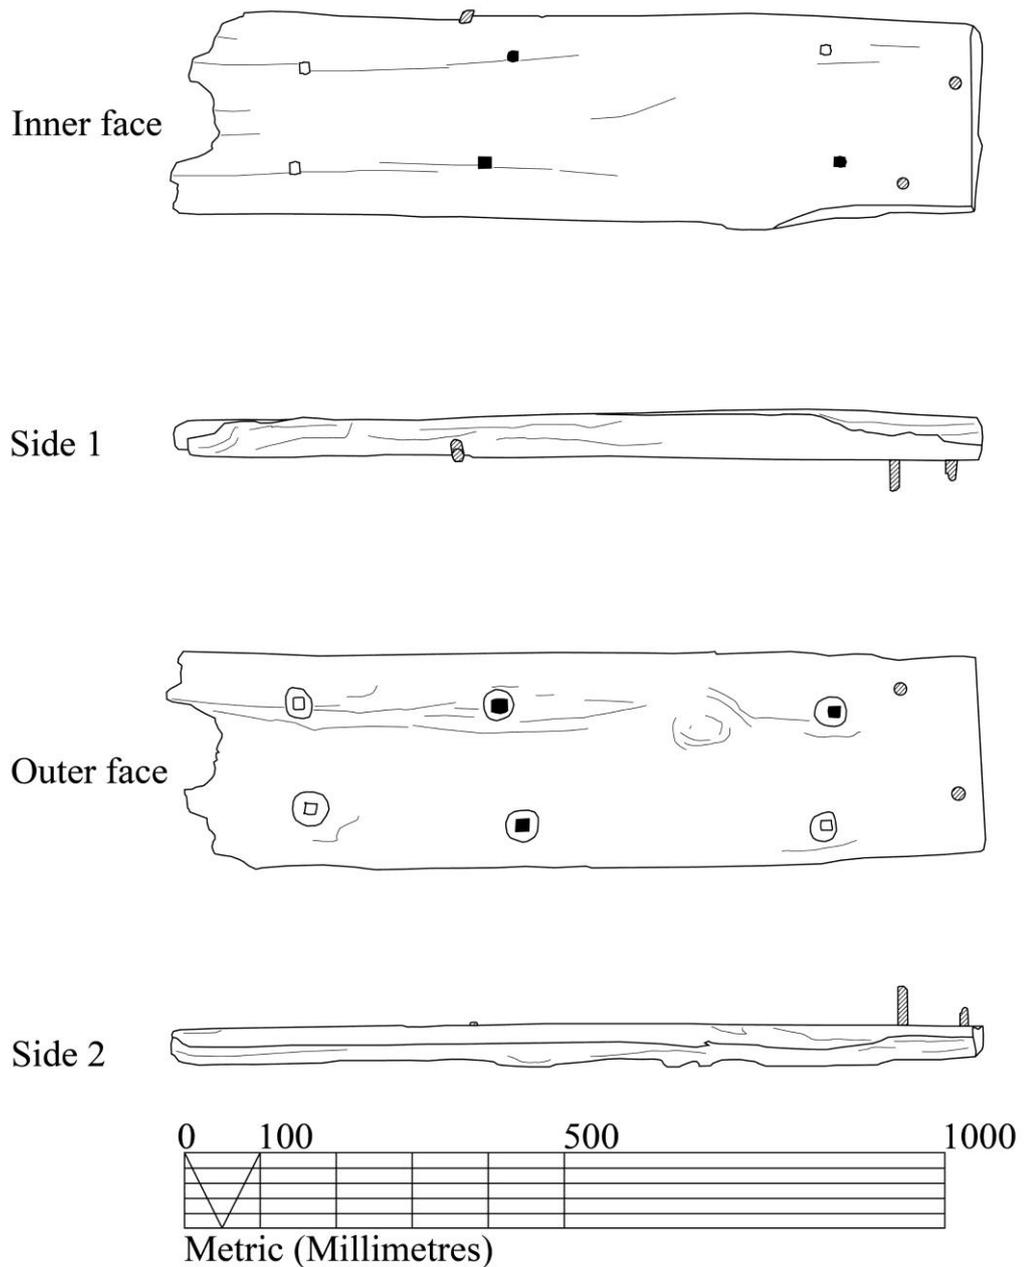
Figure 73. END_027 ceiling plank fragment drawing.

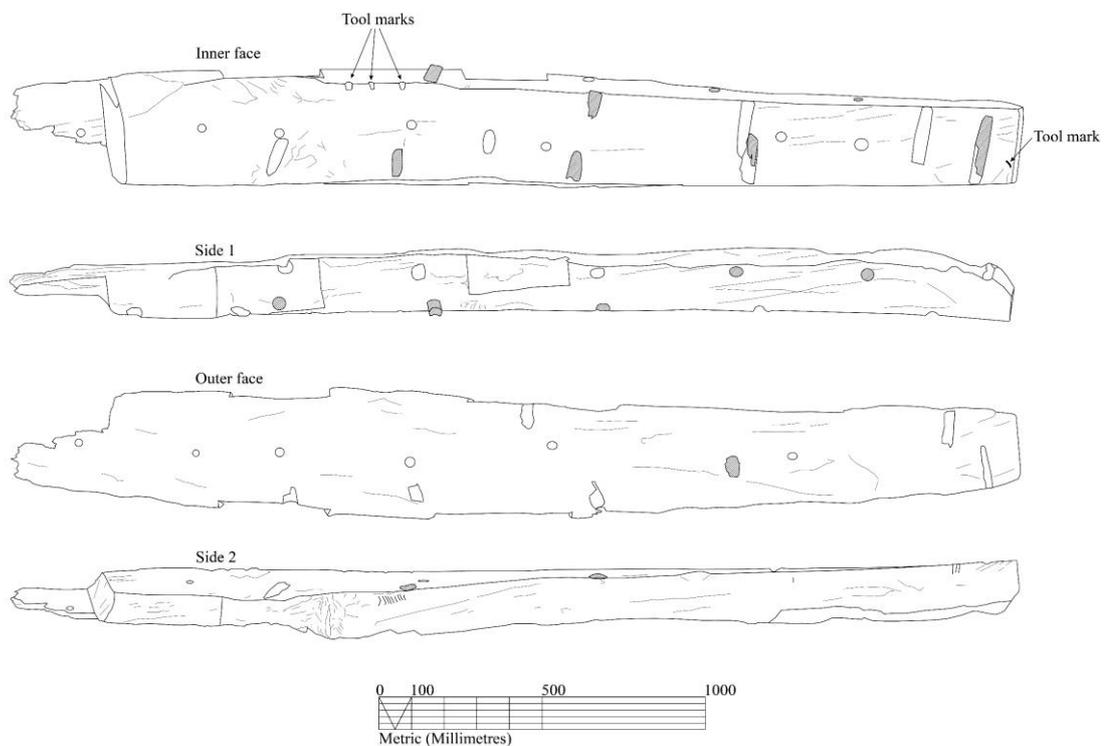
Figure 74. END_006 unidentified timber fragment drawing.

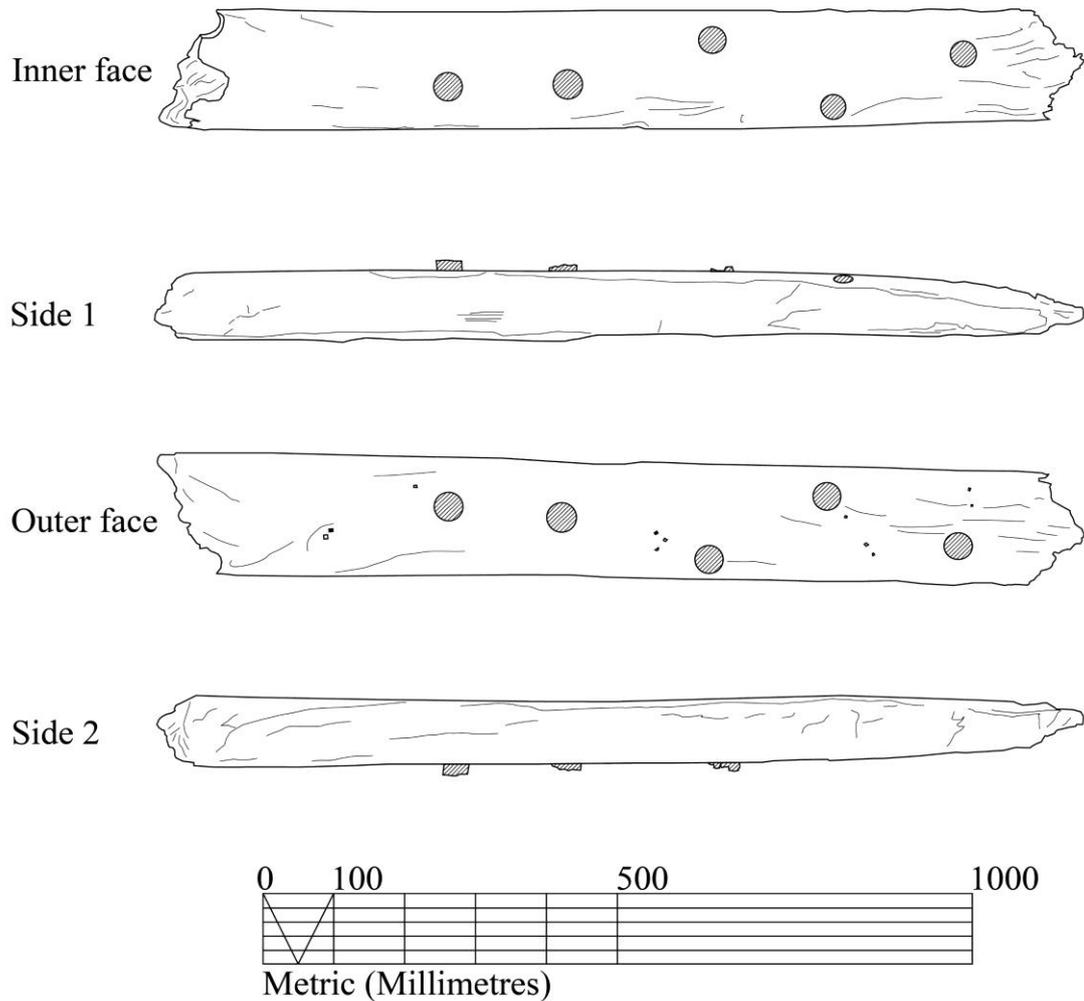
Figure 76. END_009 unidentified timber fragment drawing.

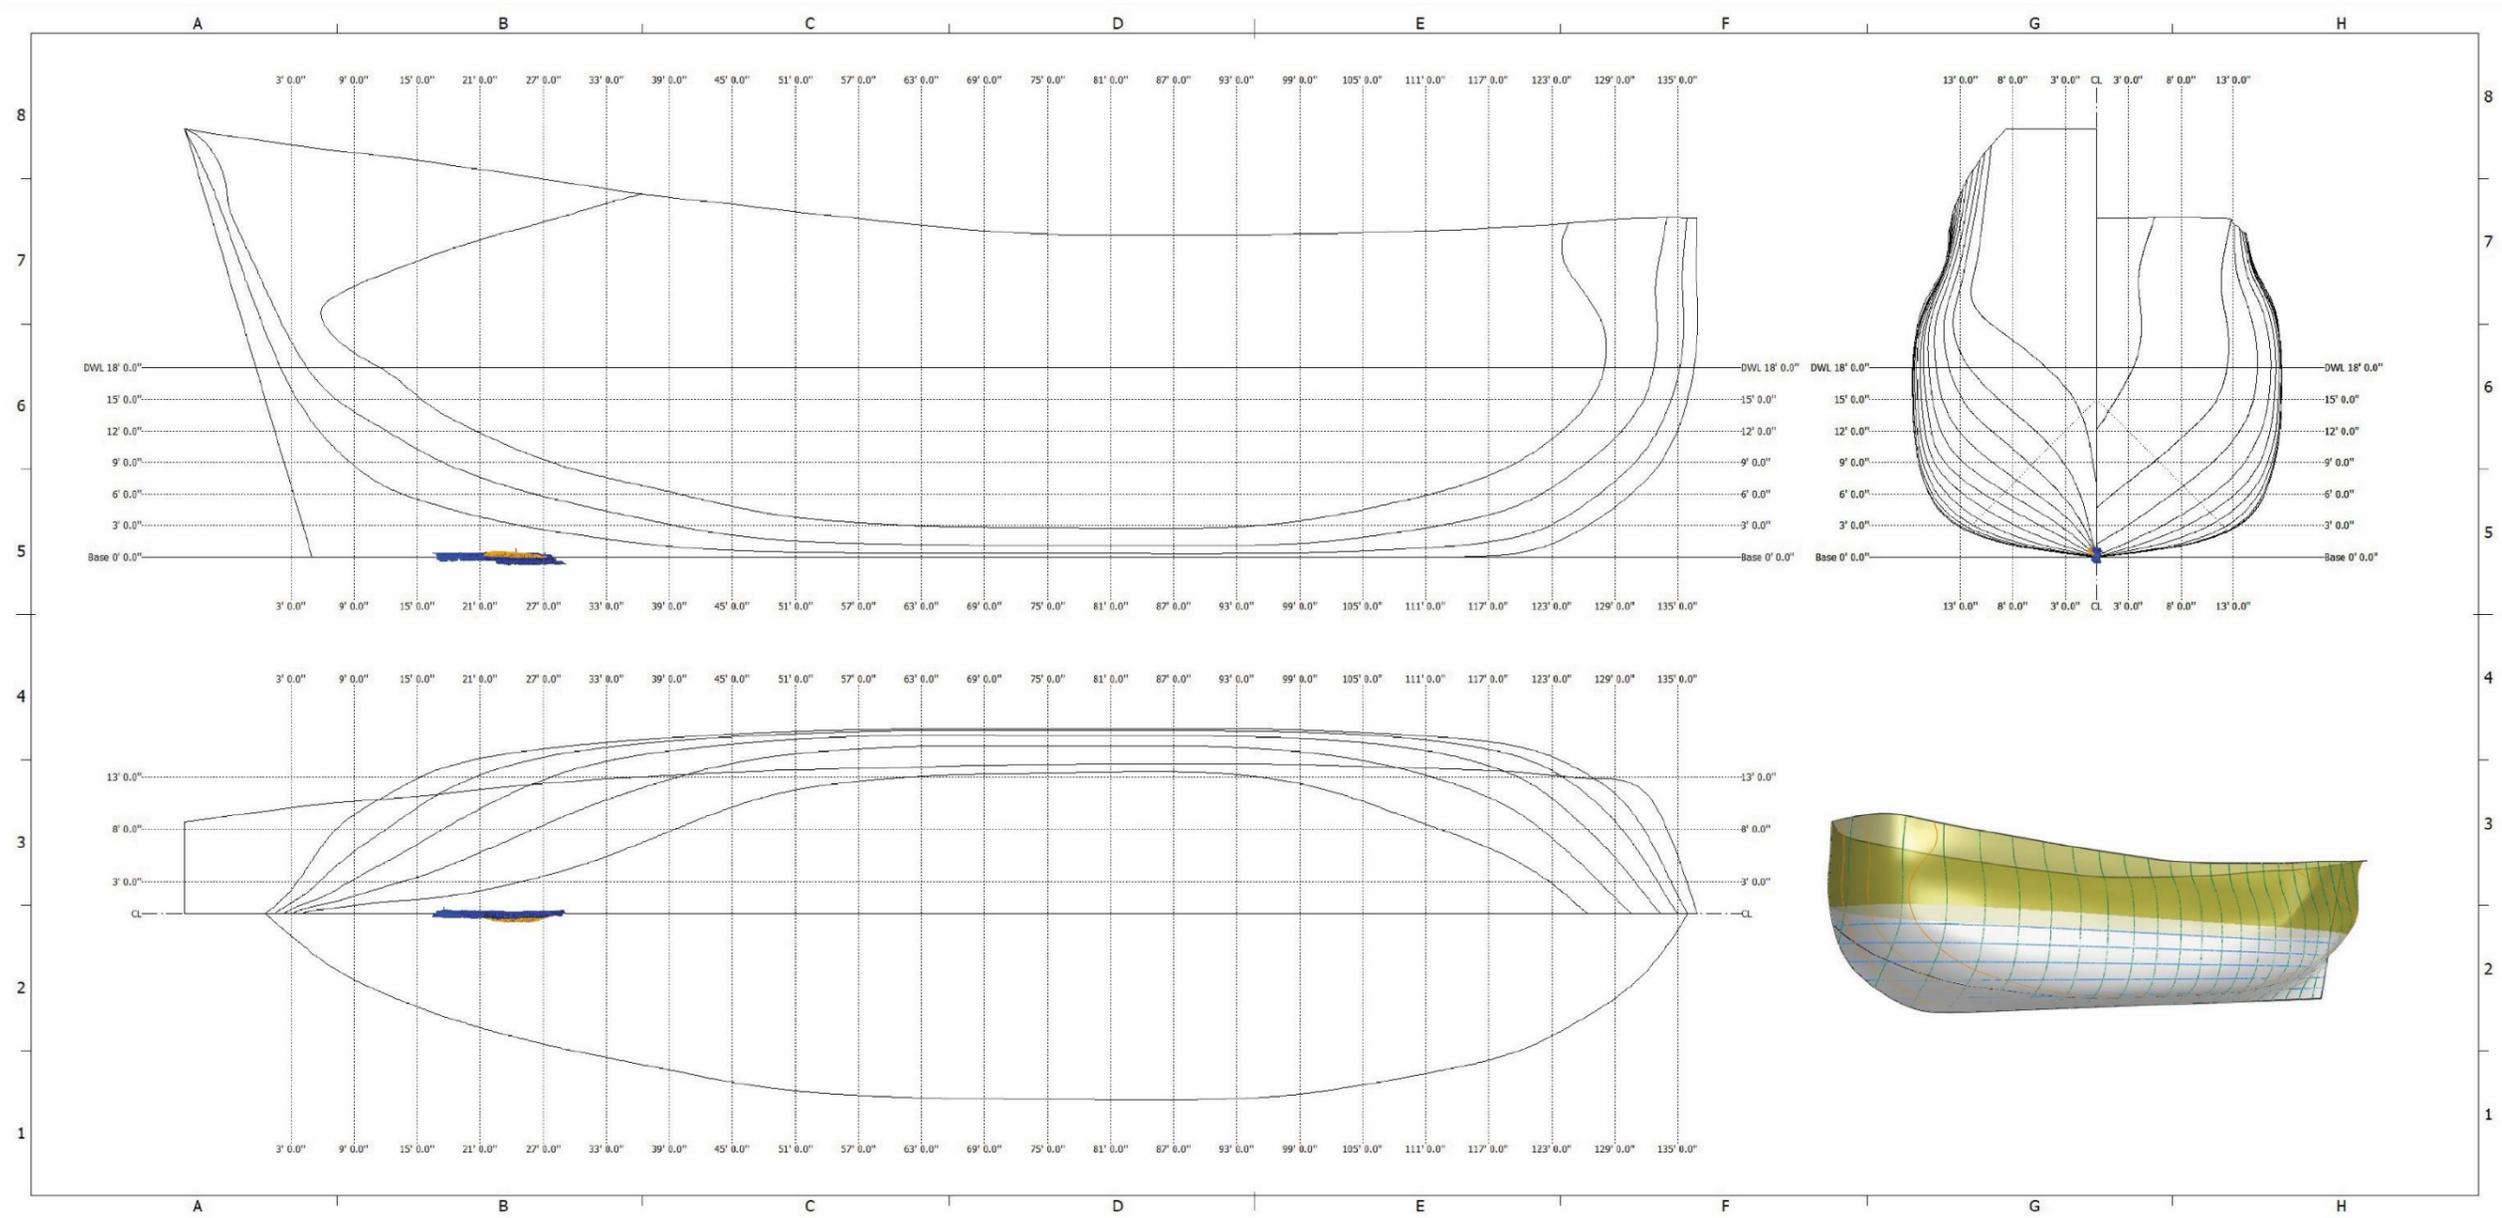
Figure 79. Keel assembly overlaid onto the Endeavour lines plan.

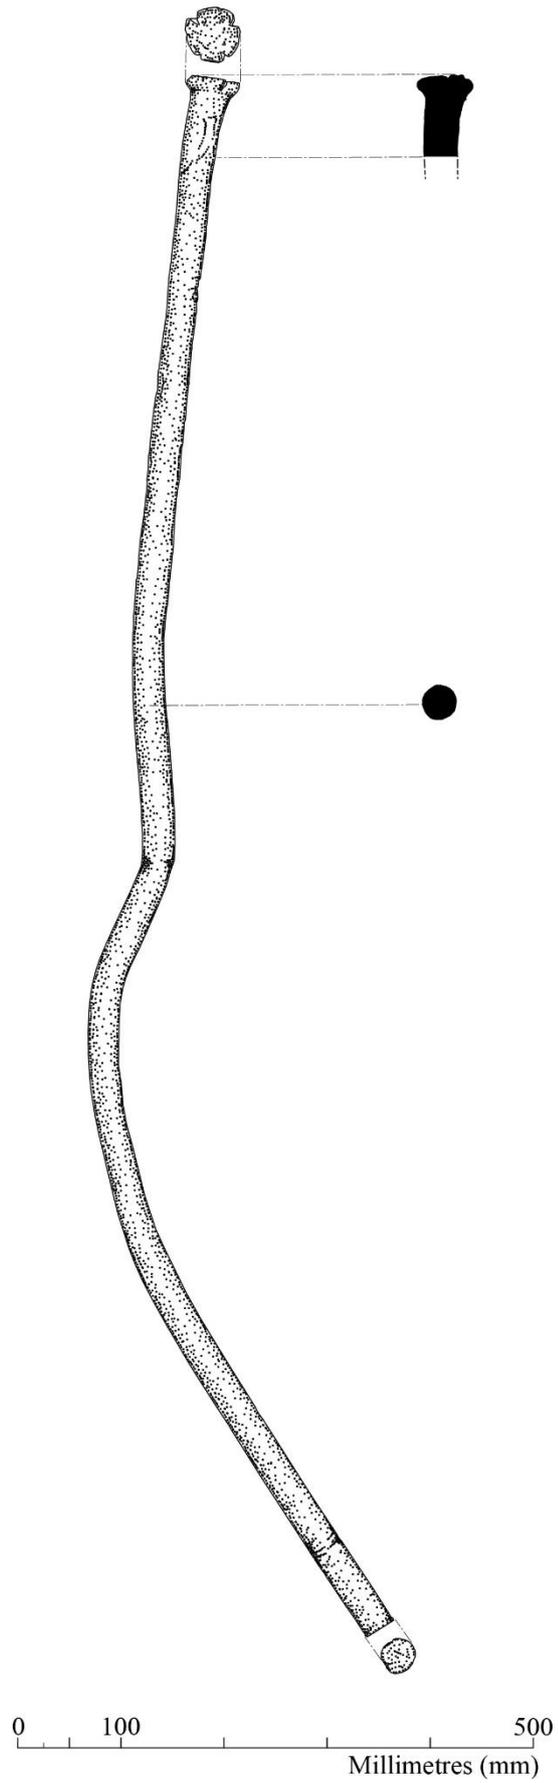
Figure 82. Loose keel bolt (END_038) drawing, from the *Endeavour* collection, Southland Museum and Art Gallery Niho o te Taniwha.

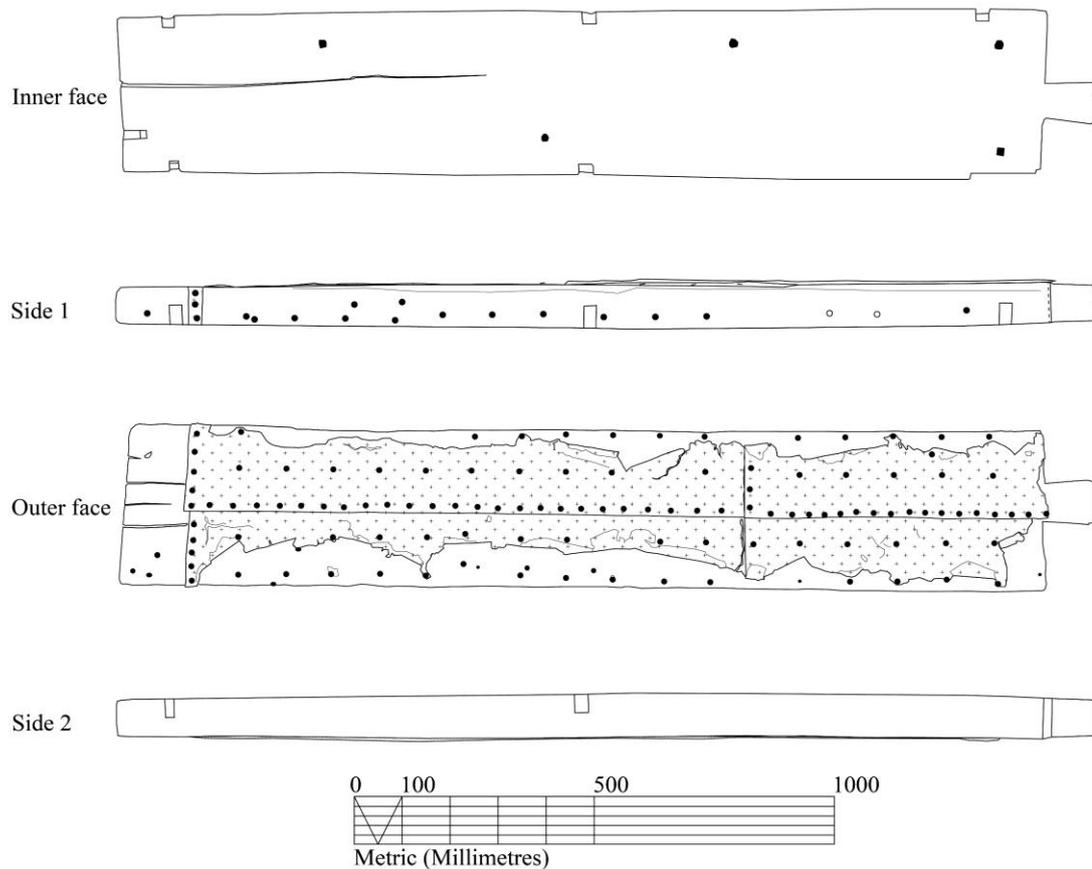
Figure 87. BUF_014 false keel timber fragment and metal sheathing drawing.

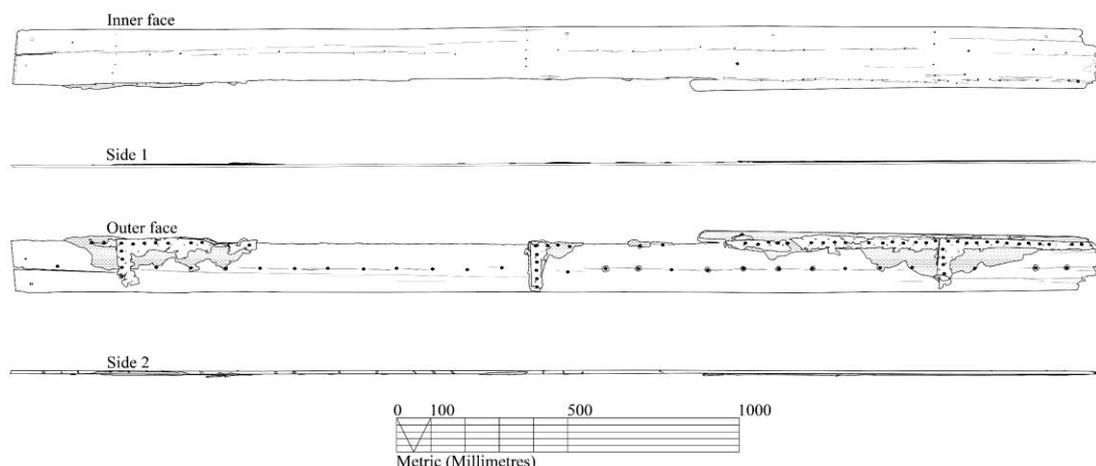
Figure 89. BUF_001 sacrificial timber sheathing fragment drawing.

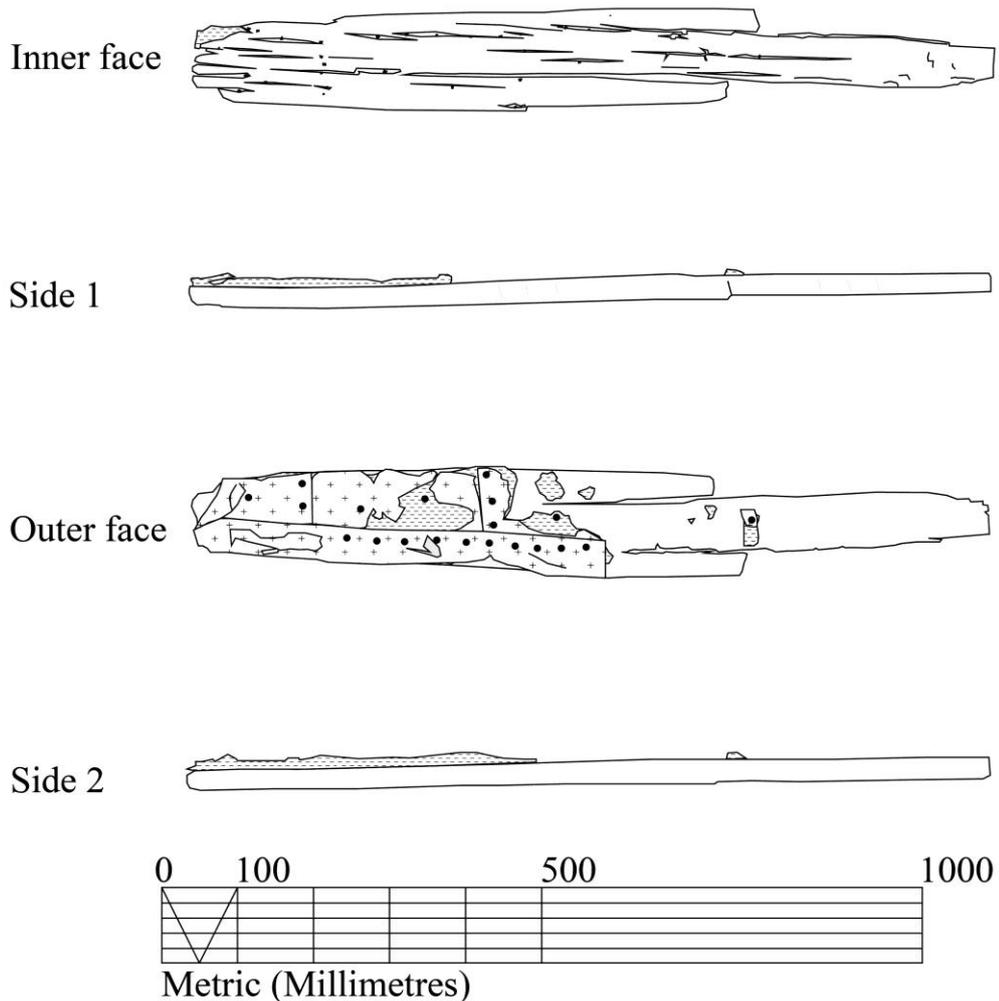
Figure 90. BUF_002 sacrificial timber sheathing fragment drawing.

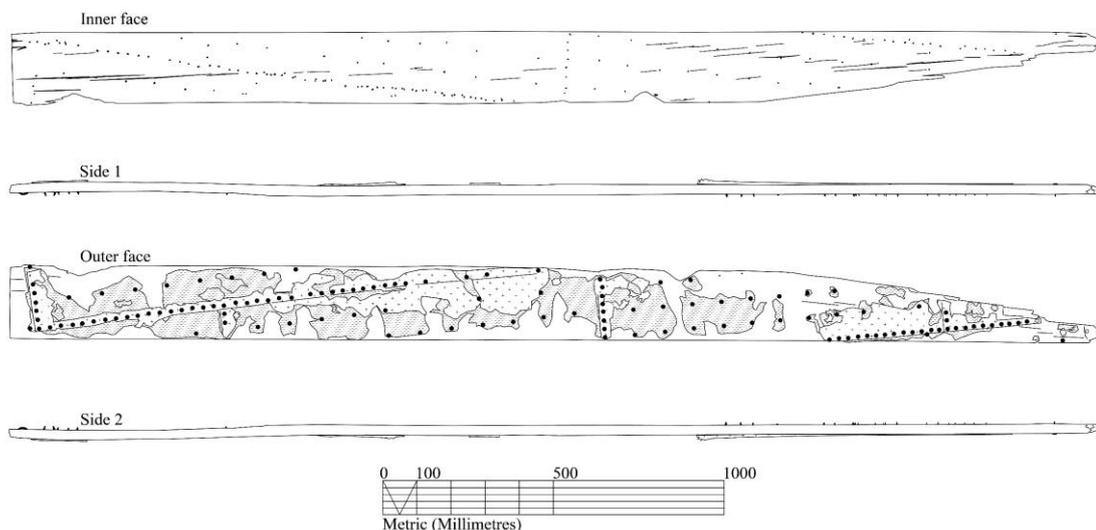
Figure 91. BUF_003 sacrificial timber sheathing fragment drawing.

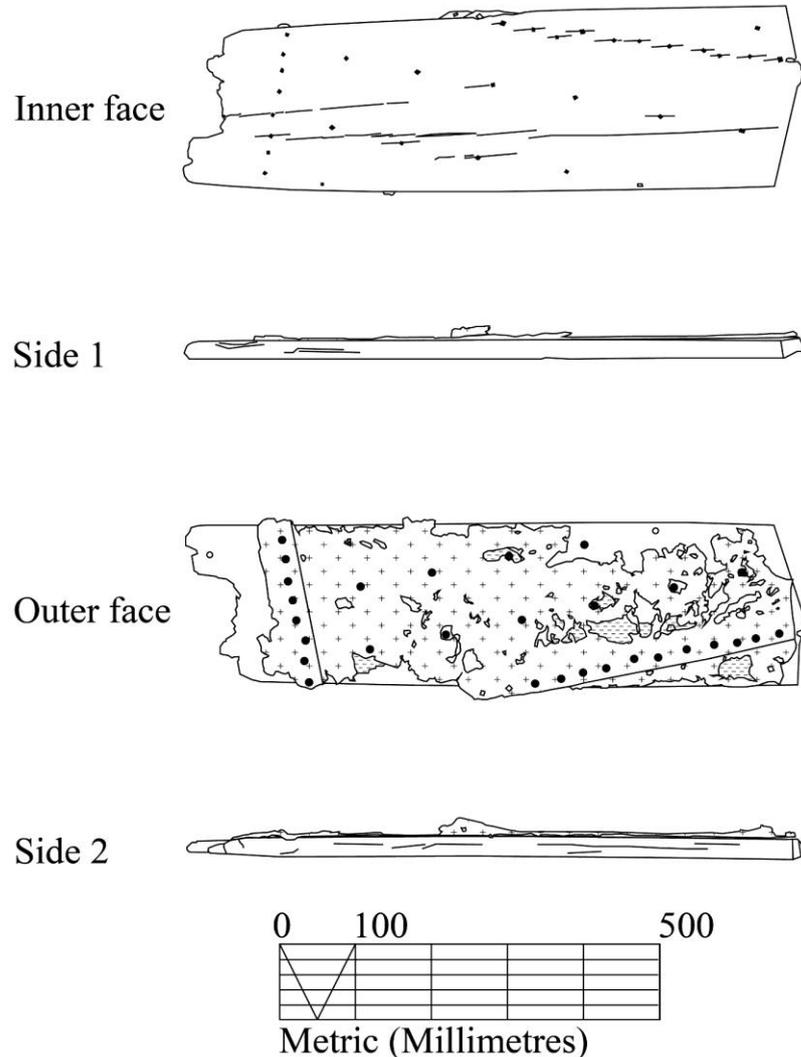
Figure 92. BUF_004 sacrificial timber sheathing fragment drawing.

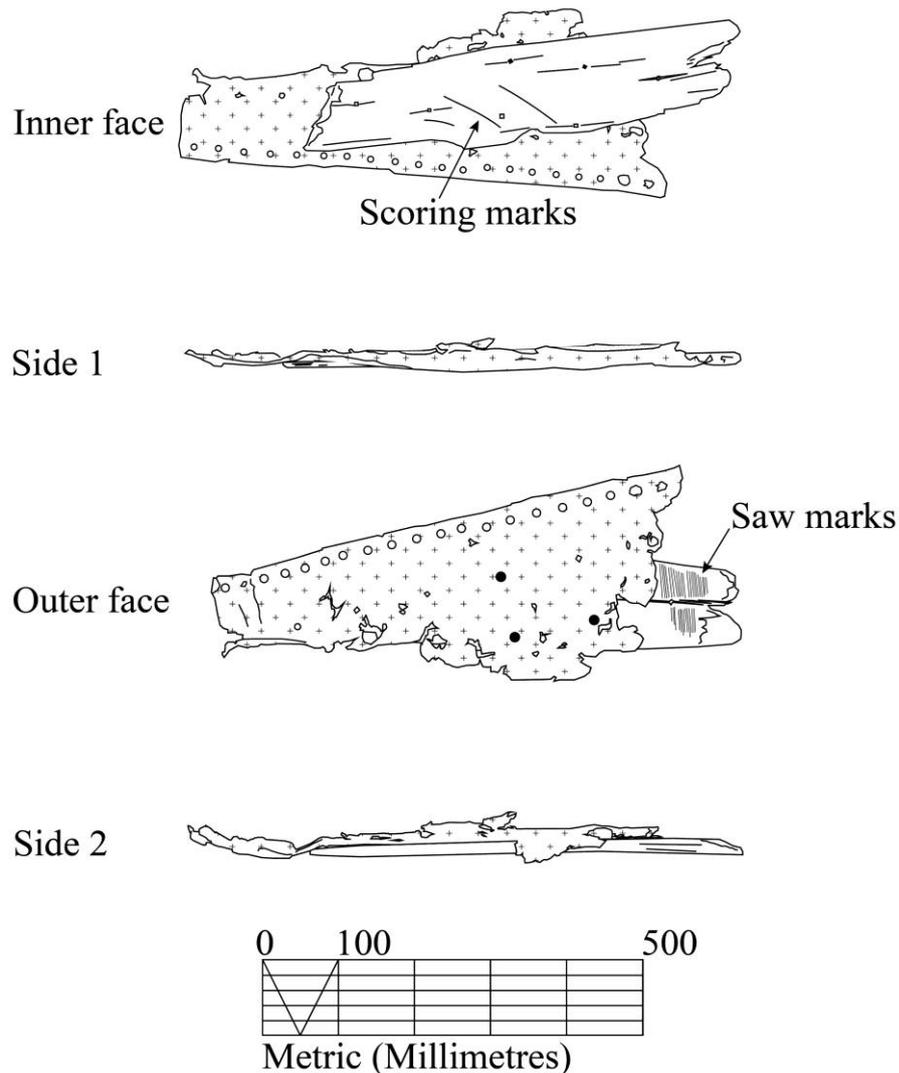
Figure 93. BUF_005 sacrificial timber sheathing fragment drawing.

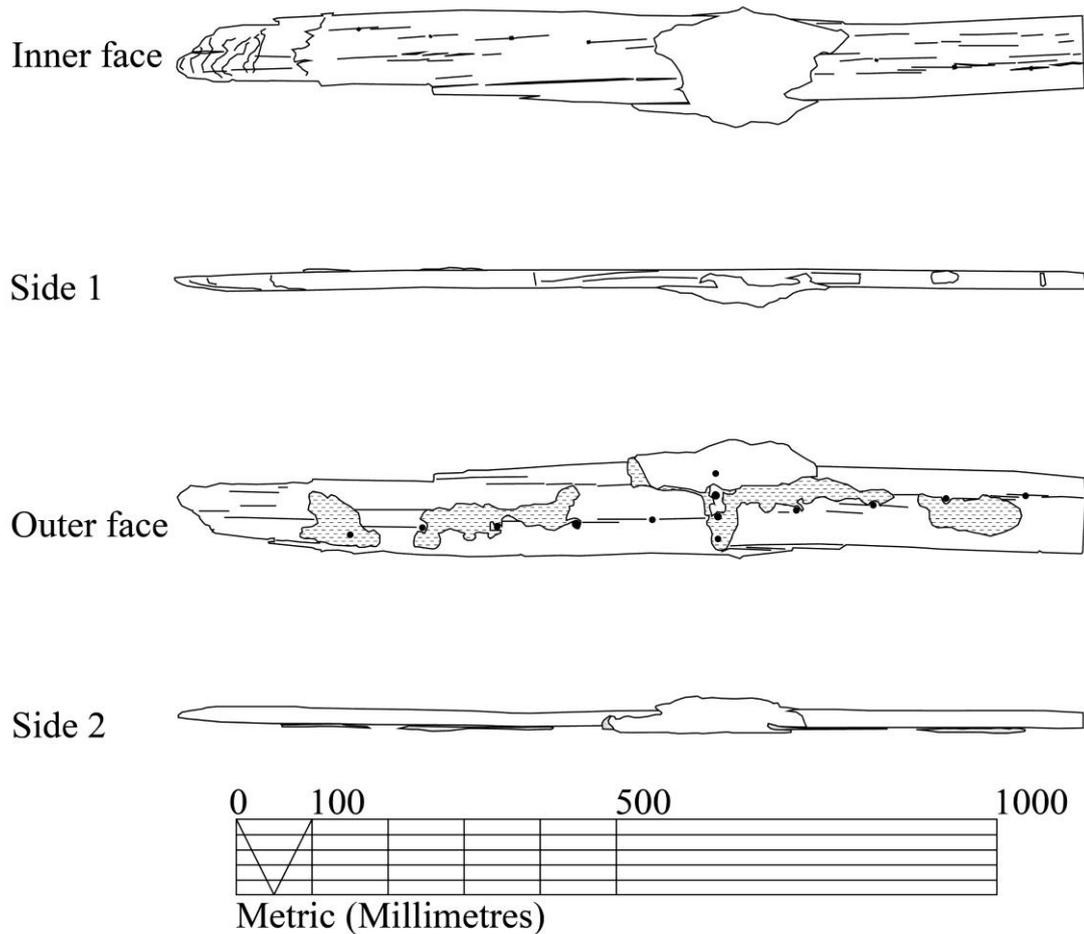
Figure 95. BUF_006 sacrificial timber sheathing fragment drawing.

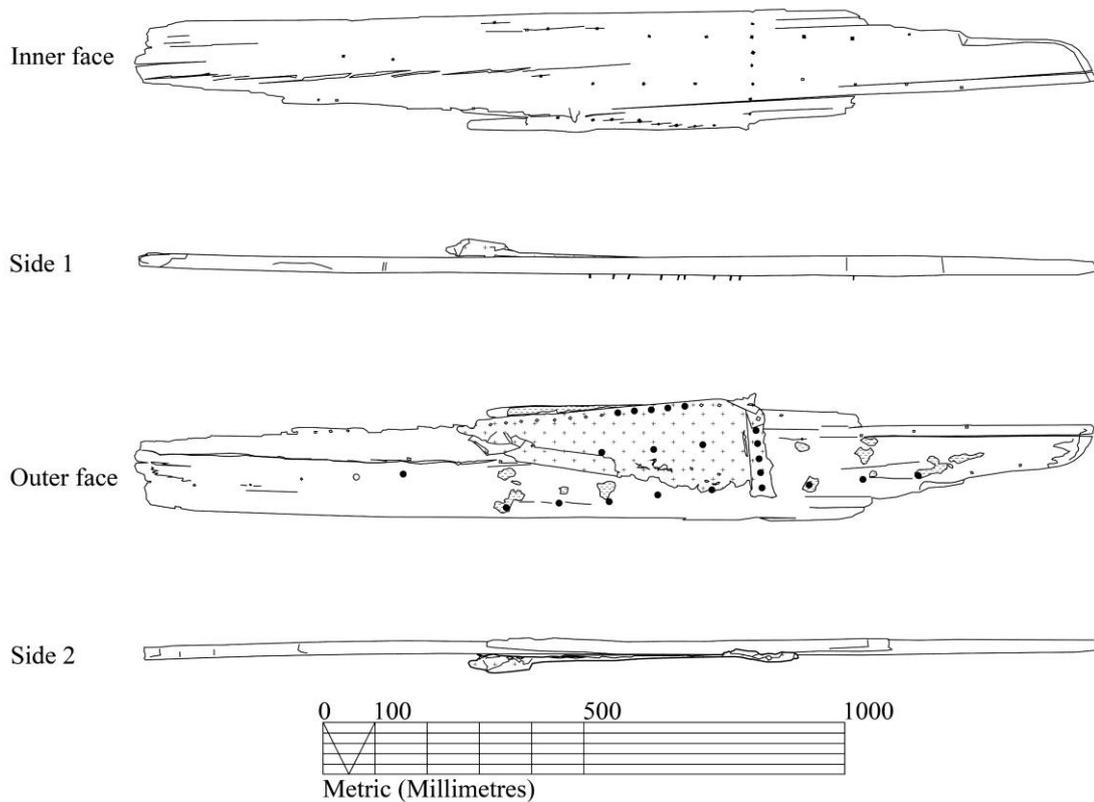
Figure 96. BUF_007 sacrificial timber sheathing fragment drawing.

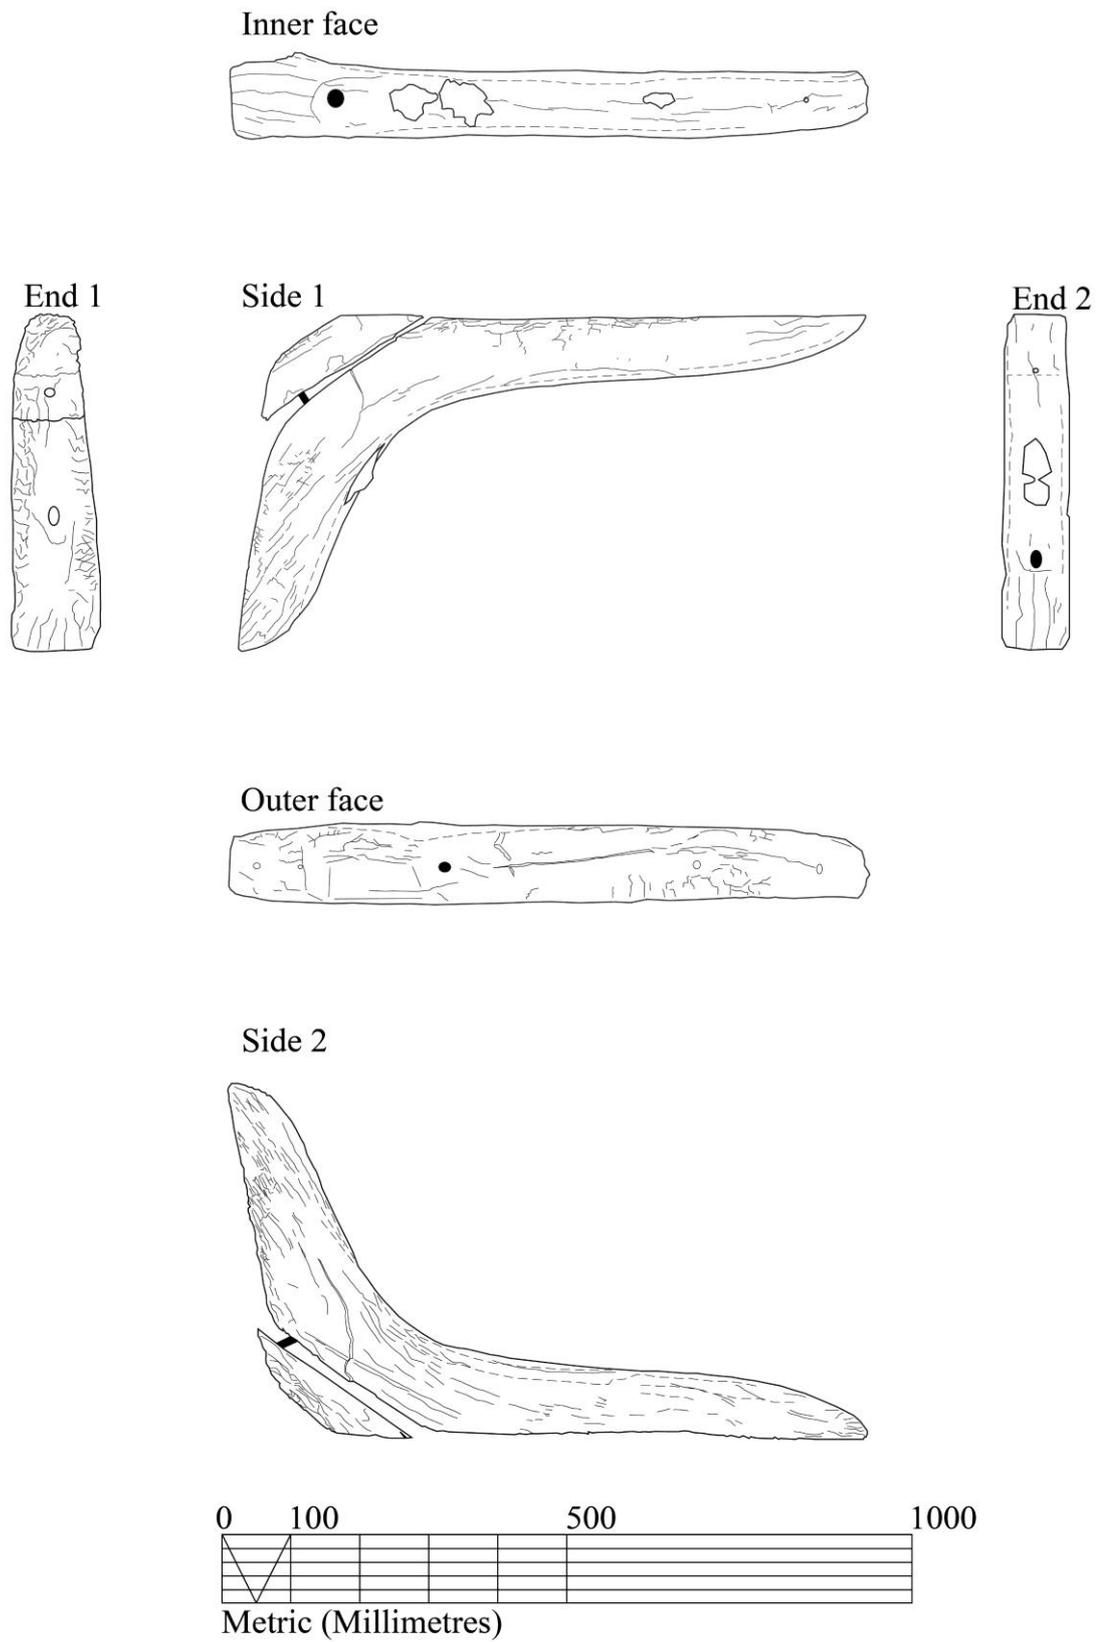
Figure 98. BUF_013 timber knee drawing.

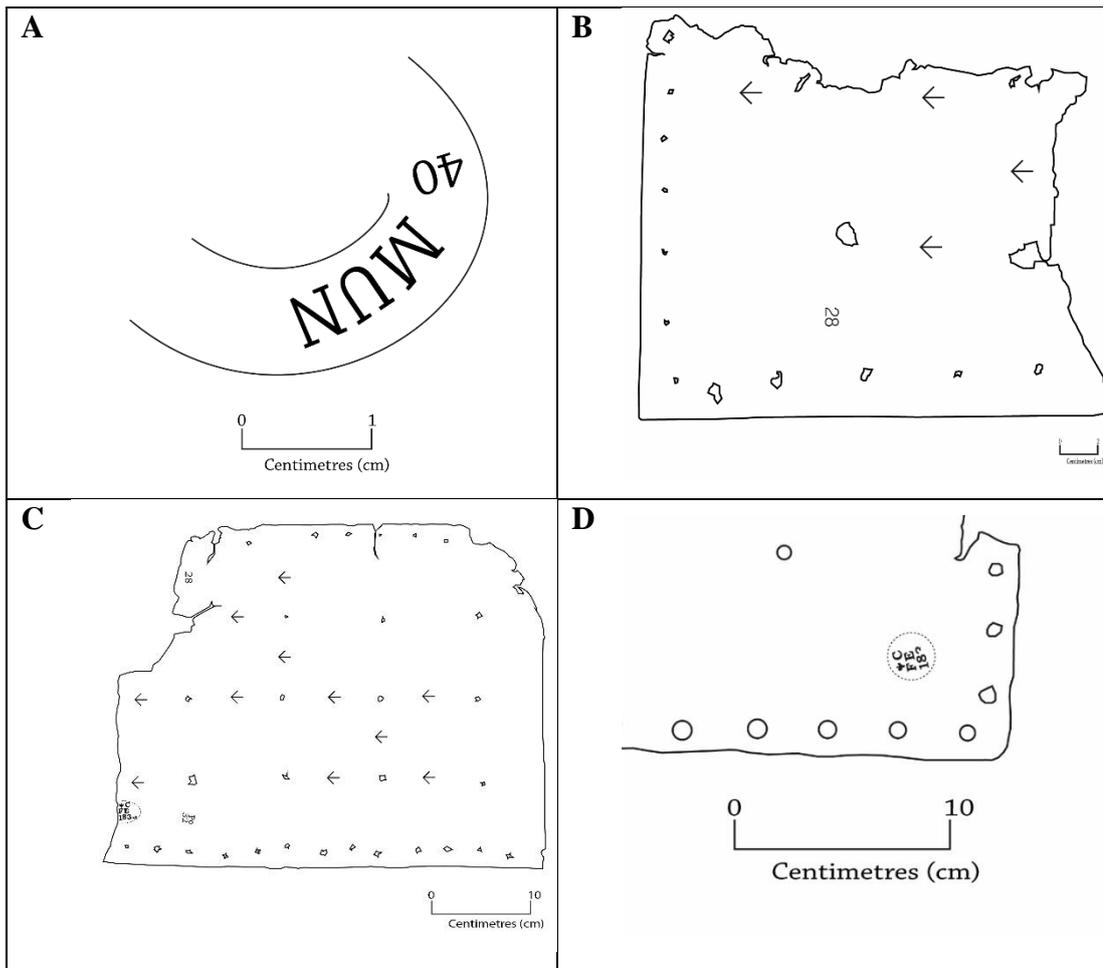
Figure 99. (A) *Buffalo* sheathing stamp 008, (B) *Buffalo* sheathing stamp 009, (C) *Buffalo* sheathing stamp 010, (D) *Buffalo* sheathing stamp 011.

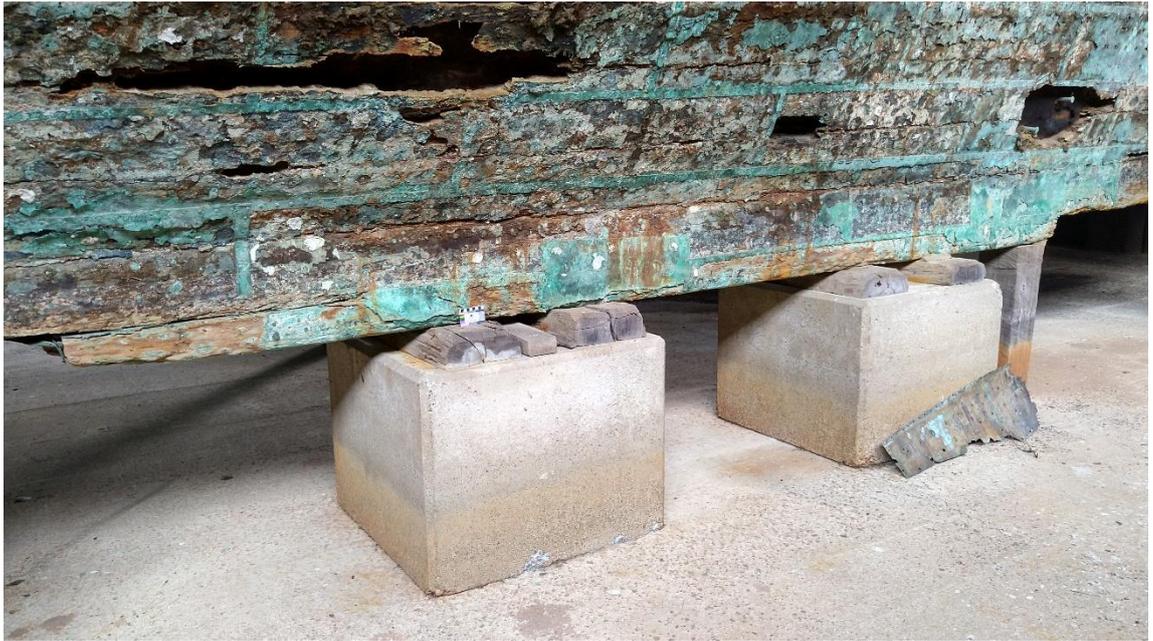
Figure 103. Aft section of the false keel attached to the main keel of *Edwin Fox*, facing port side.
