**Shipwright artistry: cultural
transmission of British colonial ship
design and construction during the
eighteenth and nineteenth centuries**

*Thesis
Submitted to Flinders University
for the degree of*

Doctor of Philosophy

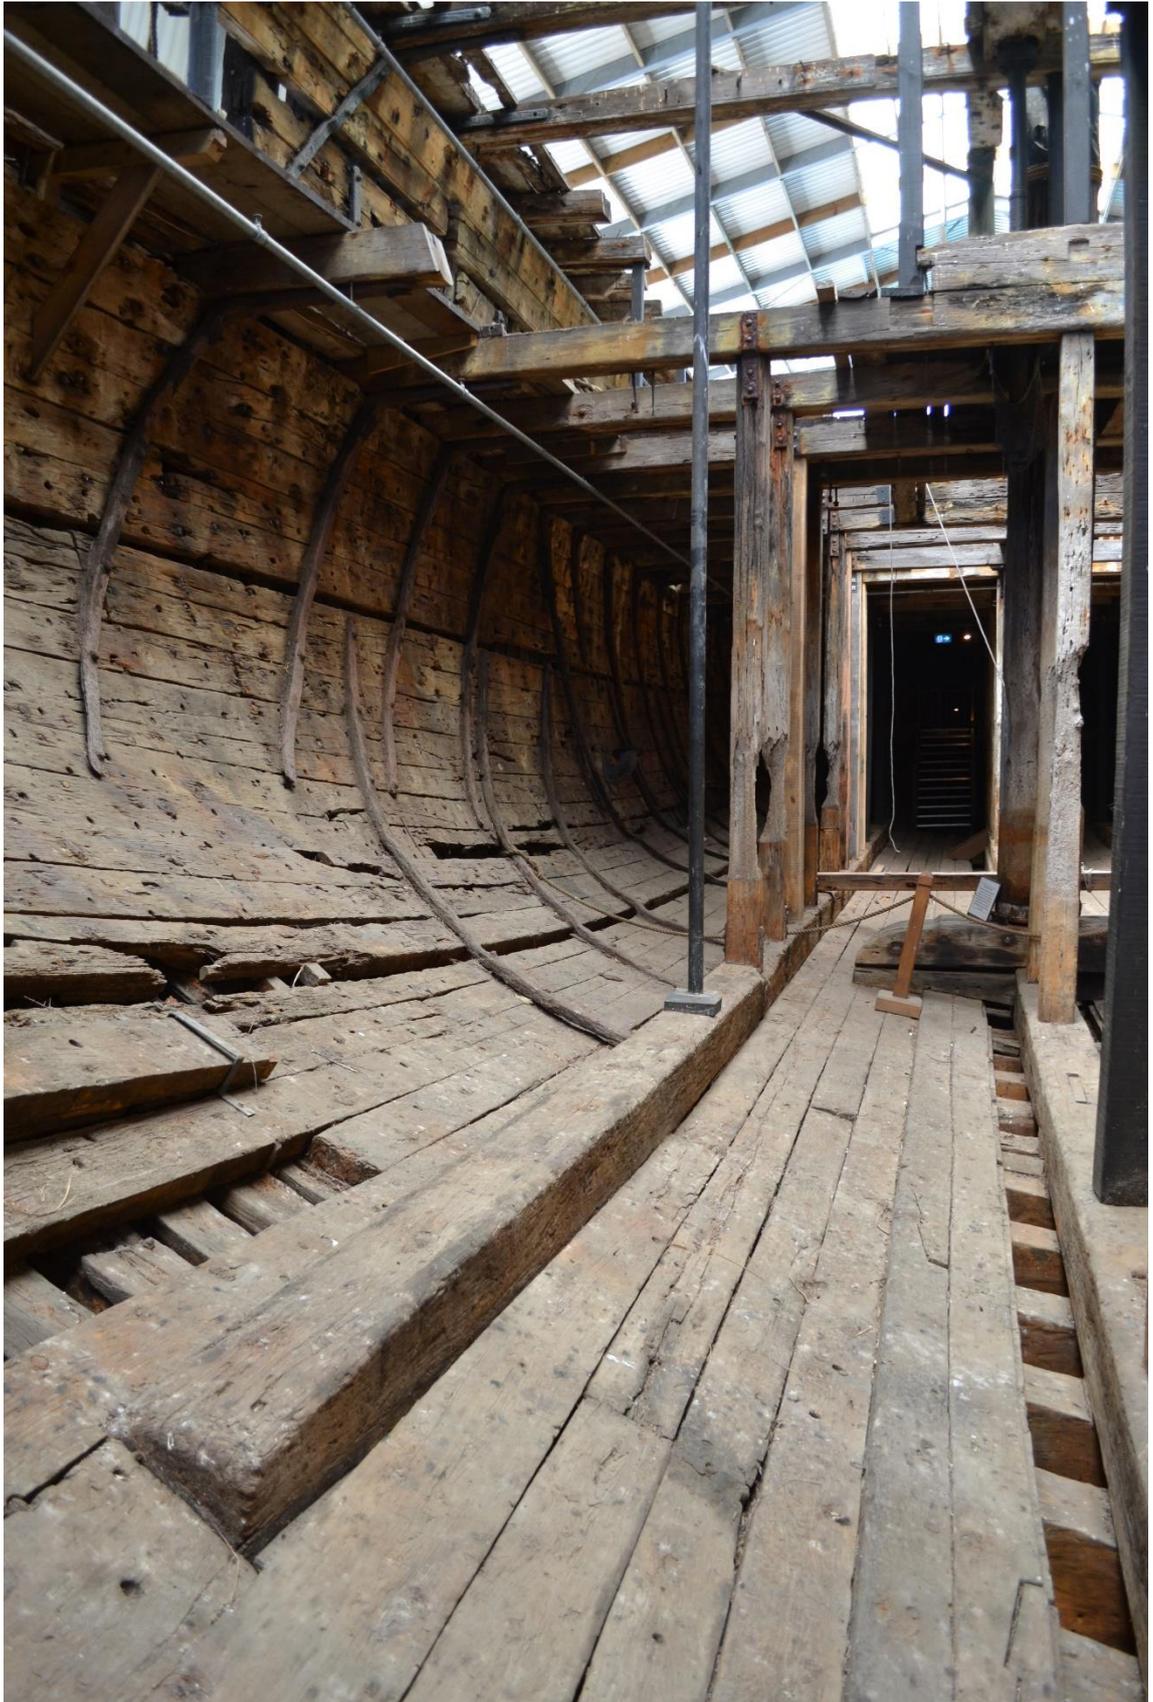
Figure 106. Ceiling planking inside the hull of *Edwin Fox*, port side, facing forward. The main mast is located to the far right.

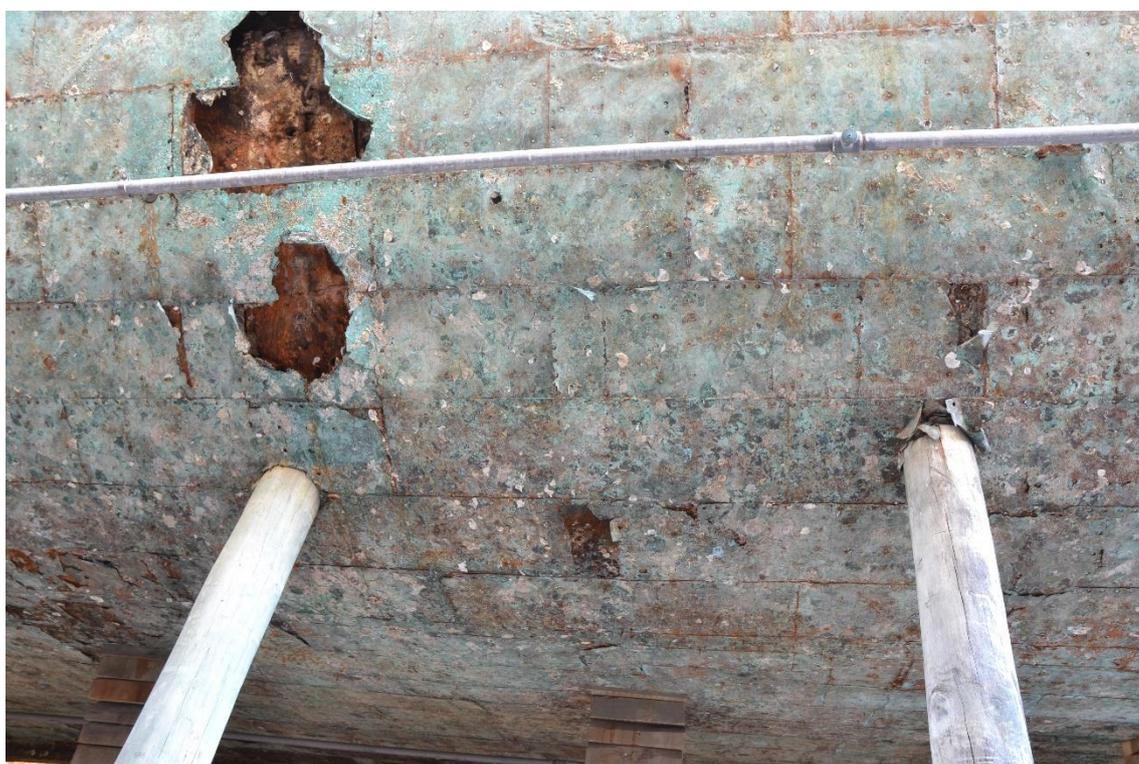
Figure 107. Damage caused by tongs (support poles) (Photograph: Matt Carter, April 2017).

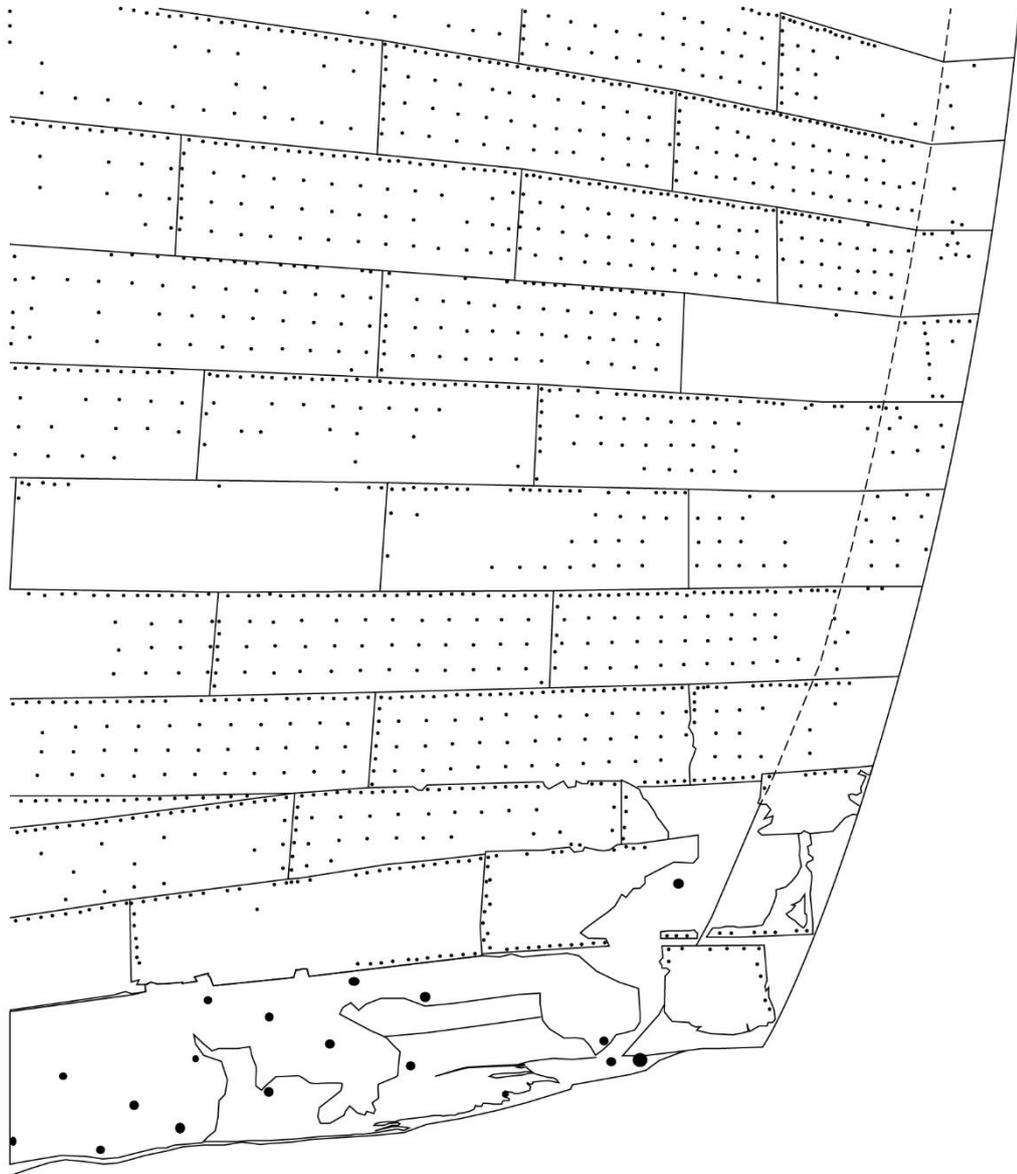
Figure 108. Arrangement of Muntz sheathing on the starboard bow of *Edwin Fox*. Note: where the tacks are not depicted is because of surface corrosion. Not to scale.

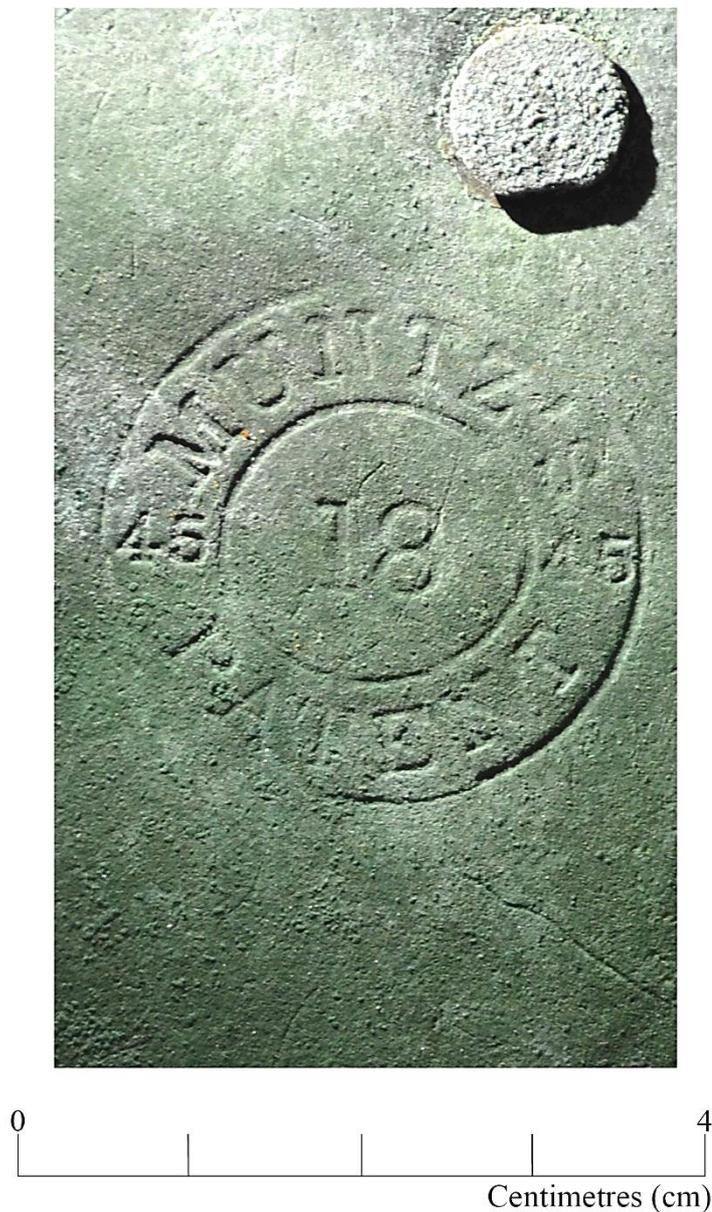
Figure 109. Muntz stamp recorded on the *Edwin Fox* hull.

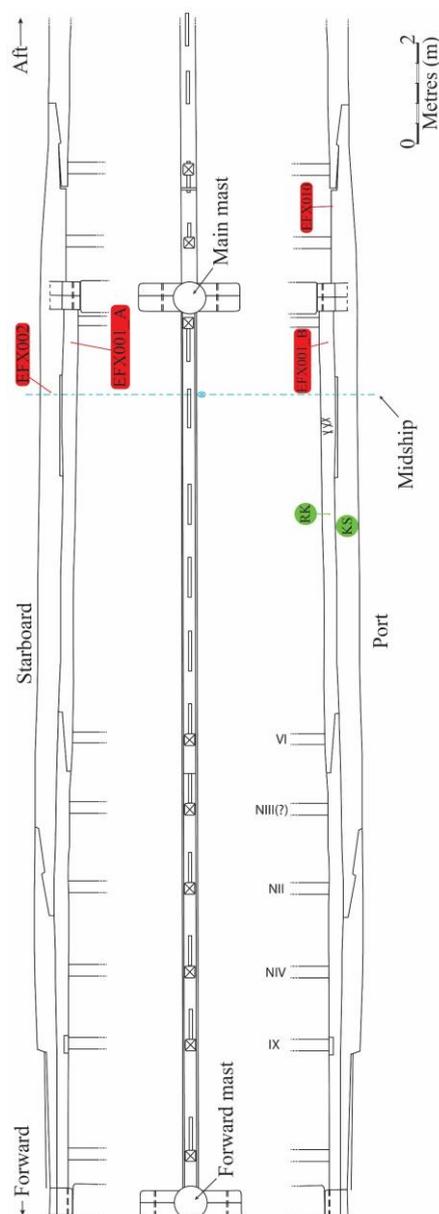
Figure 110. Site plan of markings in relation to *Edwin Fox*'s keelson, rider keelson, forward and main mast steps.

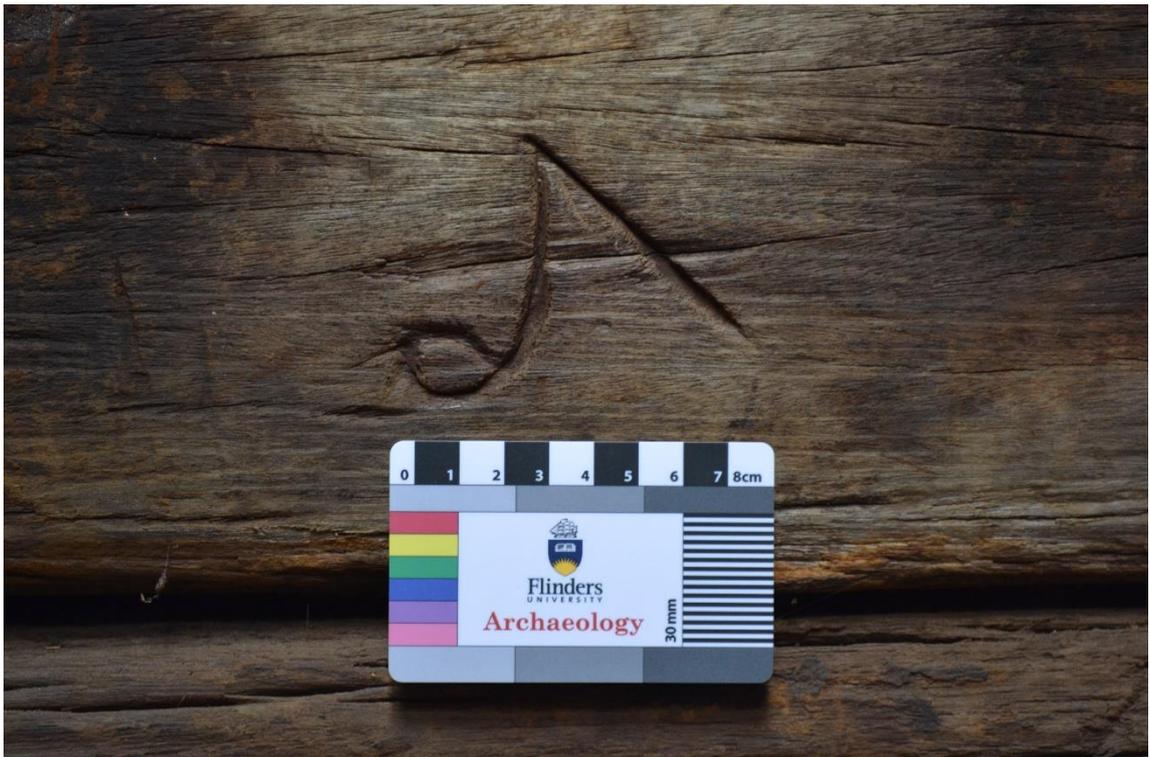
Figure 111. Carved letter, number or symbol on *Edwin Fox*'s main mast step.

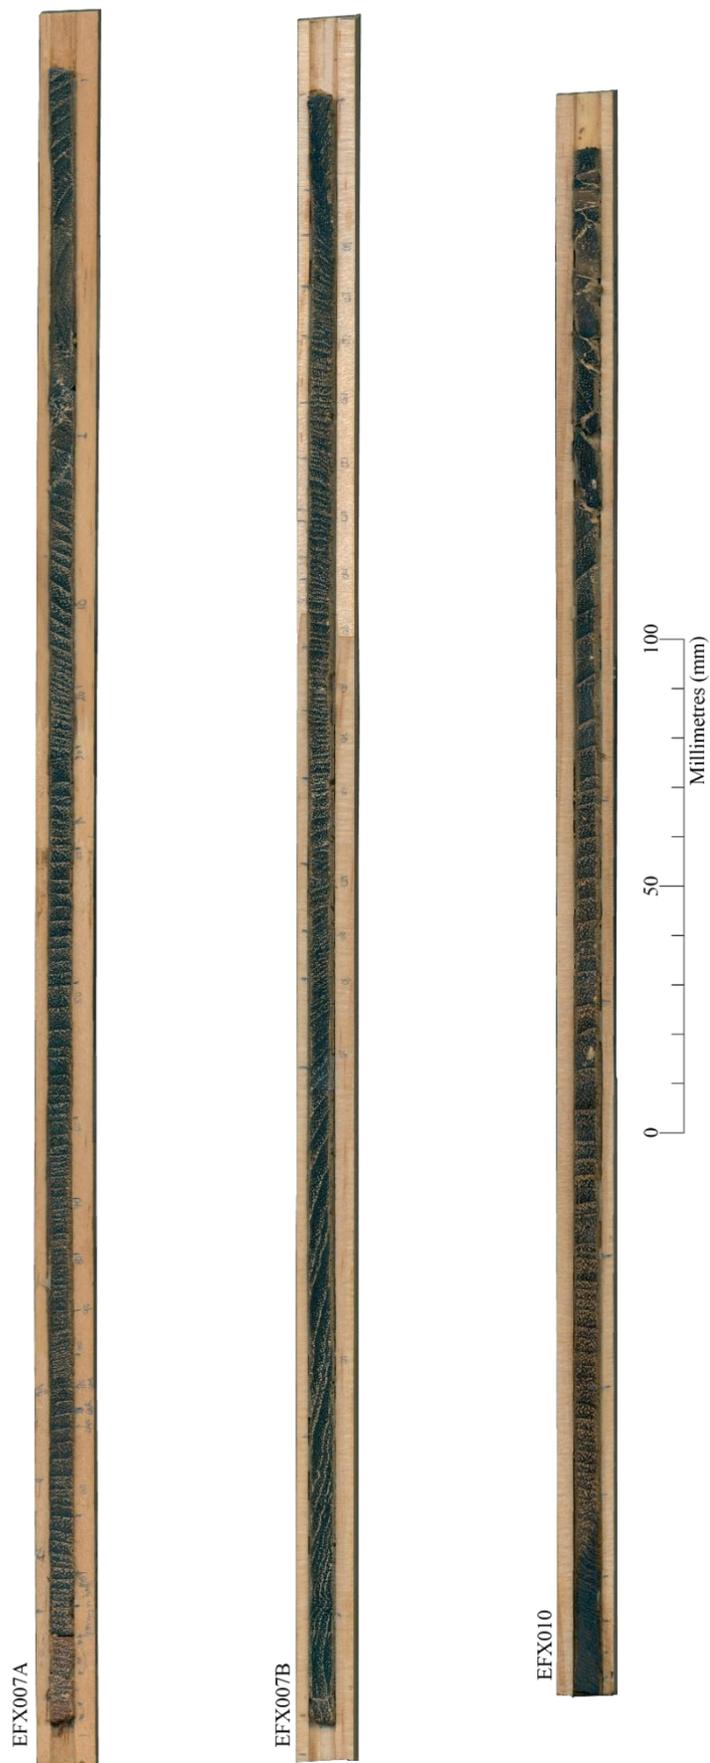
Figure 114. Dendrochronology core samples EFX007A (left), EFX007B (centre) extracted from *Edwin Fox*'s keel and EFX010 (right) extracted from the keelson.

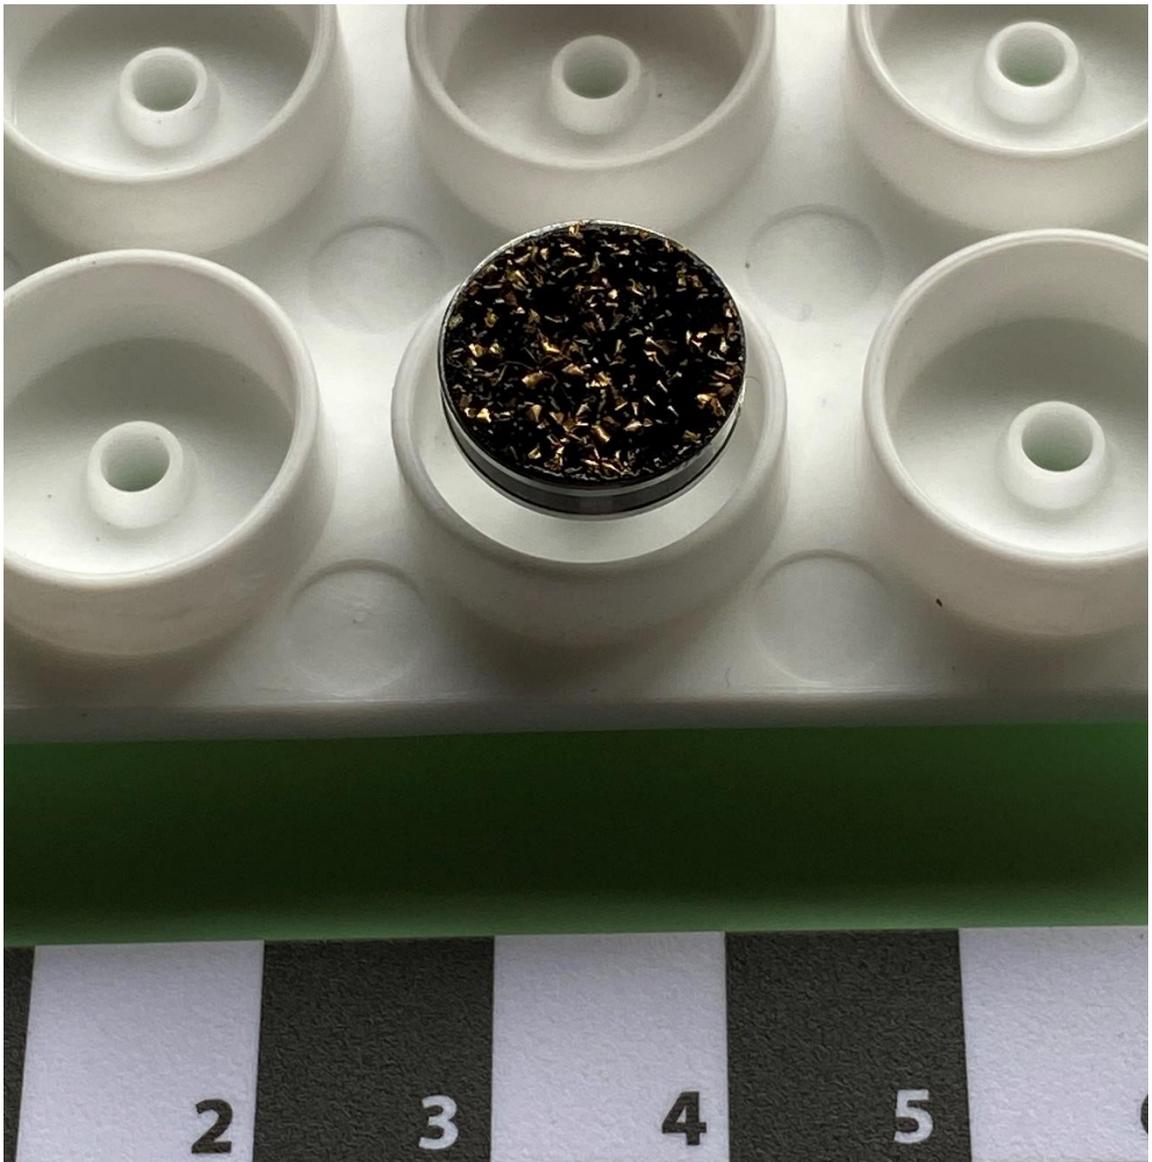
Figure 115. CS-008 set in resin before polishing (Photograph: Wendy van Duivenvoorde, 2020).

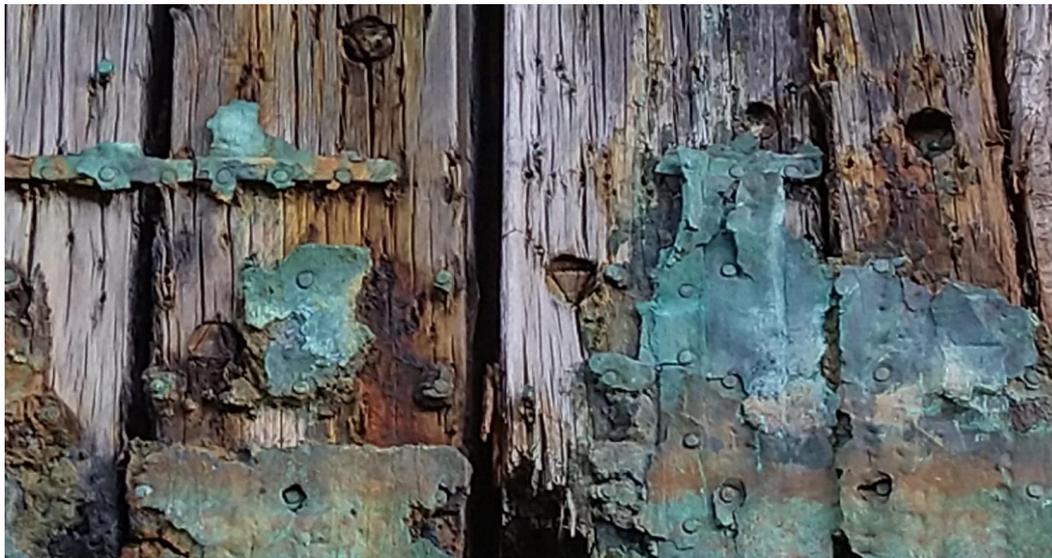
Figure 120. Triangle treenail wedges (centre) on the second planking layer on *Edwin Fox*, port side (2017).

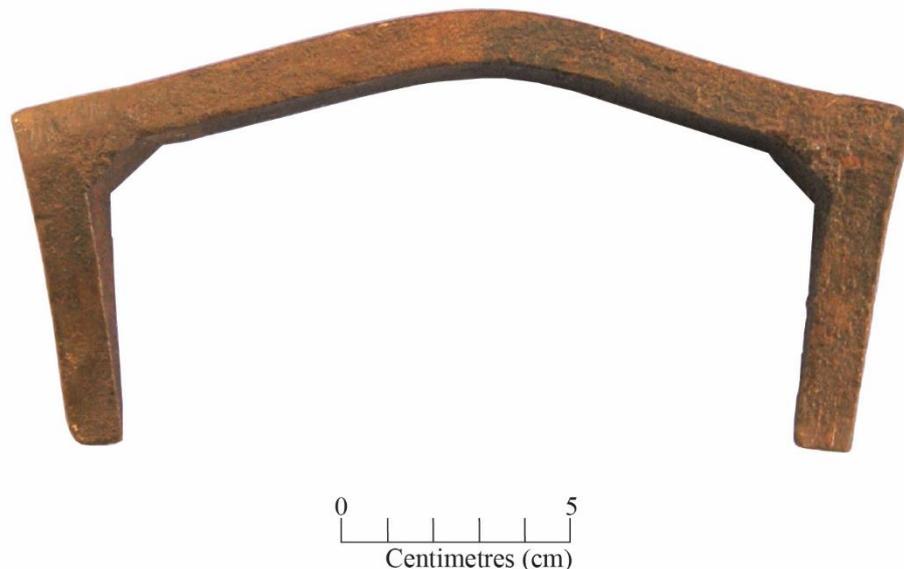
Figure 123. HMS *Buffalo* staple on display in the Mercury Bay Museum. The bend is probably caused by modern salvage processes.

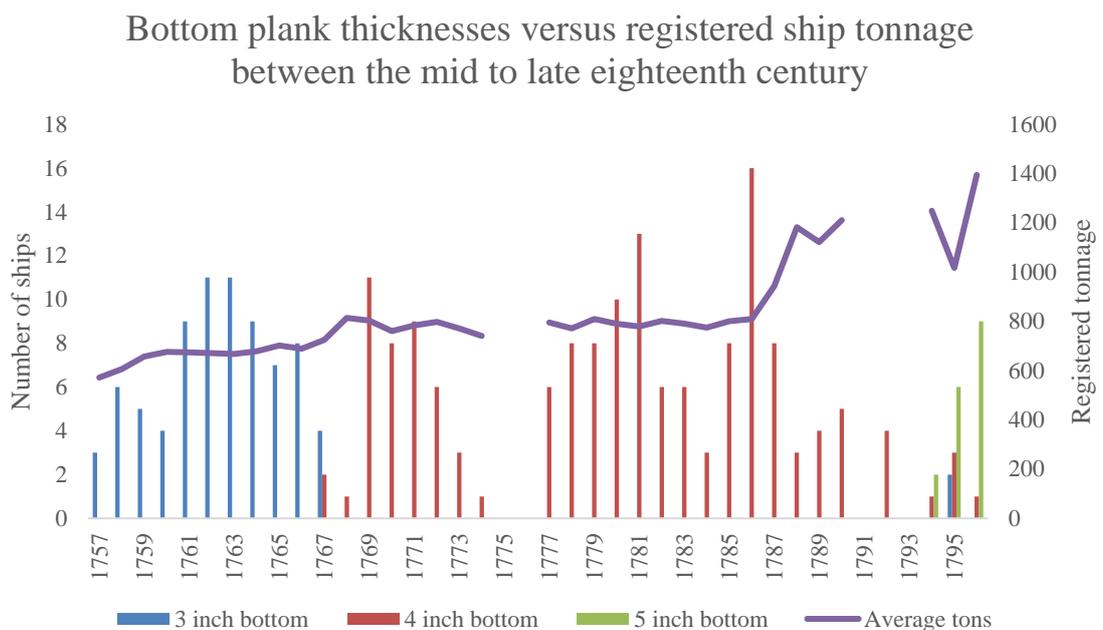
Figure 128. BEIC bottom plank thicknesses versus registered ship tonnage between the mid to late eighteenth century. Data extracted from (Snodgrass 1797a:63–74).
