CHAPTER FOUR – The Sites

Mount Benson (South East South Australia)

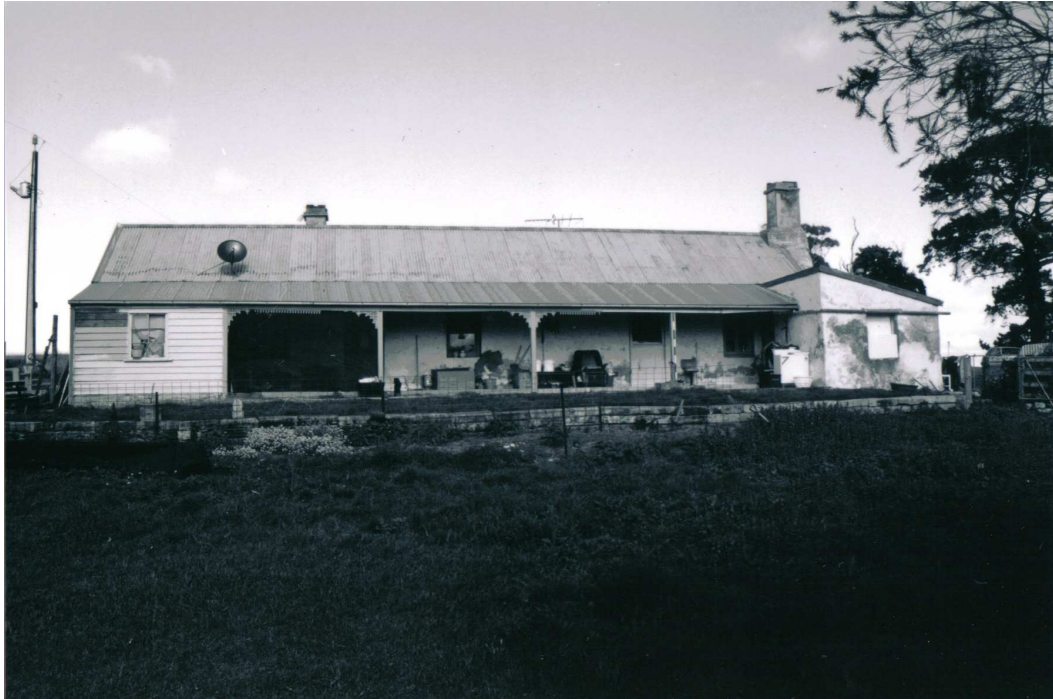
Figure 4.1.0. 'Mount Benson', now 'Wangolina' homestead as it appears today, view of north side.

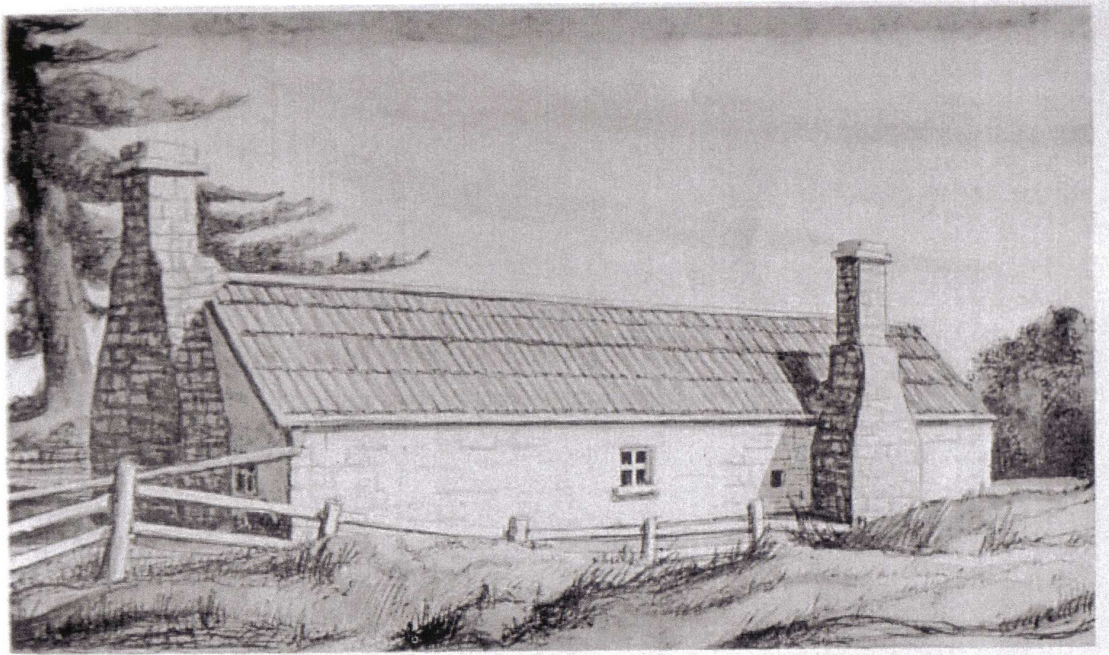
Sketch showing artist's impression of Gifford's Old Wangolina homestead. The small rifle port-hole is close to the left-hand side of the right-hand chimney.

It is not known where Barrowman obtained this information. There are three possible ways this interpretation of the building's design may have originated. The first is that someone passed the myth on to him in the form of local oral history. The second is that Barrowman interpreted the small aperture as an embrasure himself, based upon his own knowledge of defensive architectural techniques. The third possibility is that someone else told Barrowman of the aperture's function, based on their own interpretation. The myth was repeated in Sutton's 2004 book, *Full Circle* (Sutton, 2004: 25). This was in the form of the inclusion of an illustration of the building, along with a caption mentioning

the 'rifle port-hole', which originally appeared in Barrowman (1971: 56) (See Figure 4.1.1).

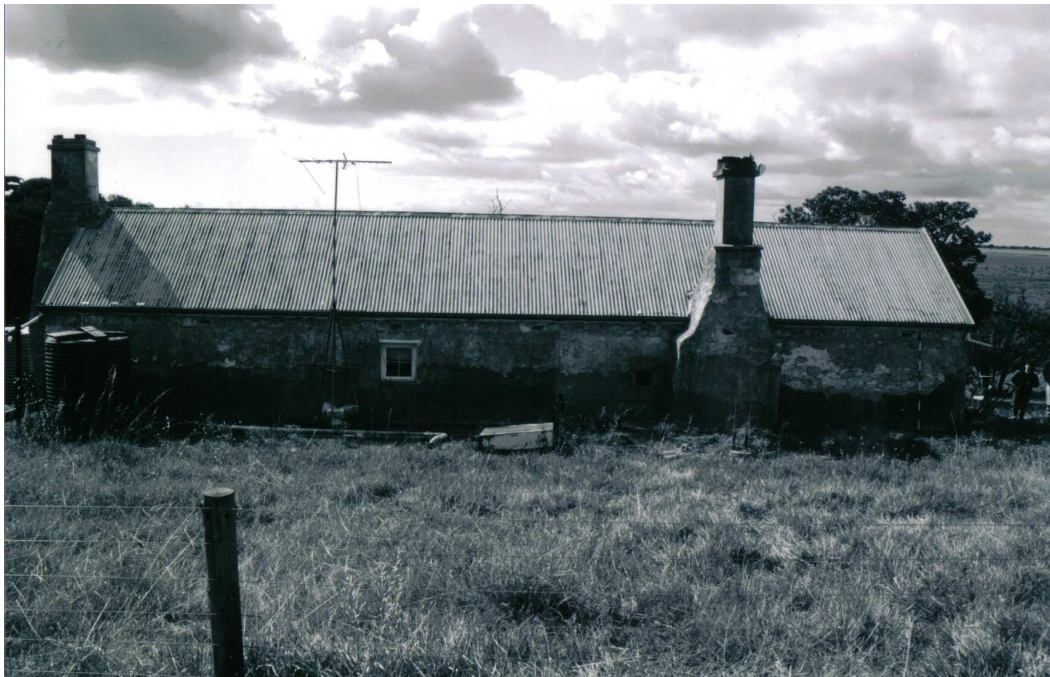
Figure 4.1.3. View of southern side of dwelling, showing the height of the ground at this point. The ‘embrasure’ can also be seen just to the left of the chimney at right. Photograph taken from atop the mound which is immediately to the rear of the building.

The building as it stands today is an elongated, three roomed one. The interior space is divided into two main sections by a wall which does not have a communicating door. This wall divides the building into a large (west) room (room 1) and a smaller (east) room (room 2). Both have an open fireplace, although that in the west room is larger. In addition, there is another dividing wall with a door on the eastern side of the building, creating a third small room here (room 3). The northern side of the dwelling was evidently the front, as it is here that all of the doors and most of the windows are located (Figure 4.1.0 & Figure 4.1.9). The dwelling is built partly into the slope of the hill on which it stands. This can be clearly seen on the southern side where the ground level is only approximately 70cm below the window (Figure 4.1.3).

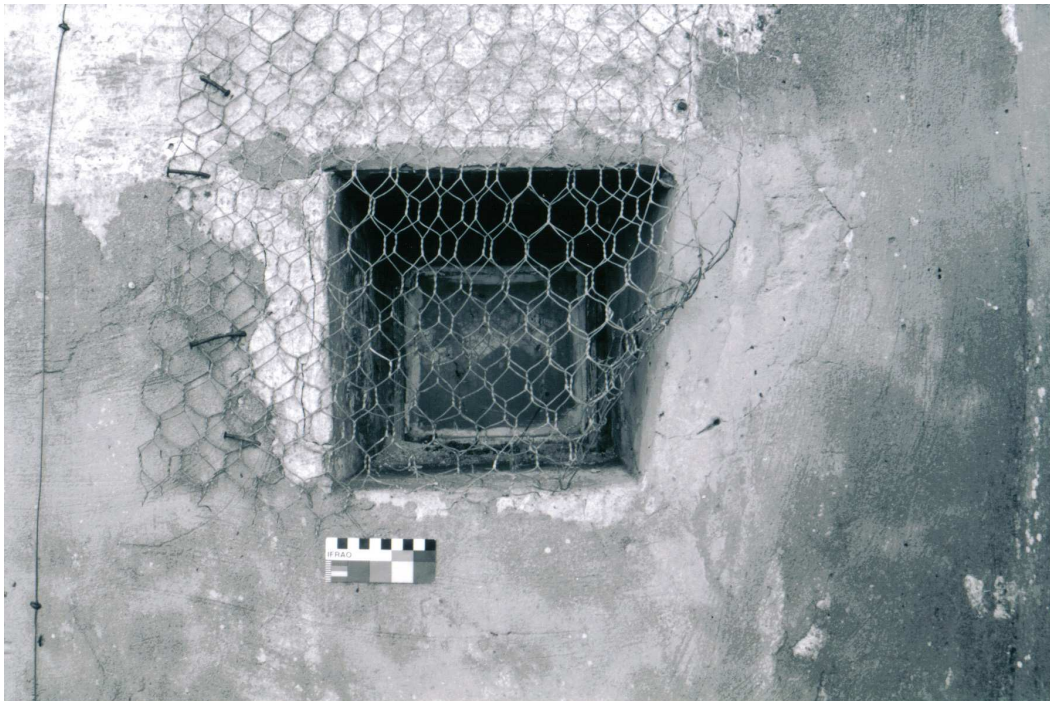
Figure 4.1.4. Close-up of the exterior of the ‘embrasure’ in the Mount Benson dwelling.

According to the myth, what is an embrasure for firing through can be seen at the rear (i.e. southern side) of the dwelling. This comes in the form of a small square aperture built into the stonework, between the chimney and the interior dividing wall in the east room (room 2). This feature measures approximately 25cm by 25cm. A small glass window has been fitted on the interior, which may or may not be original (Figure 4.1.4). There is also a relatively small casement window on this side which is part of the west room (room 1).

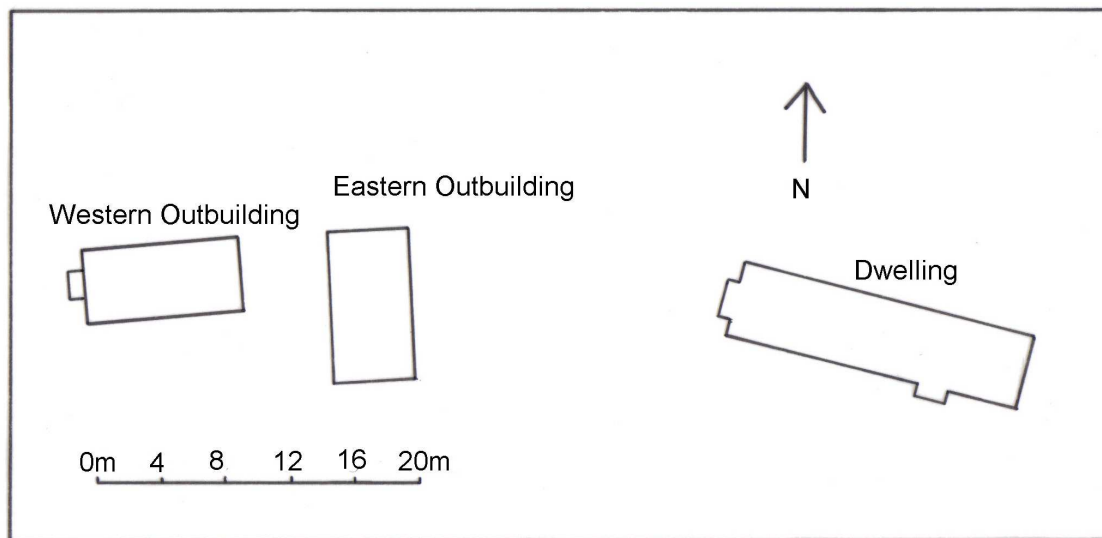
Figure 4.1.5. Site plan showing the layout of the remaining 19th century structures at Mount Benson.

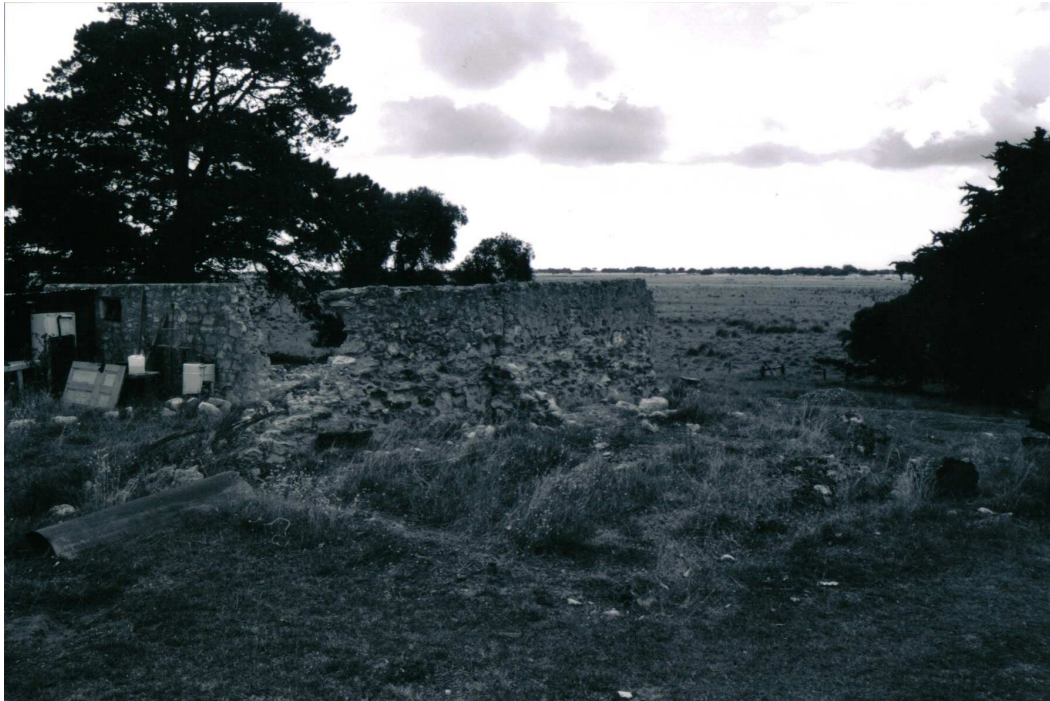
Figure 4.1.6. View of the remains of the eastern outbuilding at Mount Benson. The remains of the western outbuilding can be seen to the left. Facing north-west.

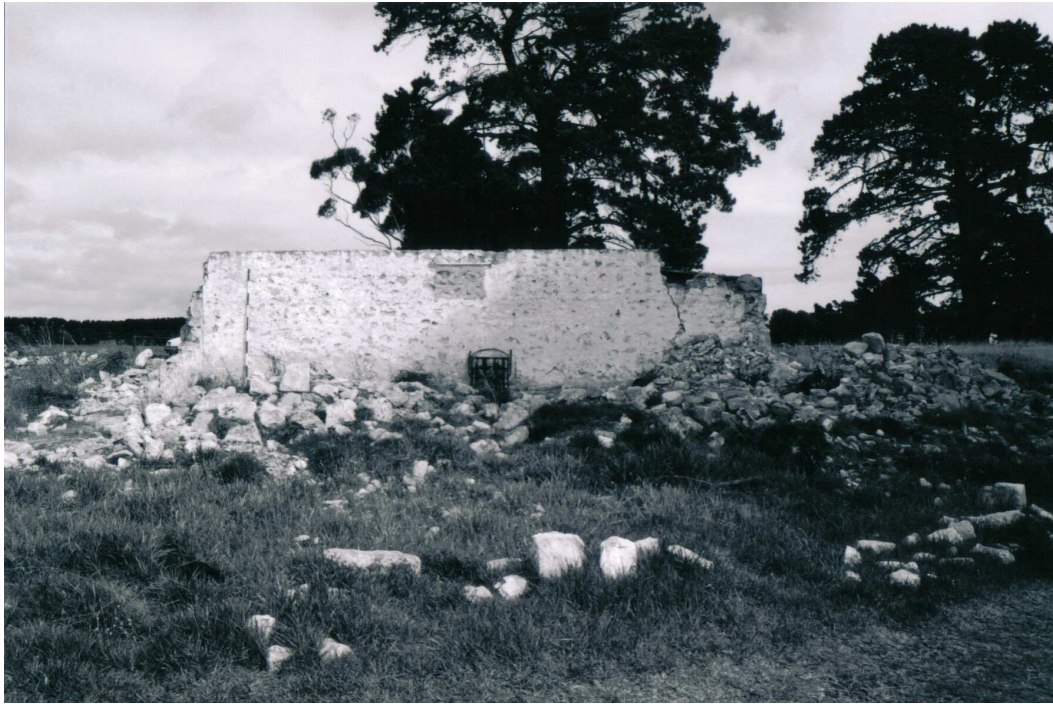
Figure 4.1.7. View of the western outbuilding at Mount Benson. The blocked up window can be seen in the upper centre of the wall, as can the rubble pile, evidently from the chimney, at right. The two large trees in the background are part of the avenue of trees believed to have marked the line of the old road. Facing south-east.

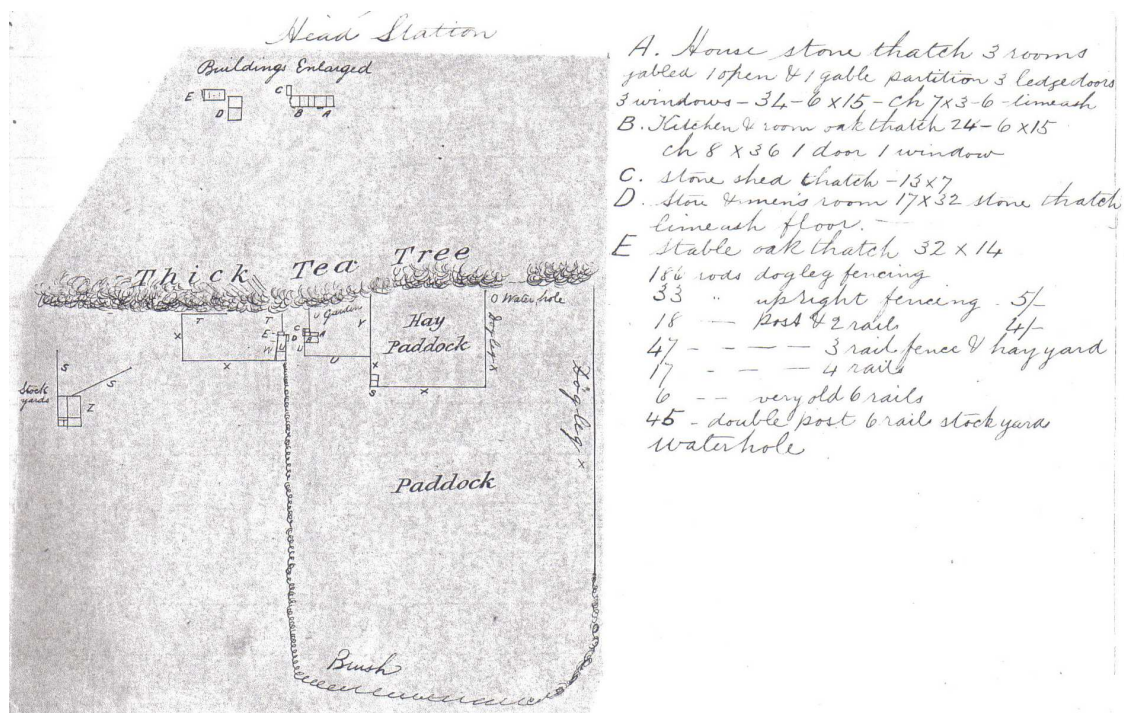
Figure 4.1.9. 1864 hand-drawn plan of the layout of the Mount Benson head station with accompanying description.

The plan and accompanying description (Figure 4.1.9) describe the dwelling as being of stone, gabled, with three rooms, three doors and three windows. There were two interior dividing partitions, one gabled and one open. There was also a chimney. The roof was thatch. Adjoining the dwelling was an oak kitchen and room with one door and one window, also with a chimney and a thatch roof. The plan shows these oak structures standing on exactly the same sites as the later stone ones (SRSA, GRG 35/653). Evidently the oak structures were demolished and replaced with stone ones, thereby extending the dwelling, sometime after 1864-66.

room. As described above, the current remains of the westernmost outbuilding show that it was made of stone. However, the description accompanying the hand-drawn plan describes this structure as made of oak with a thatch roof. This indicates that, like the kitchen and shed described above, the oak structure was demolished after 1864 and replaced by a stone one. Curiously, although a chimney appears to be shown on the plan, it is not mentioned in the description. The easternmost structure is evidently the same one as described in 1864, as its form as shown on the plan is identical to its extant plan today. It too had a thatch roof (SRSA, GRG 35/653).

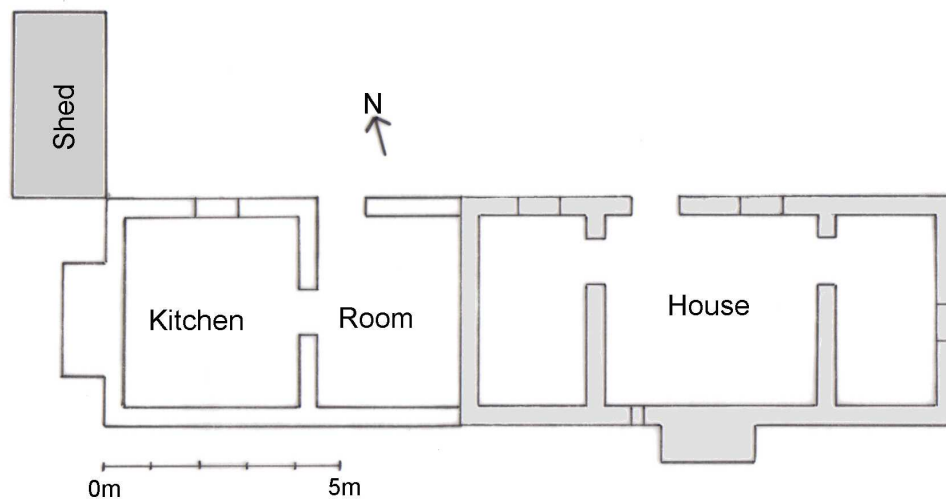
Figure 4.1.10. Suggested reconstructed plan of Mount Benson homestead at the time of the dwelling's construction. The grey-shaded portions indicate stone construction, non-shaded portions indicate oak construction.

Going by the evidence, it can be confidently argued that, at the time of the dwelling's construction, structures present at the head station consisted of the stone dwelling itself, an oak kitchen and a stone shed, the latter two structures having been replaced with stone ones after 1864-66, on the same sites. It is possible that there were additional structures at the site at this time, though no evidence was found at the time of fieldwork, and none were still standing in 1864-66. The fact that the kitchen and shed were constructed of oak may suggest that the current stone dwelling was not the original one, but was built later during Gifford's period (1847-1854) to replace an earlier dwelling, also of oak, though separate to Stirling and Grote's "Old Station". Taking into account the available information regarding the early appearance of the homestead, its suggested appearance at the time of the stone dwelling's construction is shown in the plan below (Figure 4.1.10).

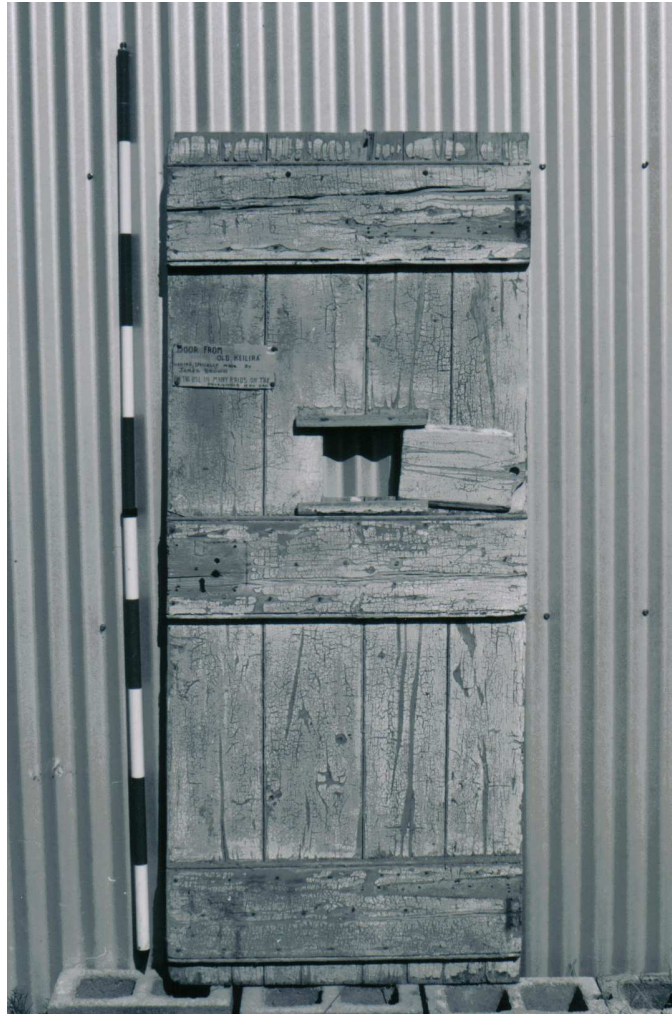
Figure 4.1.11. Door taken from James Brown's 'Avenue Range' ('Keilira') station, near Kingston South East. Brown's station was established in the late 1840s. The label attached to the door reads, "Door from old 'Keilira', opening specially made by James Brown for the use in many raids on the Aborigines of his day." View of interior side of door. Courtesy of the Kingston South East branch of the National Trust.

Visual inspection of the door gave no grounds to suggest that it was not of the period claimed (i.e. late 1840s – early 1850s). The aperture can also be said with confidence to be original, showing that the door was purpose-built with the aperture included. There has been minor repair work done in modern times, consisting of the fitting of a new upper slide housing, but this is easily discernable from the rest of the fabric. Unfortunately, there is little information regarding what particular building at the homestead the door

However, the presence of the aperture makes this door highly unusual. This was not a feature usually found in non-defensively designed doors of this period, rural or urban. There is, however, supporting documentary evidence of the use of such doors in frontier Australia. Hudson Fysh, in his 1933 book about the Queensland frontier, described homestead doors loopholed to accommodate rifles in case of Aboriginal raids (Fysh, 1933:126). The closest comparison with such an aperture are those fitted to the doors of 19th century gaol cells. The significant difference between the two, however, is that those in cell doors are opened and closed from the outside, and the doors themselves are generally much more strongly built, for obvious reasons. The aperture from the Avenue Range door, on the other hand, is clearly designed to be opened and closed from the inside.

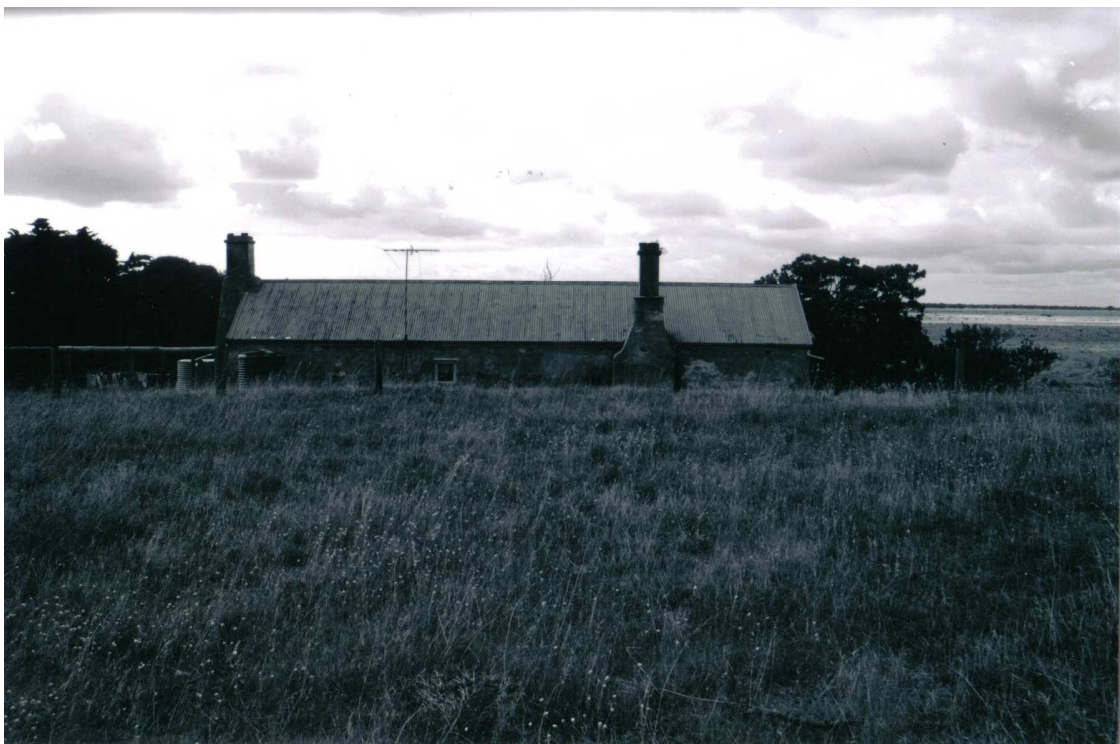
Figure 4.1.12. View of southern side of dwelling, from the reverse slope of the mound. This view shows the point at which the dwelling's defender would be able to see, and therefore, fire upon an attacker through the aperture (i.e. approximately 29 metres from dwelling). Facing north.

On the southern side of the dwelling the earth rises in a mound, beginning approximately two metres from the southern wall and gently rising before falling away to the low, flat plain south of the homestead site. This was immediately noted as being of possible significance to the assessment of the dwelling's defensive functionality, since it appeared

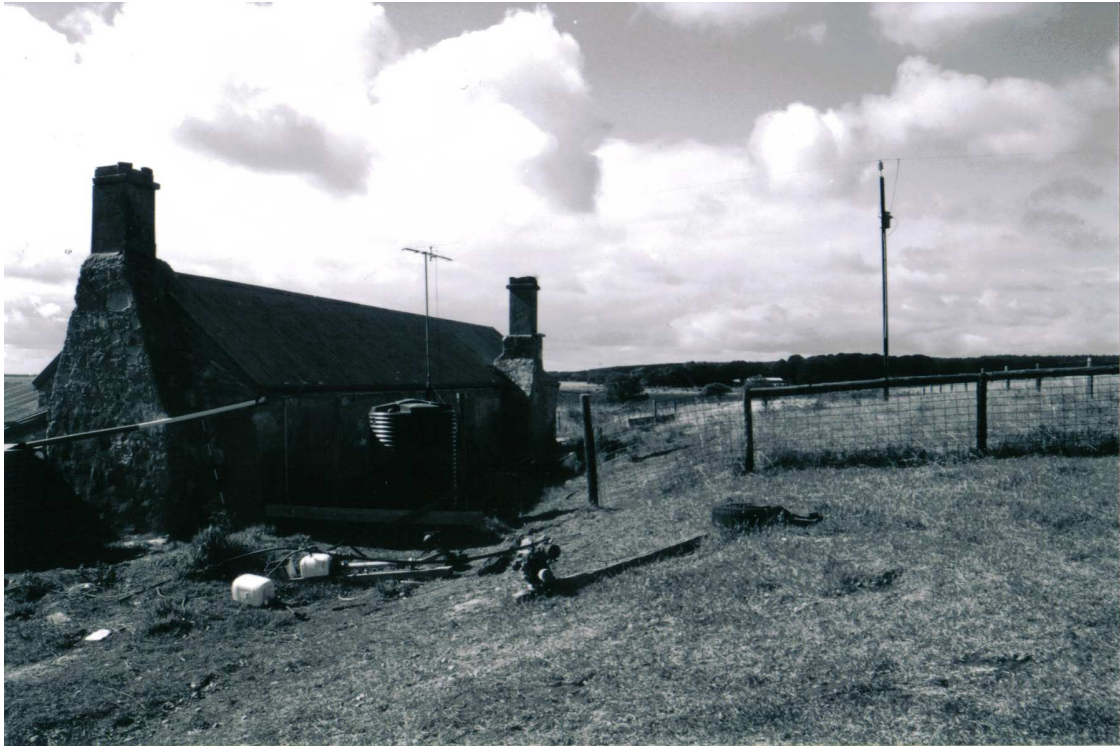
Figure 4.1.13. View showing the southern wall of the dwelling in relation to the mound. Facing east.

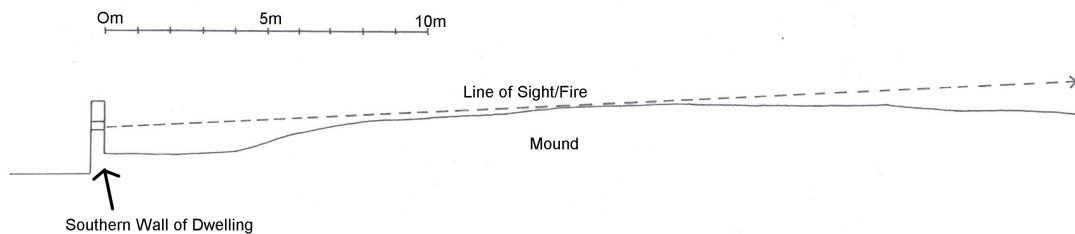
Figure 4.1.14. Diagram showing the line of sight and fire offered by the aperture, in relation to the mound on the southern side of the dwelling.

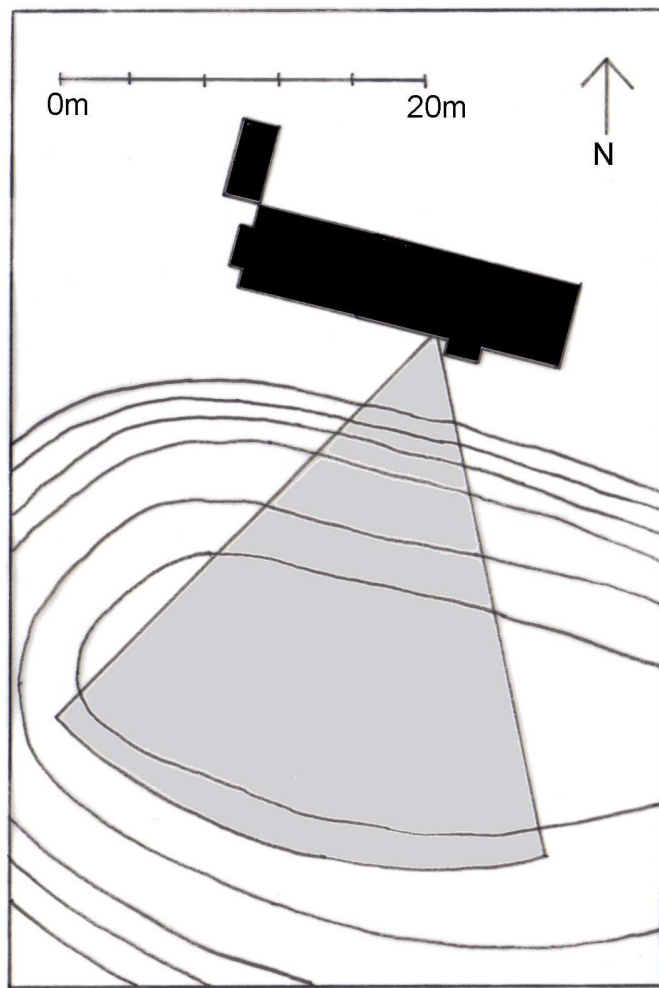
Figure 4.1.15. Diagram showing arc of fire available to defenders on the southern side of the dwelling as well as the mound. The length of the aperture's arc shows the maximum distance one can observe and fire on an attacker approaching from the south. Contour intervals: .25m.

In order to assess the practicality of the aperture for use as an embrasure, it was necessary to determine the arc of fire available to a defender using it. Here, again, the mound was significant. This was because it was the main feature of the site that affected the arc of fire through the aperture. The protruding chimney base next to the aperture on its eastern side was also found marginally to narrow the arc of fire.

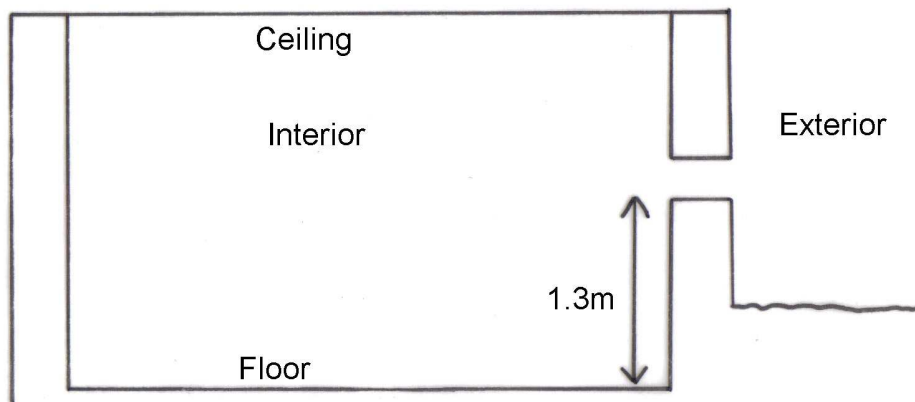
Figure 4.1.16. Elevation showing height of aperture above interior floor of dwelling.

Although embrasures found in military buildings are typically angled outwards on the interior, allowing a small exterior opening and a larger interior one, Mount Benson homestead's aperture, on the other hand, is simply square in shape, with parallel sides. However, the size of the aperture (approx. 25cm x 25cm) actually compensates for its amateur-like design. Its dimensions are such that it allows a very reasonable arc of fire and vision (Figure 4.1.15), yet is still small enough to give the defender a great amount of protection from Aboriginal missile weapons. It would have taken an extremely lucky throw for a spear to pass clean through the 25cm square hole and strike the defender.

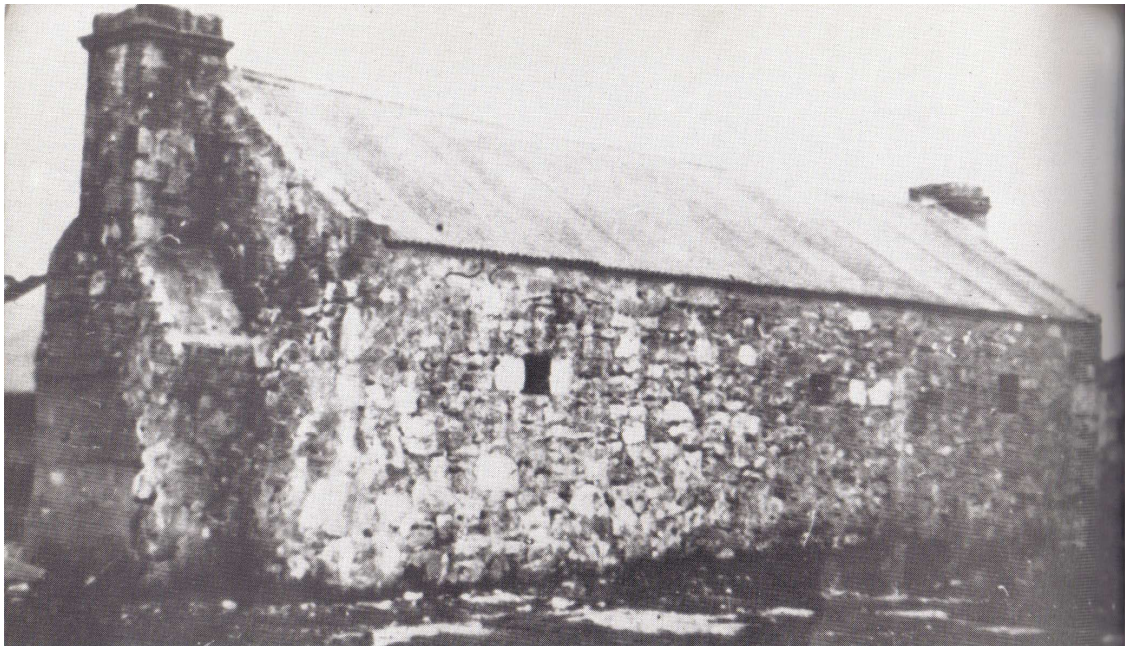
Figure 4.2.0. Western side of the 'Men's Hut' at Central Outstation. This photograph, taken in 1970, shows the appearance of this side of the building before the collapse of a large portion of the wall. Three rectangular apertures are clearly visible, evenly spaced along the wall. From Baillie, 1978: 134.

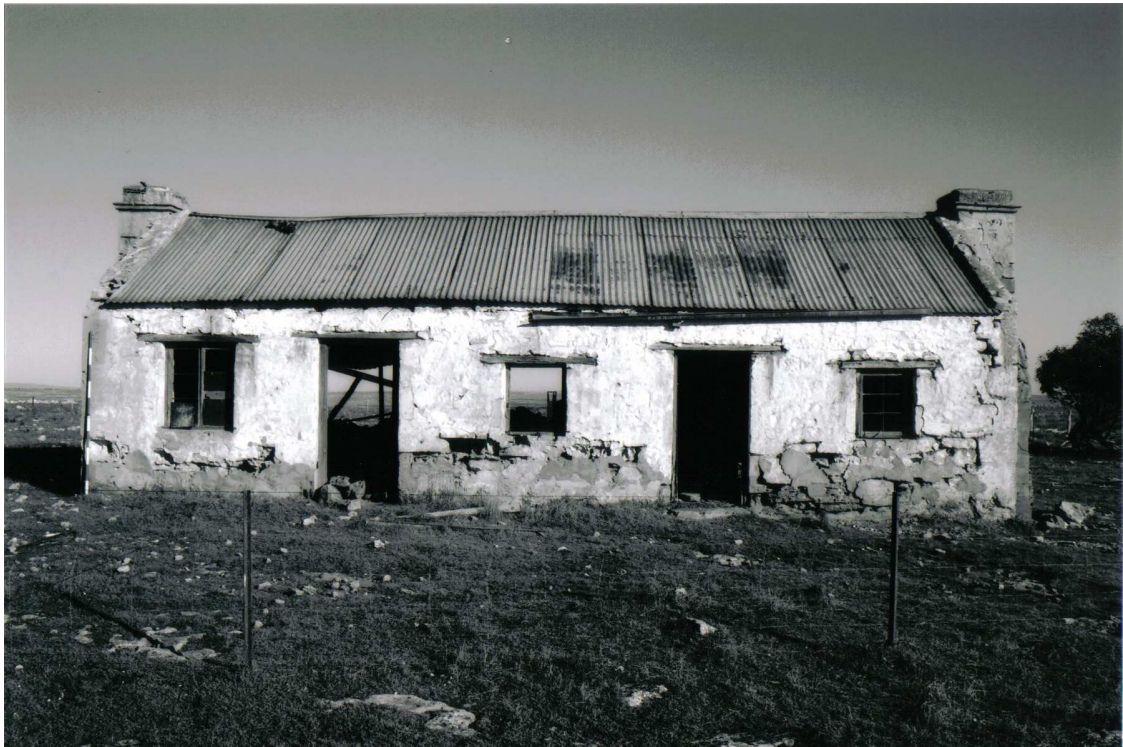
Figure 4.2.2. Eastern (front) side of the Men's Hut at Central Outstation, 2005.

This is the only 19th century structure still standing at the site (Figure 4.2.2). The building is gable roofed and made of limestone random rubble. The front (eastern) side of the building has been plastered and whitewashed, evidently a very long time ago, judging by its condition and appearance. All of the interior wall surfaces have been similarly plastered and whitewashed. The building has wooden floorboards and underneath the corrugated iron roof can be seen an evidently much older shingle roof.

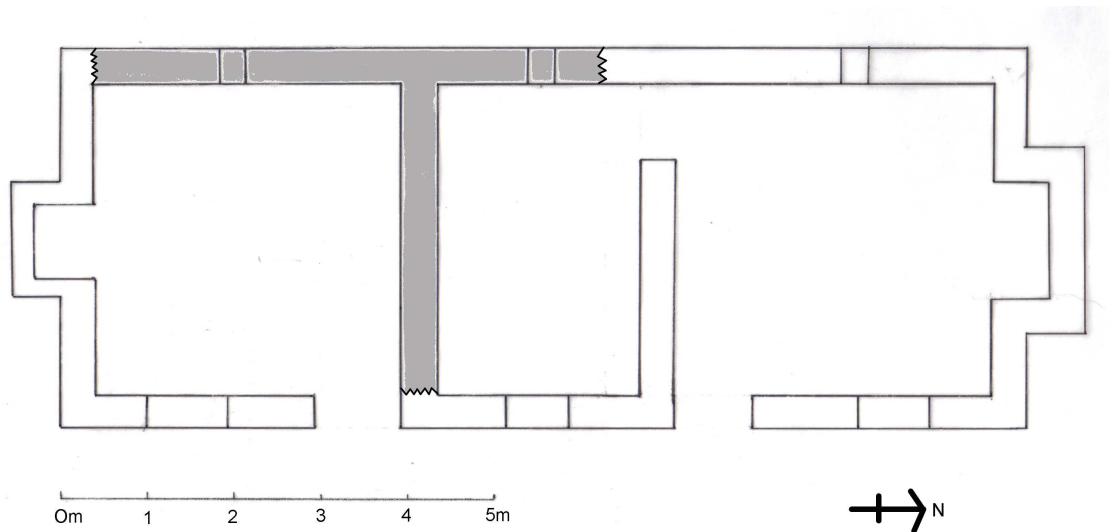
Figure 4.2.3. Plan of the Men's Hut. Grey-shaded portions are reconstructions of collapsed wall sections.

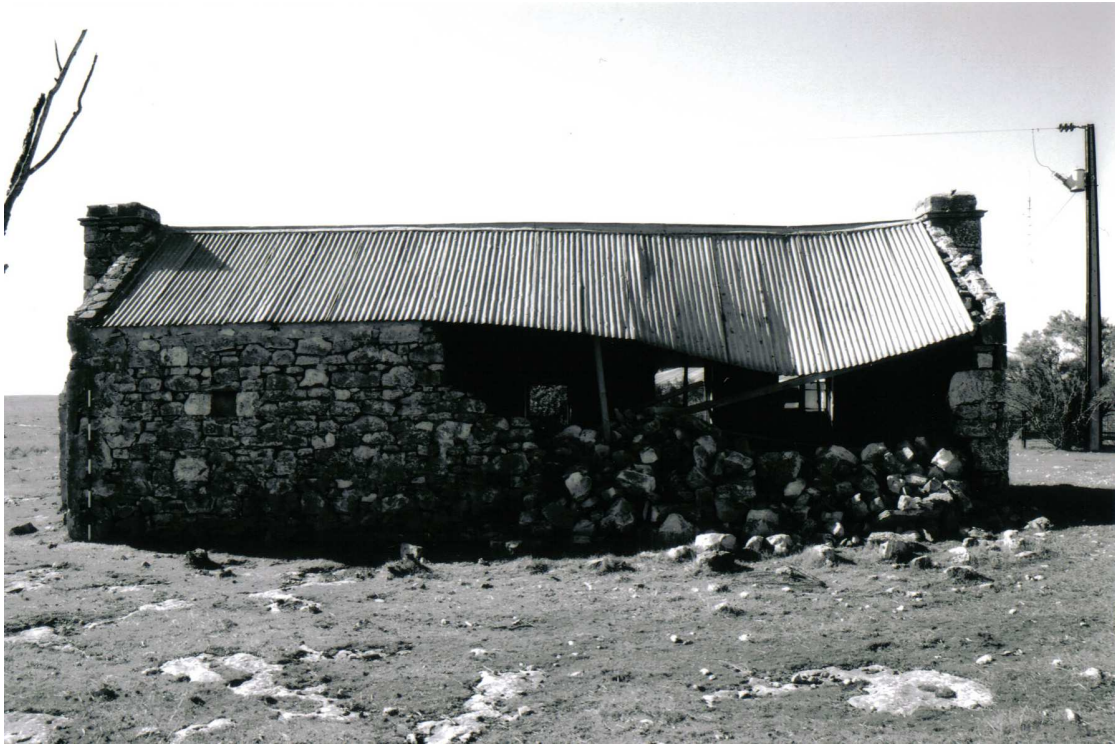
Figure 4.2.4. Recent (2005) photograph of the Men's Hut, showing the collapsed portion of wall on the western side.

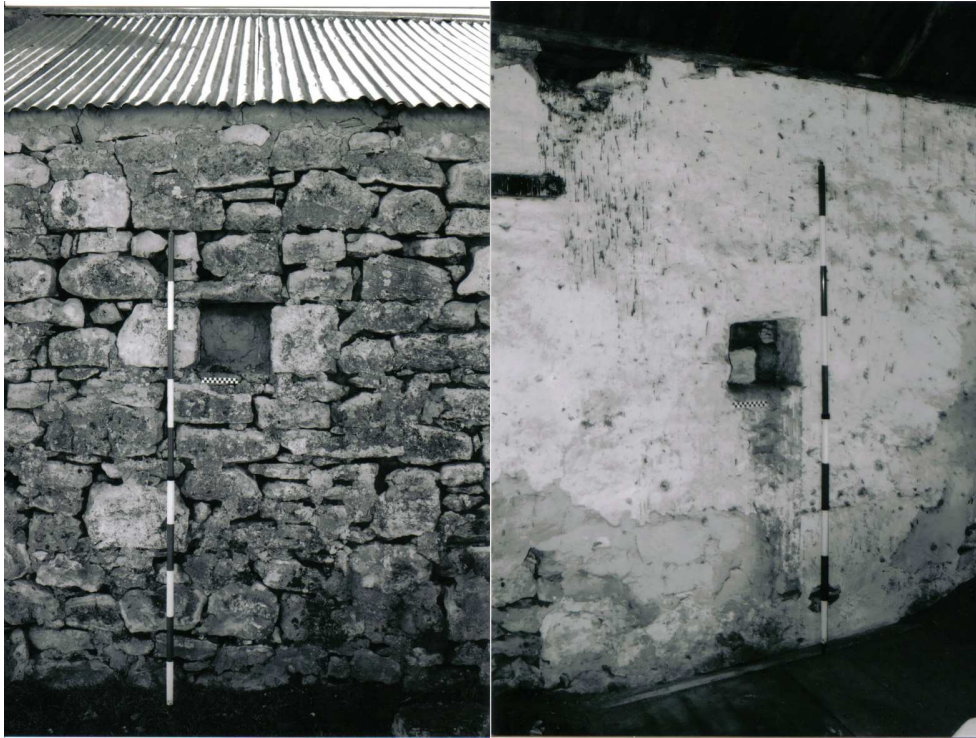
Figure 4.2.5. Exterior (left) and interior (right) views of the surviving aperture in the northern room of the Men's Hut.

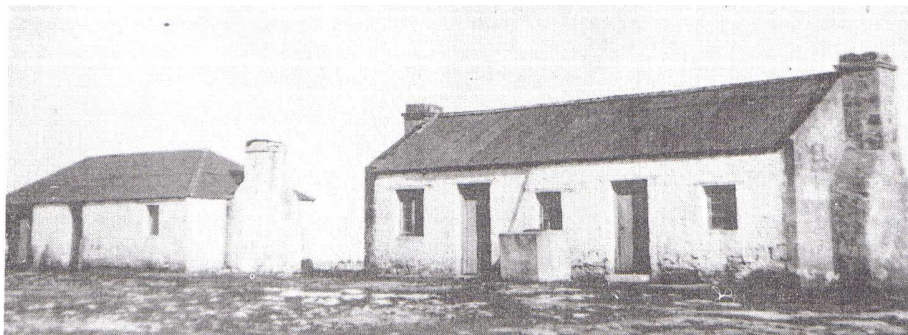
Figure 4.2.6. Undated photograph of Central Outstation. The Men's Hut is at right. The building at left has been demolished. The original caption reads "Original living quarters at Central Station". From Nosworthy, 1988: 87.

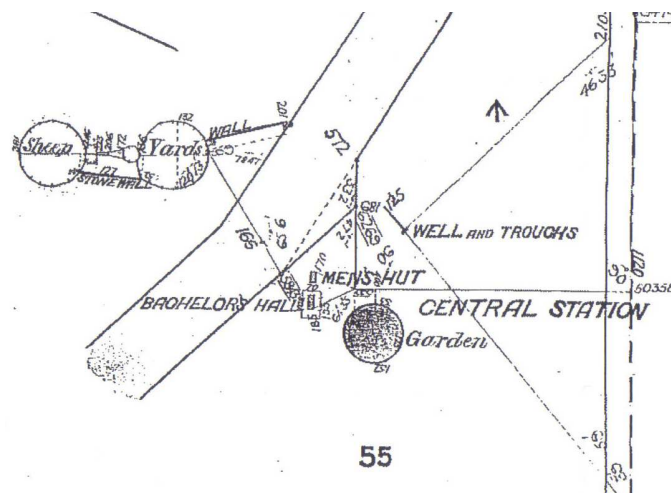
Figure 4.2.8. Survey diagram, dated 6/8/1884, showing the 'Men's Hut' and the now-demolished 'Bachelor's Hall'. Courtesy of the Land Services Group, S.A.

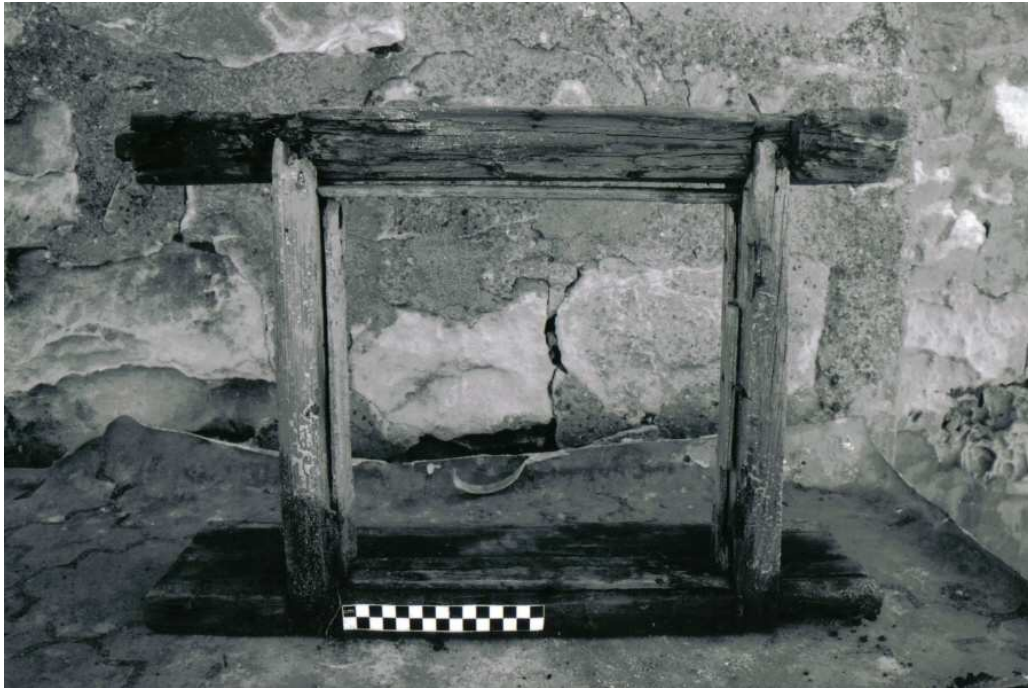
Figure 4.2.12. Reconstructed shutter frame from central aperture. The cut-outs of the inner frame for the shutter's hinges can be seen on the right inside the frame.

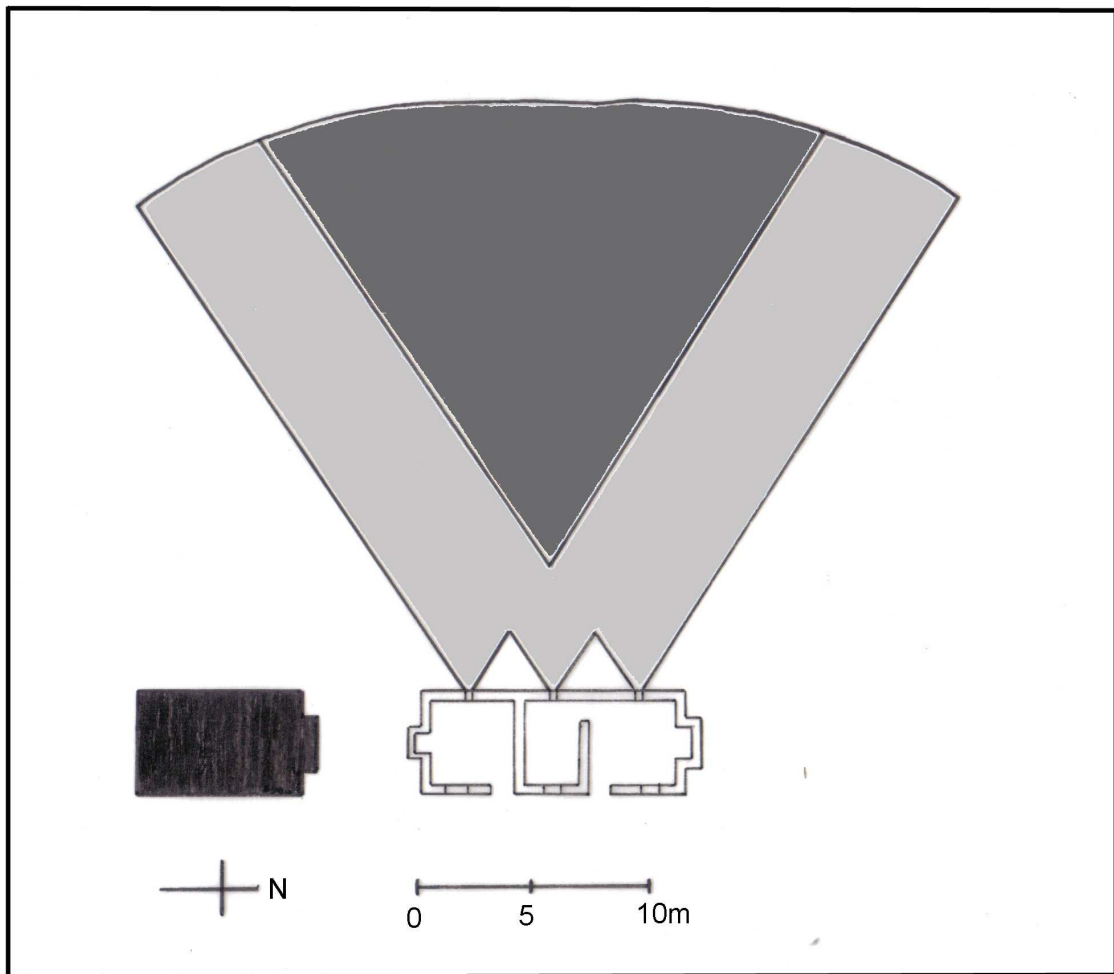
Figure 4.2.13. Plan showing arcs of fire provided by the three apertures in the Men's Hut, shown extending out to an arbitrary distance of 25m. Dark grey portion shows terrain able to be covered by all three apertures simultaneously. Shown to the left is an approximate reconstruction of the position and dimensions of the other structure which once stood on the site.

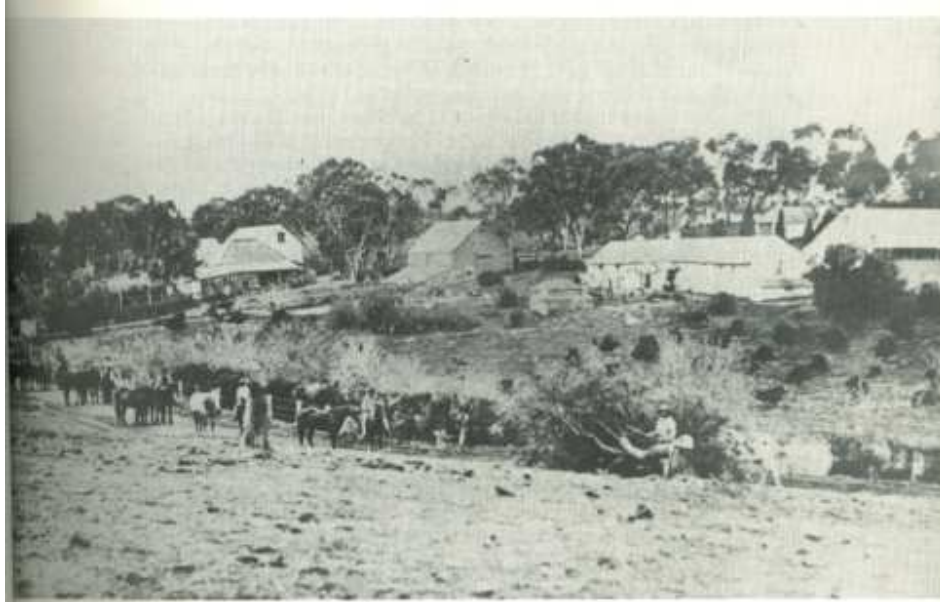
Figure 4.3.0 Lizard Lodge ca 1865. The coach-house can be seen in the centre of the photograph. Courtesy of the Mortlock Library of South Australiana.

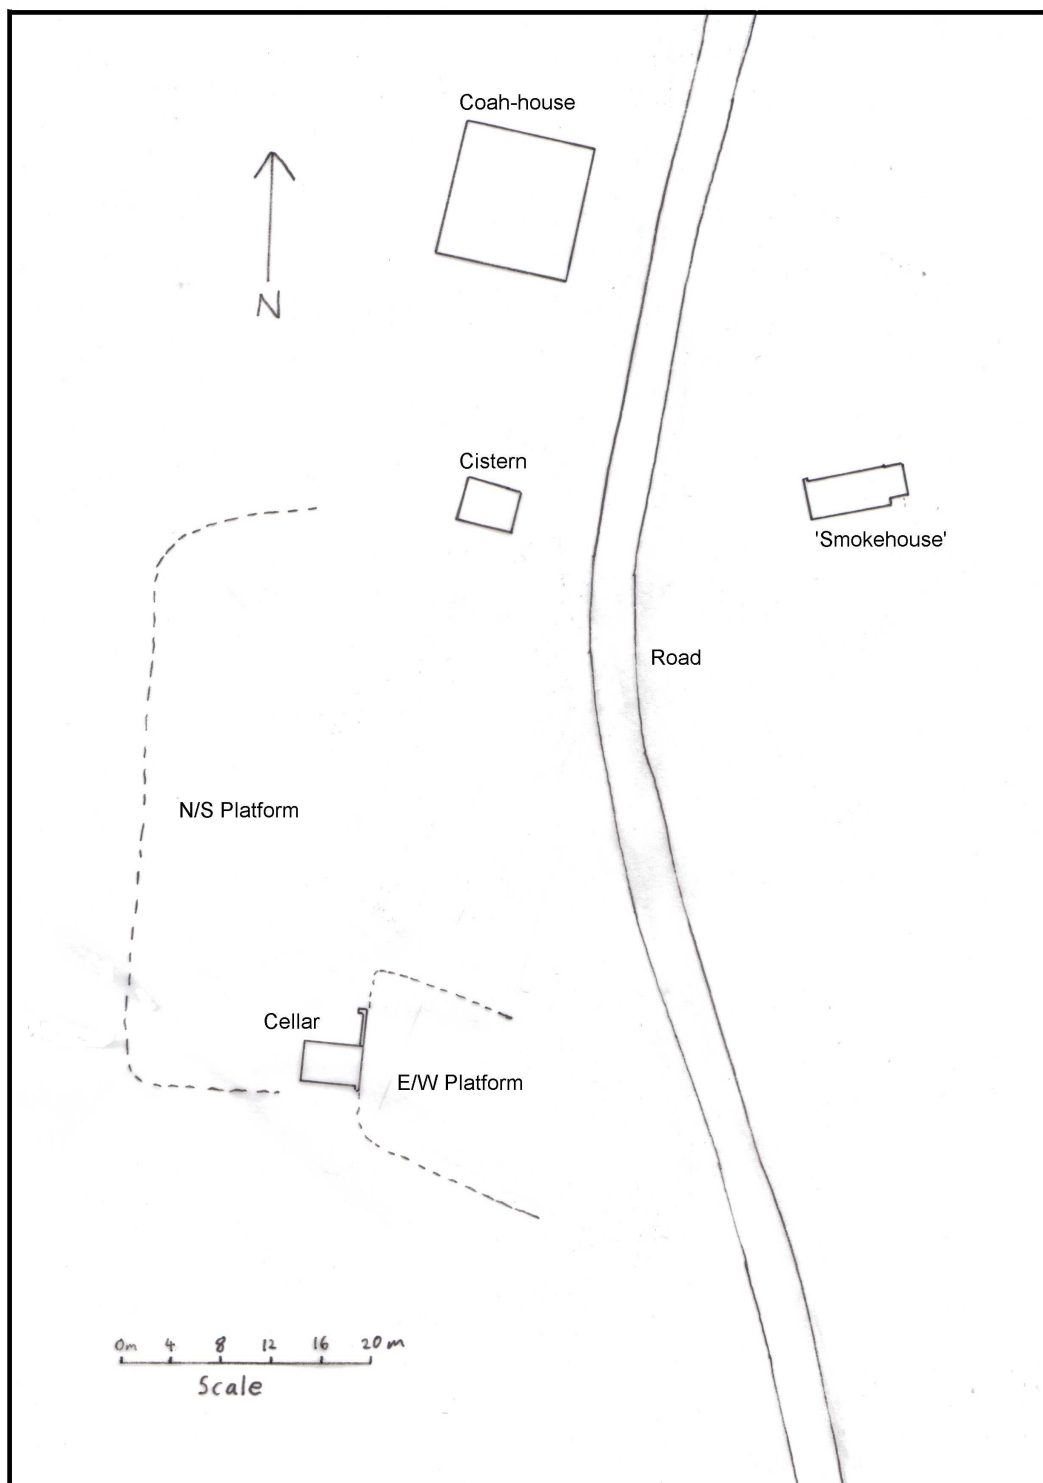
Figure 4.3.2. Site plan of 19th century features present at the site of Lizard Lodge homestead, April 2005.

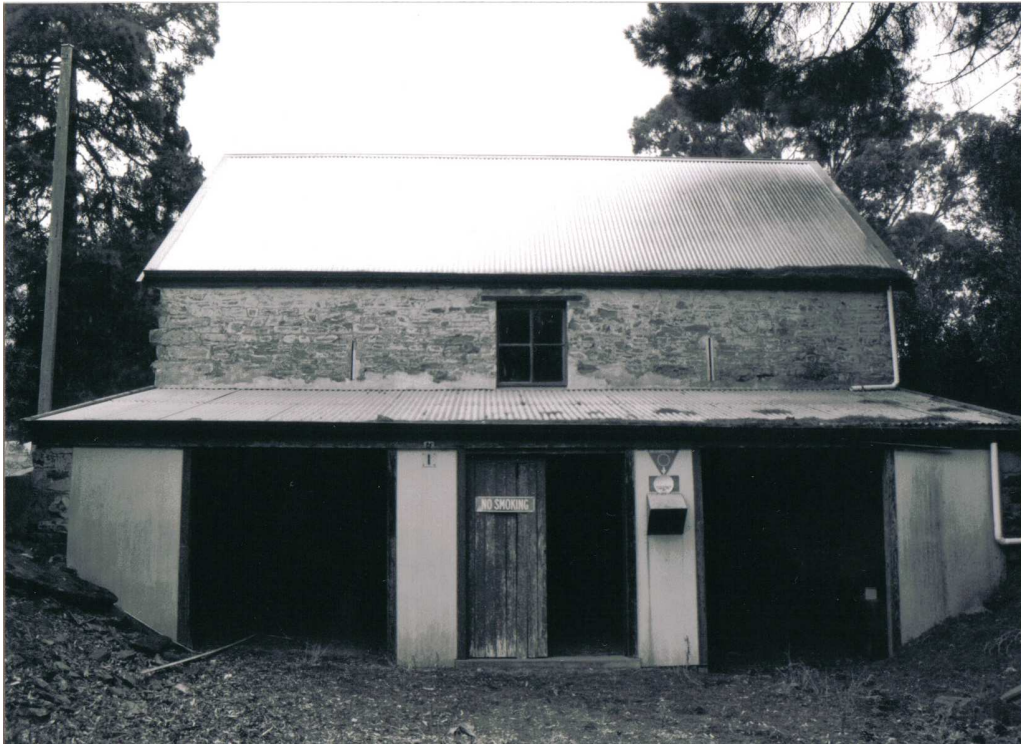
Figure 4.3.3. The western side of the coach-house. The apertures are visible on either side of the window, nearly half way between the window and the sides of the building, as narrow vertical slots.
