CHAPTER FOUR – The Sites

Mount Benson (South East South Australia)

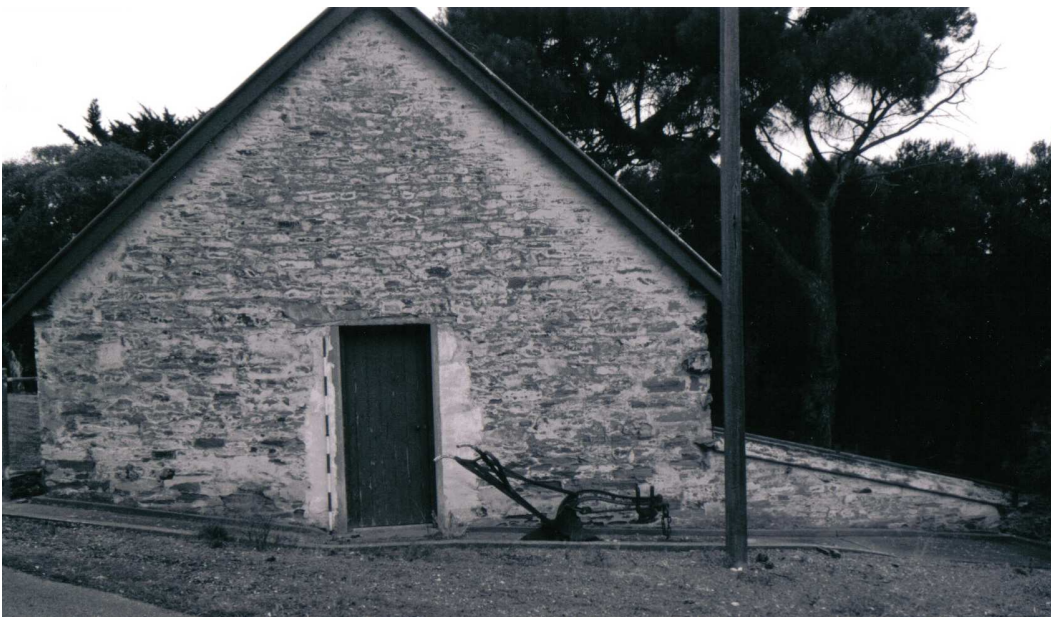
Figure 4.3.4. Northern side of coach-house, showing the single door on this side providing access to the upper ground level.

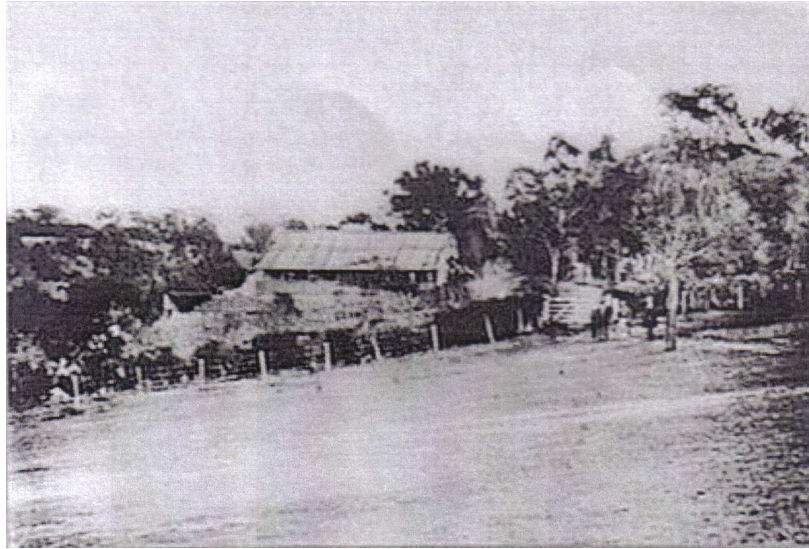
Figure 4.3.7. Lizard Lodge dwelling. This photograph, dated to ca 1880, was taken from the south facing north. The caption that comes with the photograph states that the interior was imported in sections from England, and remained in a good state of preservation for nearly 100 years, until destroyed by fire. Courtesy of the Morlock Library of South Australiana.

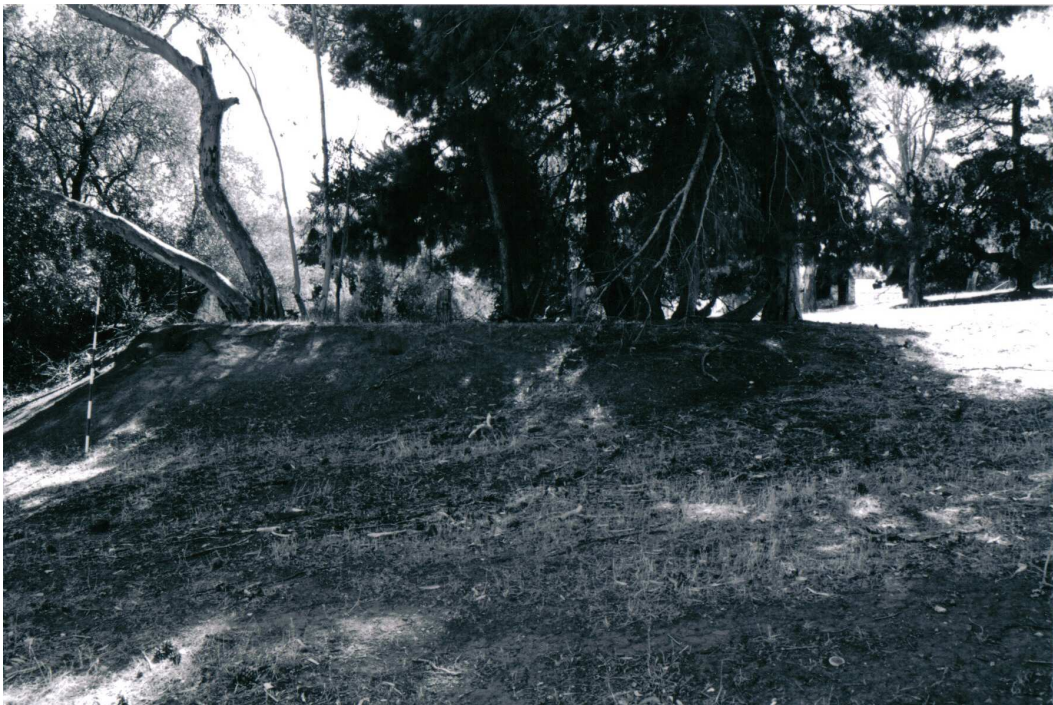
Figure 4.3.8. The earthwork platform on which the original dwelling may have stood, facing north. Although originally probably much higher, today it still stands ca 150cm high at its western end.

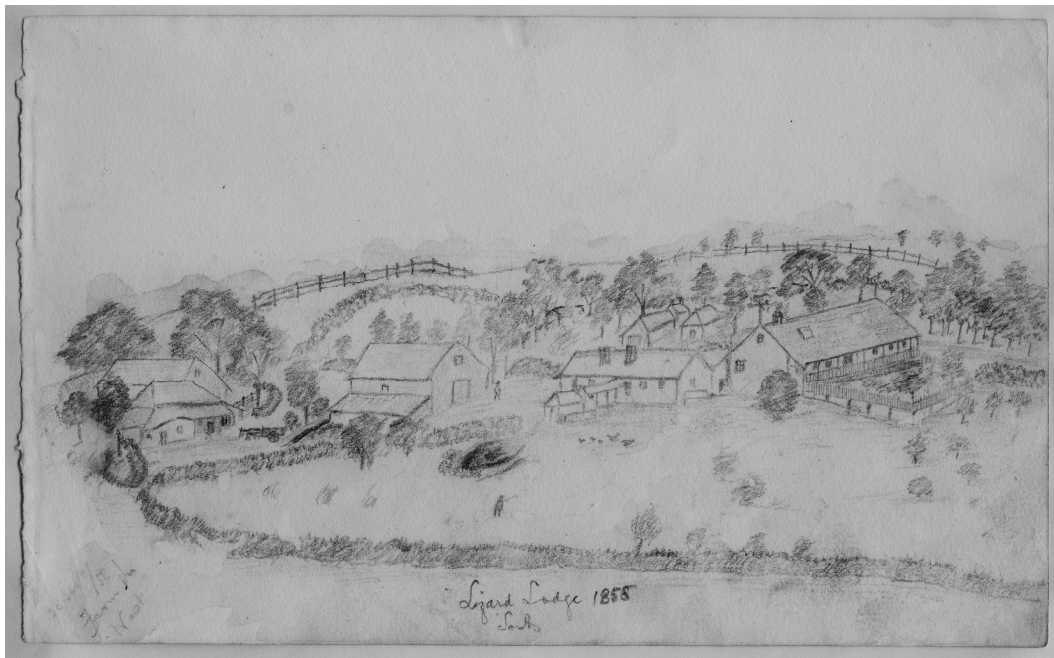
Figure 4.3.10. Another pencil drawing of Lizard Lodge, this one dated 1855. This illustration shows the newly-built coach-house, as well as many of the other structures that stood on the site. Courtesy of the Mortlock Library of South Australiana.

There is some very good pictorial documentation of the appearance of Lizard Lodge in its early decades. In the O'Halloran papers in the Mortlock Library there are two small pencil drawings from the 1850s (Figures 5.3.9 & 5.3.10). One, dated 1851, shows four buildings and some fenced paddocks. The homestead, servant's quarters and another building have all been demolished since, but an outbuilding in the drawing still stands as a ruin (the 'smokehouse'). Another drawing, dated 1855, clearly shows the coach-house,

which is still intact today. From this evidence it can be deduced that the coach-house must have been built sometime between 1851 and 1855. Furthermore, there appears to be evidence in the earlier (1851) drawing that the coach-house was built closer to the early side of this date range. This comes in the form of a fenced-off area located in the very position where the coach-house was later to stand, and of slightly larger dimensions than the later coach-house. Inside this area is an irregularly-shaped black area. This black area, therefore, may represent the cutting-away of that part of the hillside in order to build the coach-house. The fence around it probably served to demarcate it as a construction site and as a safety barrier to prevent people and animals from falling into the excavation. Therefore, since there is evidence that construction of the coach-house had commenced by 1851, it is likely that the building was completed within a year or so of the sketch, which would date it to 1851-1852. A third pencil sketch of Lizard Lodge is held by the South Australian Art Gallery. This sketch was made by Edward Frome and is dated to ca 1840s. This sketch clearly shows that the Lizard Lodge dwelling was built upon a walled embankment (Figure 4.3.6).

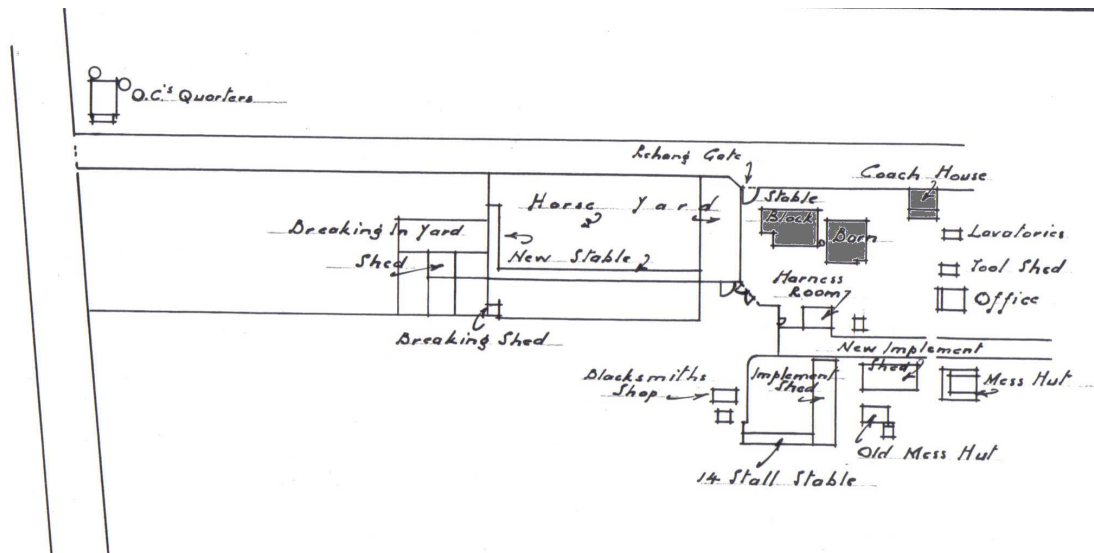
Figure 4.3.11. Plan of part of the Army Remount Depot at Glenthorne, 1925. The position and dimensions of the Lizard-Lodge stables and barn can be seen just to the left (north) of the coach-house, shaded grey. The remainder of the structures shown are of a later date. Scale: 200ft to 1 inch. National Archives, Adelaide.

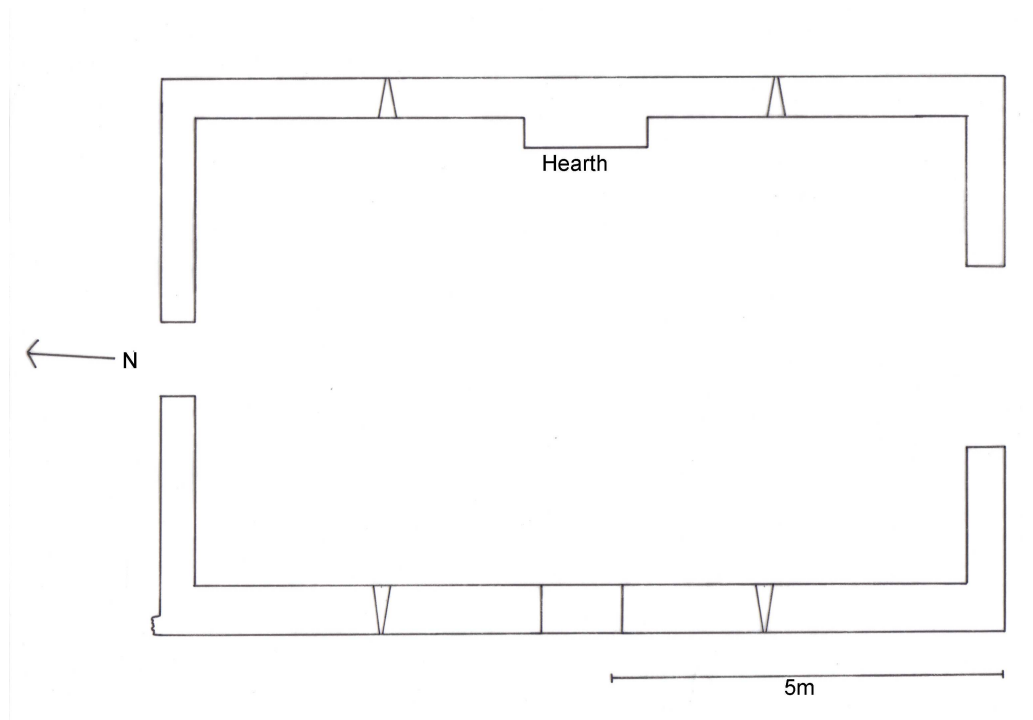
Figure 4.3.15. Plan of the upper ground floor of the coach-house, showing the two entrances, window, and position and dimensions of apertures.

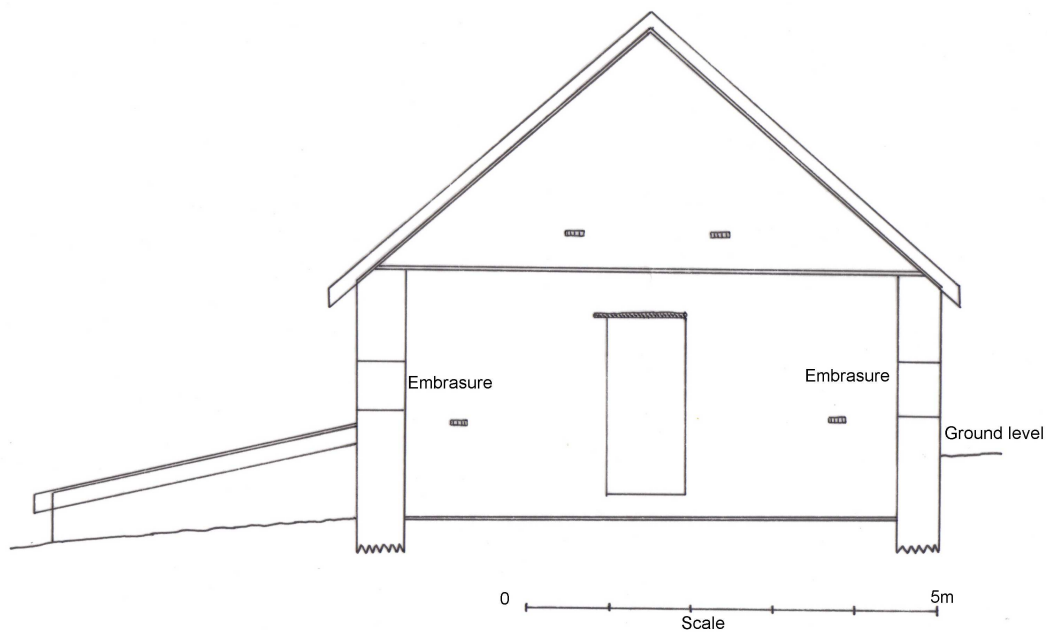
Figure 4.3.16. Sectional elevation of the coach-house showing the interior of the upper-ground level room and loft, facing north.

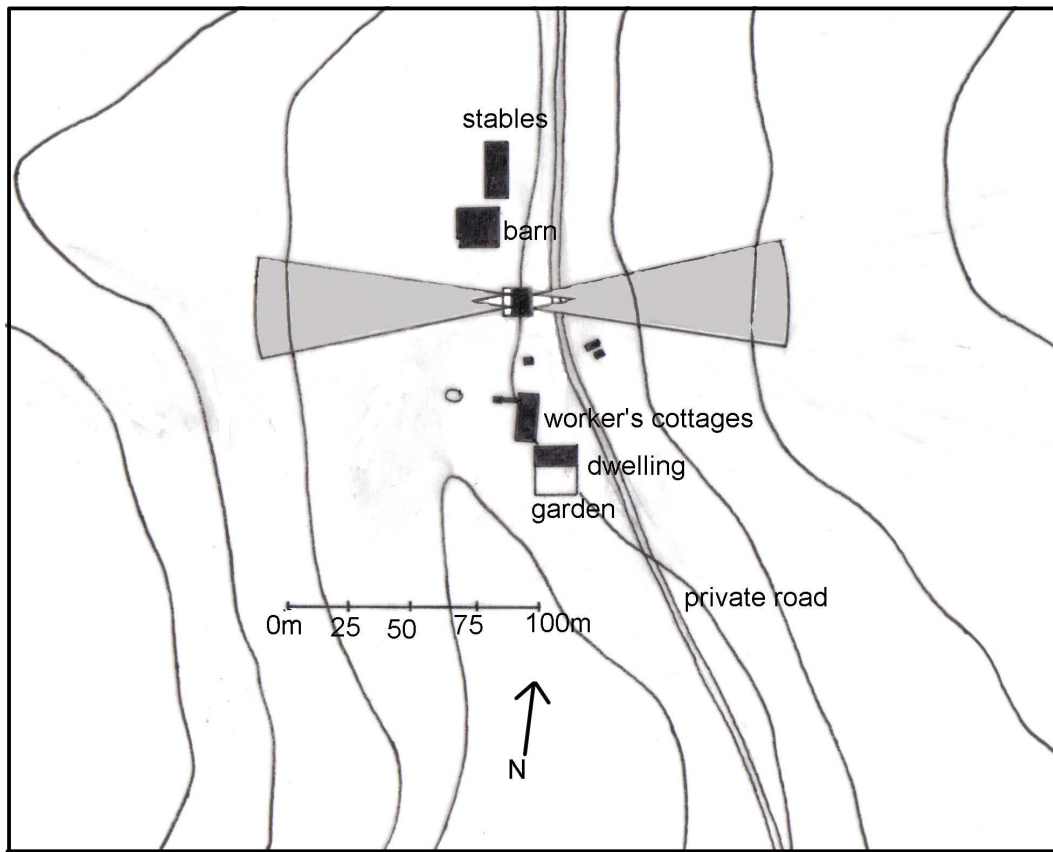
Figure 4.3.17. Reconstruction of Lizard Lodge homestead at the time of the completion of the coach-house (ca 1852). The arcs of fire offered by the coach-house's apertures are shown shaded grey. The arcs have been extended out to 100m, this being the maximum effective range of the type of firearms it is believed would have been used at the time (i.e. Smoothbore longarms).

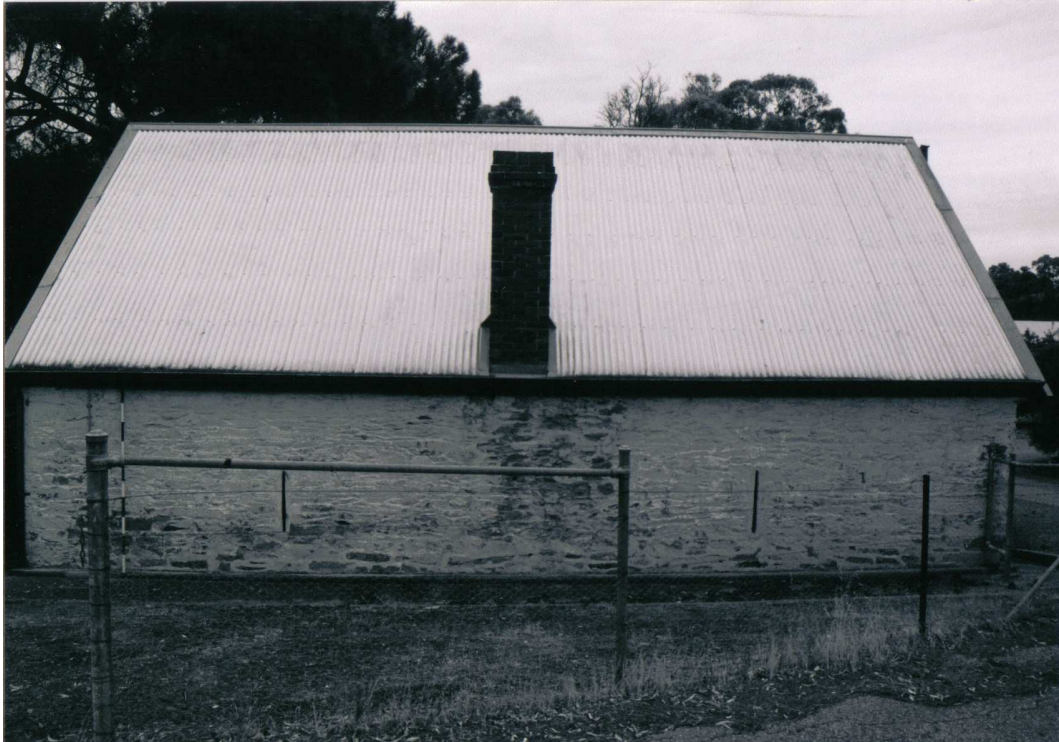
Figure 4.3.19. The eastern side of the coach-house, showing the apertures and the chimney.

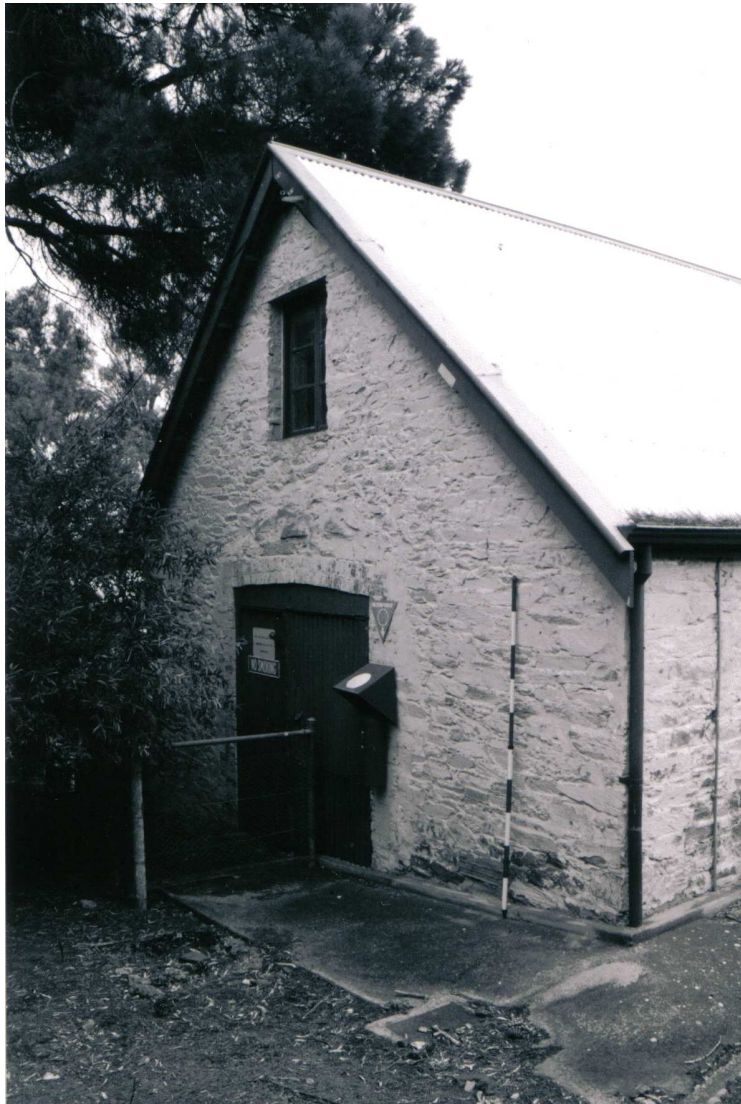
Figure 4.3.20. The south side of the coach-house, showing the double doors and loft window.

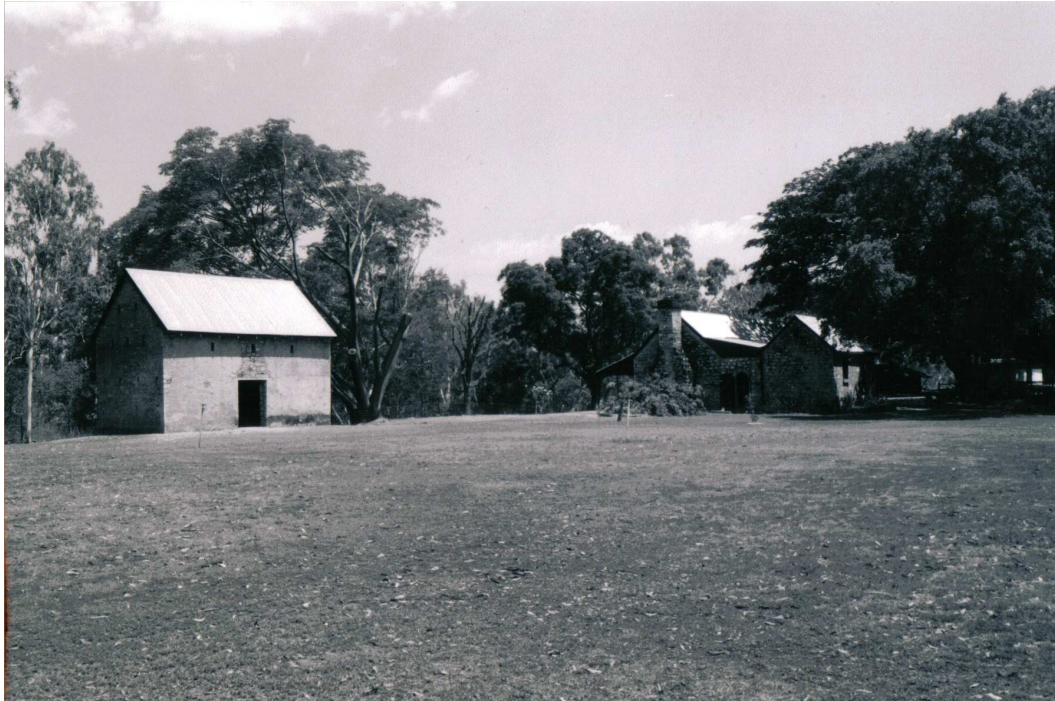
Figure 4.4.0. Extant structures of Springvale Station. The store is at left, the dwelling at right. At far right is one of the large raintrees. The dense trees behind the store mark the sloping bank of the Katherine River. Facing north east. 2004.

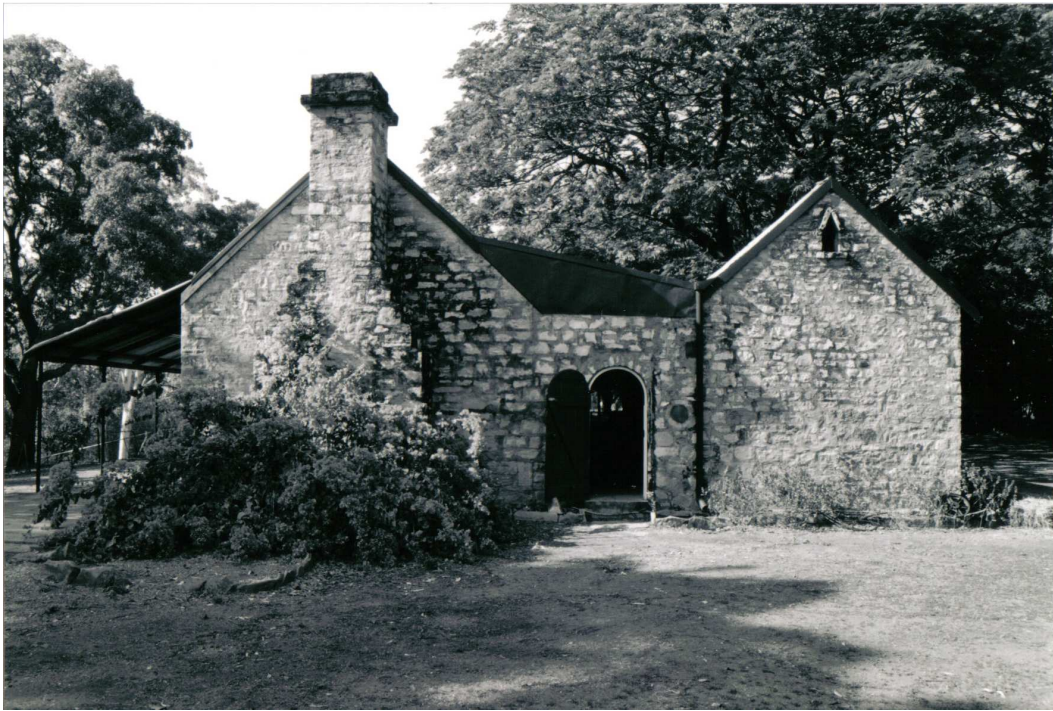
Figure 4.4.3. The northern side of the dwelling, 2005.

The dwelling is a low-set, single storey building of two linked sections. The larger section is to the east and consists of a kitchen and two larger rooms. It faces the river, and has an open verandah on its eastern side, and an enclosed verandah to its west. The smaller section contains two rooms and is attached to the enclosed western verandah. Each section of the building has a steeply pitched gable roof. The walls are made of coarse, squared stone finished with lime plaster on the interior. The floors are concrete slabs laid on the ground, with a variety of applied finishes. The roof is sheeted with corrugated asbestos-cement, and corrugated galvanized steel with machine-sawn hardwood framing, indicating that the roof is a later replacement. The ceilings are sheeted with asbestos-cement, including the western verandah roof soffit (Allom, 1984: 11).

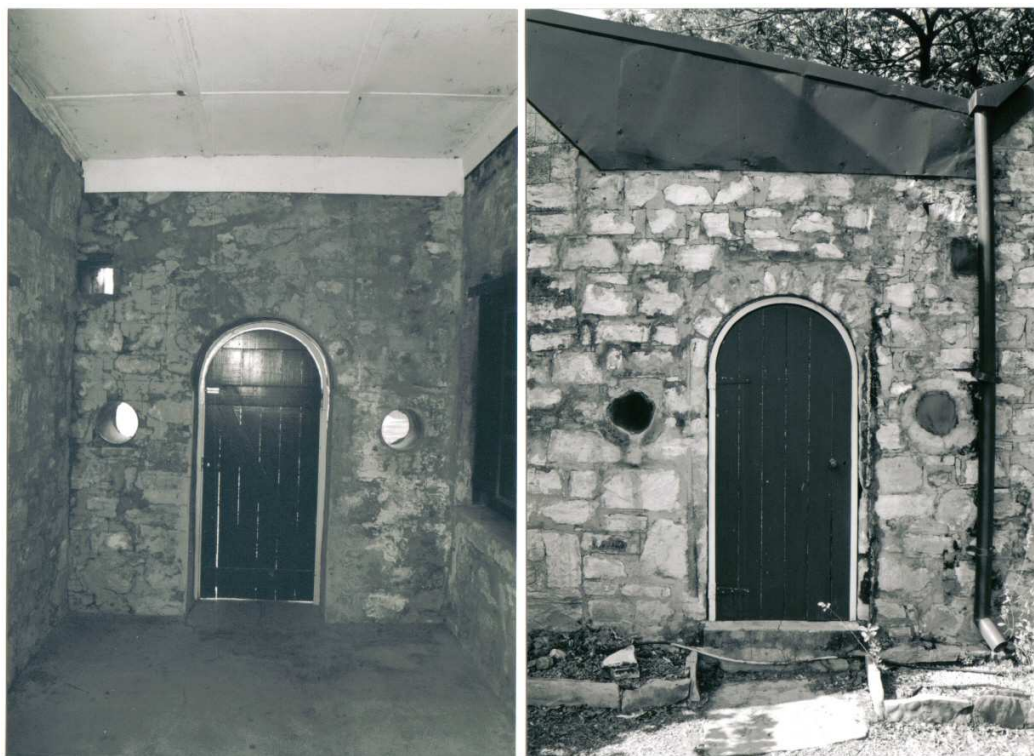
Figure 4.4.4. Interior (left) and exterior (right) of the northern door of the dwelling, showing the apertures built into the stonework.

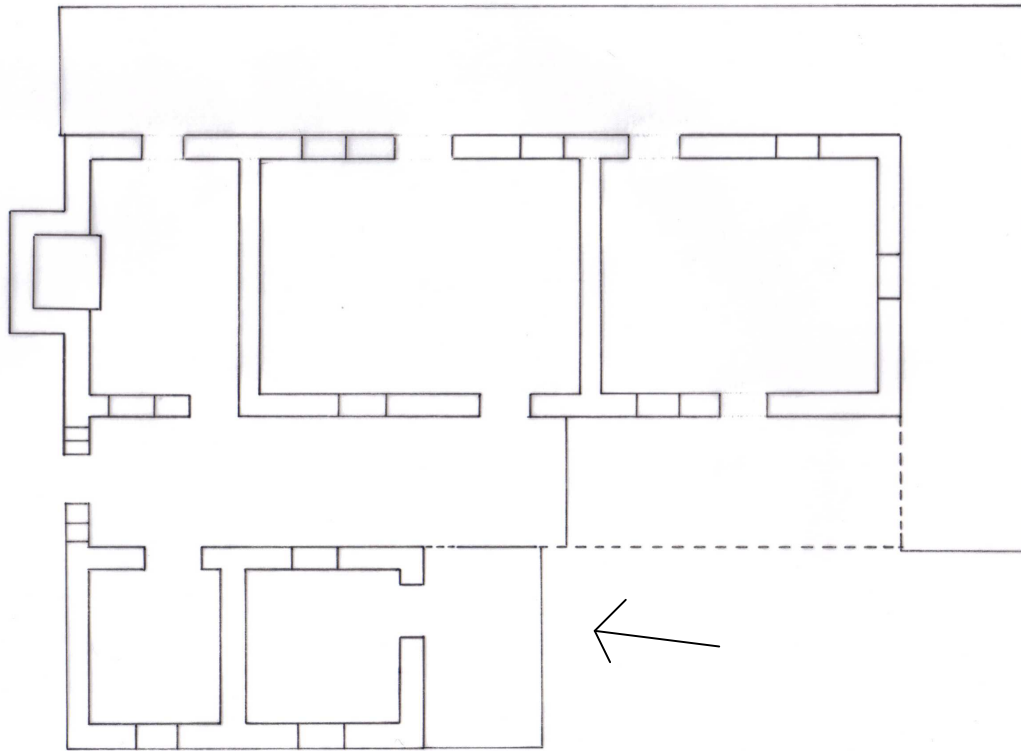
Figure 4.4.5. Plan of the dwelling showing original layout. Scale 1:100.

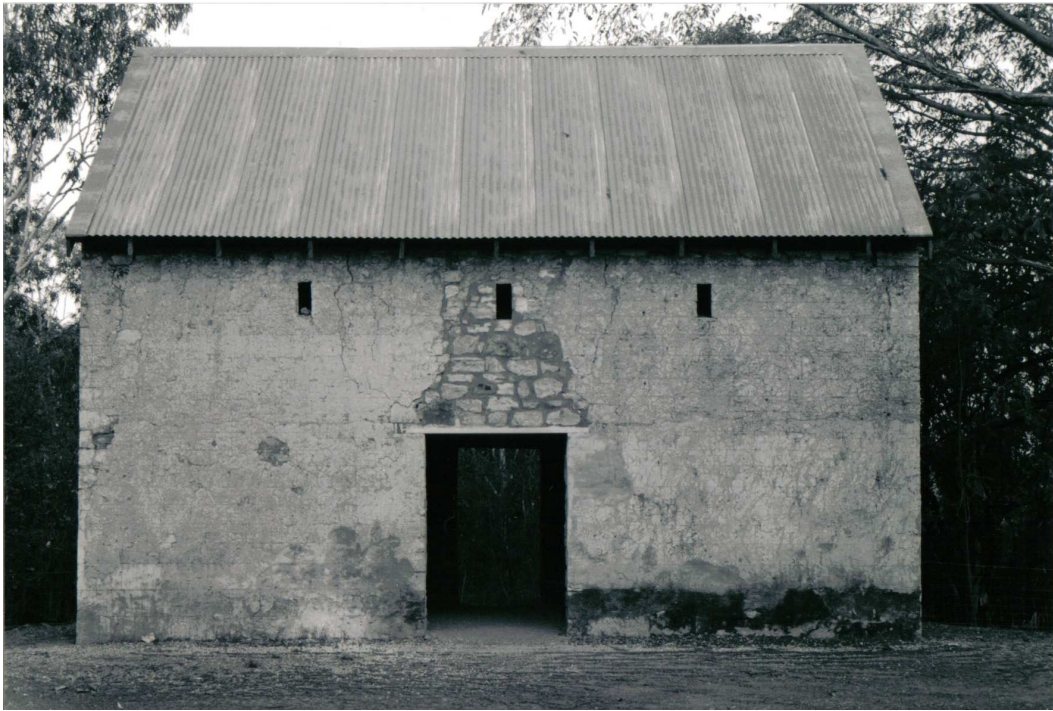
Figure 4.4.6. Photograph of the western side of the store building.

The store is located to the rear of the dwelling, which was the standard location for a store in Australian homestead layouts (Cox and Stacey, 1972: 11). Although the current stone store was a later construction, it was located immediately beside the original store. The original store (made of wood) was probably built very early on, perhaps even before construction of the dwelling was completed.

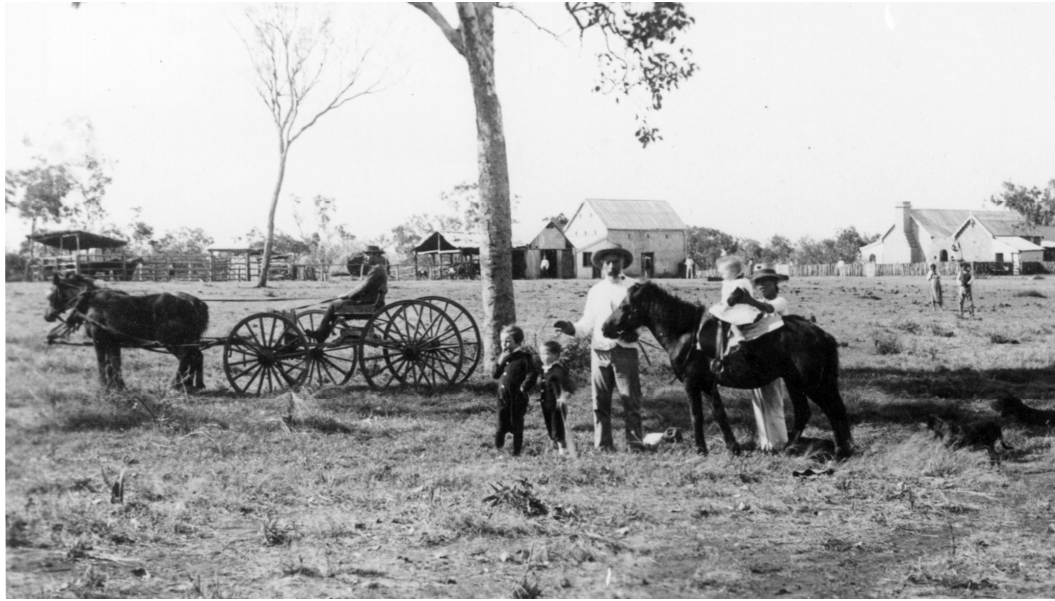
Figure 4.4.7. Alfred Giles and family in front of Springvale Homestead ca 1894. Note the lean-to attached to the store. Courtesy of the Northern Territory Library.

The four housings visible on the exterior of the northern wall did in fact support a skillion-roofed lean-to made of wood. This can be seen in early depictions, although its construction is not recorded in the station diaries.

Another early building which survived until at least 1894 can be seen in the 1883 photograph (Figure 4.4.9 and Figure 4.4.7). This may be the old store which is referred to regularly in the station diary before and during the construction of the new store. This structure was made out of wood with a gable roof, the eastern side of which is visible in the 1883 photograph. The fact that it appears to have been built early on, and that it was placed close by the hut, is further evidence that it was a store. The construction of a secure place to store the station's provisions would have been a high priority. Also, by placing the store close to the dwelling it would have been easier to guard, as well as convenient.

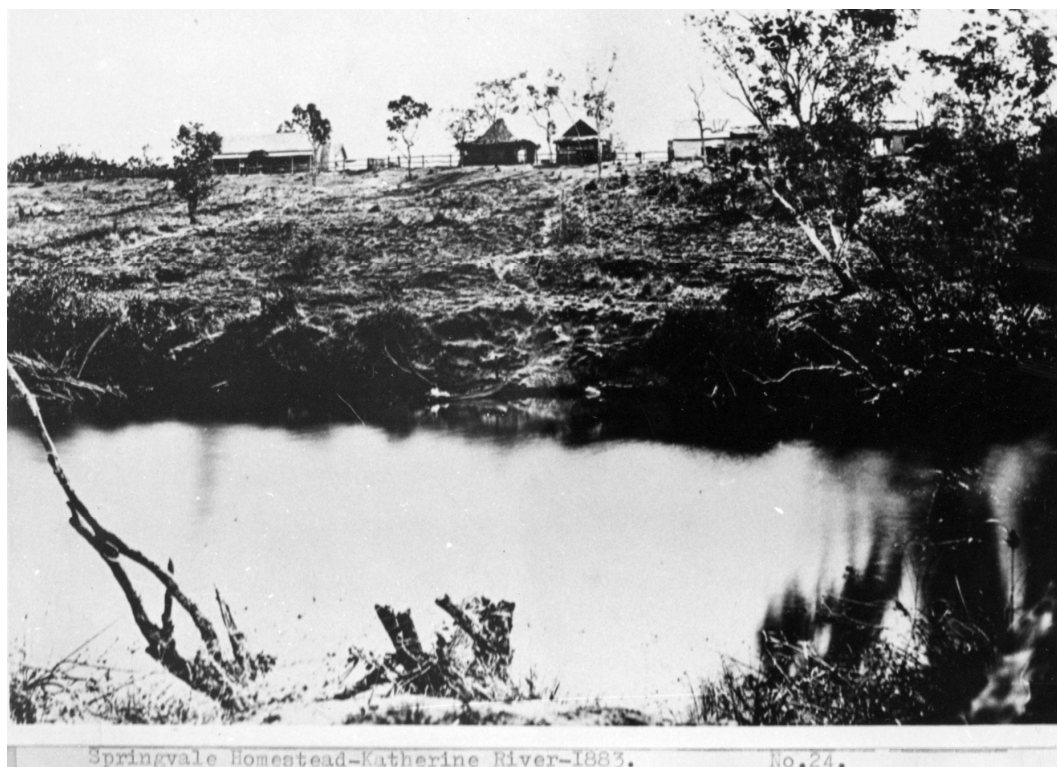
Figure 4.4.9. The earliest known photograph of Springvale, dated 1883, taken from across the Katherine River. The hut can be seen top centre. Courtesy of the Northern Territory Library.

This suggests that the structure visible in the photograph is the old thatched hut, shortly before its demolition. The structure in the photograph is curious because it appears to have a tall, conical roof, supported by posts, which spread out to serve as a verandah as well – more akin to an Indonesian or African hut than a European one. However, a photograph of the Newcastle Waters homestead clearly shows just such a hut (Figure 4.4.10). This latter photograph shows many details of the construction of what appears to be a definite ‘type’ of pioneer dwelling. Further research into this area may determine whether such huts were common to this region or perhaps other regions in Australia, or whether they were introduced by Giles himself. As Newcastle Waters was established after Springvale, and also under Giles’ supervision (Forrest, 1985: 43), it is possible that

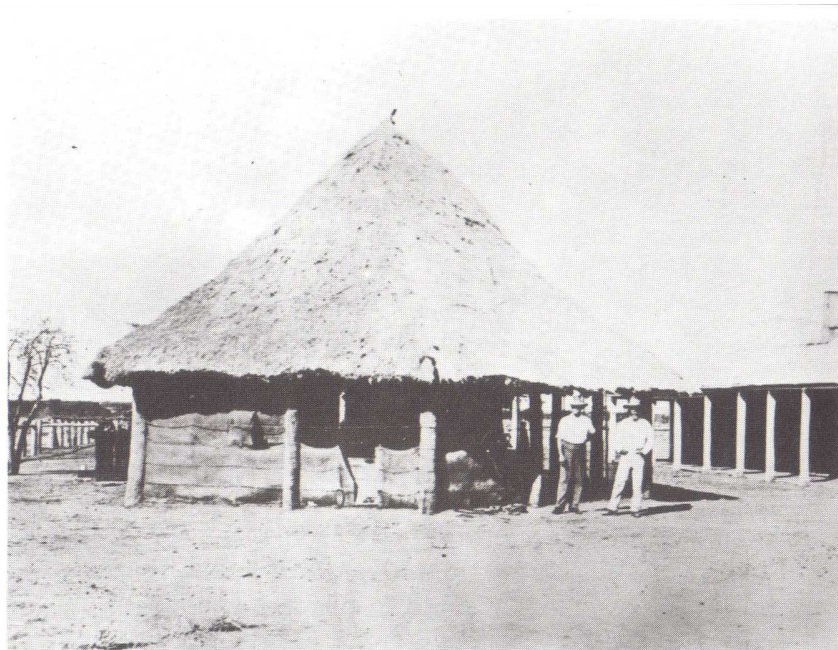
Figure 4.4.10. The hut at Newcastle Waters homestead. Note the similarities in form between it and the structure visible in Figure 4.4.10. Courtesy of the Northern Territory Library.

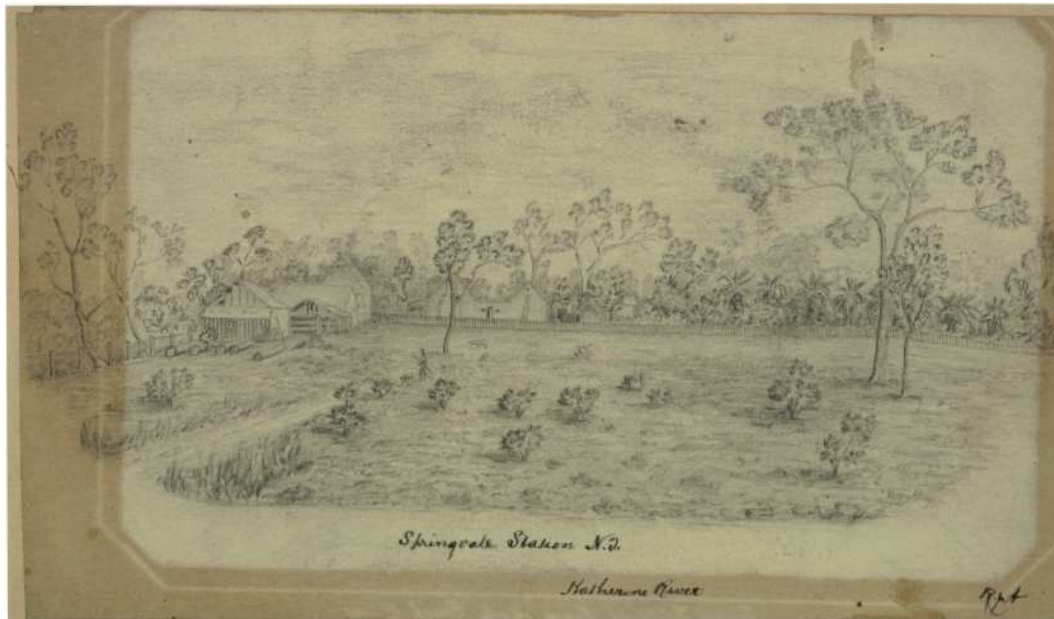
Figure 4.4.11. Pencil and ink sketch of Springvale, 1886-1889. It shows the dwelling and store as well as other outbuildings now demolished and some of the 19th century fence lines. (Courtesy of the National Library of Australia).

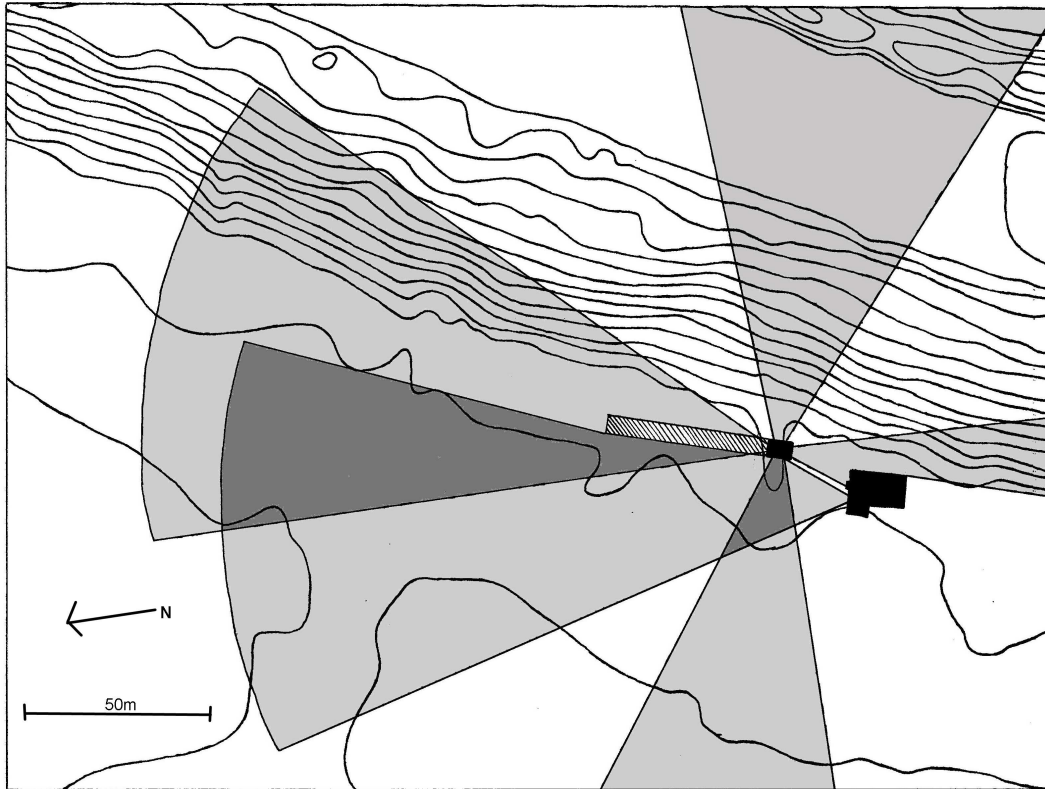
Figure 4.4.13. Diagram showing the arcs of fire offered by the embrasures at Springvale, shaded grey. The darker grey areas indicate ground covered by embrasures of both the store and the dwelling. The approximate area covered by the pre-1885 conflagration shed-line is shown by the diagonally-hatched area. Note that this does not show areas of 'dead ground'.

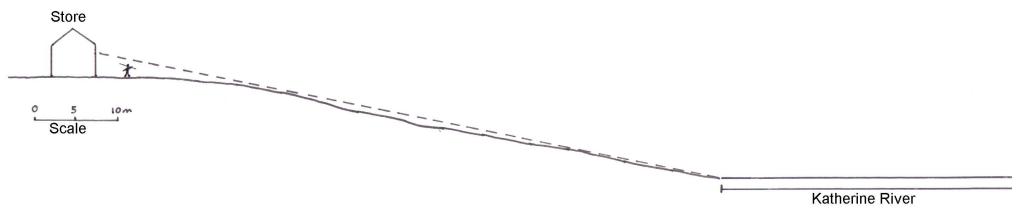
Figure 4.4.14. Diagram showing fire-coverage of river bank from the store's eastern apertures (indicated by the dashed line). The relative height of a person is shown by the figure to the right of the store.

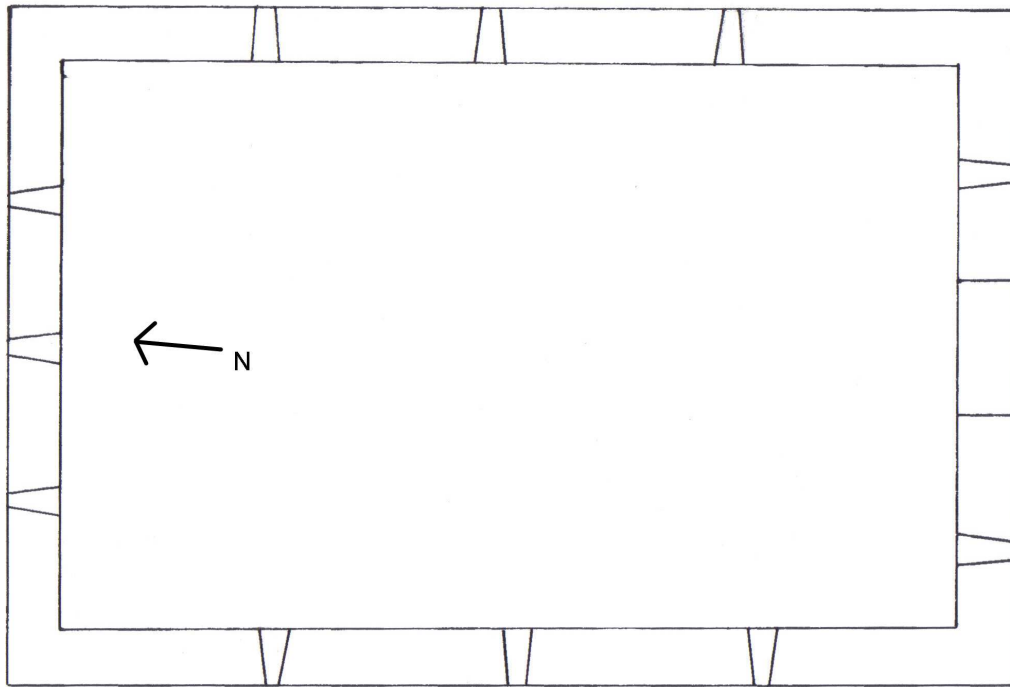
Figure 4.4.15. Plan of upper level of store showing position and shape of apertures.
