**The collecting behaviour conundrum...or not:
a community and the *Amazon* shipwreck in Inverloch, Victoria**

**A thesis submitted in partial fulfillment of requirements for the degree of
Master of Maritime Archaeology**

**Maritime Archaeology Programme
College of Humanities, Arts and Social Sciences,
Flinders University**

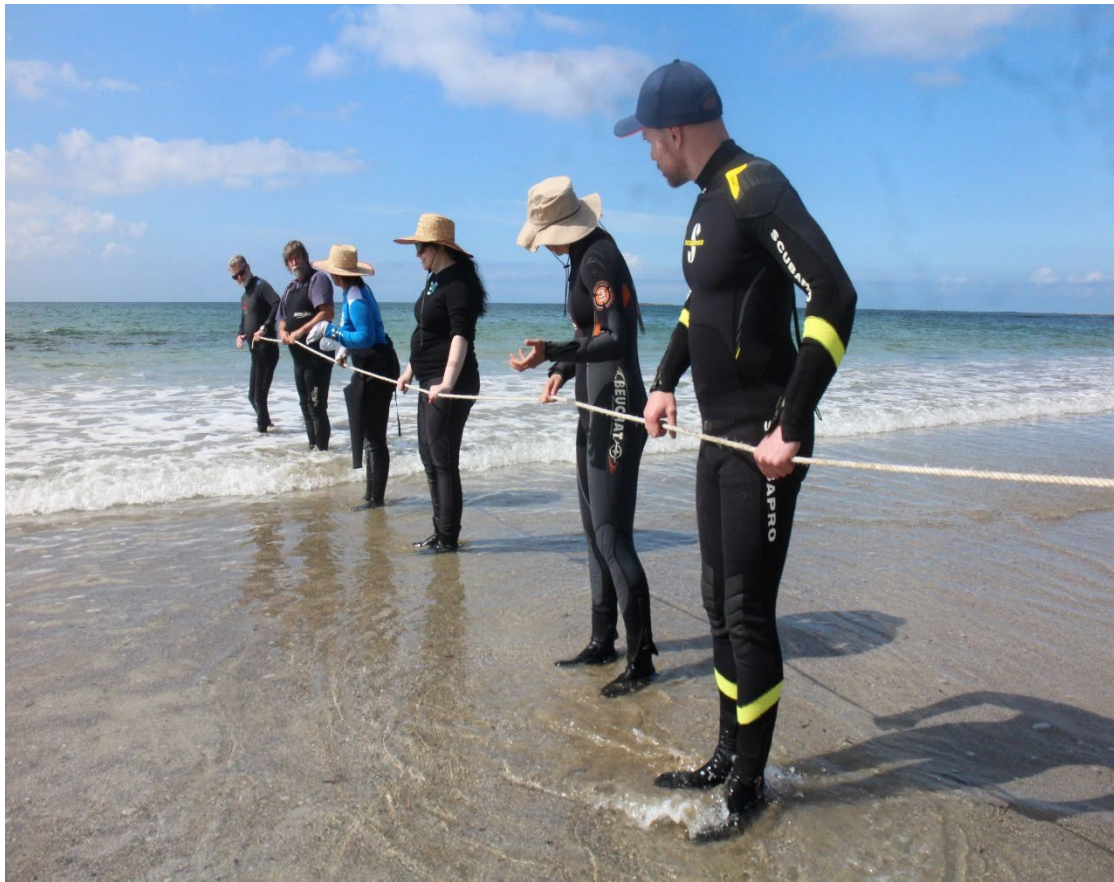
Figure 3.1 Walking visual survey (photograph by S. Landicho).

The primary aim of this survey was to cover the beach area surrounding the shipwreck in order to locate any artefacts from the shipwreck and also to locate the shipwreck underwater (Figure 3.1). The exposed timber facing north from the beach was deemed the most suitable point to begin this survey. Both blue and green teams combined to walk transects westward approximately three metres apart from each person. Each transect line was 150 metres long and 70 metres wide along the beach and moved towards the shallow waters. The objects of potential cultural significance found during this survey were marked, inspected and recorded with a Global Positioning System (GPS). During the final transect run, the *Amazon* shipwreck was relocated at the intertidal zone at a depth of one metre. While the visibility was too poor to examine the vessel, the author and other team members confirmed that some wrecks components were exposed on the seabed. The team managed to measure the length of the site as accurately as possible and acquired the distance between the exposed timber and the shipwreck. The location of the vessel was recorded with GPS.

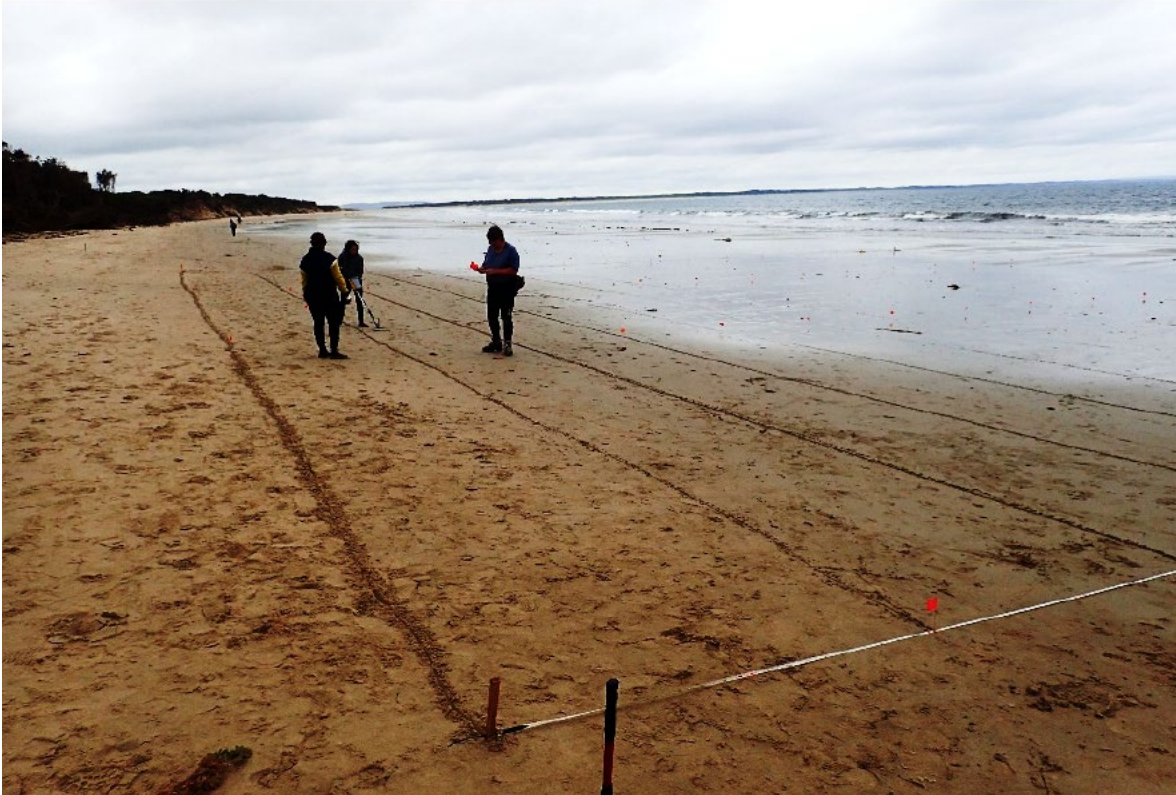
Figure 3.2 Blue team conducting metal detector survey (photograph by W. van Duivenvoorde).

Upon contemplating the results from the walking visual survey, a metal detector survey was deemed necessary to locate any possible metal features, such as the bow-shackle site. For this purpose, two metal detector models with the ability to operate in intertidal areas were employed: a J.W. Fisher Plus 8x and a Minelab Excalibur 1000. This survey took place over two consecutive days (Figure 3.2). On the first day, the transect lines of the survey extended 112 meters to the west and 32 meters to the south from the exposed timber, ending at an arbitrary region relatively adjacent to the shipwreck site under water. On the second day, the transect lines extended 30 meters to the east and 18 meters

towards the waterline from the exposed timber. Each transect line was two metres in distance, allowing a one metre overlap to cover the ground as extensively as possible. Collectively, the survey area spanned 142 metres in length and 50 metres in width. Both surveys were 50 metres wide, with each transect line two meters apart, allowing operators to cover the ground as quickly as possible. Anomalies located were marked by flags and then verified by using the second metal detector for better accuracy. The bow-shackle site was successfully discovered during the survey. GPS points were obtained of this site and all anomalies. The anomalies were then examined by test digging using hand or trowels to groundwater level

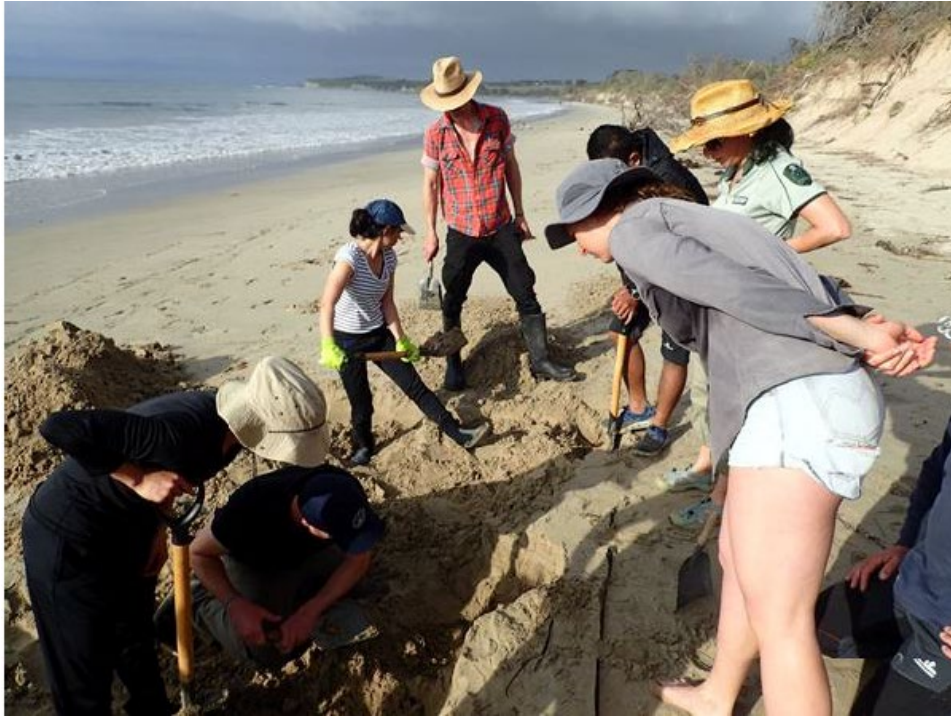
Figure 3.4 Initial excavation of Site B (photograph by R. Galloso).

Site B is located approximately 120 metres northwest from the shipwreck site in water and around 80 metres west off of Site A (Figure 3.3). Unlike Site A, a grid was not established for Site B due to the possible lack of original context the anomaly was discovered in. Excavation was conducted by following the exposed materials in Site B to uncover as much as possible (Figure 3.4).

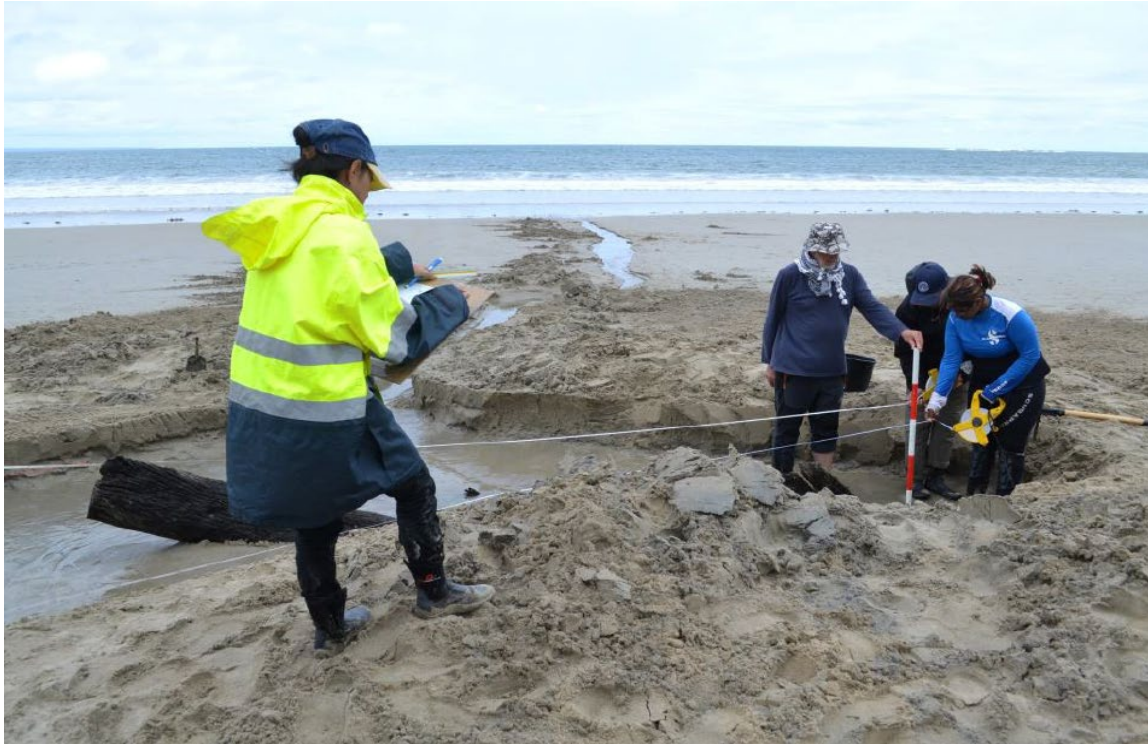
A few members from blue and green teams drafted mud maps of Sites A and B respectively with measurements. To measure the features found in Site A, trilateration was used for accurate results (Figure 3.5). Tape measures were attached to Points A and B in Trench 1 and then extended to a particular point on a feature of interest. These specific points were selected depending on accessibility and necessity. A designated

Figure 3.5 Participants measuring Site A using trilateration with C. King illustrating the site (photograph by S. Landicho).

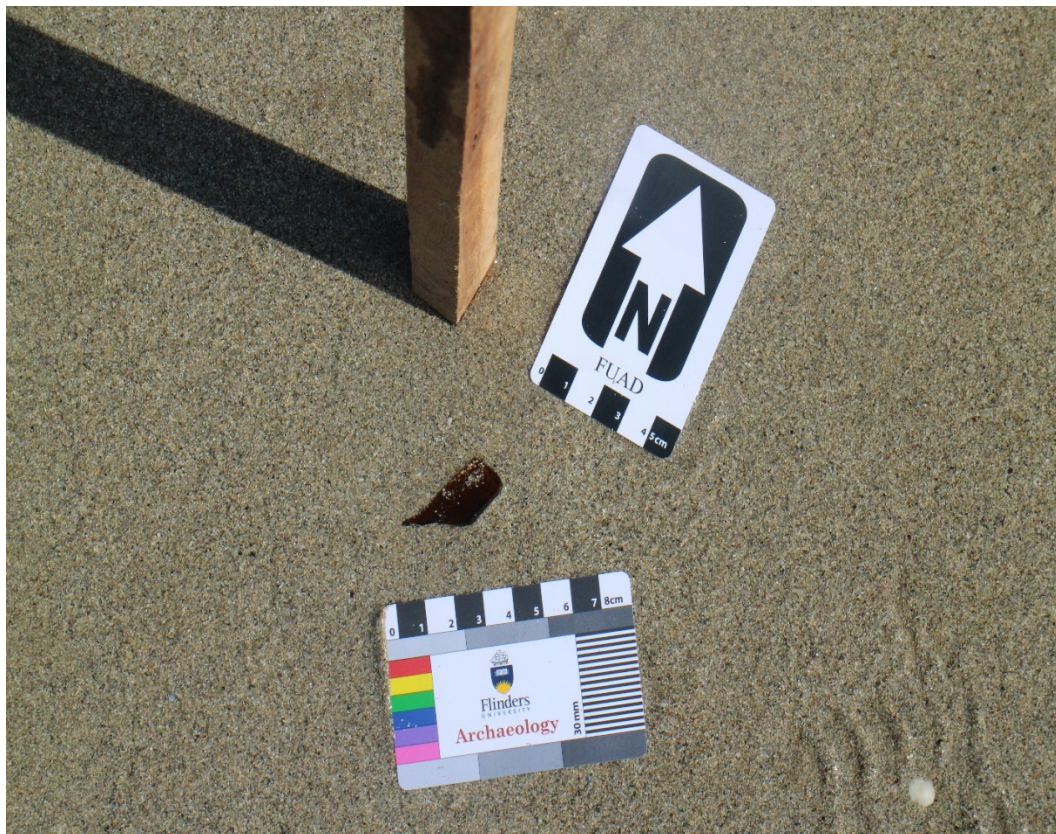
Figure 4.1 Glass shard found during walking visual survey (photograph by S. Landicho).

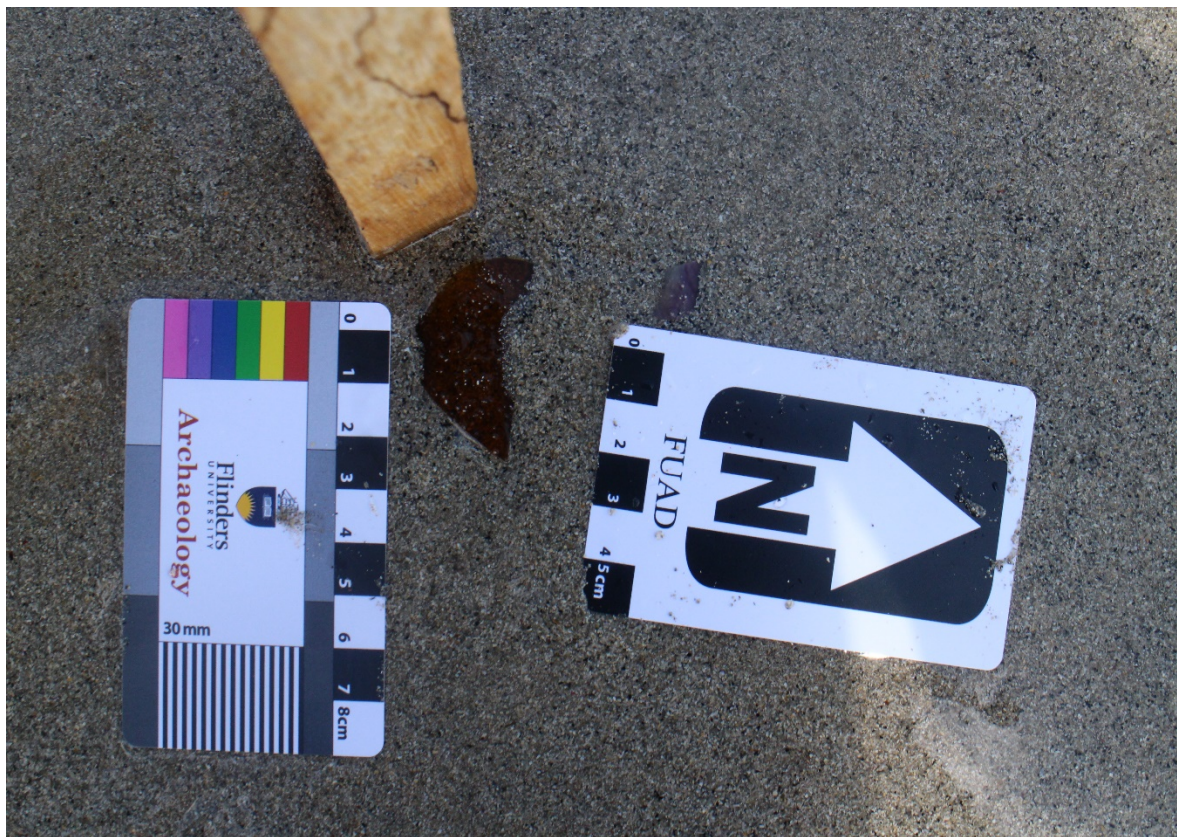
Figure 4.2 Iron fragment discovered during walking visual survey (photograph by S. Landicho).

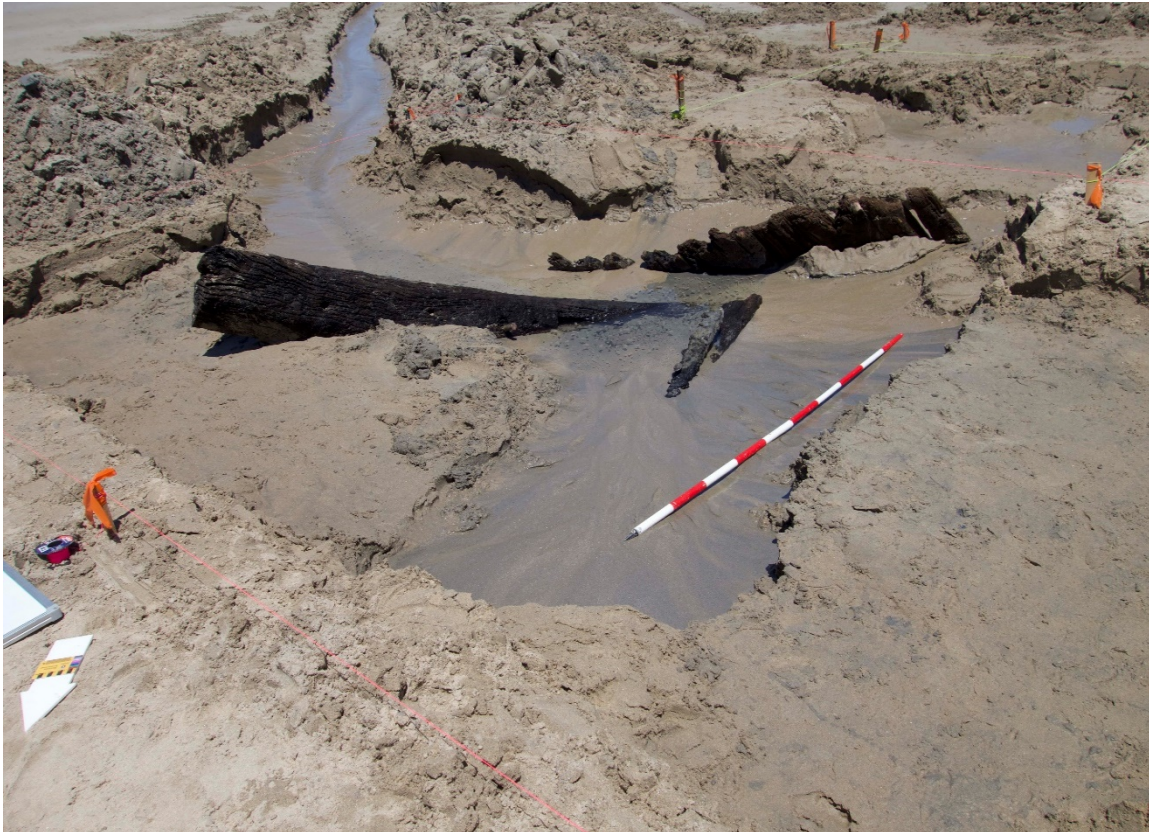
Figure 4.3 Features in Site A (photograph by S. Landicho).

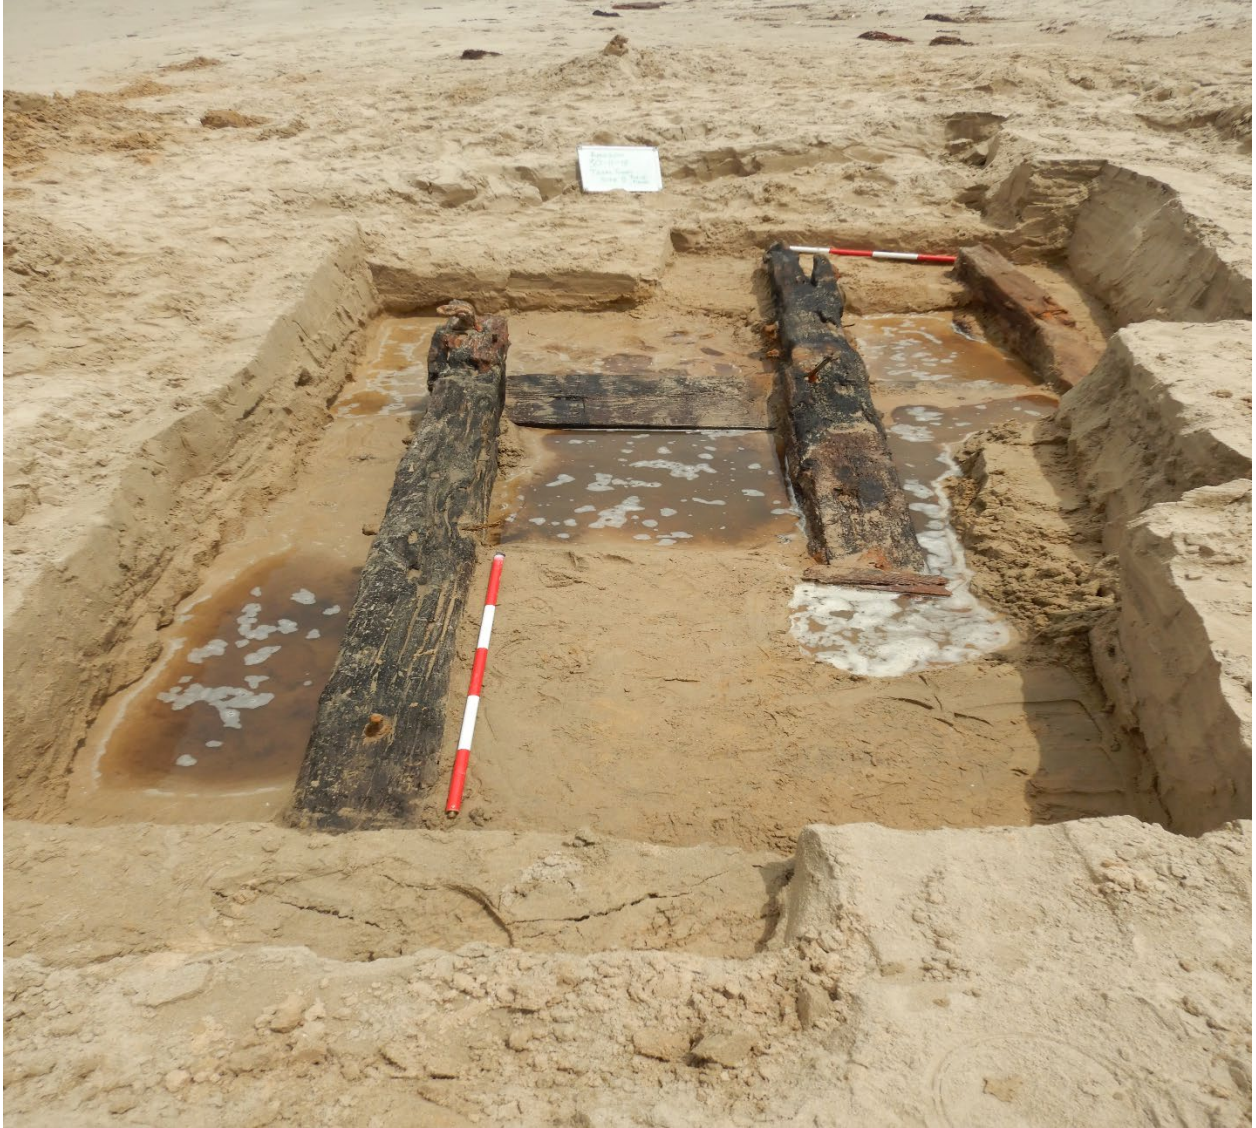
Figure 4.5 Features of Site B (photograph by H. Boyle).

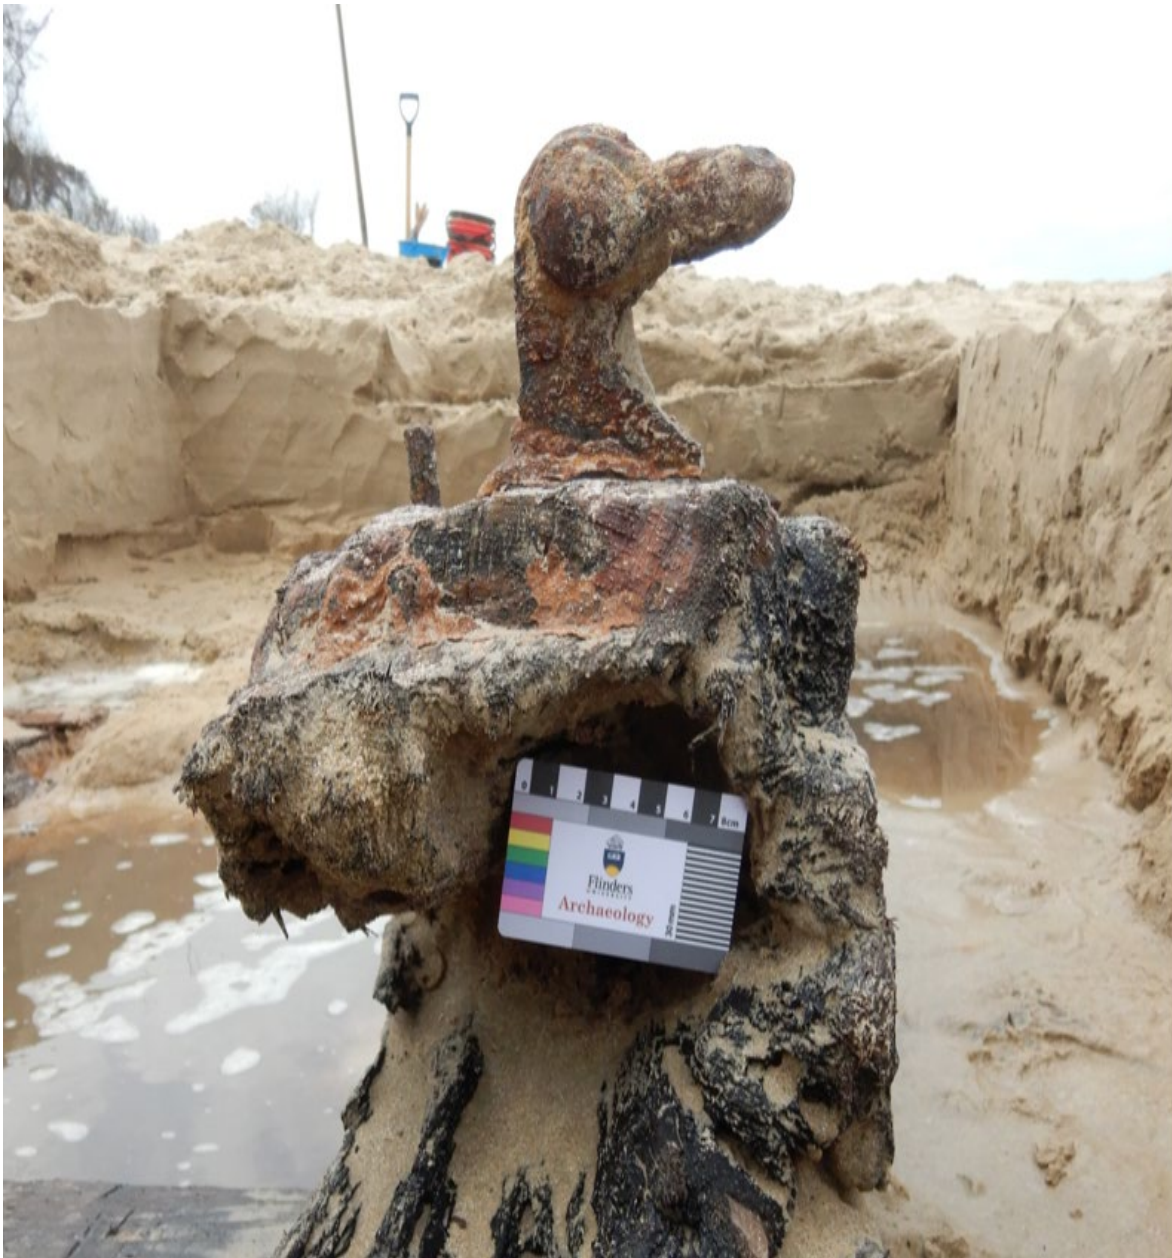
Figure 4.6 Bow-shackle attached to Timber 1 (photograph by R. Galloso).

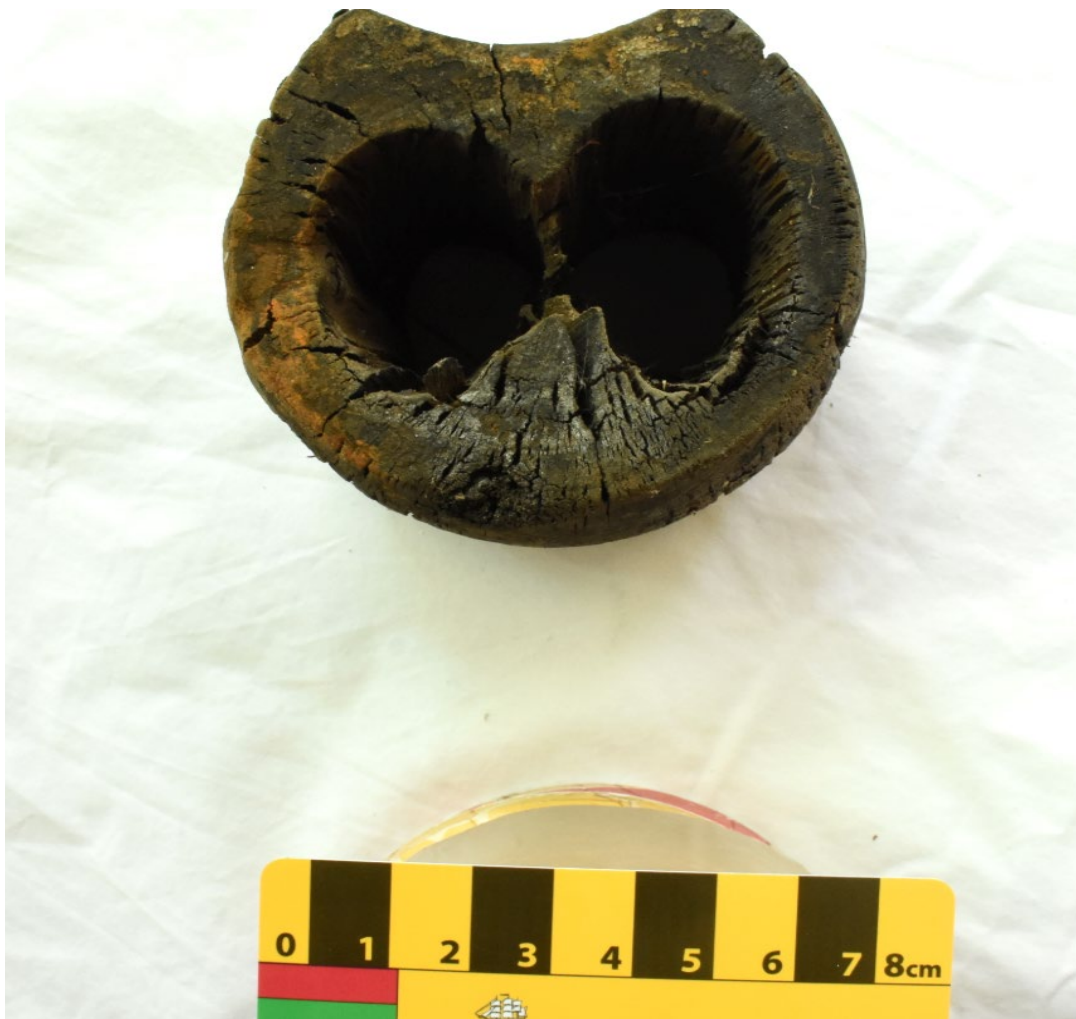
Figure 4.9 Fairlead (photograph by C. King).

The fairlead (artefact 23.00005) measures 8.5 centimetres in diameter and length and is 8.5 centimetres thick. There are two large holes at the centre and several cracks are visible throughout. Apart from these objects, an artefact parcelled in leather and containing fibrous rope material suspected to be a rigging component of *Amazon*, is also part of the collection (Figure 4.11). This measures 17 centimetres in length and seven centimetres in diameter and thickness. HV accessioned the deadeye, the fairlead, a well-preserved sheet of copper and the leather-bound artefact for conservation, while the rest were returned to the respective custodians.

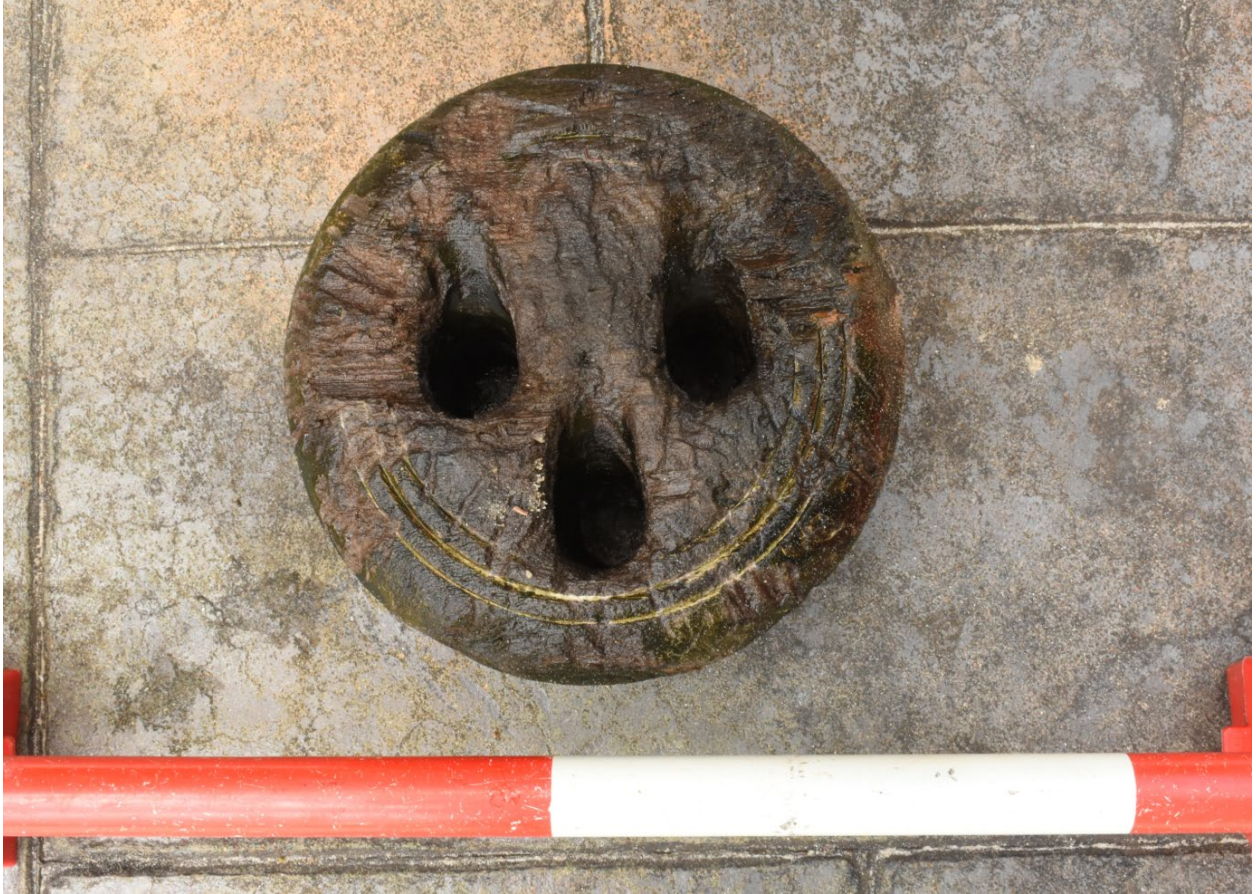
diameter of the deadeye is approximately 20 centimetres and the length is five centimetres.

Figure 4.10 Deadeye (photograph by C. King).

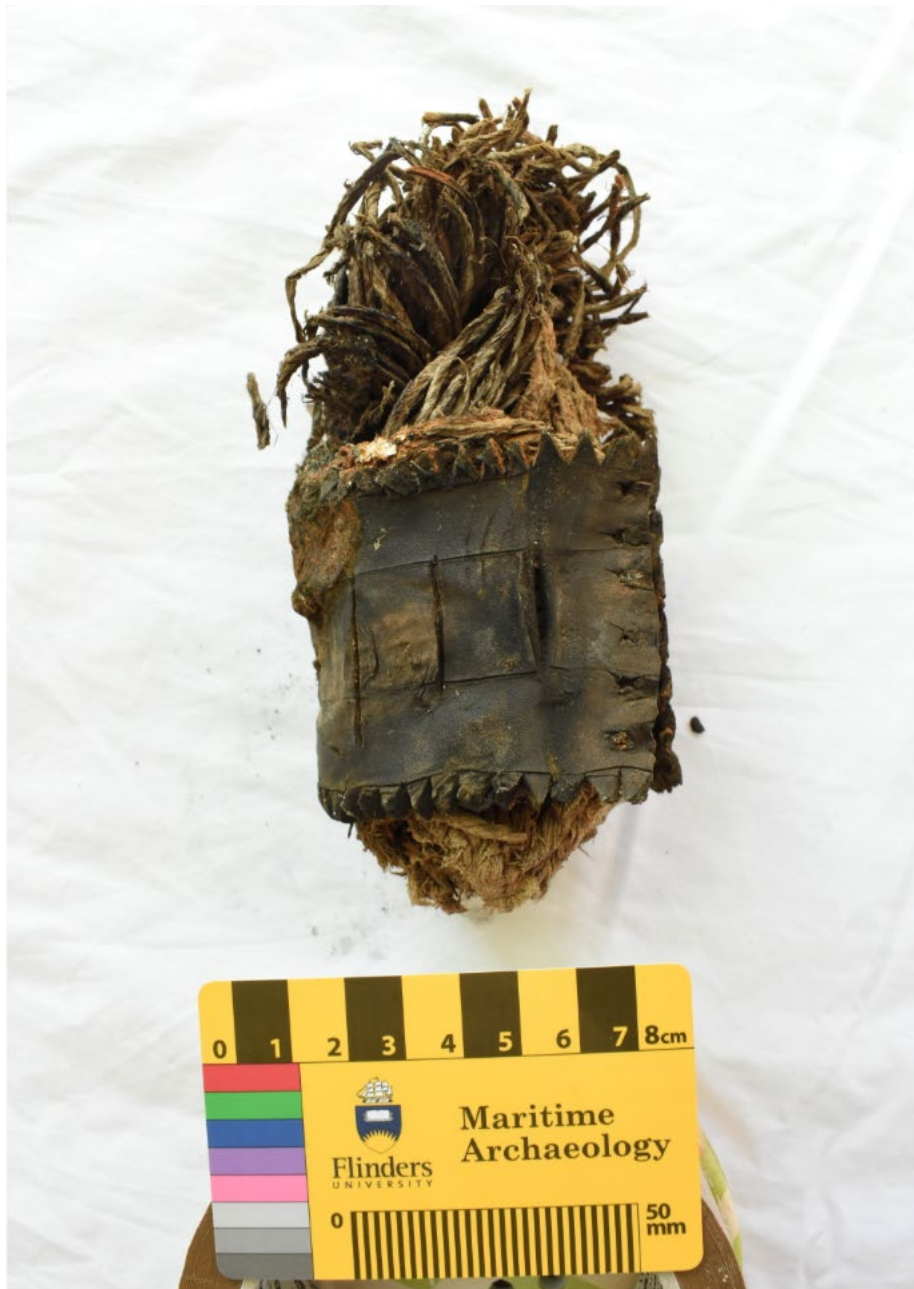
Figure 4.11 A leather-parcelled artefact (photograph by C. King).

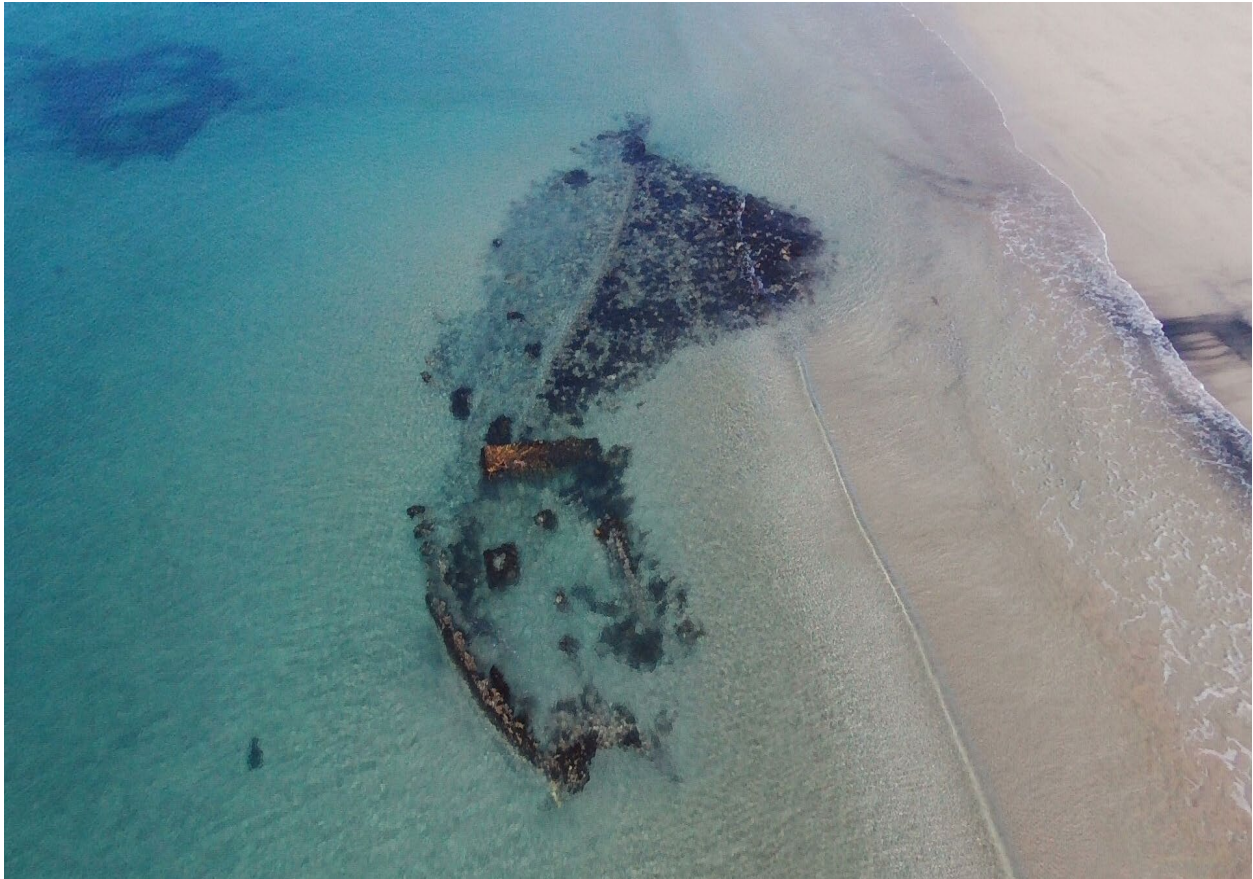
Figure 4.12 Aerial view of the *Amazon* shipwreck (photograph by J. Laurie).

archaeologists from HV and and have provided pictures taken of the site after fieldwork. These pictures illustrate an aerial view of the shipwreck site at the intertidal zone as well as some submerged wreck components—both impossible to acquire during fieldwork (Figures 4.12 and 4.13).

The shipwreck lies at a water depth of one metre at the intertidal zone and contains a water tank, ship fragments and frames and large amounts of ballast mounds. From aerial photographs, it is evident that the shipwreck lies parallel to the beach with the bow facing east (see Figure 4.12). This orientation is consistent with the historic account by Captain

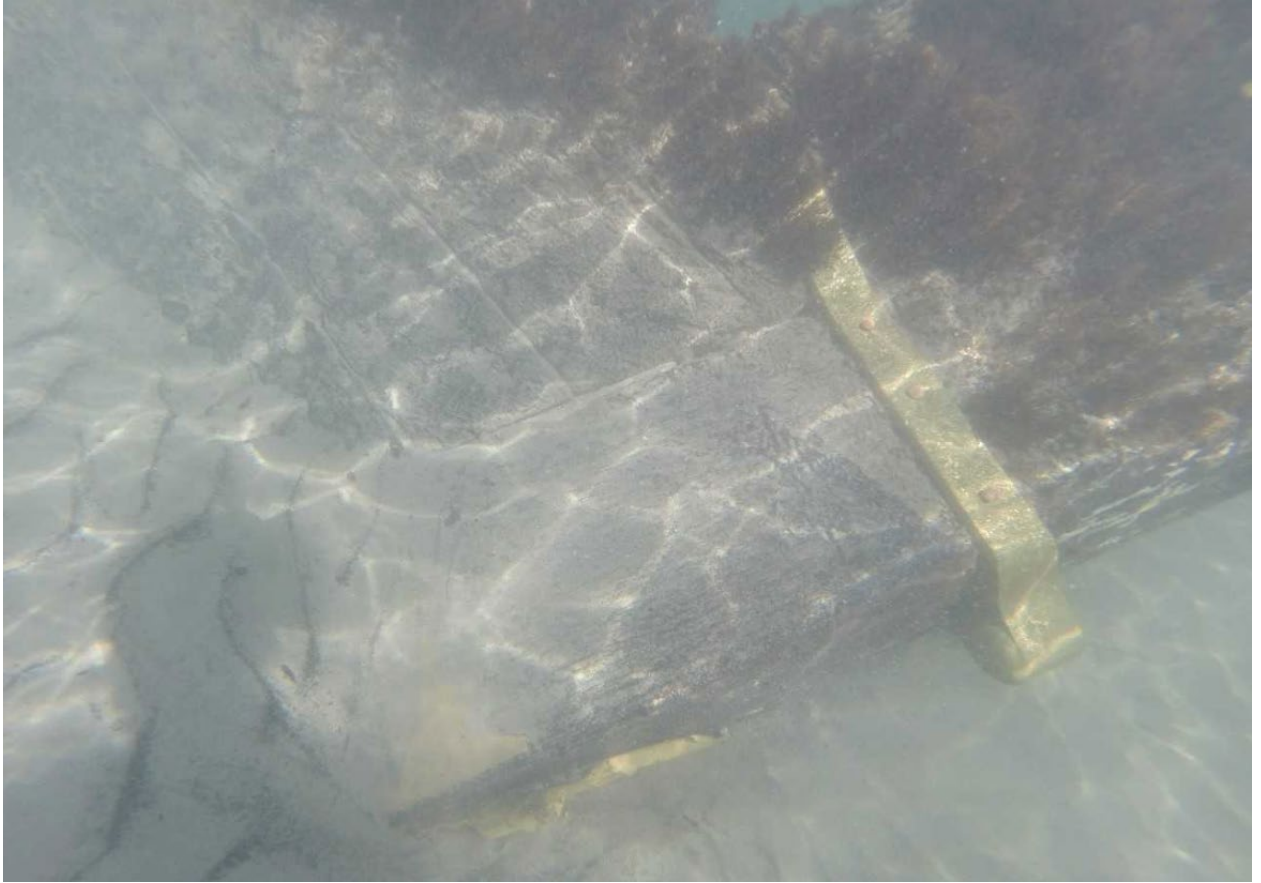
Figure 4.13 Gudgeon and sternpost of *Amazon* (photograph by J. Laurie).

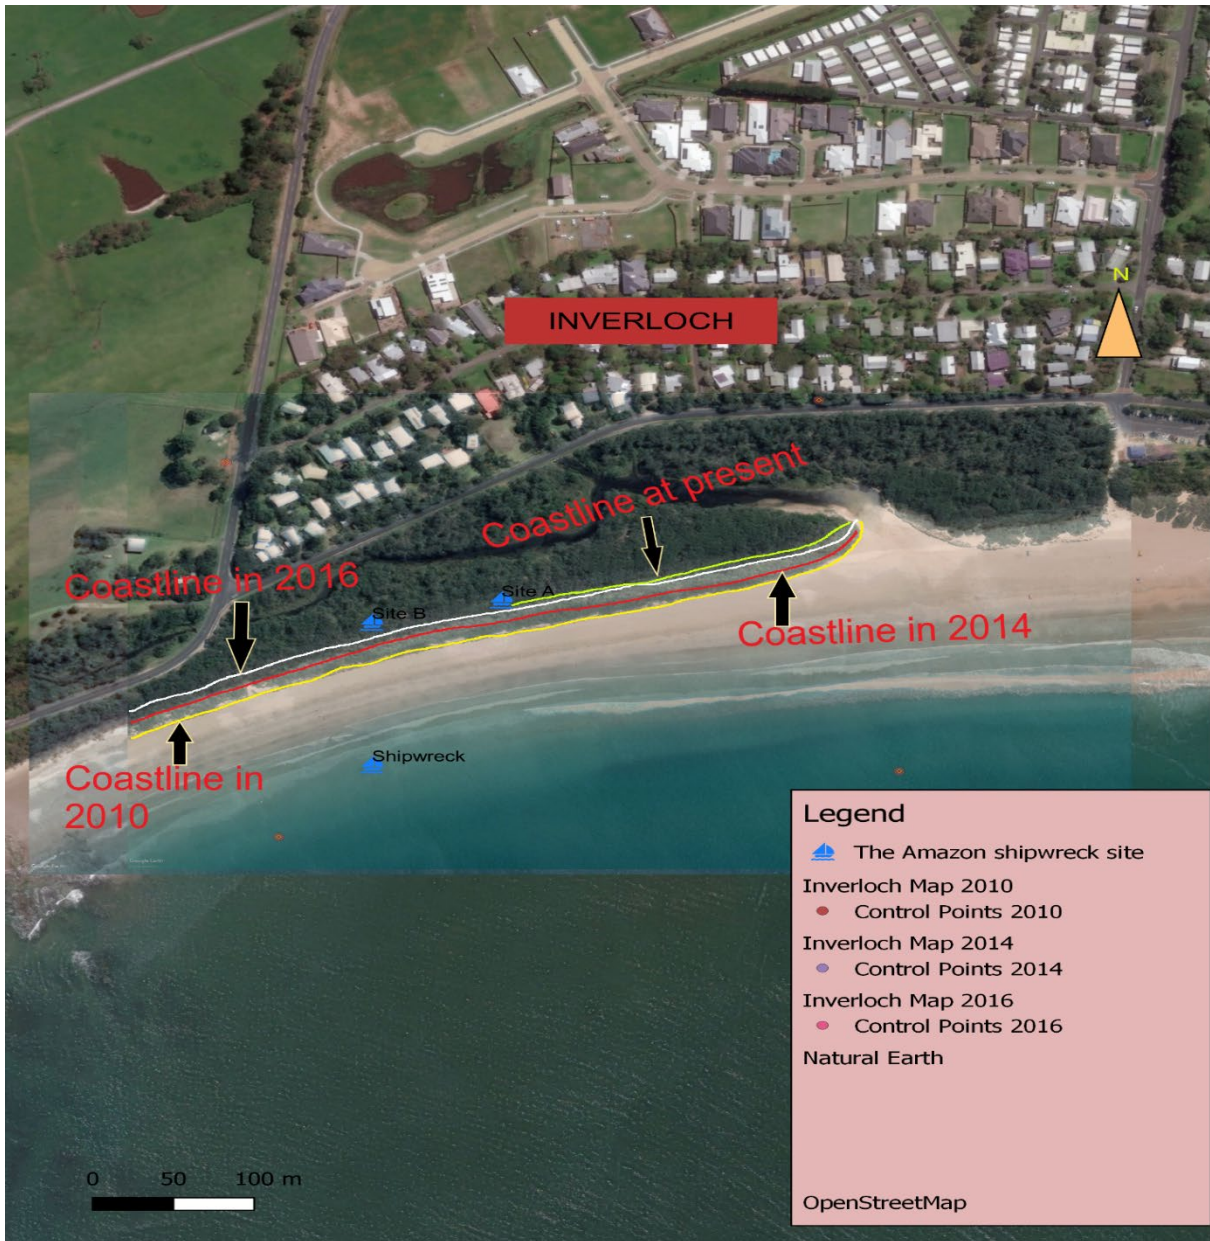
Figure 5.1 Coastal recession caused by erosion in Inverloch (map by M. Chandrasekaran).

The waves and currents generated are higher in intensity during winters and reach the landmass farther and more severely than regular and gradual hydraulic forces. During this specific period of time, the sand accumulation rate surmounts the depositional rate. This causes coastal recession and it is unmistakably evident in the map generated (Figure 5.1). Public buildings and roads are threatened by erosion, specifically the foreshore ahead of Inverloch Surf Life Saving Club and Bunurong road. The map illustrates that coastal erosion since 2010 has accelerated in Inverloch beach, leading to a significant loss of sand dunes and vegetation. Since 2012, both areas have been subjected to an average 33.5 m coastal retreat; the Inverloch Surf Club building is at a mere distance of

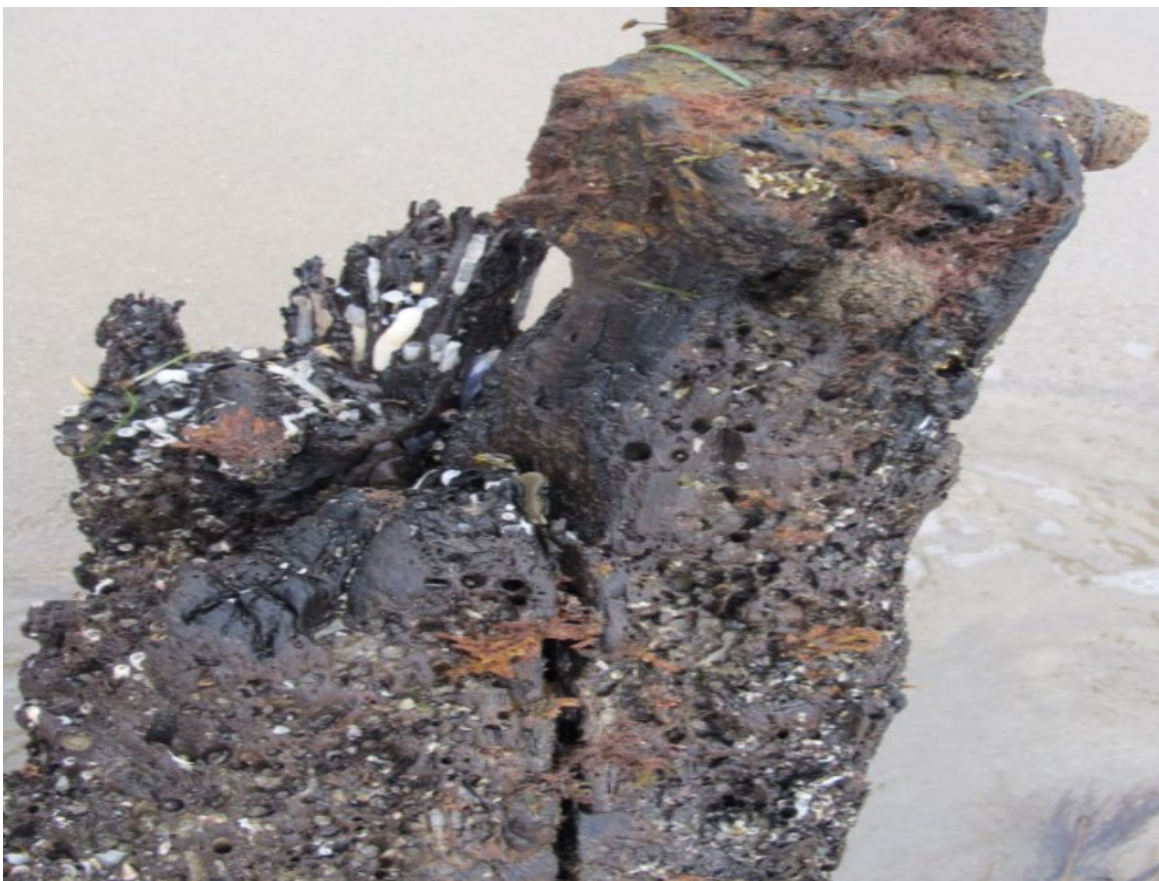
The wooden structures in Sites A and B appear comparatively better preserved than the shipwreck underwater. The reason is the sites' location on the beach. They remain buried in the sand to a greater extent in comparison to the shipwreck. The sustenance of shipworms is derived from water, allowing the organisms to thrive out of the water only for a short period of time. This situation favours the preservative condition of the archaeological remains in both sites.

Figure 5.2 *Teredo navalis* attack on frame timber (photograph by J. Mitchell).

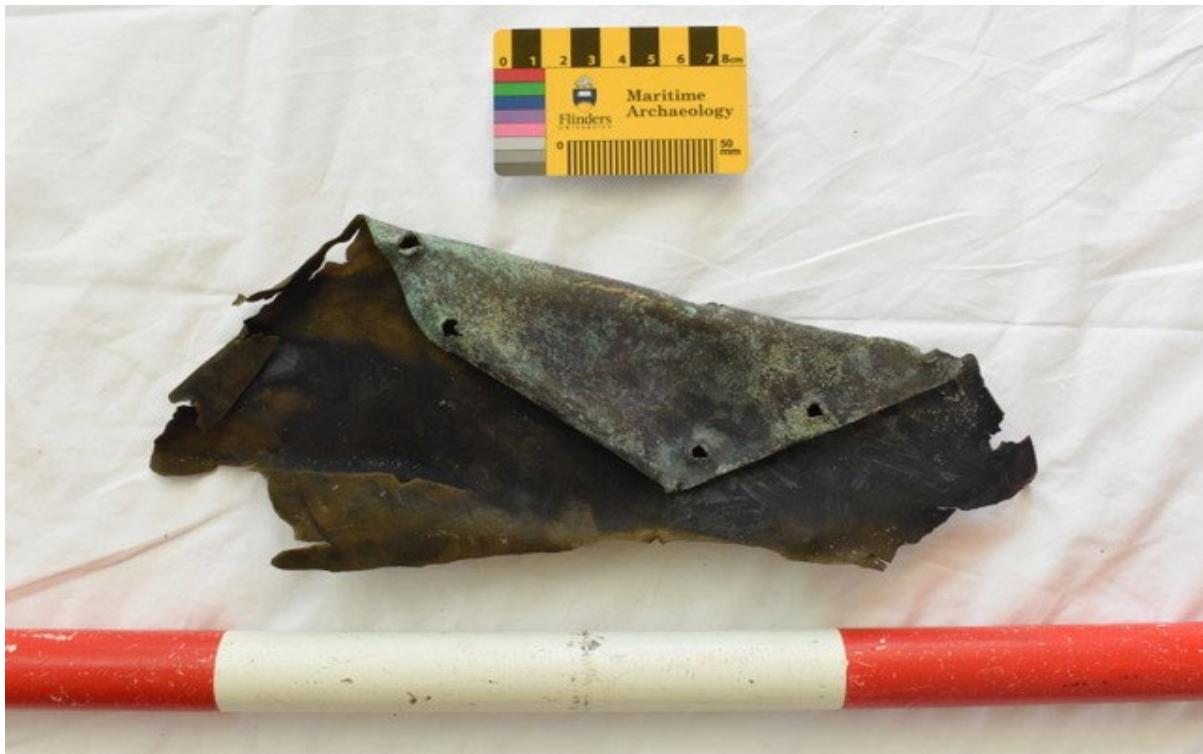
Figure 5.3 Corroded fragment of copper (photograph by R. Galloso).

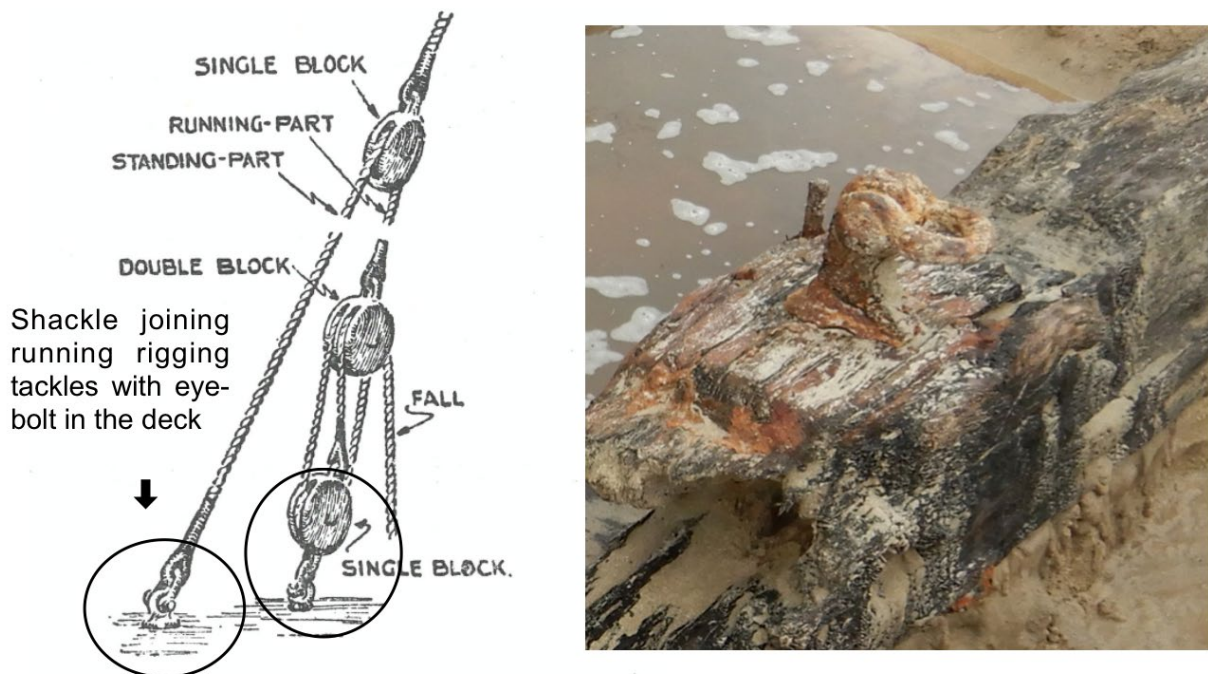
Figure 5.4 Possible use of a bow-shackle in a ship's upper works (after Underhill 1972:275).

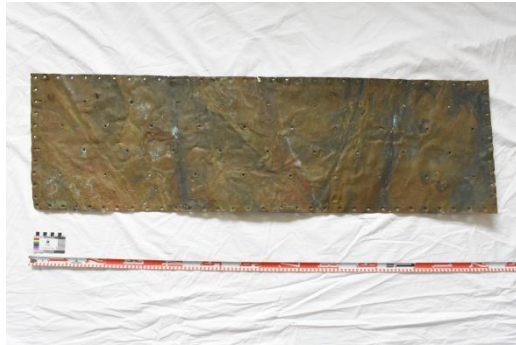
Description: Large rectangular sheet of copper sheathing. Square-copper tack marks approximately 6-8mm diameter, 35mm approximate distance from one hole to another. About 5mm distance from edge to perforated outline of tack marks. Slightly crumpled with multiple indentations. Tack marks aligned on a diagonal axis within tacked bordering.

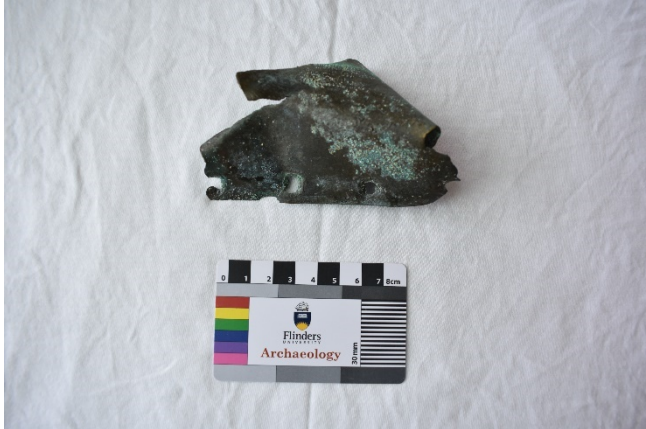
Description: Fragment of metal sheathing. Square perforation, approx. 5mm diameter, along edge. Bent. Very corroded. Large areas of patina visible.

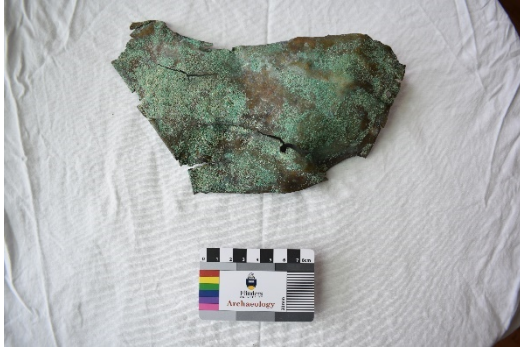
Description: Copper sheathing fragment of irregular shaping. Bent. One side folded. Patina largely present on one side.

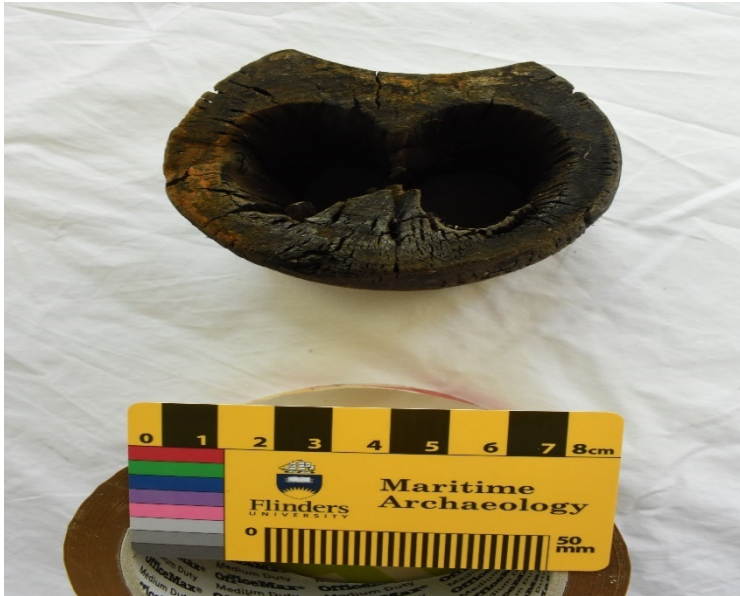
Description: Wooden fairlead with various cracks. Broken barrier between two large holes within face. Grooved indentation along height. Rigid indentation along centre circumference extending from one end of groove to another groove end.

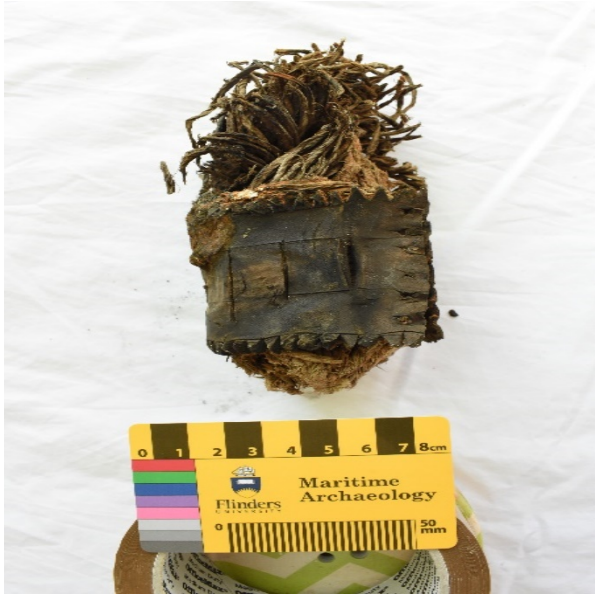
Description: Piece of large rope part of standing rigging. Section has been wormed, seized and parcelled. One end heavily frayed. Broken leather parcelling.

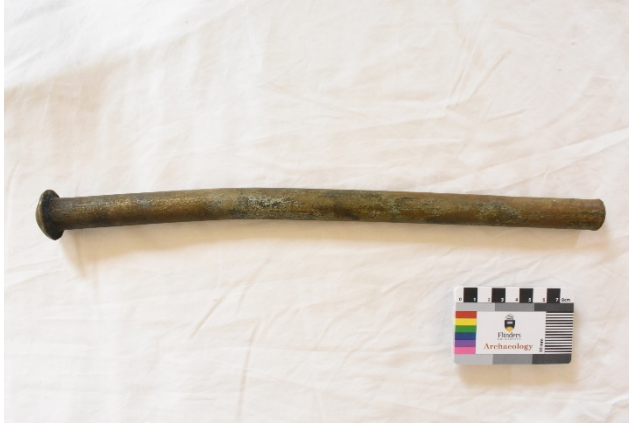
Description: Long copper bolt with head. Slight bend. Patina presence.
