**The collecting behaviour conundrum...or not:
a community and the *Amazon* shipwreck in Inverloch, Victoria**

**A thesis submitted in partial fulfillment of requirements for the degree of
Master of Maritime Archaeology**

**Maritime Archaeology Programme
College of Humanities, Arts and Social Sciences,
Flinders University**

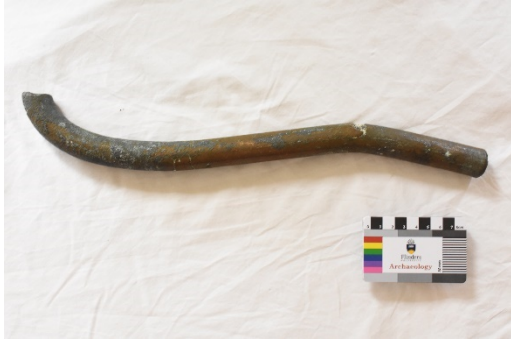
Description: Long copper bolt, bent. Patina present. Two bends. Exposed bolt opening on crack near base, and smoothed curvature towards head.

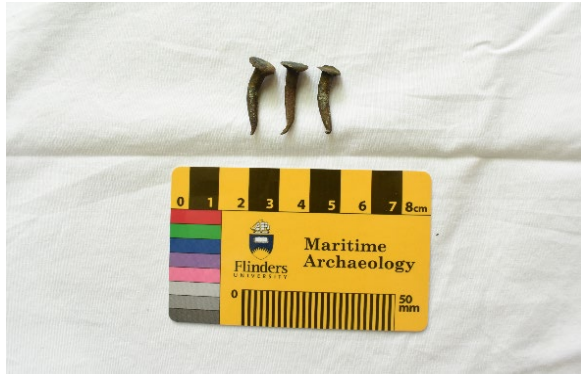
Description: Three small bent copper tacks. All bent at base head and tip. Two tacks sharply bent at tip, one with U-bend visible.

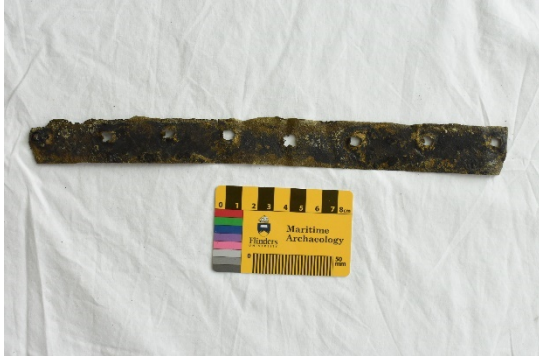
Description: Corroded copper metal strip with jagged, square perforations. One length displays clean straight-lined edge. Other side length is corroded and jagged. Fragmented.

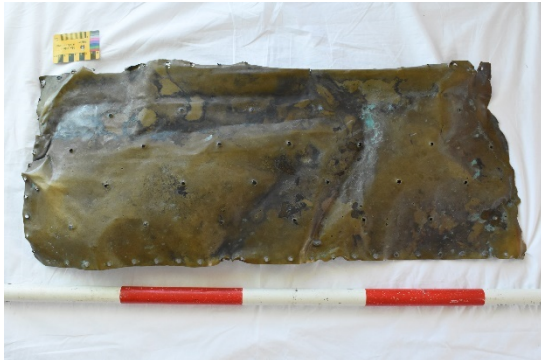
Description: Large metal copper sheet with hole perforations alongside edge and middle. Corroded. Patine present. Displays jagged edges.

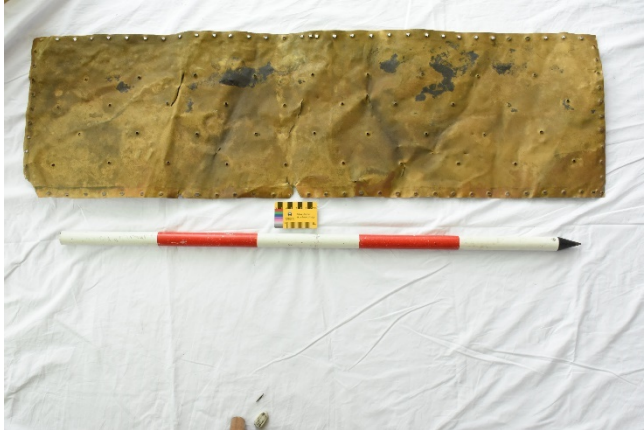
Description: Large metal sheet with straight-lined, intact edges. Perforations alongside edges and within face in a diagonally-line manner. Gold surface colouring. Various dents along face. Single jagged corner edge. Minor cracks on face.

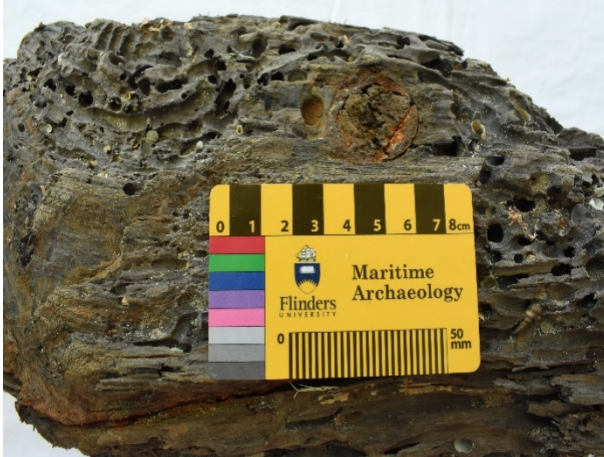
Description: Wooden frame chunk, timber. Trunnell and spike hole present. Very heavily massacred by teredo worms.

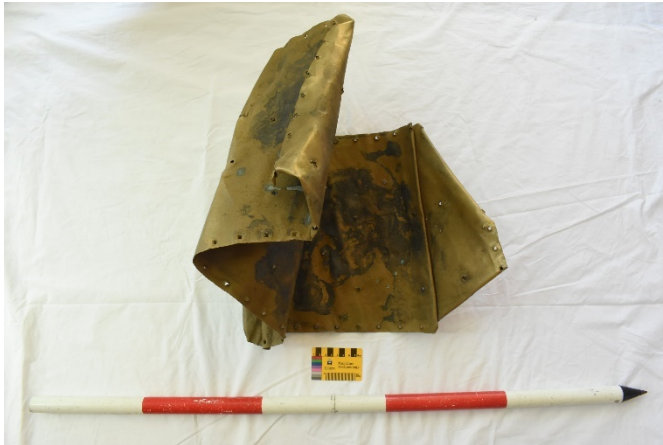
Description: Full copper sheet that has been sharply folded to various degrees. Corroded. Perforations alongside edge and face.

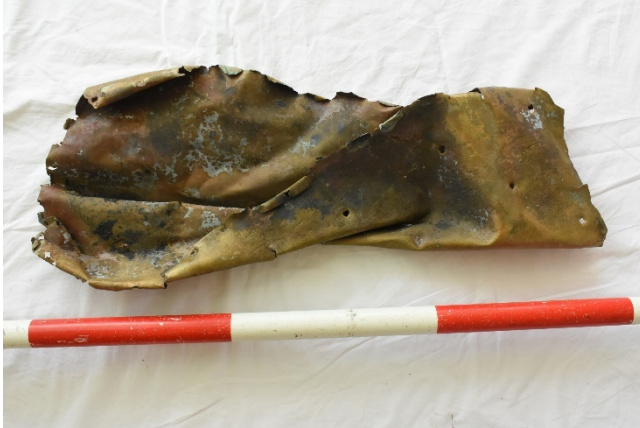
Description: Fragment metal sheathing. Various hole perforations on face. Jagged edges. Crumpled piece. Folded.

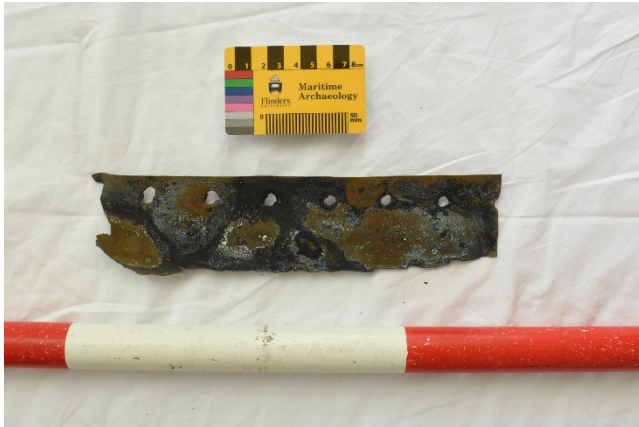
Description: Small, corroded copper strip. Perforations alongside one edge. Straight-lined edging on single length- side and width- side. Other length and width edge jagged. Patina present.

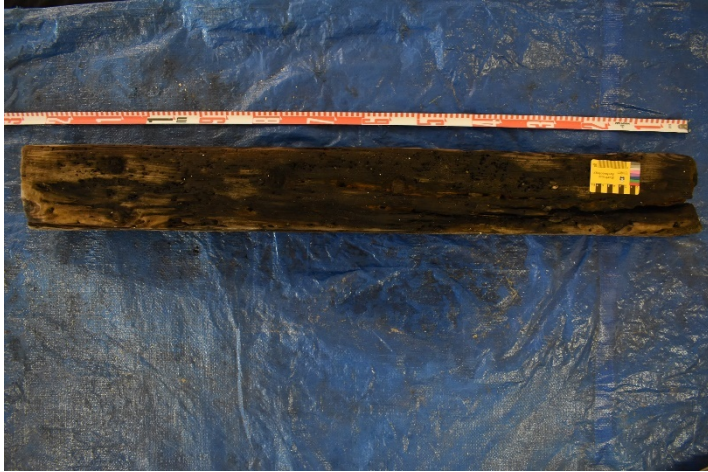
Description: Large wet timber with tree nails.

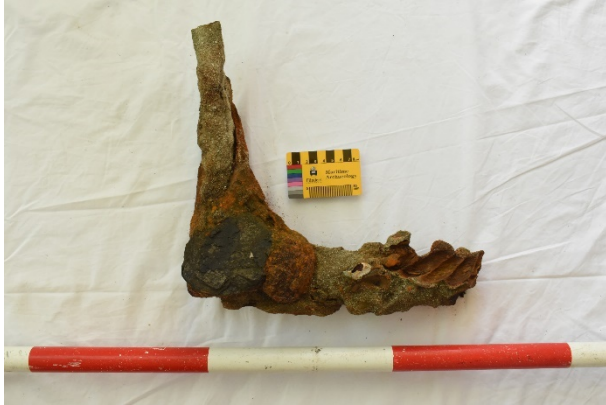
Description: Heavy iron rigging concretion with rope imprint. Much corrosion. Orange discoloration on surface. Triangular shape.

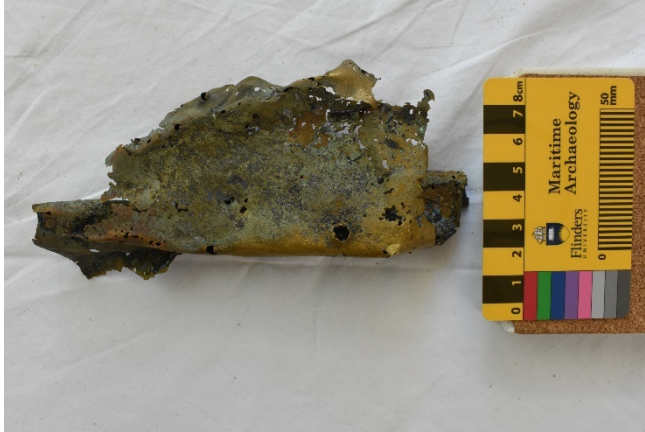
Description: Small, fragmented piece of copper sheathing. Heavy corrosion; large patina visible on surface. Crumpled.

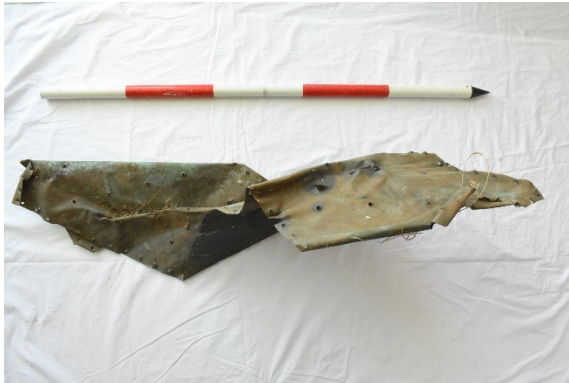
Description: Full metal copper sheet, bent and folded with multiple hole perforations. Perforations punctured within edging of sheet and on face. Corroded; patina present.

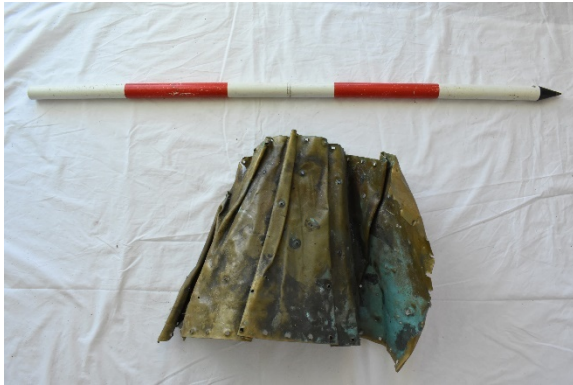
Description: Bent metal copper fragmented section with hole perforations alongside interior edges and face. Heavily corroded; patina visible on surface.
