# Investigation of loading techniques to create thoracolumbar burst fractures

Joseph Mwiseneza

Masters thesis (18 - units)

Submitted to College of Science and Engineering in partial fulfilment of the requirements for the degree of Bachelor of Engineering Mechanical (Honours)/Master of Engineering Biomedical at Flinders University - Adelaide Australia.

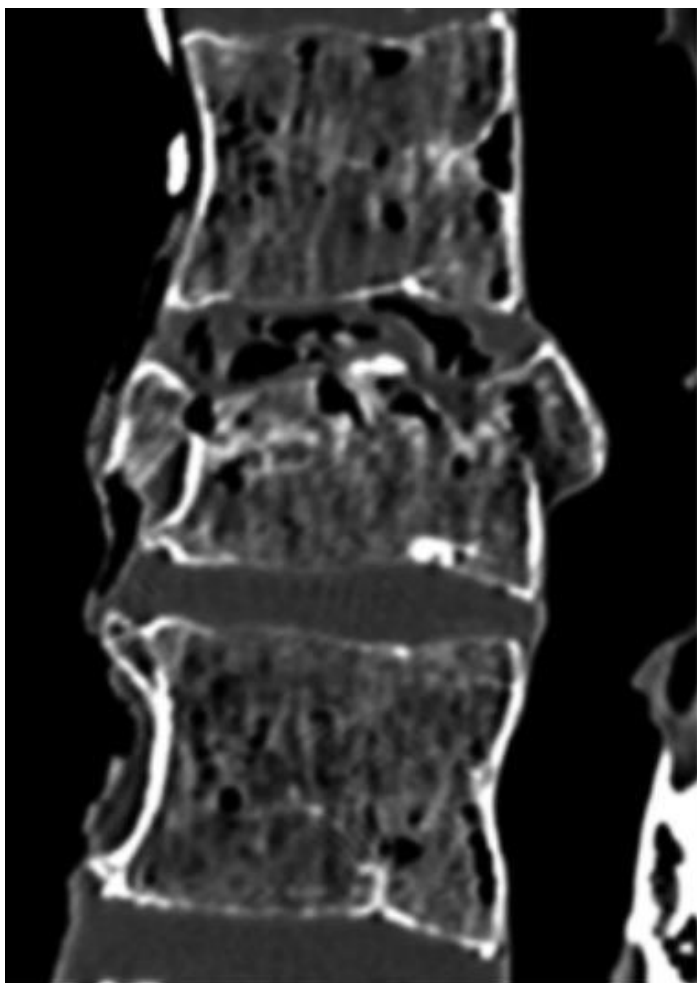
**Figure 2-7 Burst fracture of L1 (Oberkircher et al. 2016)**

As indicated in the Introduction, thoracolumbar Burst Fracture occurs mainly in young people especially active males aged between 14 and 24 who participate in sports requiring high energy or involving jumping from heights of more than 2 m (Marco, Russell & Masters 2003). These strenuous physical activities include jumping from airplanes, diving, and parachuting. When these people fall or land on their feet or buttocks at a high speed there is a potential of creation of burst fractures of thoracolumbar like fracture in Figure 2-7 caused by a fast deceleration of the ground.

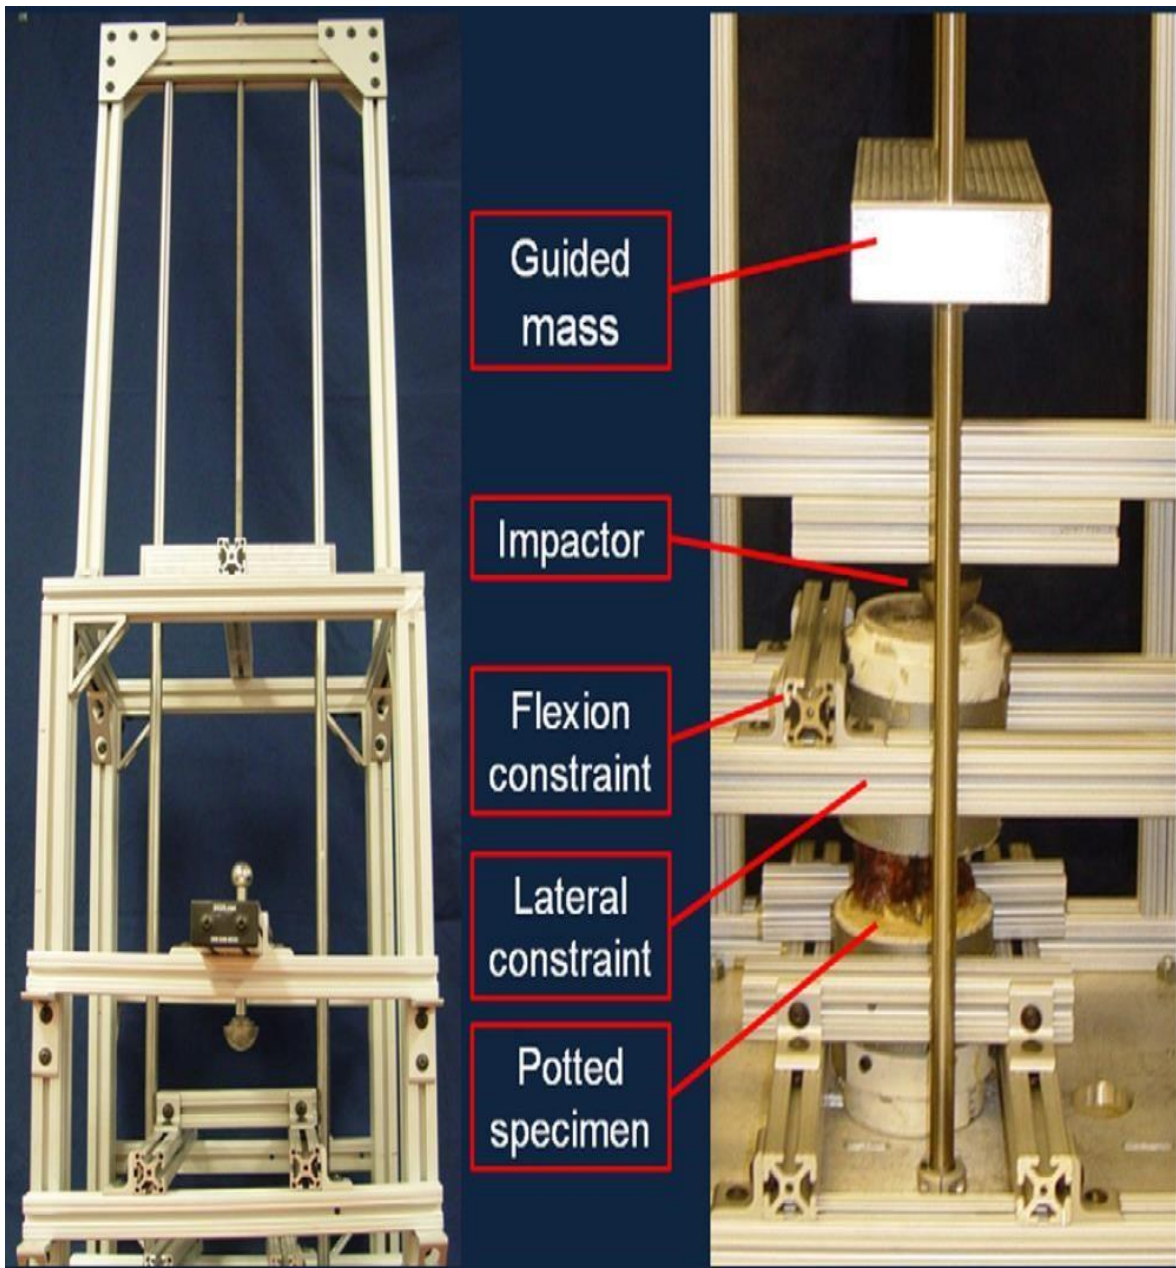
**Figure 2-8: Drop tower testing apparatus showing the impactor, guided mass, flexion constraint and lateral constraint . This drop tower was used multiple times to create burst fracture without changing its mass (Jones et al. 2011).**

Some researchers used a method of dropping weight from various heights ranging from 1 m to 2 m striking the top of the specimen at high speed and collected the data using personal computers (Jones et al. 2011; Oxland, Panjabi & Lin 1994). To gain a better understanding of different ways this fracture could occur, various impact techniques have been employed, which include grouping the specimens and performing different tests for the groups while ensuring the specimens in the same group were tested under the same conditions. For example, Oxland, Panjabi and Lin (1994) employed three different methods of testing where from a total number of 13 human spines, five of them were tested by dropping an initial weight of 8.3 kg on a flat plate interface with the specimen. This type of interface was used with the intention of avoiding bending the top vertebra in the vertical planes. The second technique used two specimens with a cylindrical impact interface aiming to facilitate sagittal rotation by applying a small mass of 2.3 kg. The last six specimens were tested by using a flat interface, and an applied mass of 4.3 kg. As many other papers commented, this procedure of testing lacked a knowledge on the exact load that would produce the thoracolumbar burst fracture which caused a need of performing multiple tests by varying the mass in 2 kg increment until the fracture occurred. According to the findings of Oxland, Panjabi and Lin (1994), more than three quarters of the specimen used, presented burst fractures like those found clinically but there was no influence from the type of interface used on the nature of fracture. Normally an access on transaxial CT scan helps to analyse the level and direction of fracture. Some of the drop towers were used multiple times to create the burst fracture without varying the weight (Figure 2-8).

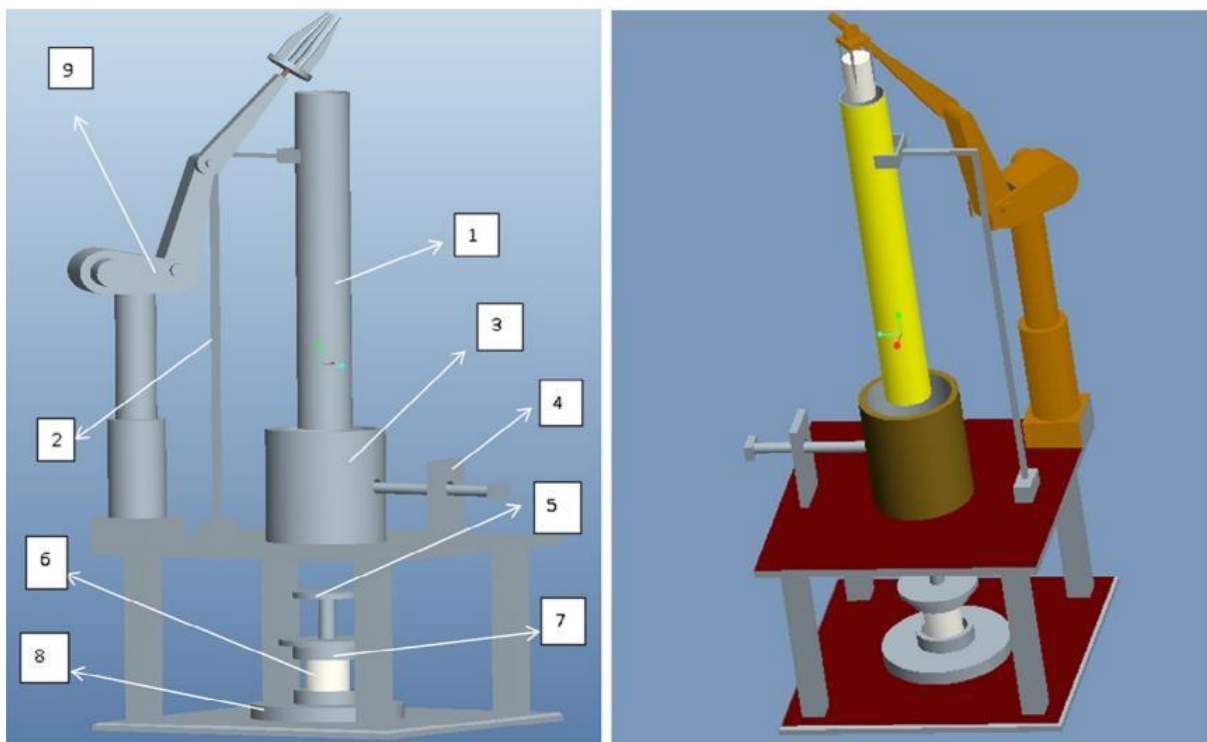
**Figure 2-9: Testing apparatus containing a guided tube, bracing piece, cylindrical barrier block, limiting rod, dental plaster cup base plate and a manipulator (Zhang et al. 2017)**

The testing machine shown in Figure 2-9 is a gravitational impact machine that used a 5 kg hammer and impact from a height of 1.4 m. It had a limiting rod that would be utilized to push the specimen away to prevent multiple impacts, the guiding tube which guided the impactor onto the specimen, cylindrical barrier block, bracing piece and susceptor. The author has determined that the results in this paper were analysed using a CT scan and based on the information provided and the data presented, the corresponding impact speed was around 5.24 m/s.

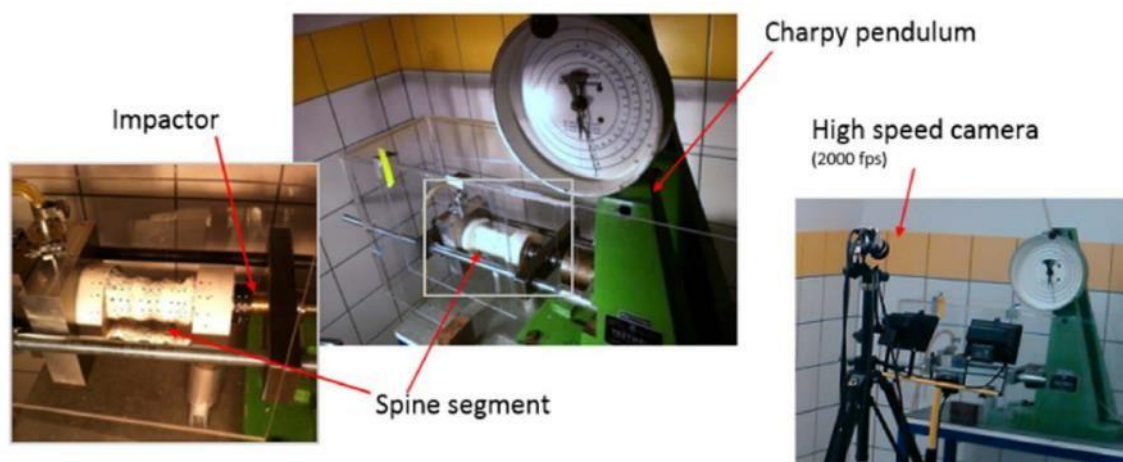
**Figure 2-10: Method of testing using a hammer, high speed camera and impactor (Germanneau et al. 2017)**

Another model called Charpy pendulum was developed by Germanneau et al (2017) and was used to produce multiple impacts on human specimens (Figure 2-10).

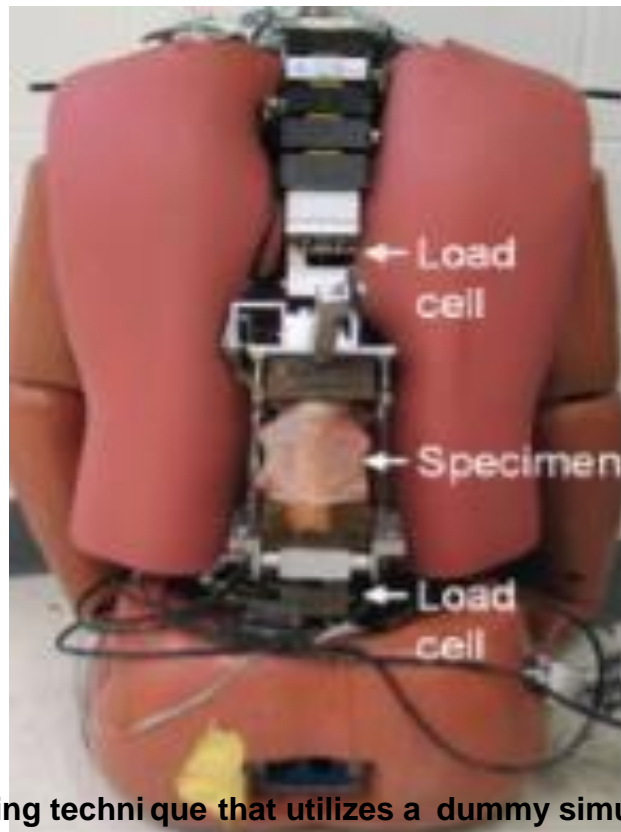
**Figure 2-11: testing technique that utilizes a dummy simulating a real -life fall from a height. it possesses load cells, specimen, and wires to hold the pieces together, trunk and pelvis (Ivancic, Paul C 2013).**

Apart from these high impact machines, there was another test that used a hybrid cadaveric simulation, shown in (Figure 2-11).

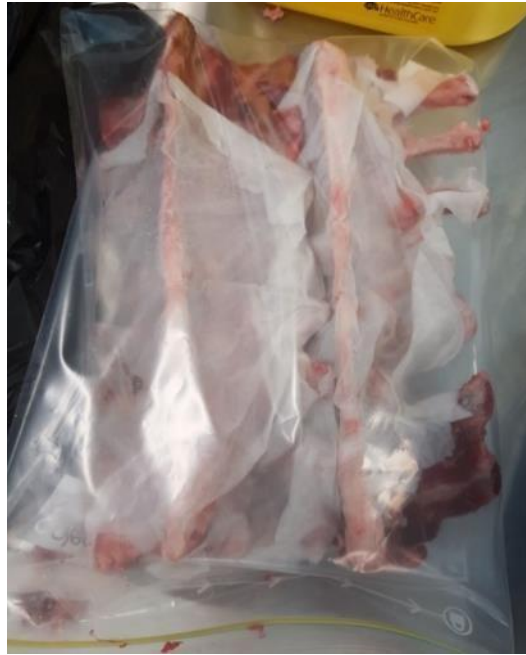
**Figure 4-3 - Specimens with removed soft tissues, wrapped in paper towels, sprayed with normal saline and then zipped in plastic bags.**

After the removal of soft tissues, the specimens were then wrapped into paper towels, sprayed with normal saline to ensure they didn't dry out, placed in zipped plastic bags (Figure 4-3) and again placed them back in a freezer at same temperature of minus 20°C until they were ready to be tested.

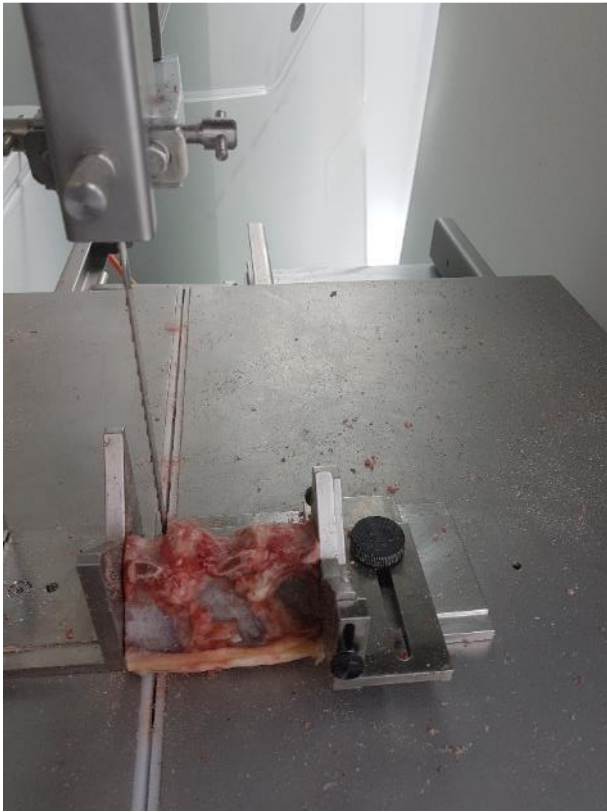
**Figure 4-4 - Sheep specimen with removed soft tissues and cut at T12 L1 using a bandsaw.**

Freezing the specimens before testing would not have made much difference compared with if they were tested before being frozen (Panjabi et al. 1994). When specimens were ready to be used, they were divided into three groups of eight specimens each. The first and third groups had segments of three vertebrae ranging from T12 to L1 and T13 to L2 respectively while the second group contained segments of multiple vertebrae ranging from T12 to L2. These specimens were then cut to the above-mentioned sizes using a bandsaw as shown in Figure 4-4.

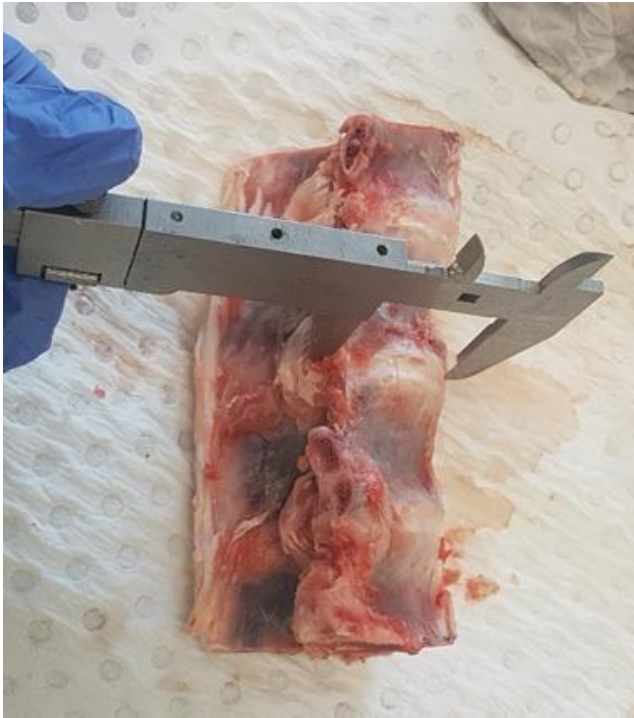
**Figure 4-5 - measuring the heights and discs of the specimen with a calliper**

Before any potting was done, all the heights, anteroposterior (AP), and lateral measurements of the vertebrae and discs were taken for all the specimens using a calliper (Figure 4-5) and recorded in a spreadsheet.

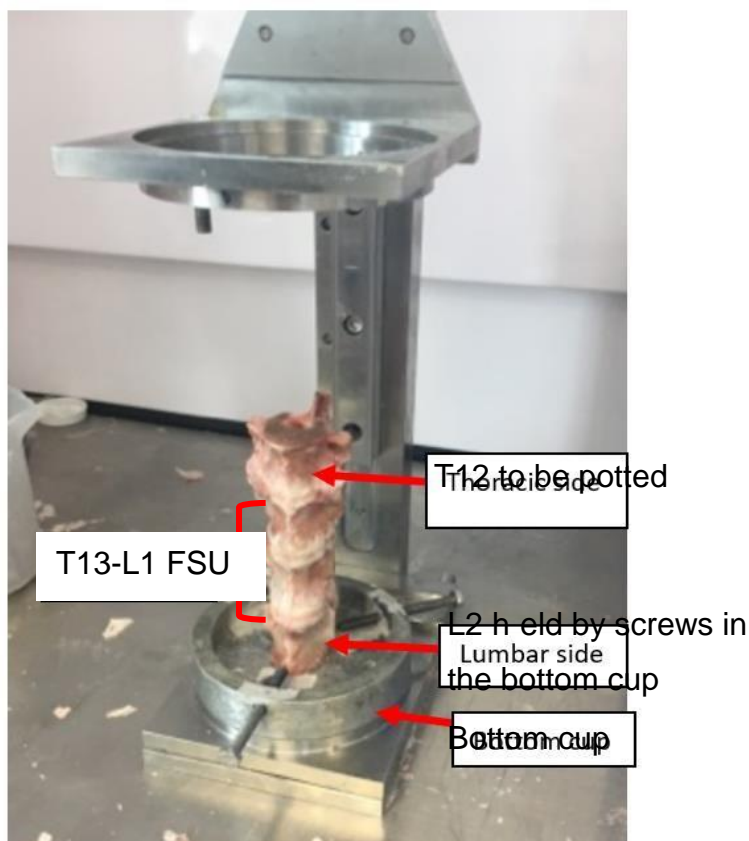
**Figure 4-6 - Specimen in the group of T13-L1 that is ready to be potted. It is held in the centre of the cup by three screws.**

This step was performed by placing both ends of specimen into two aluminium cups and potted using polymethylmethacrylate (PMMA) powder and monomer agent liquid while leaving the vertebrae to be tested free between the cups. The procedure was done for all three groups of specimens. Note that the note that the free vertebrae of the multi-segment specimens were T13 and L1 while for the other two groups, they were T13, and L1 respectively. To secure the specimens into the cups and ensuring the PMMA didn't break while testing, three screws were used in each cup and screwed all the way through until they lightly clamped the specimen. Full procedure for the potting can be referred to from the Appendix A The potted specimens were left in the fume hood for fifteen to twenty minutes and sometimes longer to ensure they were properly dried, then taken for testing. Figure 4-6 and Figure 4-7 show one of the specimens in the bottom cup before and after the specimen was potted.

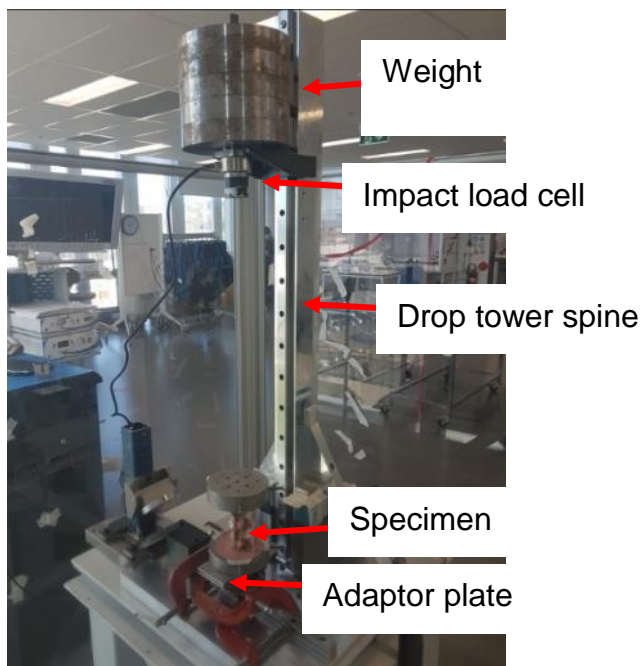
**Figure 4-8 - Specimen mount on the base of the drop tower and aligned with the impactor load cell.**

Testing was conducted into two sections where the first was pilot testing to investigate what the appropriate weight and height would be to generate reproducible burst fractures while the second section was the final tests after finding the needed parameters. Before any of the specimens was impacted, specimens were mounted on an adaptor plate and secured on an 'xy table' on the base of the drop tower vertically in line with the impact load cell using clamps (Figure 4-8). The alignment with the load cell was to avoid any flexing of the specimen that would damage it.

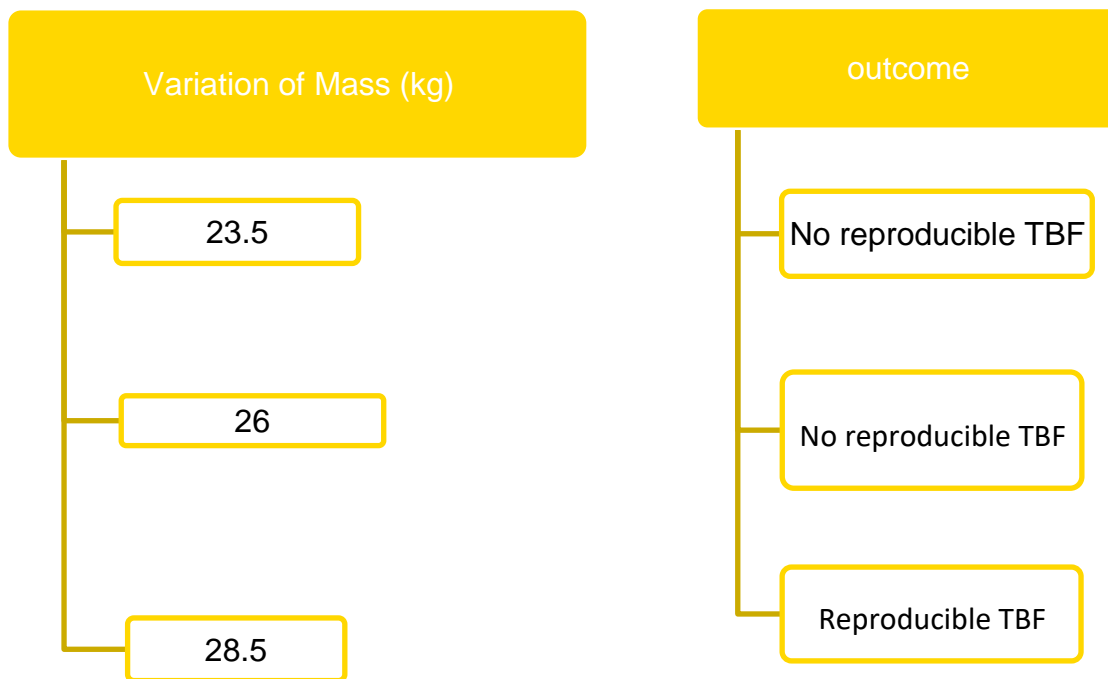
**Figure 4-9 - Variation in pilot testing and the outcome. An impact mass of 28.5kg showed a higher chance of producing a reproducible burst fracture.**

Seventeen specimens were used for pilot test while varying the drop mass in three groups. 23.5 kg were used on four specimens while 26 and 28.5 kg were used on six and seven specimens respectively. The observations indicated that 28.5 kg at the height of 0.5 m was more promising in producing reproducible BF (Figure 4-9). These parameters resulted in the energy of around 140 joules and drop speed of around 3.2 m/s. As seen earlier in the literature review, other studies have used speeds between 3 and 6m/s and energy varying between 35 to 160 joules. This led to the conclusion that a 28.5 kg drop mass at 0.5 m height was reasonable for current testing to reliably reproduce Burst Fractures.

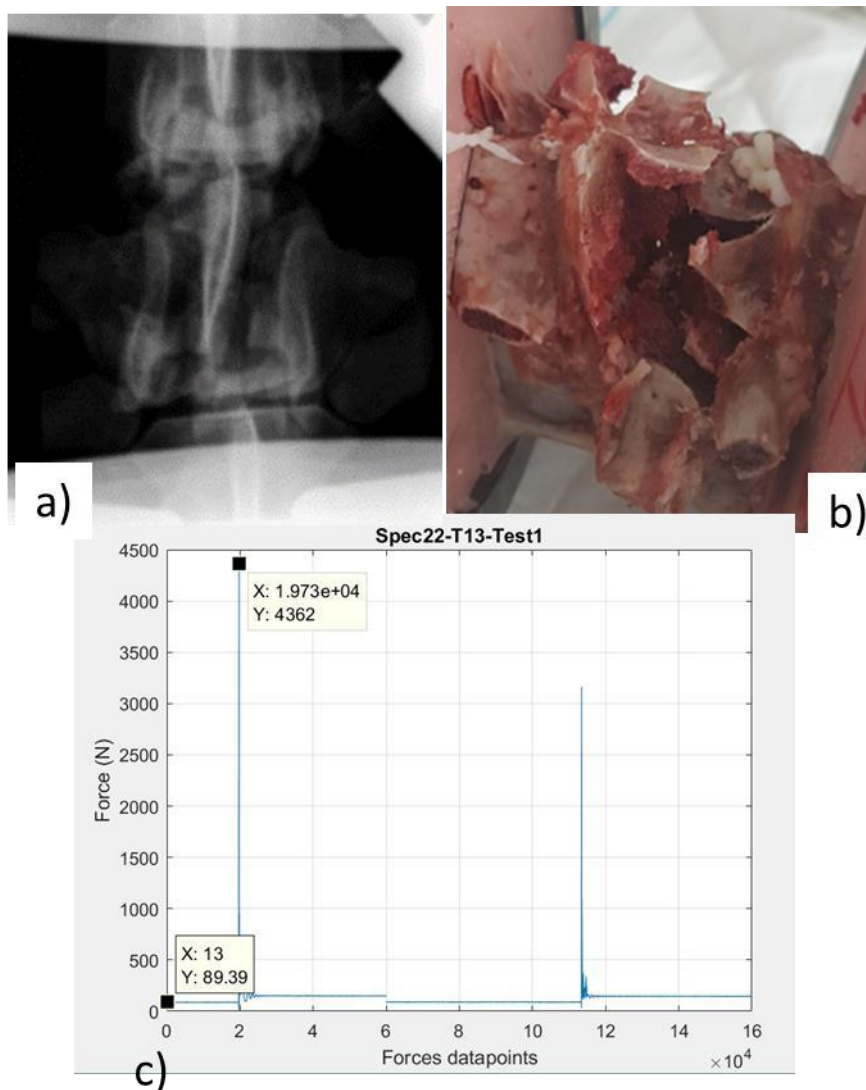
**Figure 5-1 a) represents the burst fracture x-ray image of T12-L1, b) the burst fracture and c) the MATLAB plot showing the corresponding forces applied on impact.**

It was seen that some of the specimens did not show burst fractures while some of the forces plot indicated some noise in the measurements. The noise might have been caused by the blocks that were used for the masses not being firmly tightened and rebound impact caused by the bounce after the initial impact.

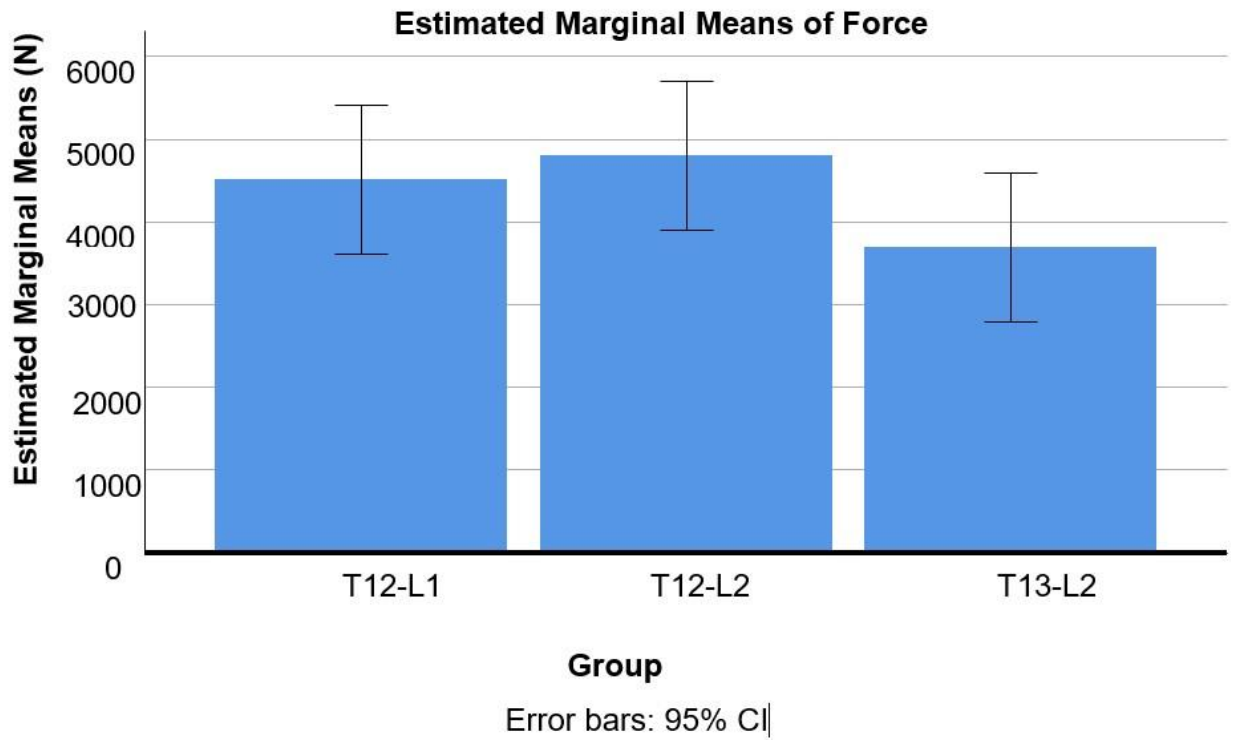
Figure 5-2 Comparison of mean value forces based on eight specimens in each group.

In Table 5-4, the forces have been shown together with energies of each specimen. The difference between these groups indicate that the mean value of T12-L2 is 293 N higher than T12-L1 and 1116 N higher than T13- L2. This means that the mean value of L1 is the lowest in all groups with T12-L2, being the highest. However, the SD of T12-L1 is lower compared to the other groups Table 5-4). This implies that there was not a big variation between the forces within this group. These differences are also illustrated in Figure 5-2 that shows the plot of these mean values.

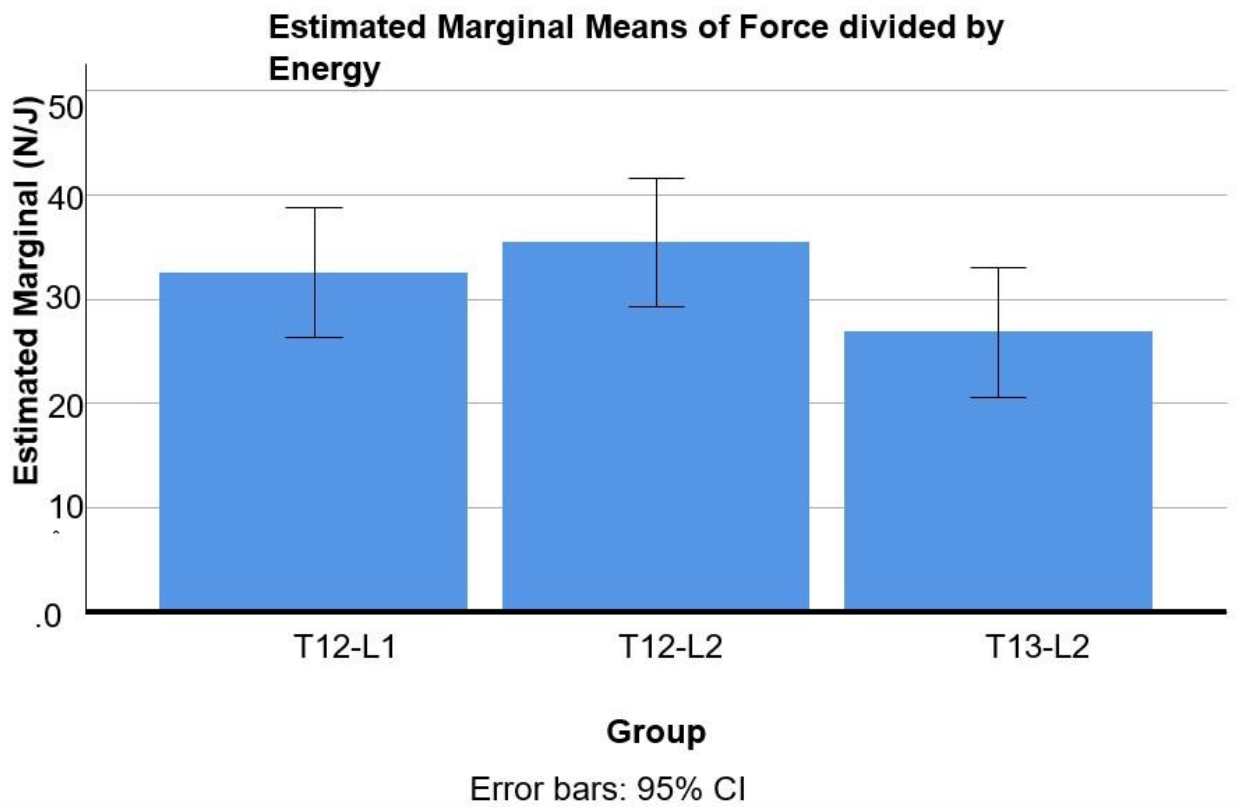
Figure 5-3 Comparison of forces by dividing the mean values of forces by mean values of energies.

This has also shown similar results as the comparison of mean forces (Figure 5-3)

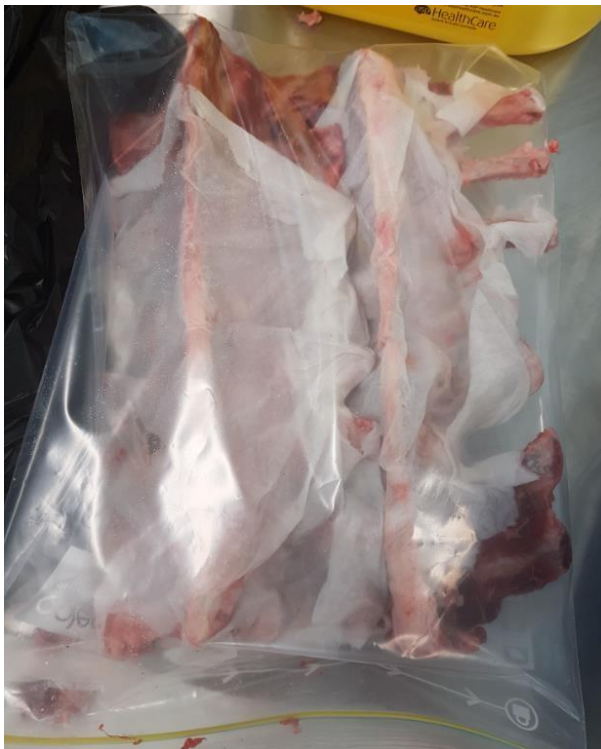
- 1.3. Wrap the specimens into paper towels and spray them with normal saline to keep them hydrated

**Figure 8-3: Specimens sprayed with**

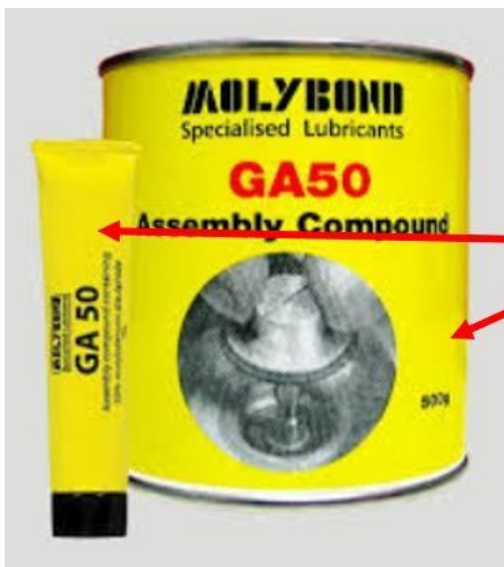
Moly bond grease to grease the screws to allow an easy removal of the screws from the cups

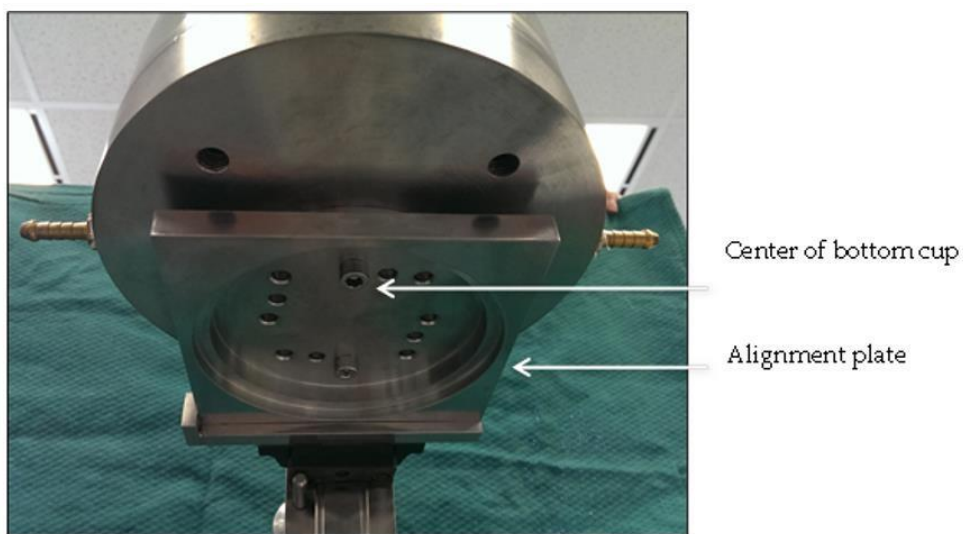
**Figure 8-7: bottom cup attached to the alignment plate**

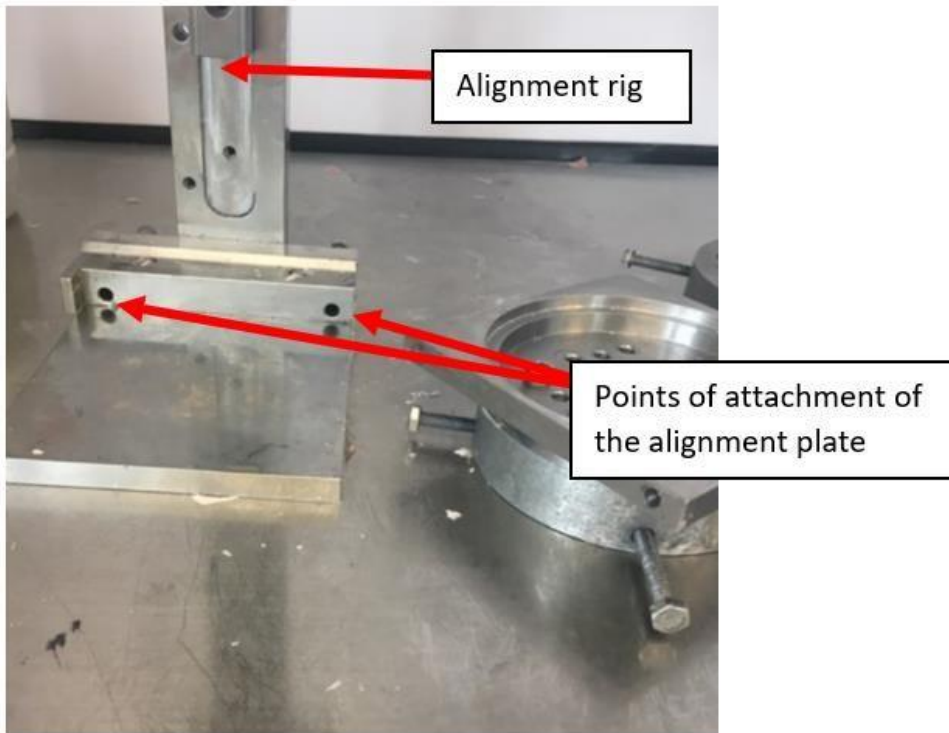
**Figure 8-8: Alignment rig displaying the location where the alignment plate is attached on its base. Note that the attachment screws are located at the back of the visible side.**

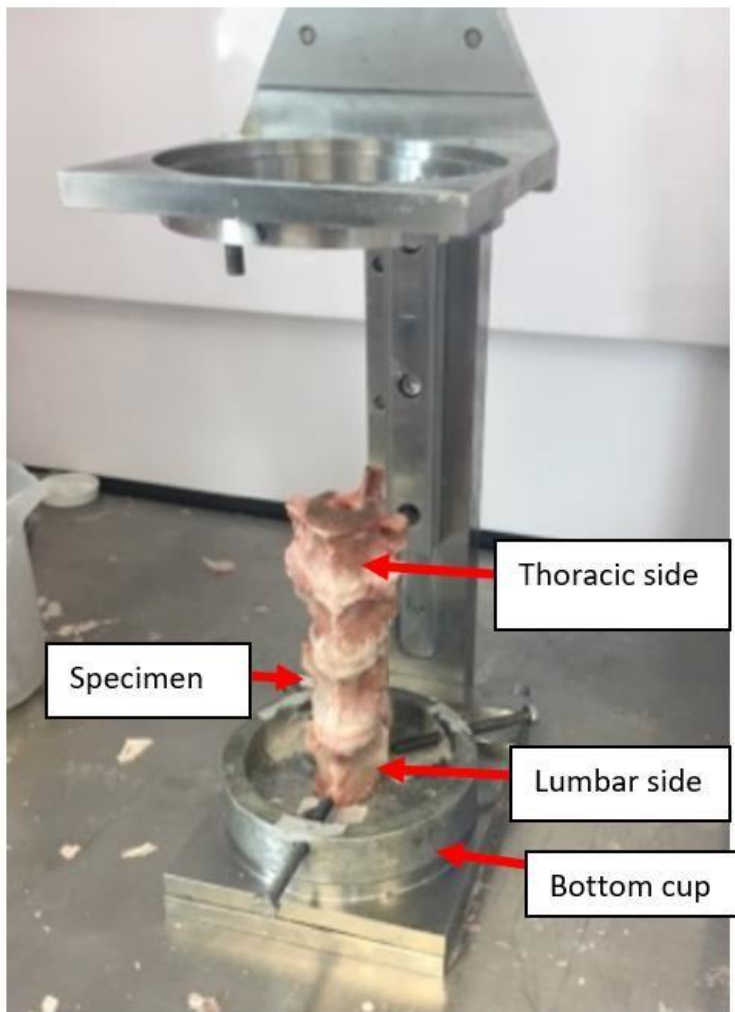
**Figure 8-9: picture showing how the specimen should be positioned in the potting cup.**

- 2.9. Place the specimen into the Centre of the bottom cup and make sure the lumbar side is on the bottom and the specimen is not rotated.

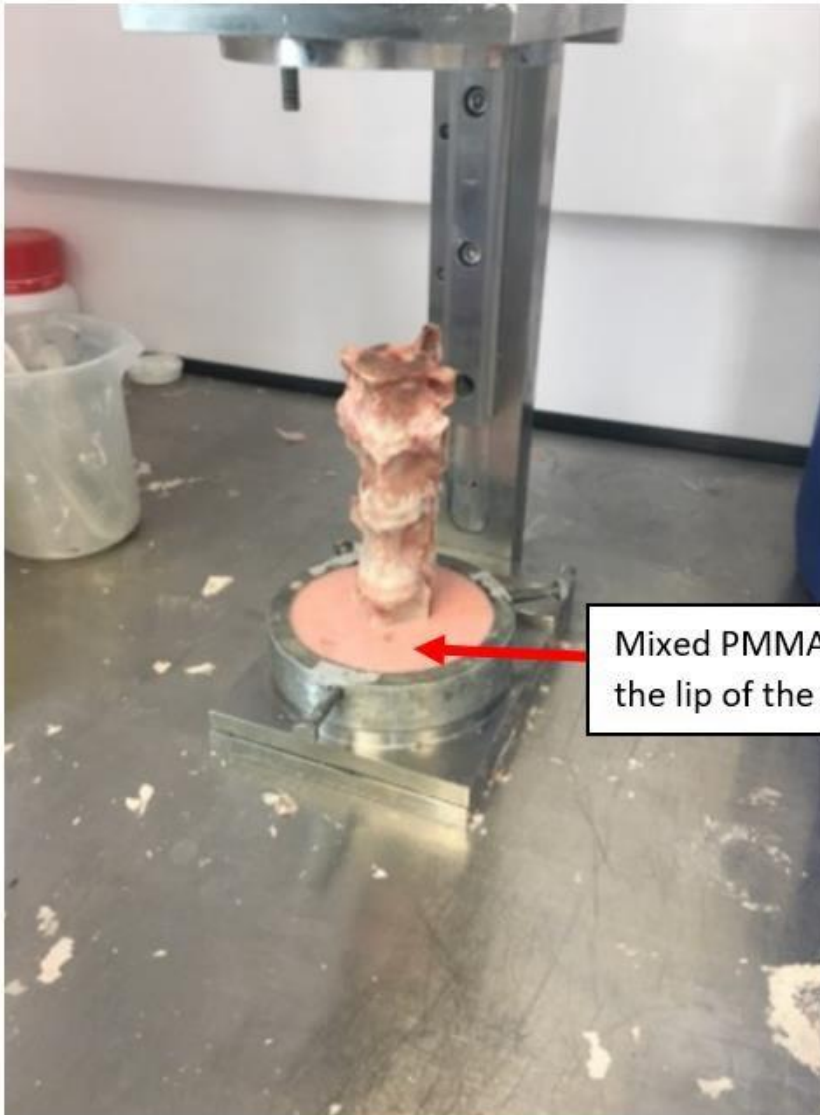
**Figure 8-10: this picture indicates the level of PMMA in the potting cup.**

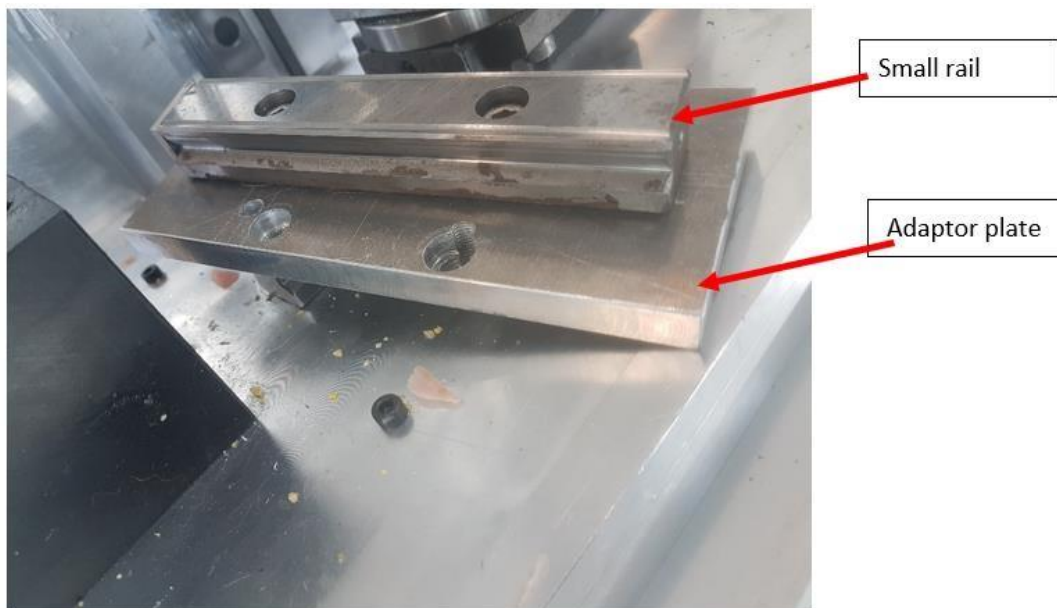
**Figure 8-11: This picture indicates the adaptor plate attached on the small rail.**

- 3.1. Take the potted specimen in the Biomechanics Lab and get a licensed person to take an x-ray
- 3.2. Using a table next to the drop tower, Attach an adaptor plate on a small rail and then the bottom cup on the adaptor plate. This step can be done on the base of the drop tower as well, but you need to make sure the release mechanism of the drop tower is secured with a screw to avoid the drop of the weight which can result in injury.

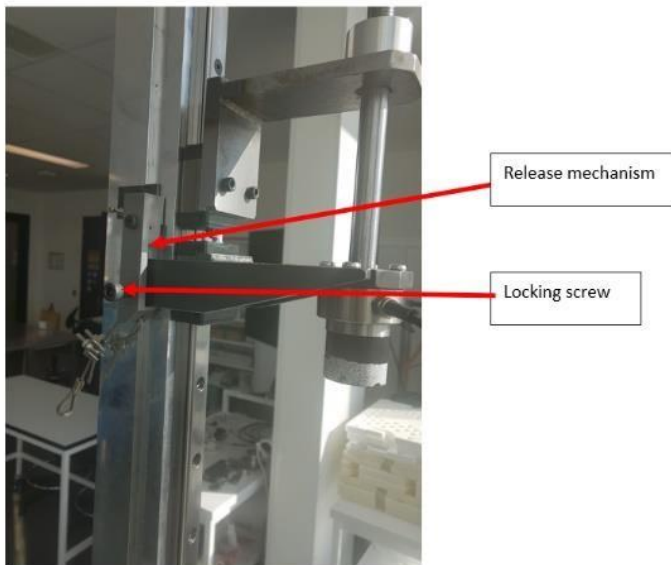
**Figure 8-13: Locking screw with a release mechanism. the locking screw prevents the unwanted release of the weight that could result in injuries or damage of the specimens.**

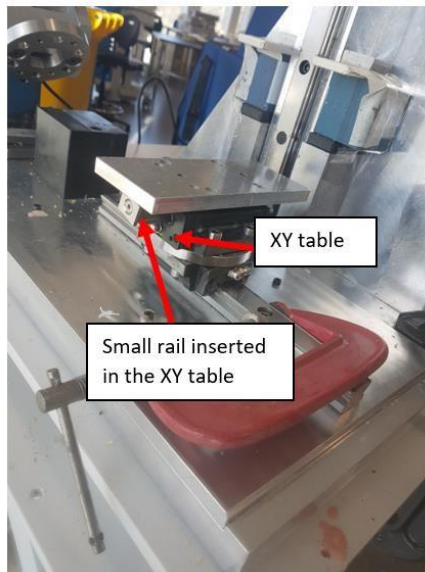
**Figure 8-15: Small rail with the adaptor plate inserted into the top of XY table**

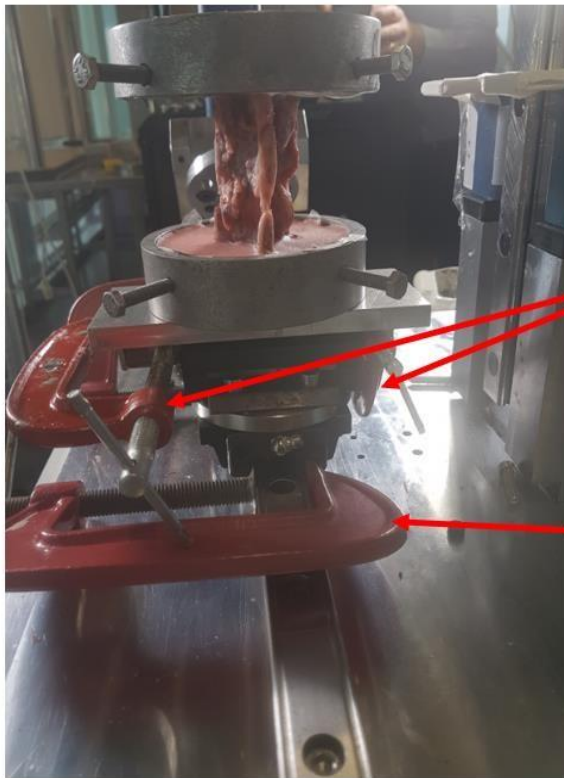
Two clamps on both sides of the small rail

One clamp on the front side of the long rail, the other clamp is behind the specimen and can not be seen

- 3.5. Slide the small rail mounted with the specimen in the bearing that is mounted on the long rail at the base of the drop tower. Secure the specimen vertically aligned with the impact load cell. Note that on the x-y table, the small rail must be on top.
- 3.6. Use four clamps, one on each side of the rail to avoid the sliding movements of the specimen while impacting

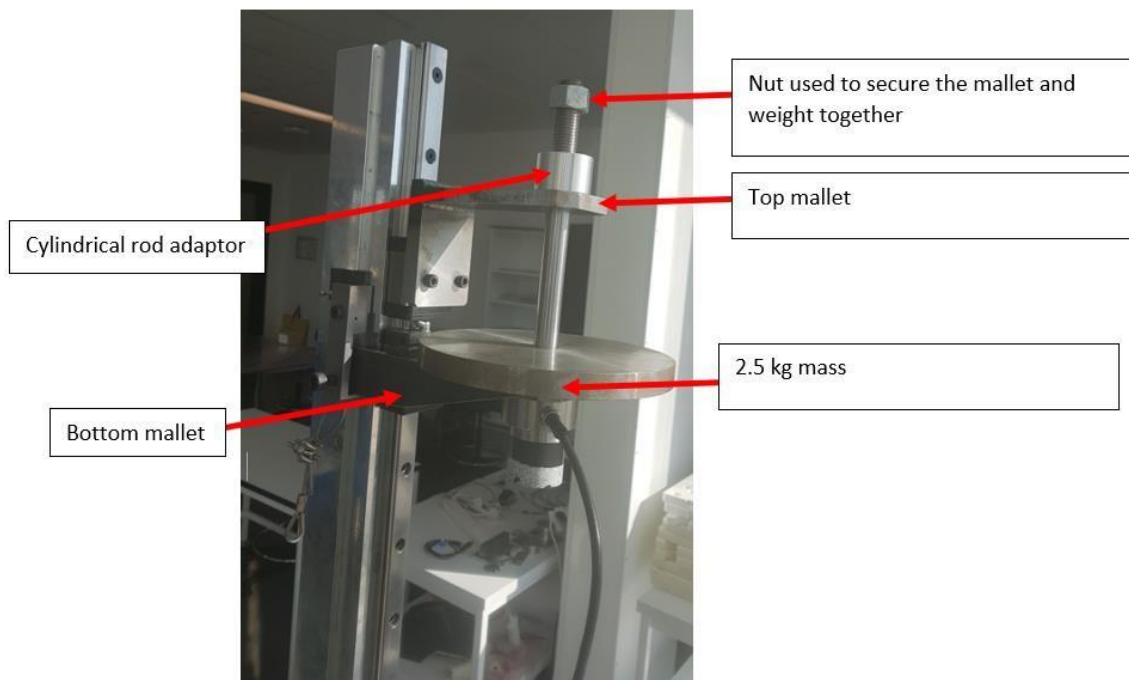
**Figure 8-17: This figure illustrates the location where the mass is loaded, the cylindrical load adaptor, the sample of mass and the nut that secures the weight on the top of the bottom mallet.**

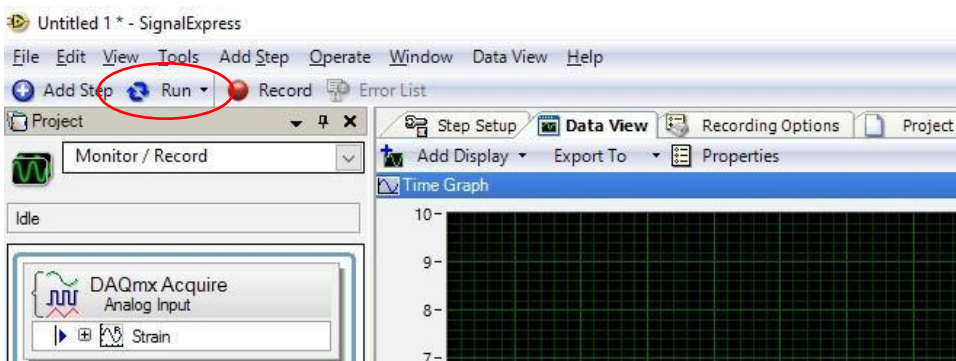
5. Ensure you are getting data in the “Step Setup” tab for the DAQmx Acquire step. (Or the “Data View” tab if you set that up.)
6. Go into the “Zero Offset” “Step Setup” tab and click the Zero Now button
7. Start your test
8. After your test has finished, click the Stop button on the toolbar.

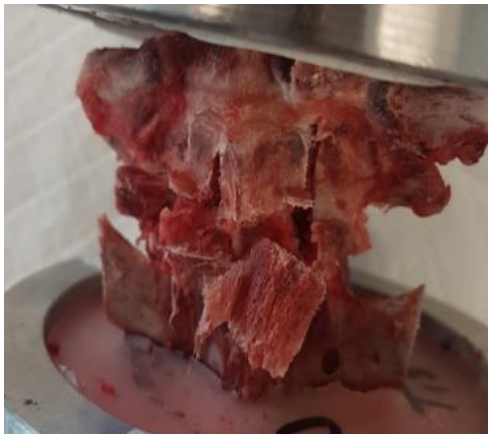
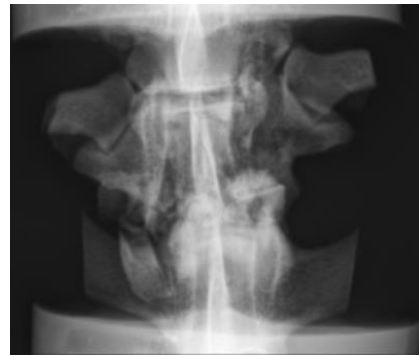
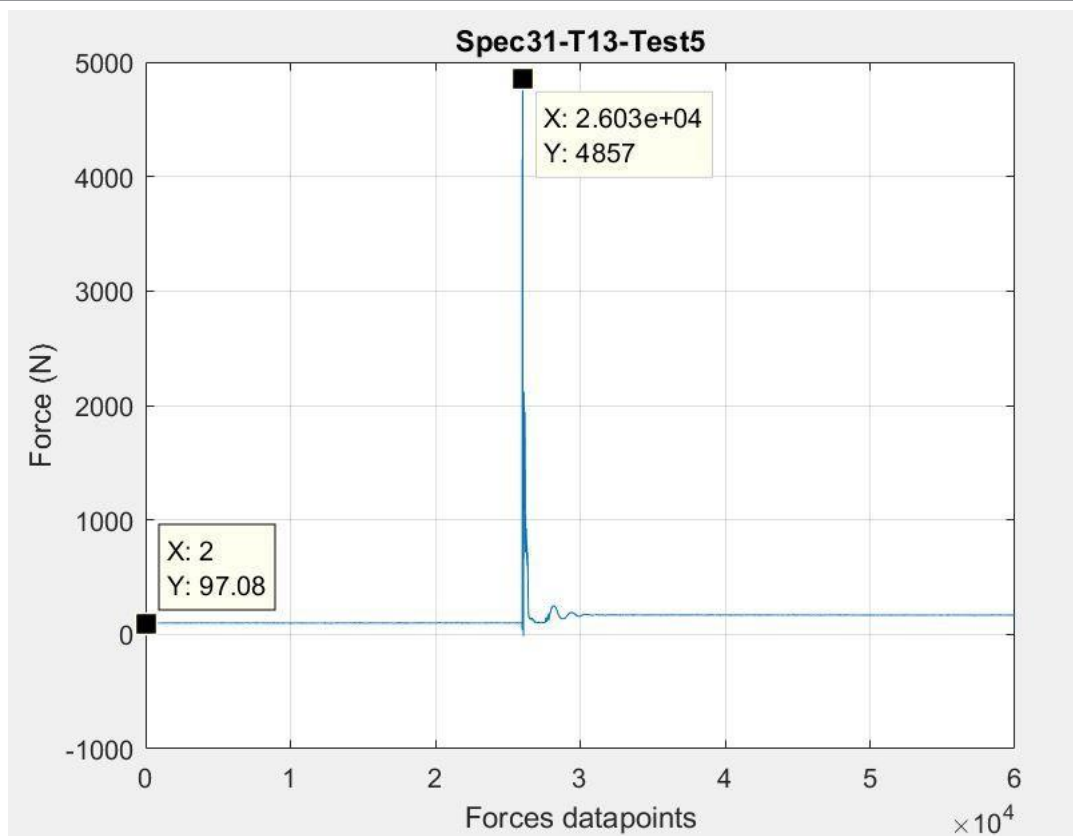
a. Burst fracture of T13 vertebra body. Vertebra body fractured into pieces

b. x-ray image shows the fractures of the specimen

Figure 8-20 - figures a, b, and b represent the burst fracture, x-ray image and the force that produce the burst fracture.

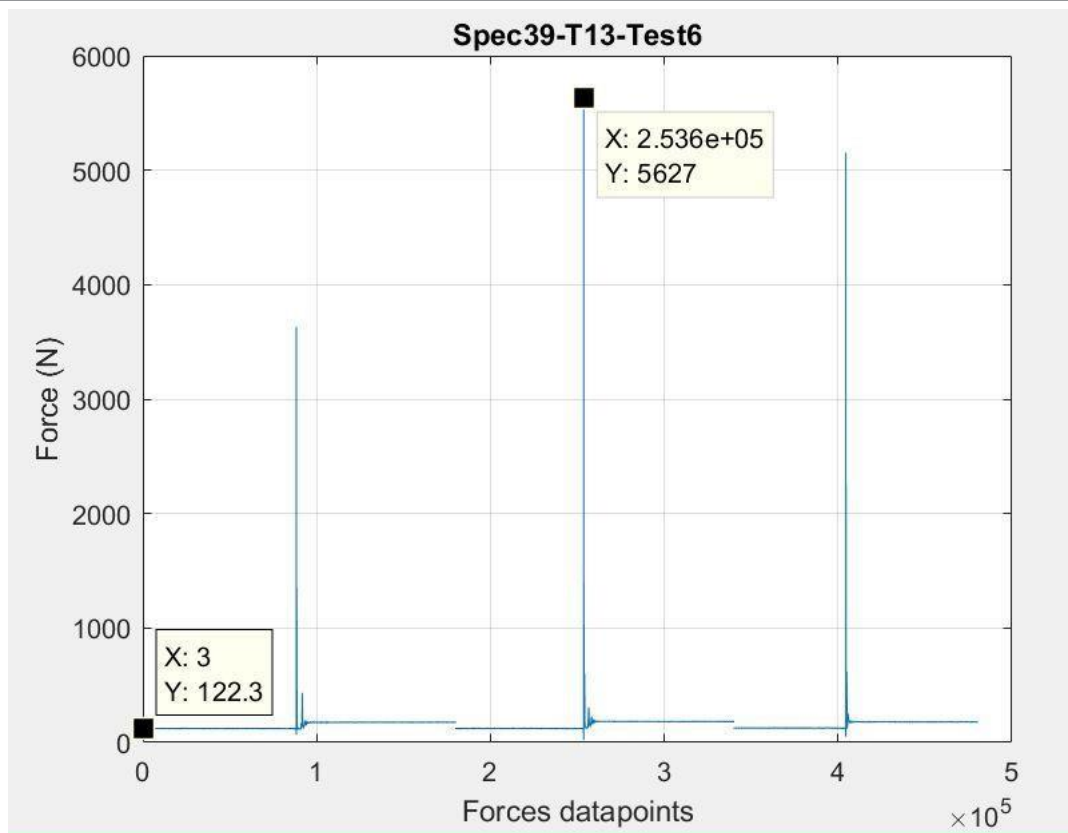
Figure 8-21 - a represent no burst fracture, b shows the image from x-ray and c the force generated to create the fracture.
