# Investigation of loading techniques to create thoracolumbar burst fractures

Joseph Mwiseneza

Masters thesis (18 - units)

Submitted to College of Science and Engineering in partial fulfilment of the requirements for the degree of Bachelor of Engineering Mechanical (Honours)/Master of Engineering Biomedical at Flinders University - Adelaide Australia.

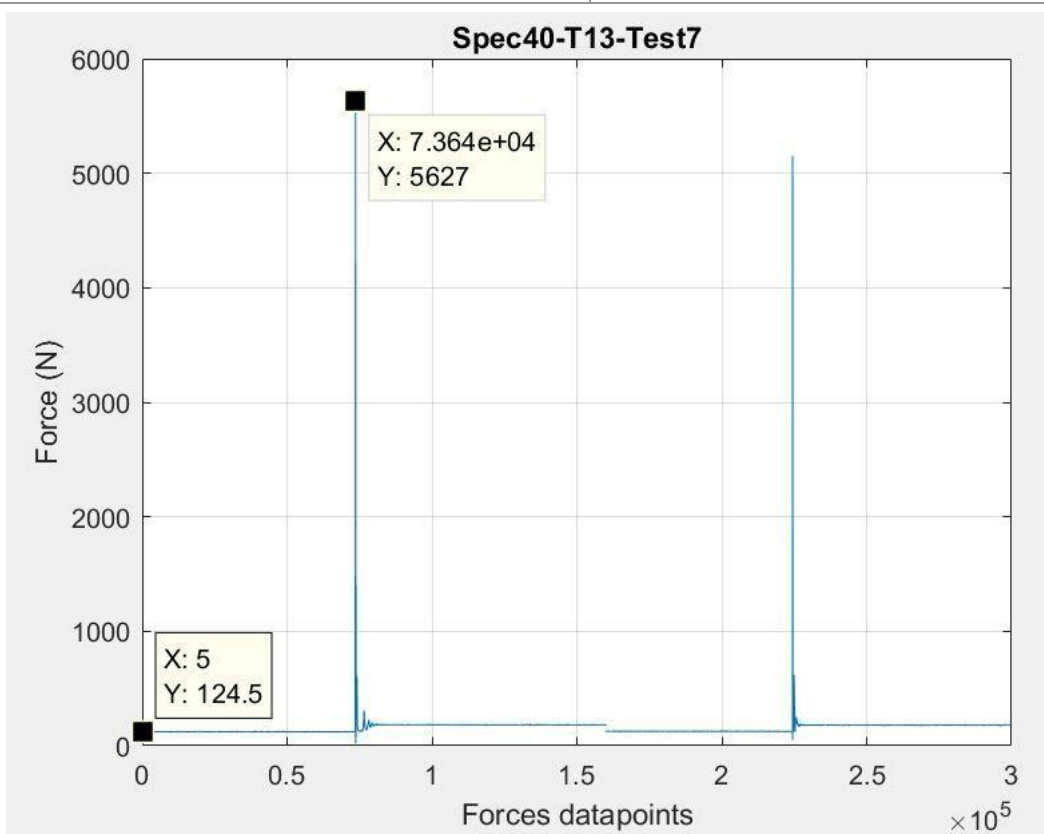
Figure 8-22 - burst fracture of the vertebra, x-ray image and force to create the fracture represented by a, b, and c respectively.

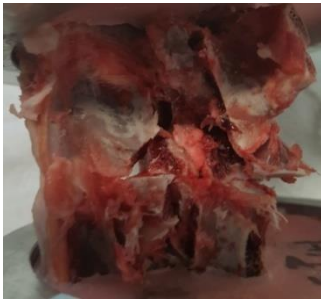
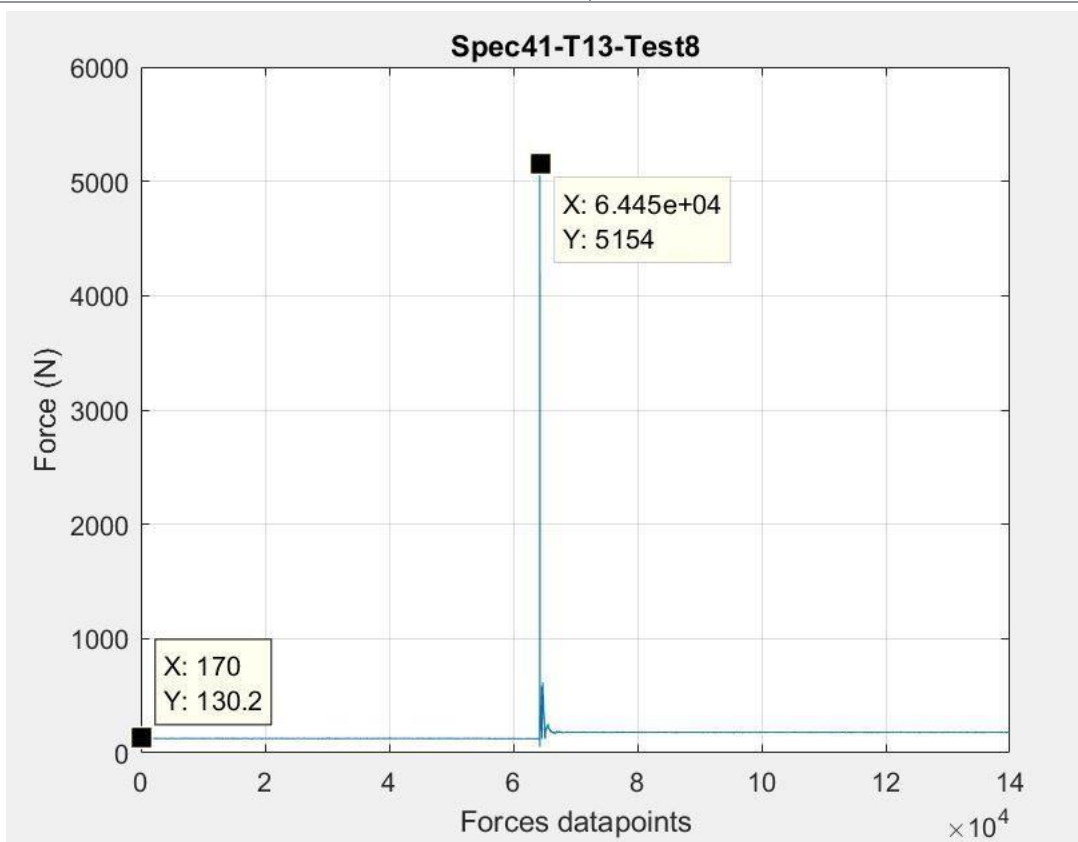
Figure 8-23 - Burst fracture, x-ray image of the fracture and the force that created to produce the burst fracture are represented by a, b, and c respectively.

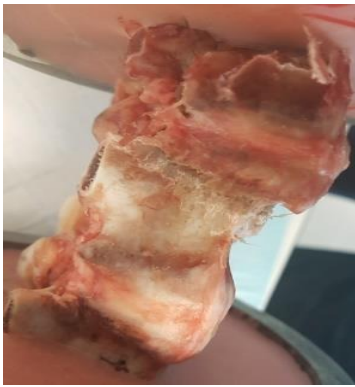
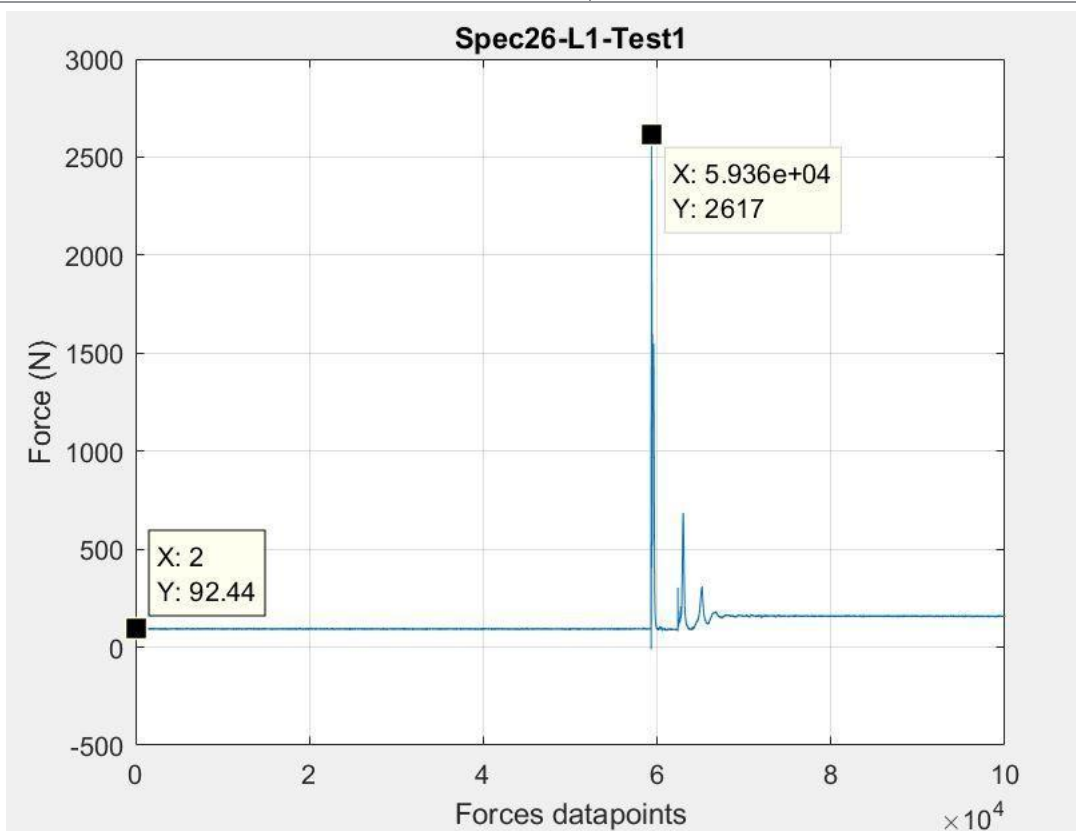
Figure 8-24 - The images in a, b and c represent the picture of the fracture, the xray to confirm it and the force that was produced during this fracture. there was a fracture at the upper endplate of L1 and a small part of T13 that was

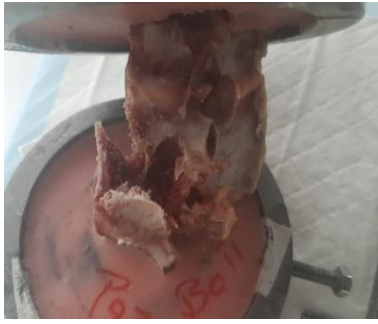
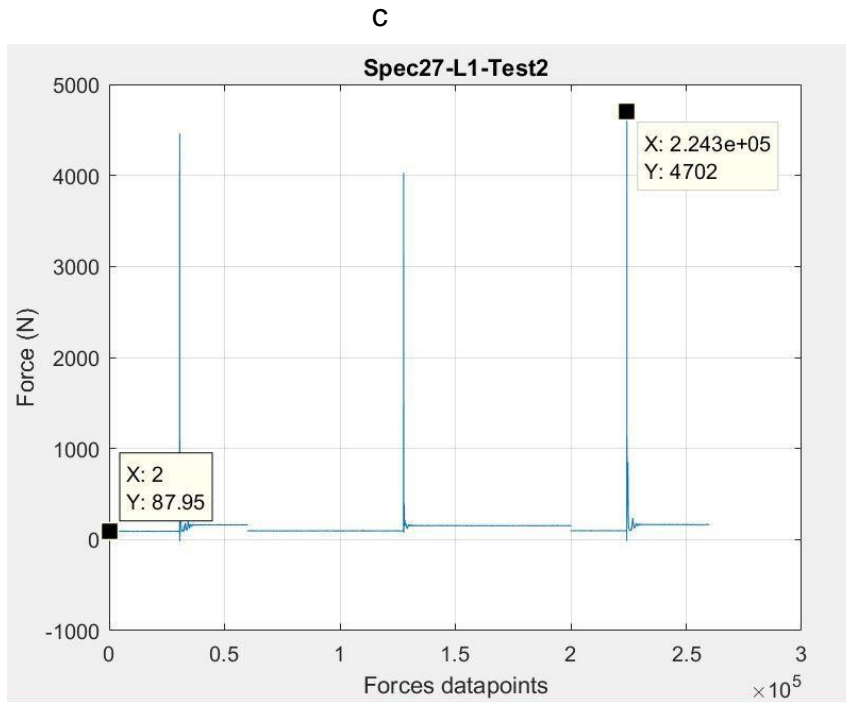
Figure 8-25 - a, b, and c represent the burst fracture of L1 with the disc remaining intact, the x-ray image that confirms this fracture, and the force of less than 300 N to create this burst fracture respectively.

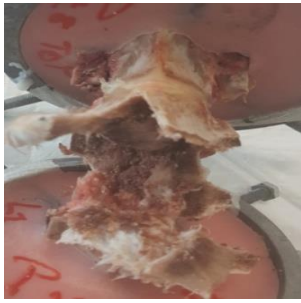
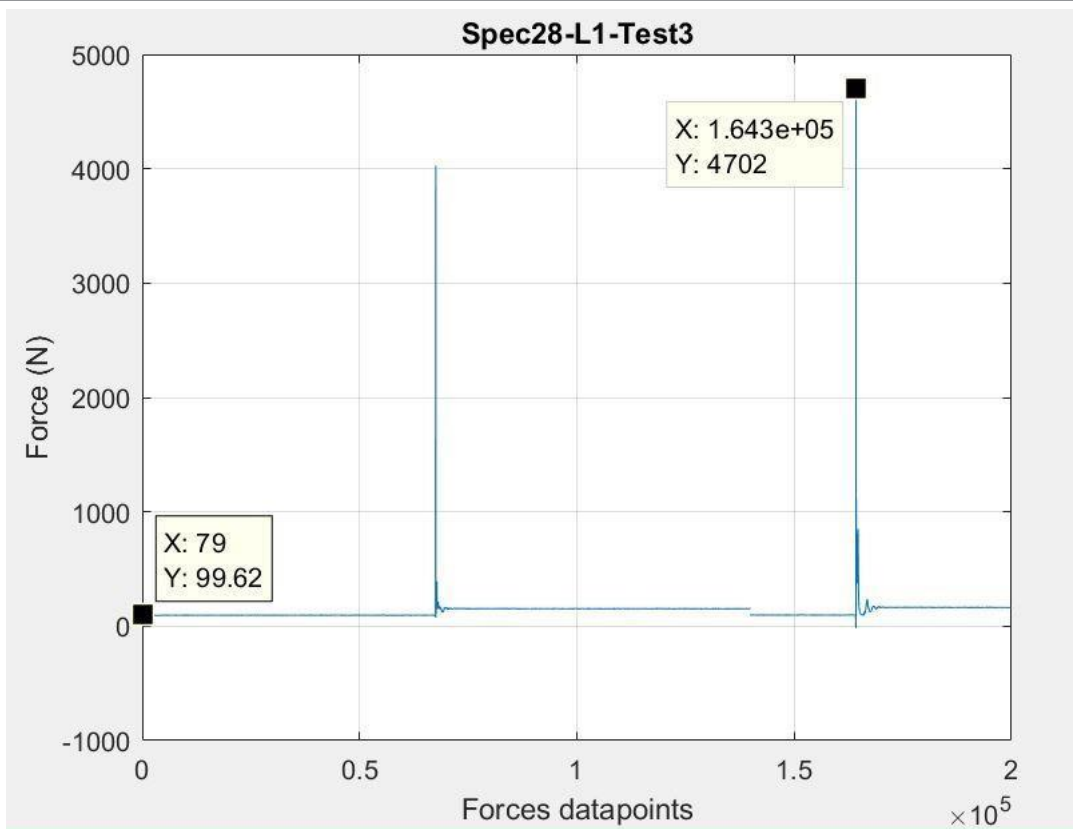
Figure 8-26 - a, b, and c represent the burst fracture initiated at lower endplate of L1, the x-ray image of the burst fractured vertebra and force of less than 600 N that produced this fracture.

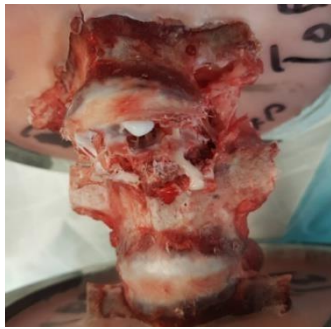
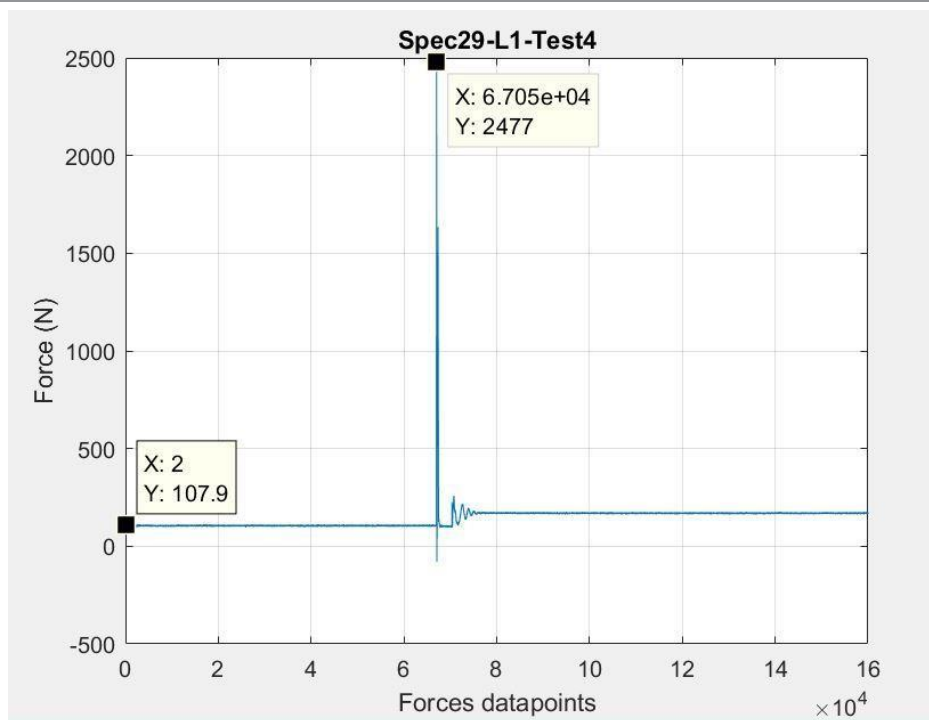
Figure 8-27 - a, b, and c represent the fracture of the top end plate of L1, the confirmation of this fracture by x-ray image and force of less than 300 N to create the fracture.

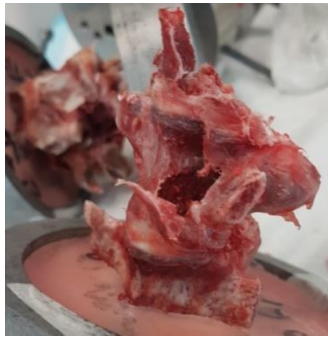
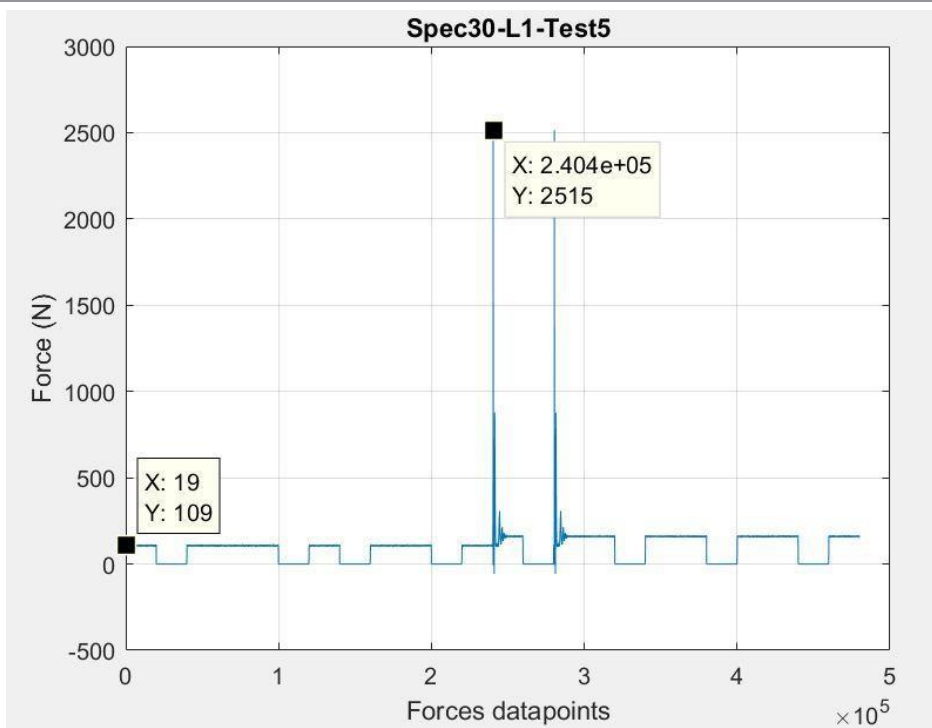
Figure 8-28 - burst fracture of the spinous process and shear fracture of L1 vertebra, x-ray image in b confirms the fracture and shows the force that produced the fracture.

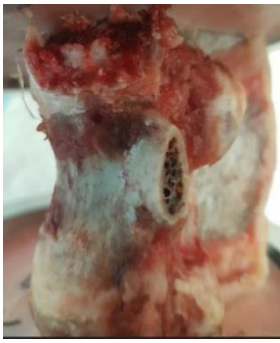
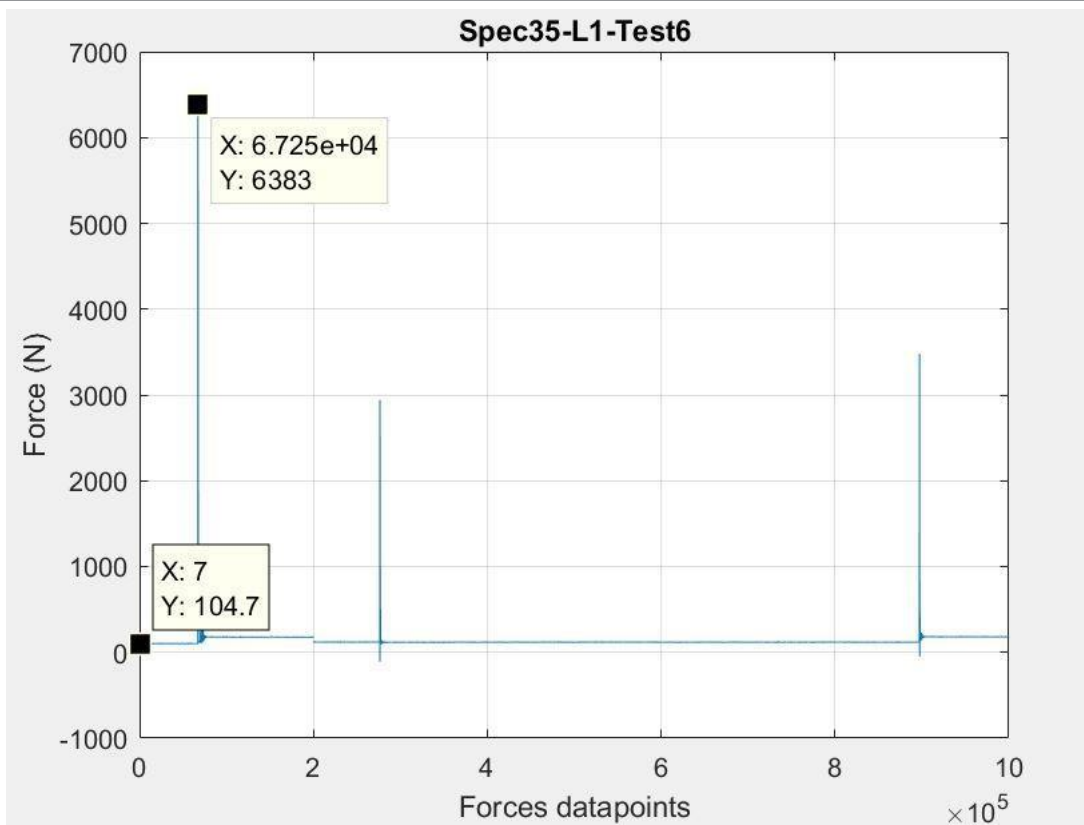
Figure 8-29 - a, b, and c represent the fracture of the lower endplate of T13, x-ray image confirming this fracture and the force of 700 N respectively

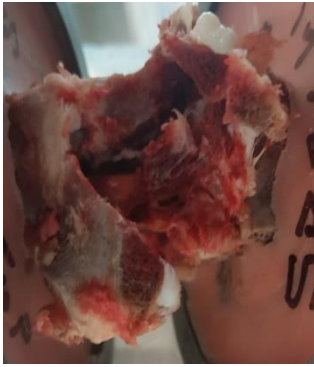
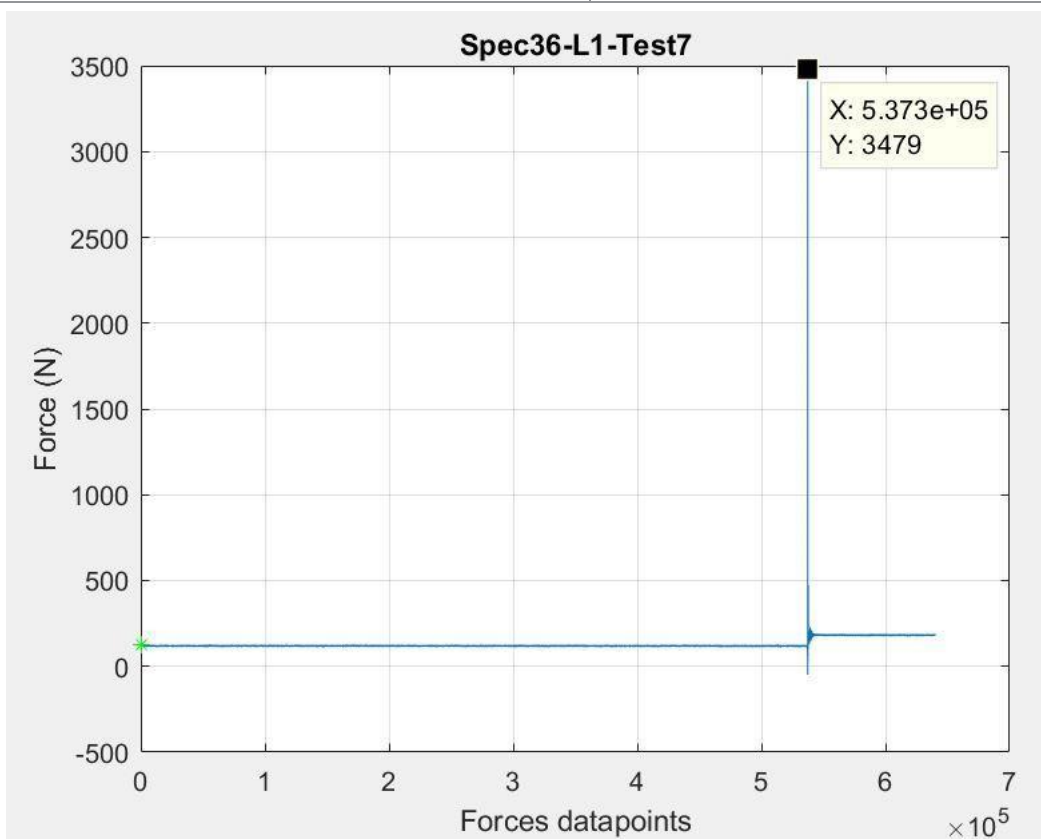
Figure 8-30 - a, b, and c represent a complete burst fracture of L1 and spinous process, the x-ray image confirming this fracture and showing a split of the vertebra body and a force of about 400 N that led to this fracture respectively.

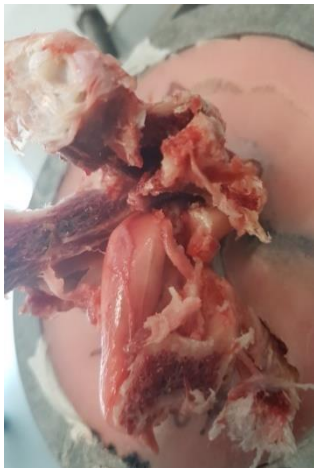
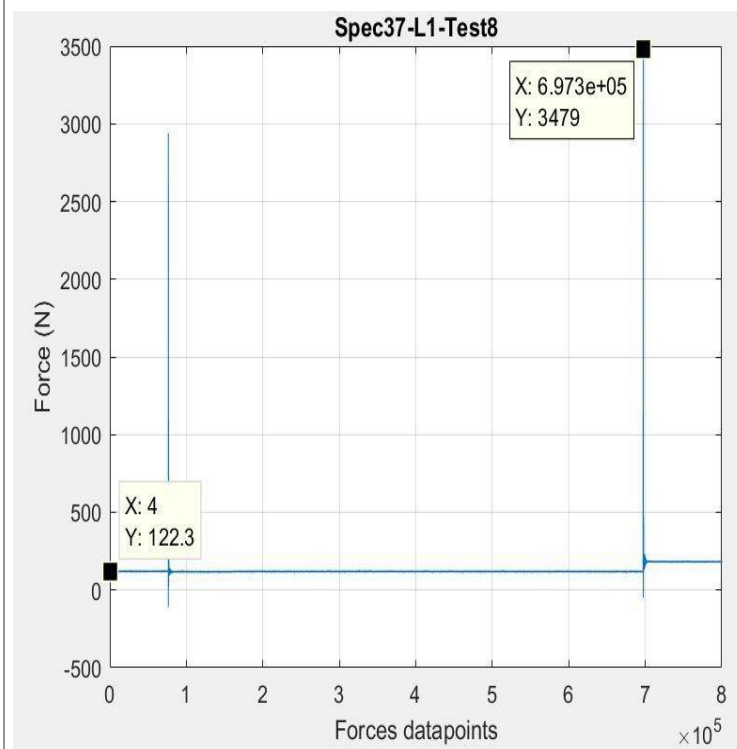
Figure 8-31 - a and b represent the burst fracture of L1 initiated at its upper endplate and split through the spinous process and the vertebra body, and the force of about 400 N to create the burst fracture.

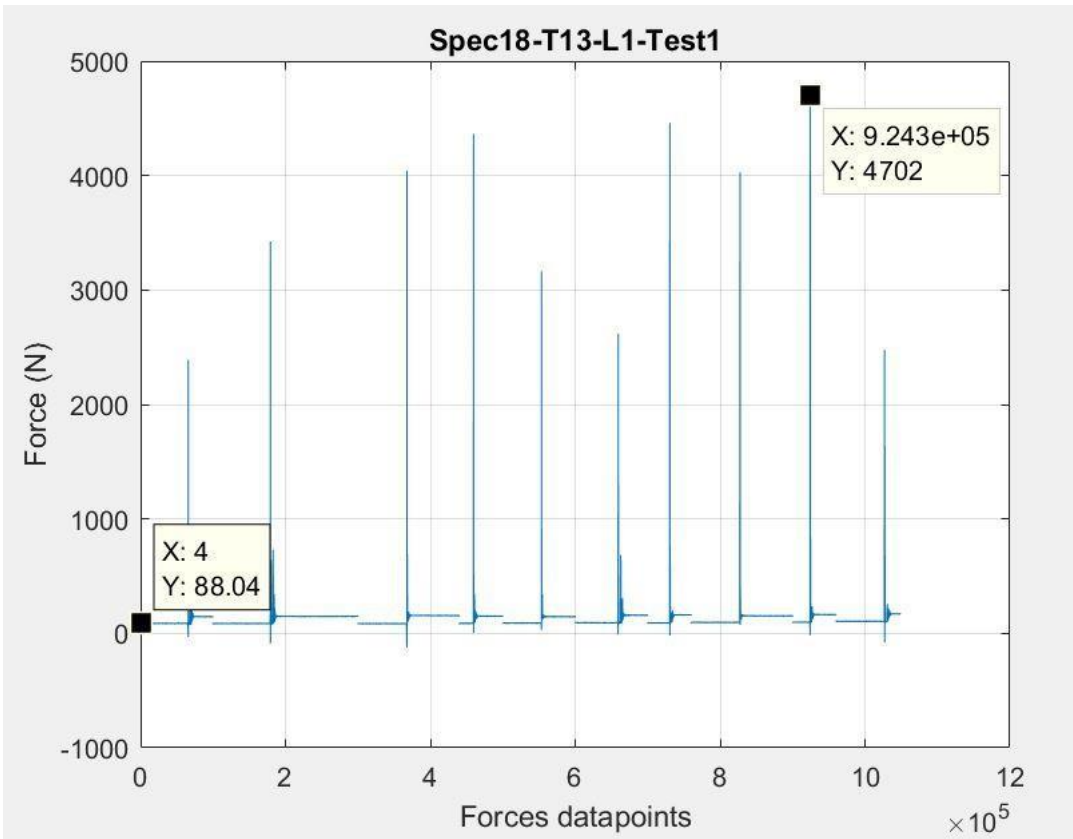
Figure 8-32 - image a represent the fracture of T13 with a split in the lateral view, the AP x-ray image in b doesn't seem to show the lateral view fracture and figure c represent the force generated during the fracture of vertebra.

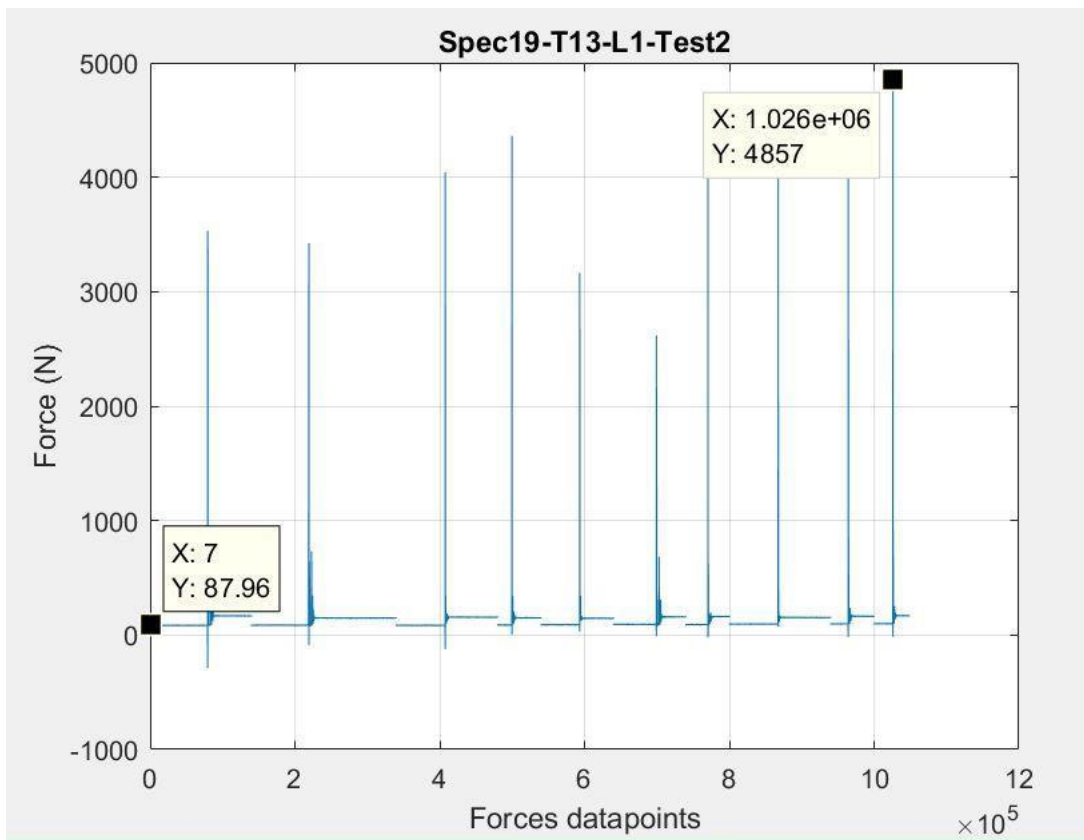
Figure 8-33 - a, b, and c represent the burst fracture of T13, its x-ray image and the force generated to create the fracture respectively. the AP of the x-ray does not appear to show the fracture of the vertebra body.

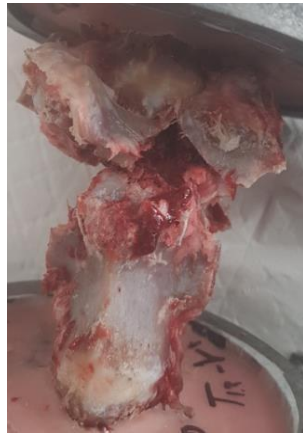
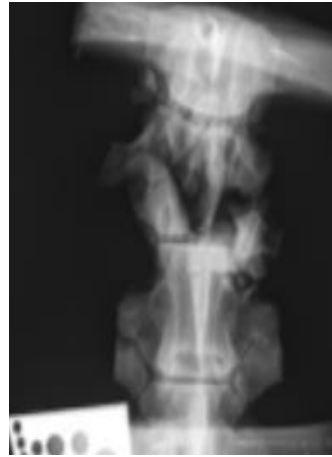
Figure 8-35 - in this figure, a, b, and c represent respectively the fracture of the vertebra body and spinous process at T13, x-ray image confirming this fracture and the force of about 3956 N that created the fracture.

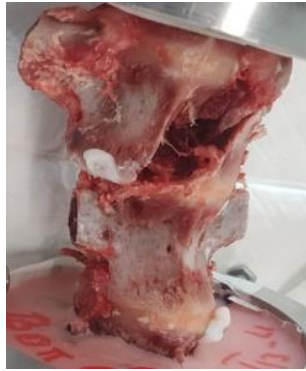
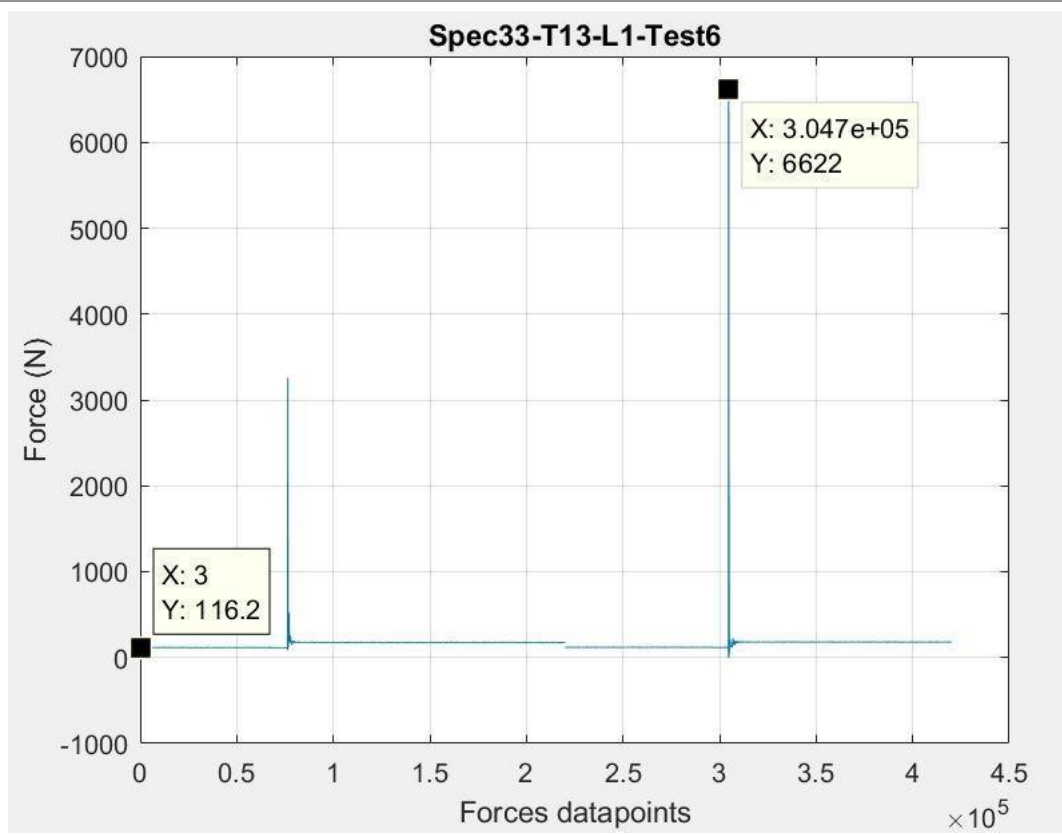
Figure 8-37 - a, b, and c indicate the burst fracture of T13 and herniation of T13-L1, x-ray image of the fracture and a force of around 6506 N respectively.

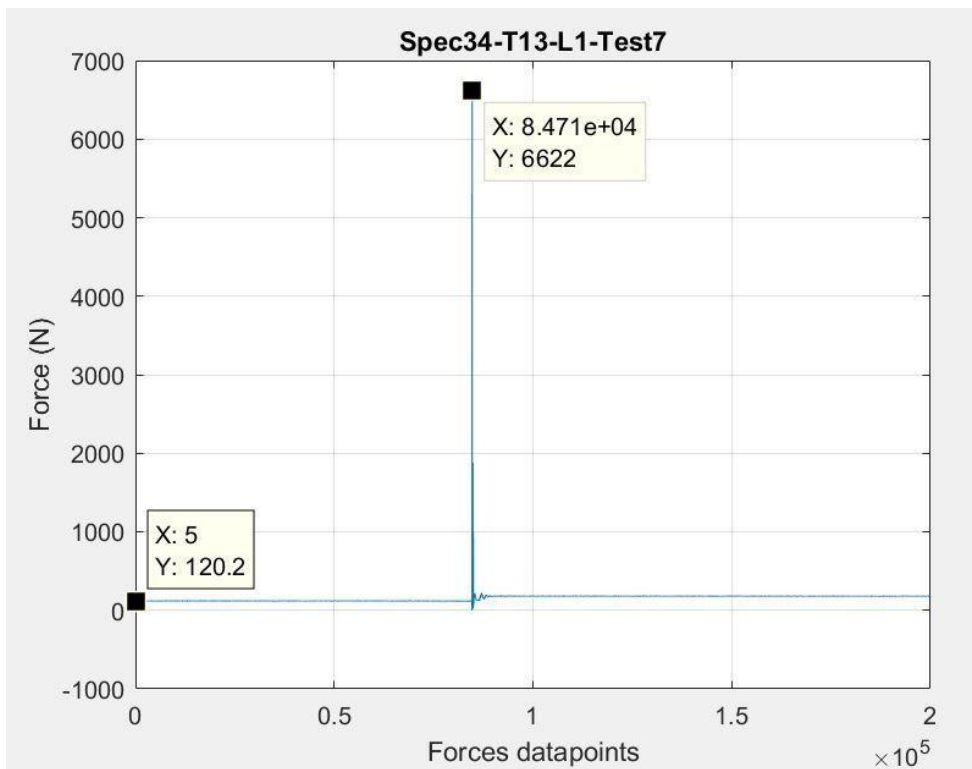
Figure 8-38 - Image a represent the burst fracture of L1 confirmed by the x-ray image b. the force of around 6502 N in graph c generated the burst fracture.

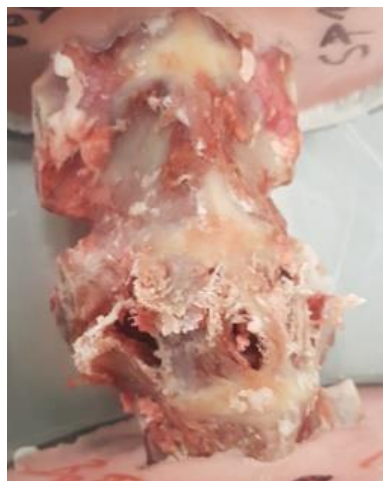
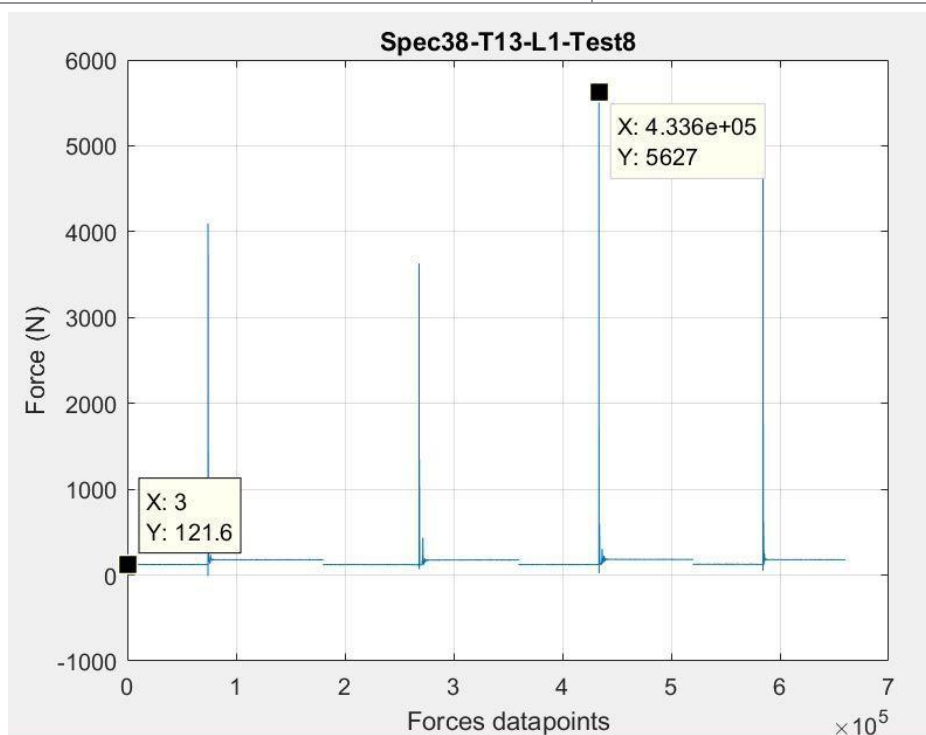
Figure 8-39 - burst fracture of L1 represented by a, b represents the x-ray image of the fracture and c represent the force of around 5506 N that created the fracture.
