Archaeology of Life in an Isolated Land

Bartholomew King

A thesis submitted in partial fulfilment of the requirements for the degree of Master of Archaeology and Heritage Management, College of Humanities, Arts and Social Sciences, Flinders University, South Australia

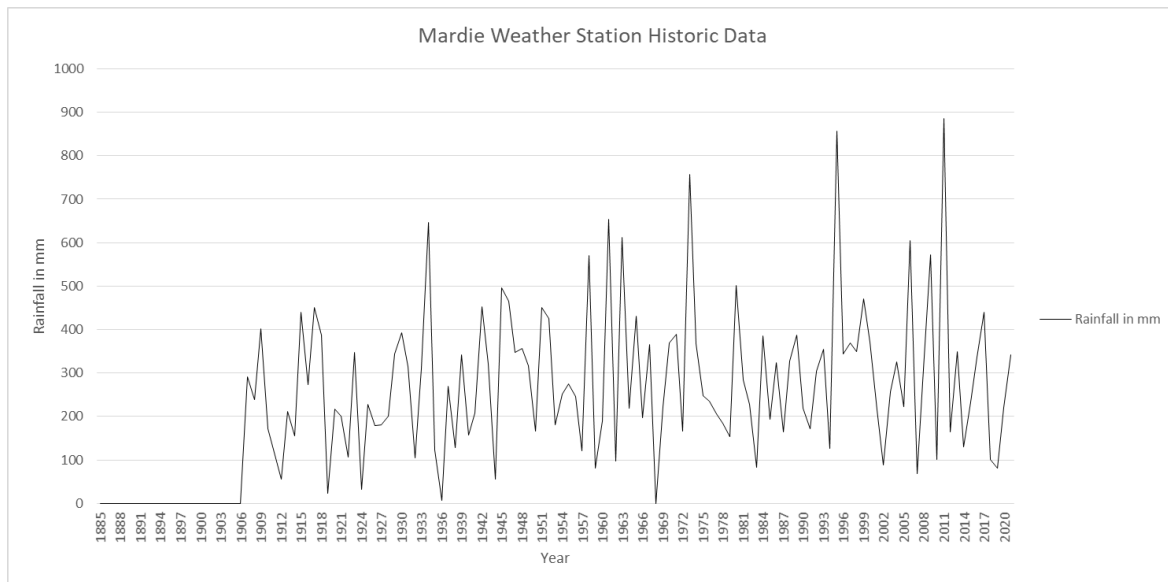
Figure 3: Annual rainfall data between 1885 and 2020

a cyclone. Two years showing greater than 800mm of rain indicates impact by at least one severe cyclone causing long term flooding. The rainfall data has been graphed (Figure 3) to demonstrate the variability and shows that, on average, the region was affected by one cyclone a year, interspersed with years of no cyclonic activity.

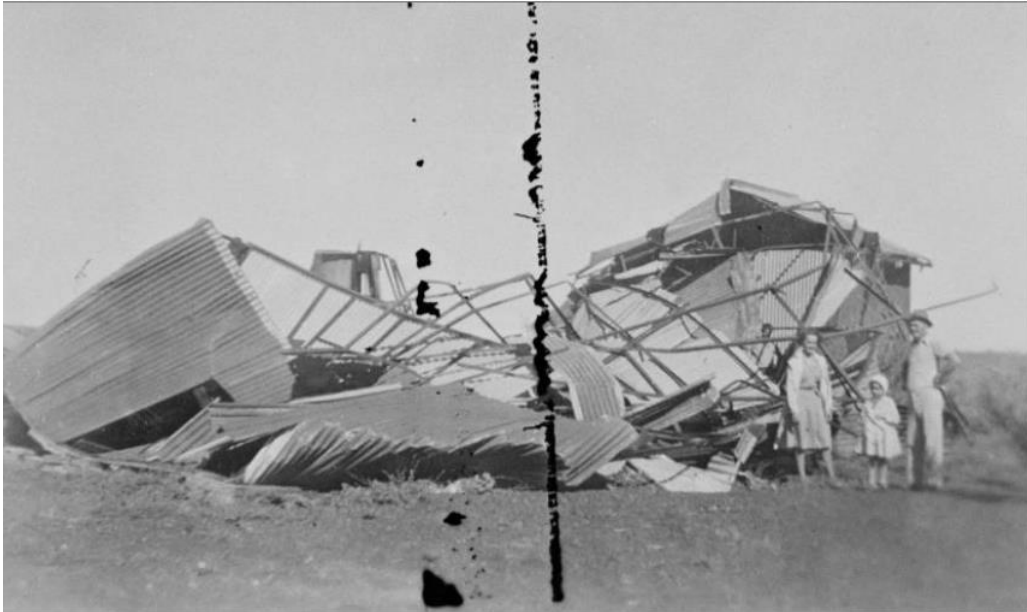
Figure 4: Balmoral Station dining hall after 1945 cyclone.

gauge to determine the volume of rain that impacted the area. The most well-known cyclonic event to hit Mardie and Balmoral stations, however, was the cyclone that impacted the Pilbara in early 1945. This cyclone was not formally named, but destroyed or damaged every building in Roebourne and most buildings across the region (Australian Bureau of Meteorology 2019; West Australian 1948:19). Figure 4 to Figure 11 show the significant damage caused to the Balmoral homestead, shearing shed and shearer's kitchen/dining hall, none of which was rebuilt until 1952:

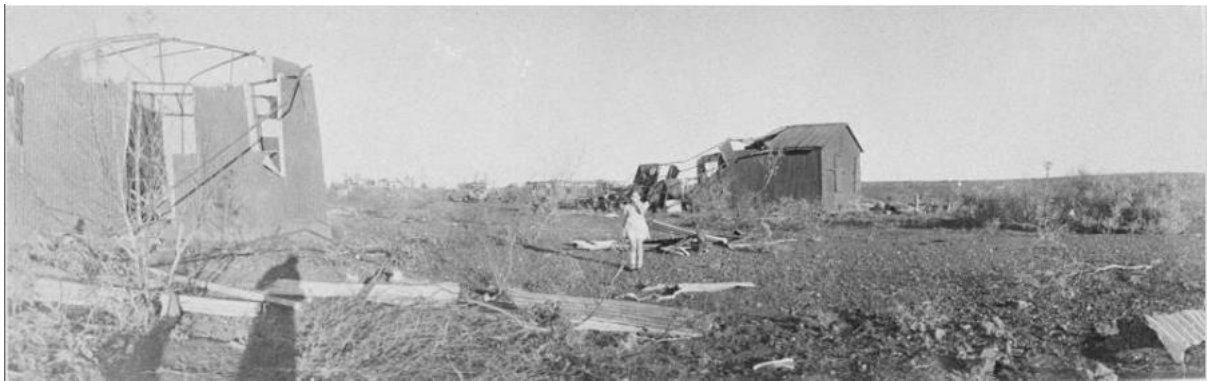
Figure 5: Balmoral Station shearers' quarters and dining room after 1945 cyclone. All structures in photograph demolished after cyclone.

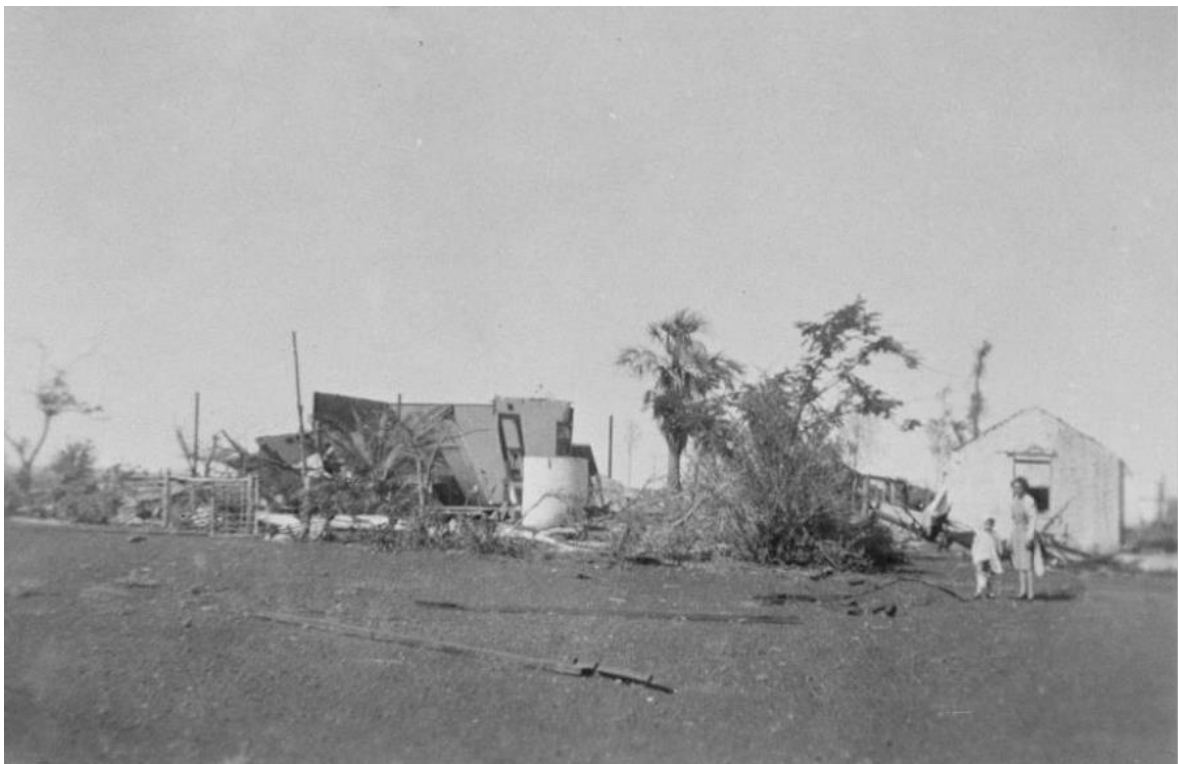
Figure 7: Balmoral homestead (left) after 1945 cyclone. Generator shed still intact (right).

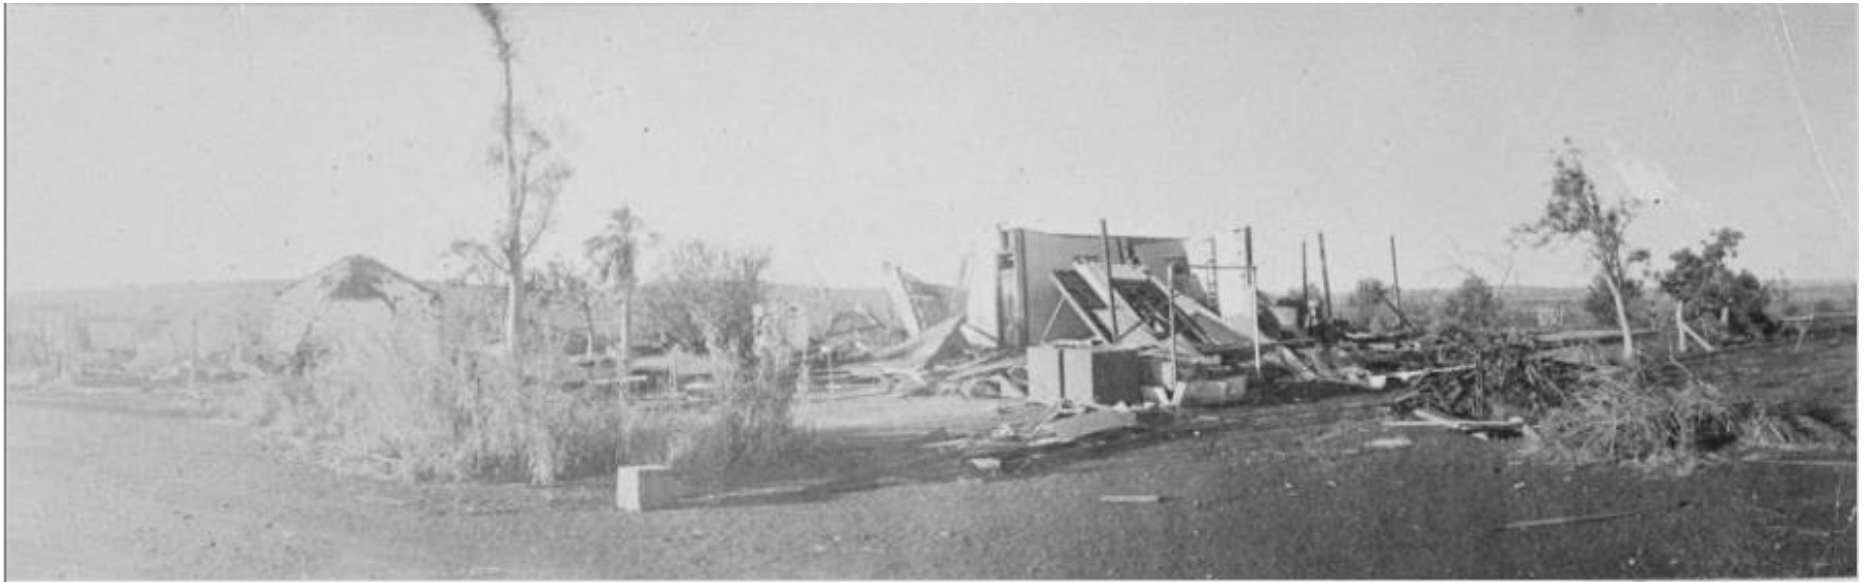
Figure 11: Panoramic photograph of Balmoral homestead indicating the degree of damage and its location in the landscape.

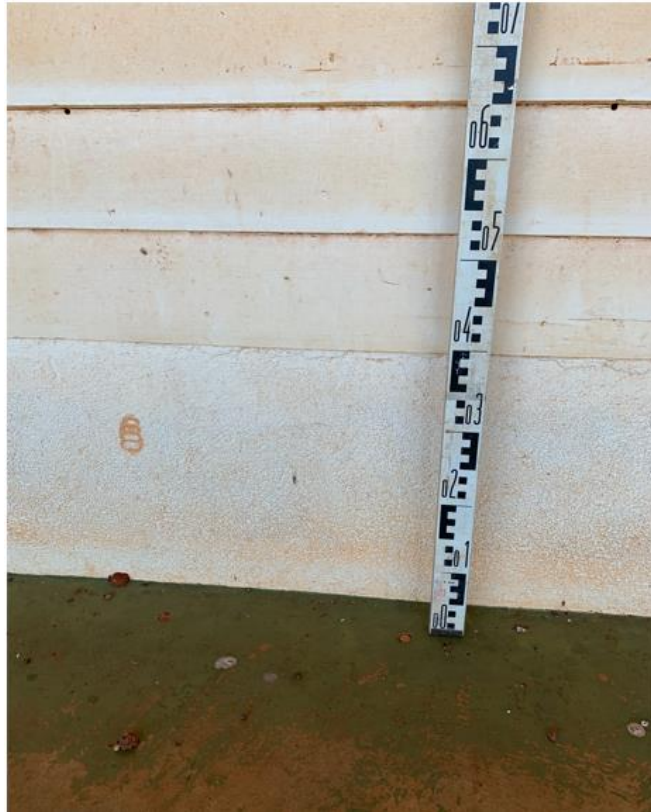
Figure 16: Height of concrete walls at Balmoral homestead (Photograph: Bart King).

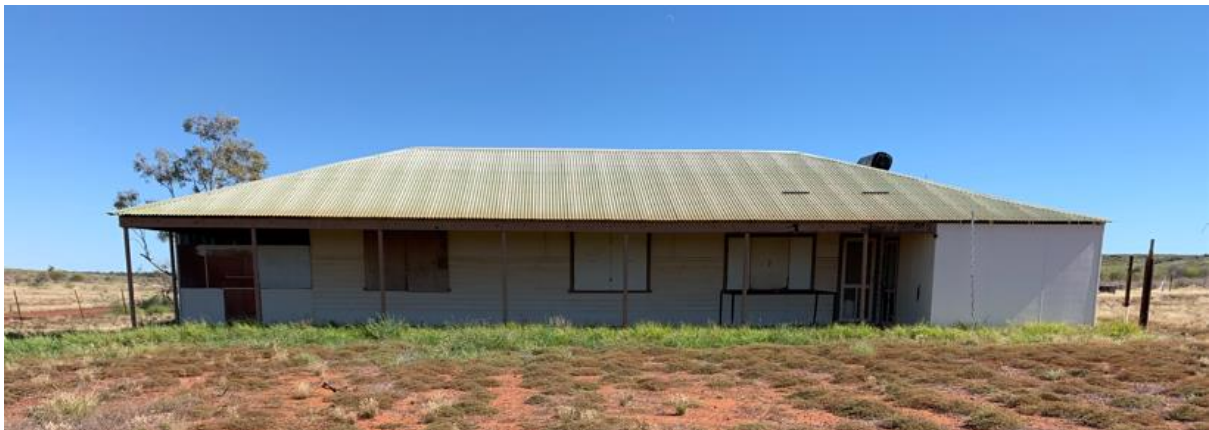
Figure 17: Balmoral homestead roof design (Photograph: Bart King)

The Balmoral homestead (Figure 15) has a corrugated iron hip roof (Figure 17), although the internal structures of the roof could not be assessed as it is cladded with asbestos sheeting. The homestead building has a concrete slab that protrudes from the ground a maximum of 40cm on the eastern side of the house. As the building is on a slight slope, the western side of the house has the slab only slightly raised at 20cm. The building has a 40cm high concrete base on each wall, including internally (Figure 16). These bases are made using local dolerite stone as an aggregate, with a smooth render placed over the top (Figure 18).

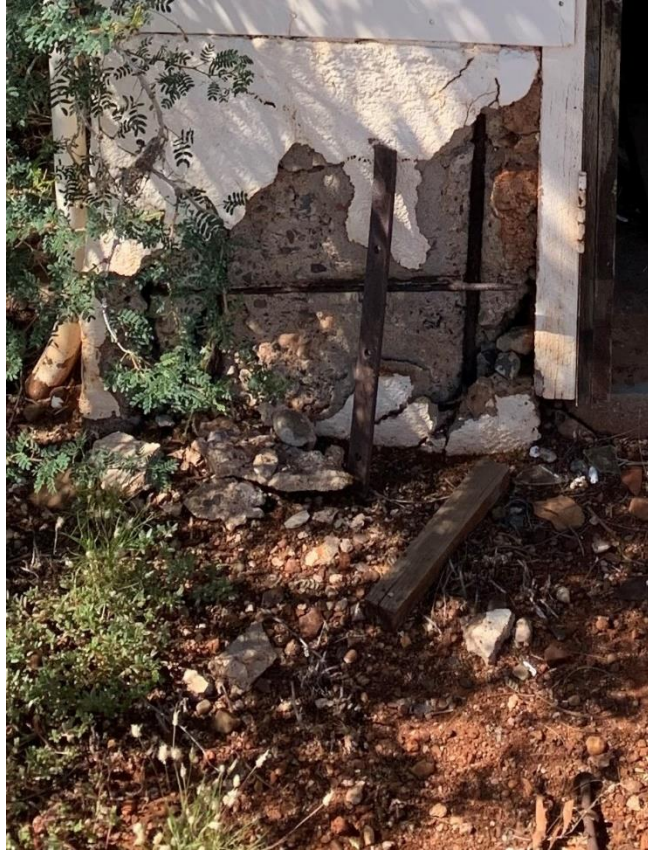
Figure 18: Concrete section of walls made up of reinforced concrete and render. (Photograph: Bart King)

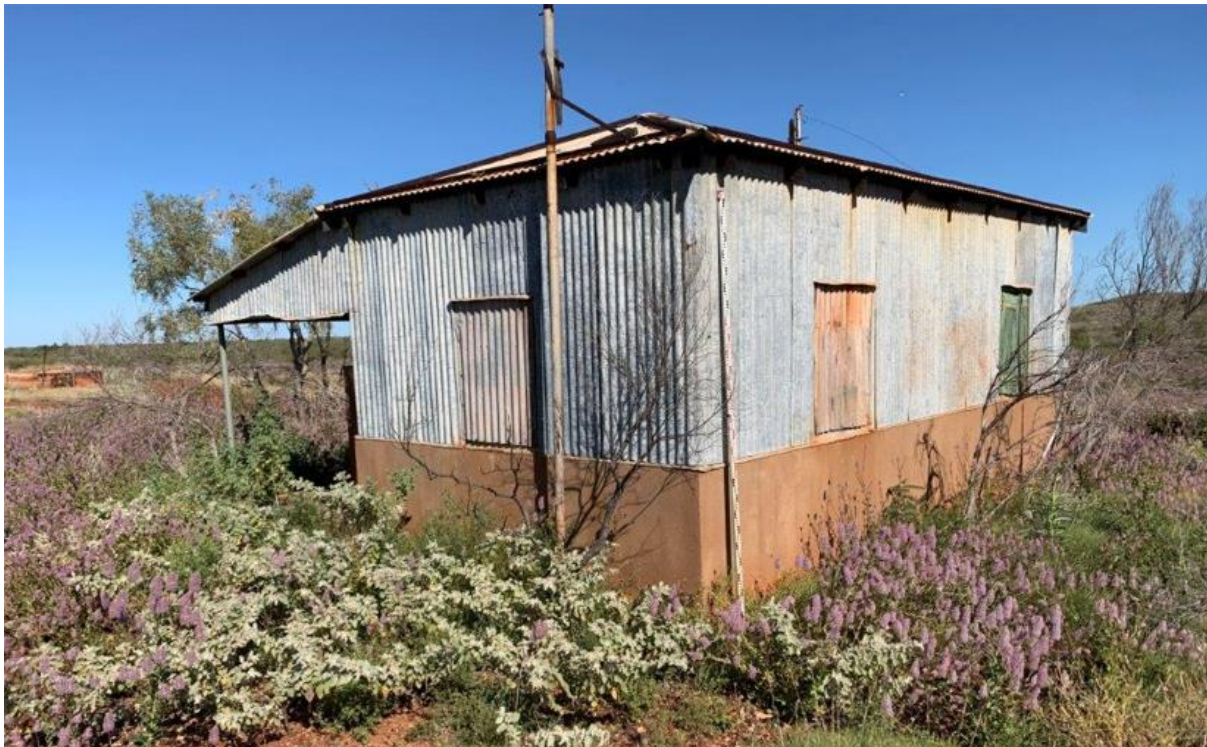
Figure 19: Balmoral supervisor's building showing hipped roof and window shutters. (Photograph: Bart King)

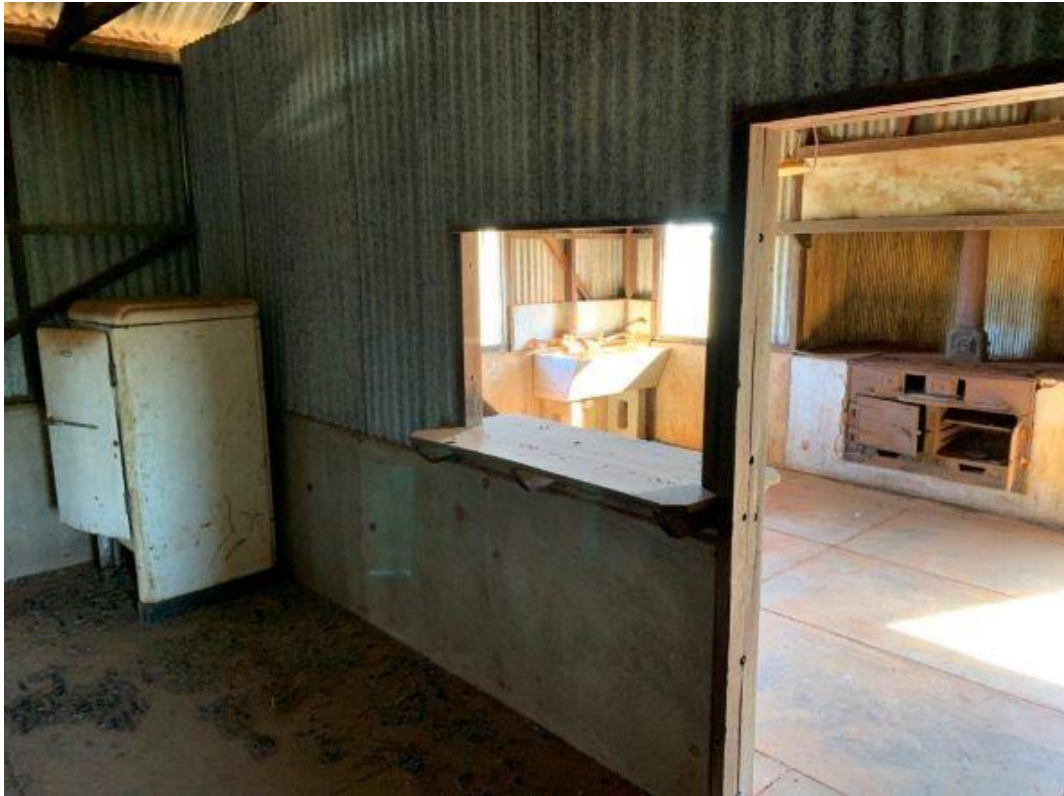
Figure 22: Servery in wall and wood fired, cast iron oven. (Photograph: Bart King)

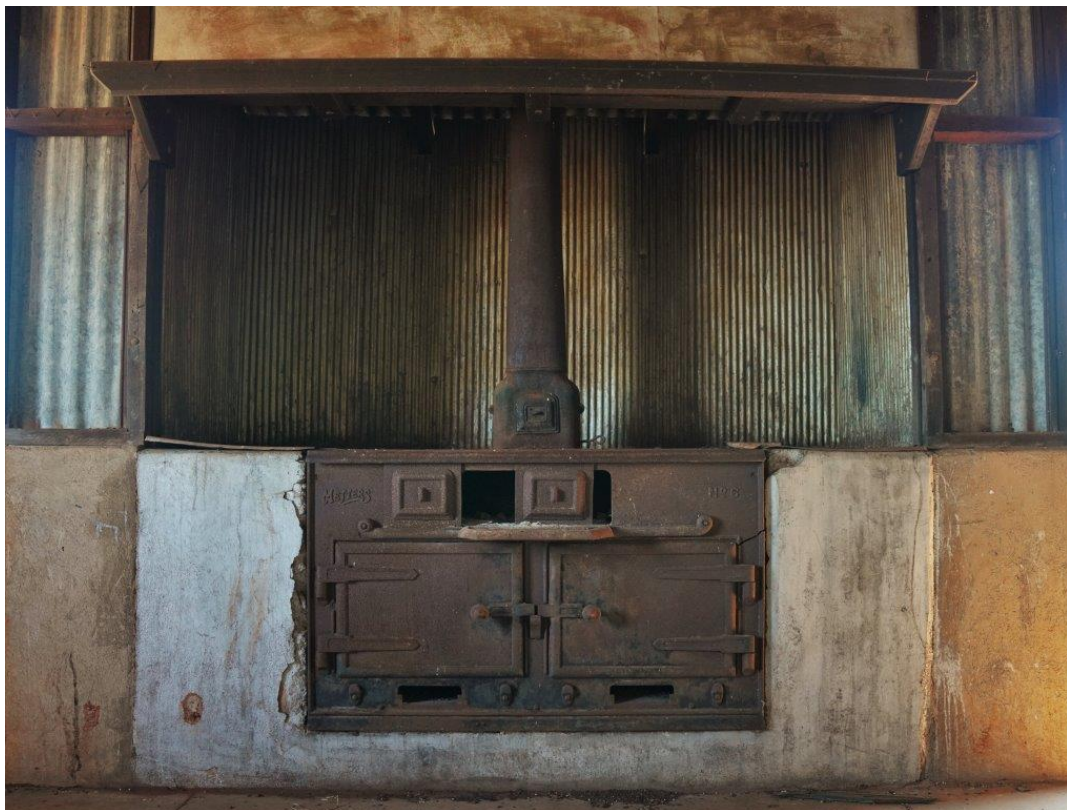
Figure 23: Metters wood fired oven at Balmoral dining hall. (Photograph: Gary Blinco)

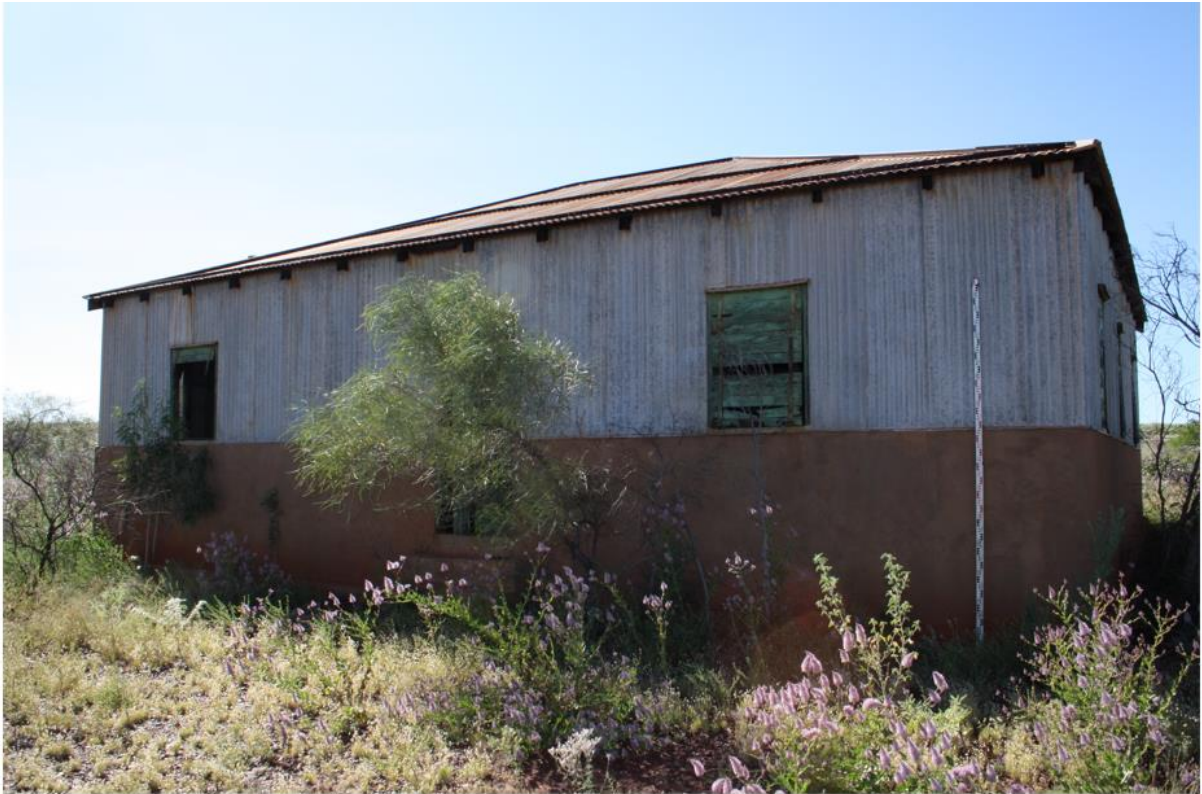
Figure 24: Balmoral dining hall western side. 1.6m concrete wall. (Photograph: Bart King)

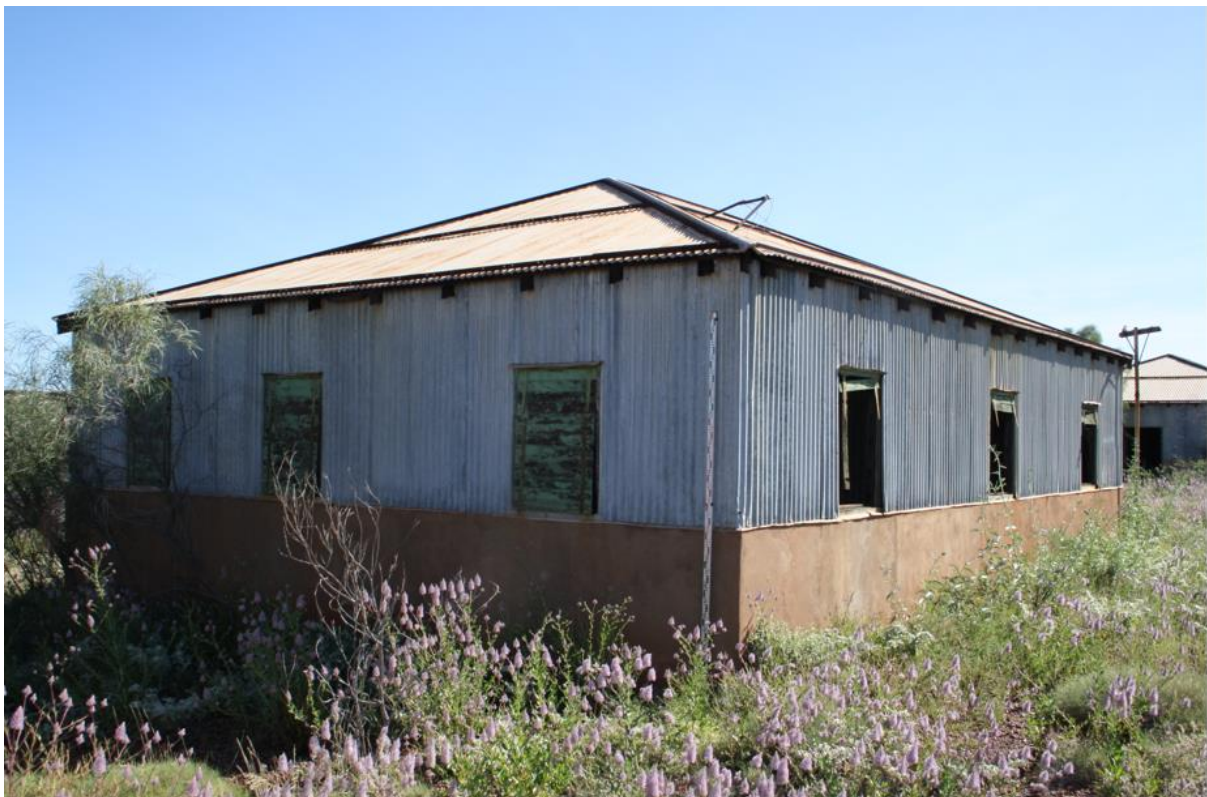
Figure 25: Balmoral dining hall eastern side. 1.2m concrete wall and roof layout. (Photograph: Bart King)

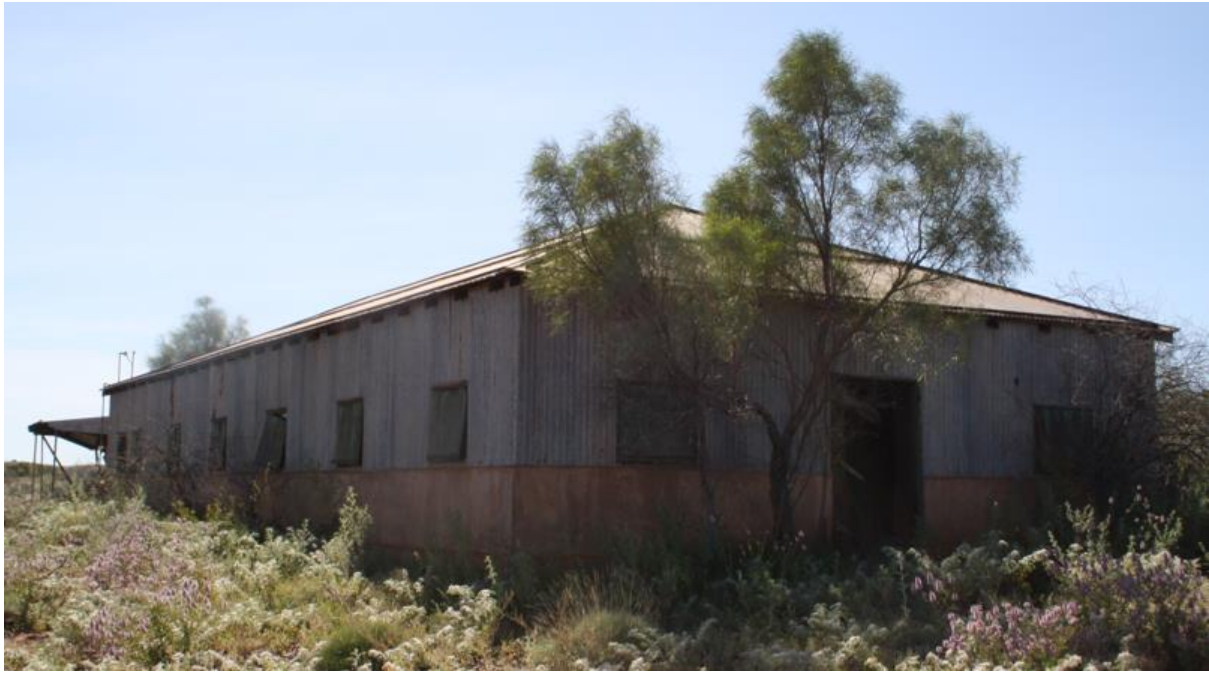
Figure 28: Shearers' quarters roof design (Photograph: Bart King)

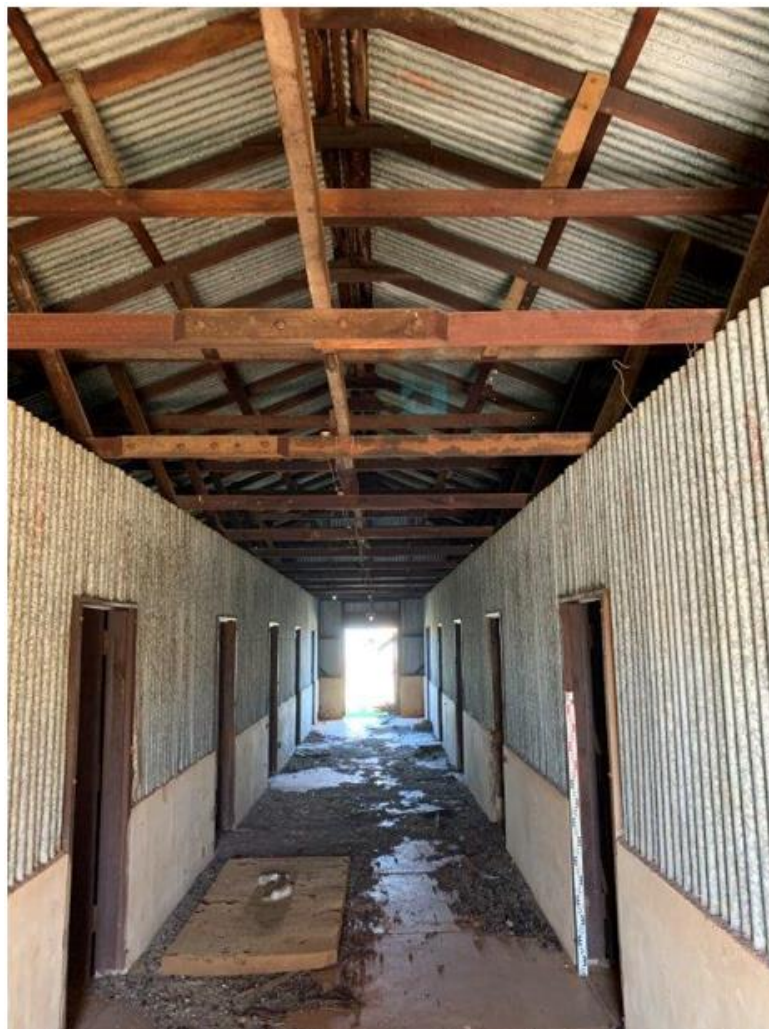
Figure 29: Balmoral Shearers' quarter's roof truss layout. (Photograph: Bart King)

The ten identical rooms line up from the southern end of the building and all open out onto the central hallway (Figure 29 and Figure 30). These were all bedrooms, some of which still contain steel bed frames, but no other furniture. The room in the north-west corner is a shower room with three cubicles and timber benched wash basin on the western wall (Figure 31 and Figure 32). The room on the north-east is suspected to be a storage room. The only identifying factor in this room is some coat hooks on the walls. This space could have been used for saddle or general equipment storage. There are no other rooms or buildings in the precinct that indicate storage for shearers' or stockmen's general equipment. This building has also been utilised by kangaroos in an attempt to cool down during summer, indicated by the droppings and deceased kangaroos.

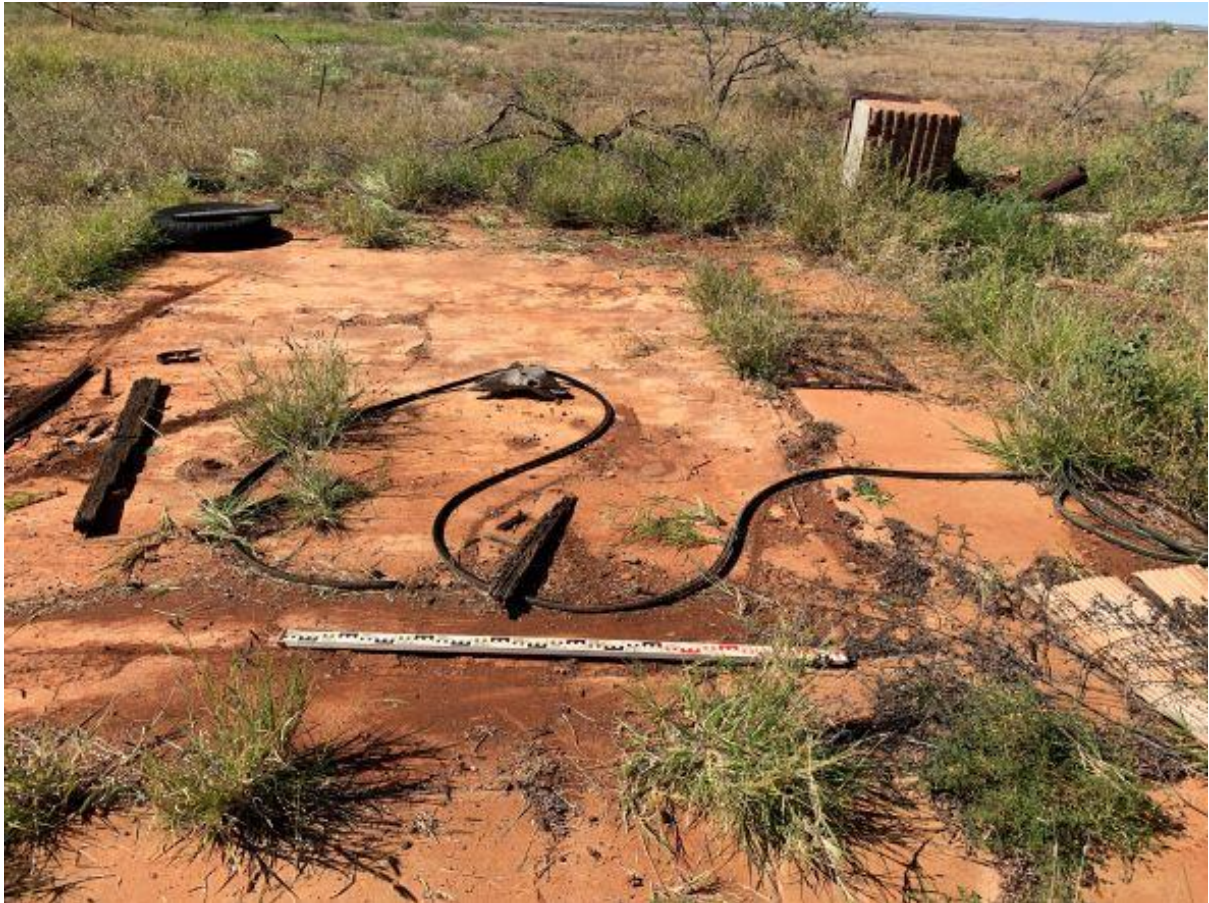
Figure 36: Concrete slab of Indigenous house with timber, metal fasteners and corrugated iron. (Photograph: Bart King)

The concrete slab is scattered with items that were once been used in the building's construction. Corrugated iron sheets that match the corrugation in the outside of the concrete slab and in the concrete around the oven are scattered around the slab. Pieces of timber with signs of termites are on the slab, with nails and fastening bolts scattered throughout (Figure 36).

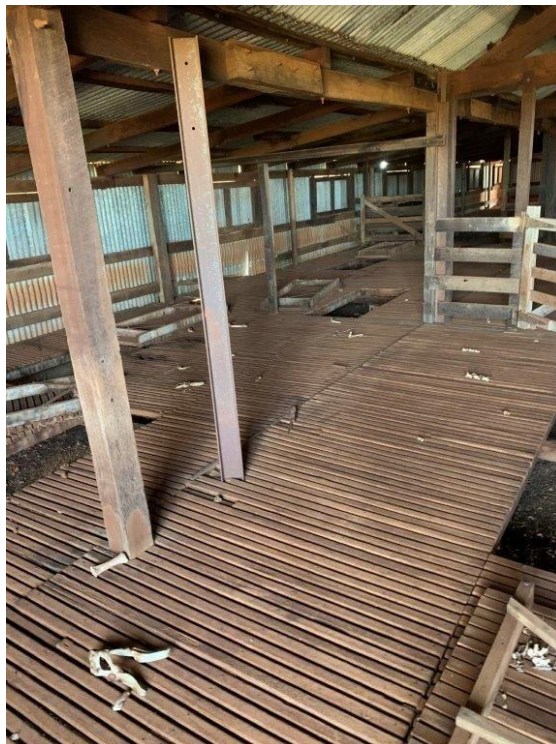
Figure 44: Catching pen area with removable floor panels (photograph: Bart King)

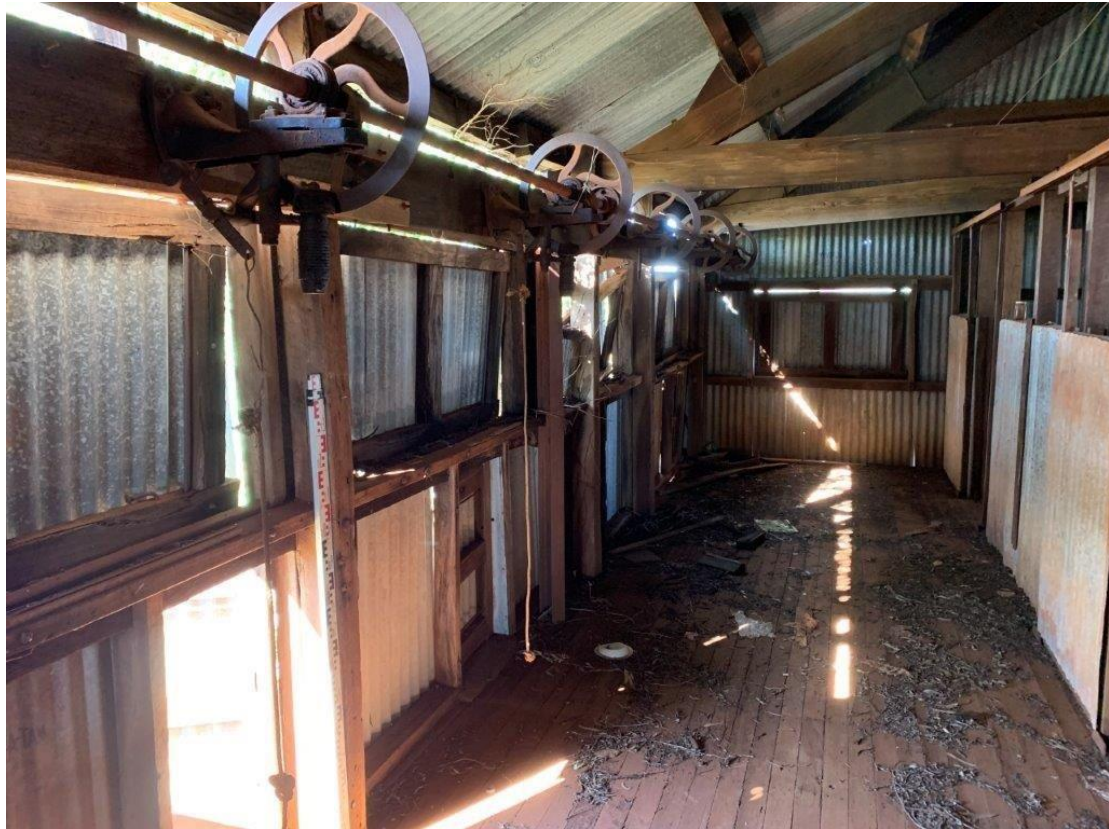
Figure 45: Shearing floor with overhead shaft drive for shears (photograph: Bart King)

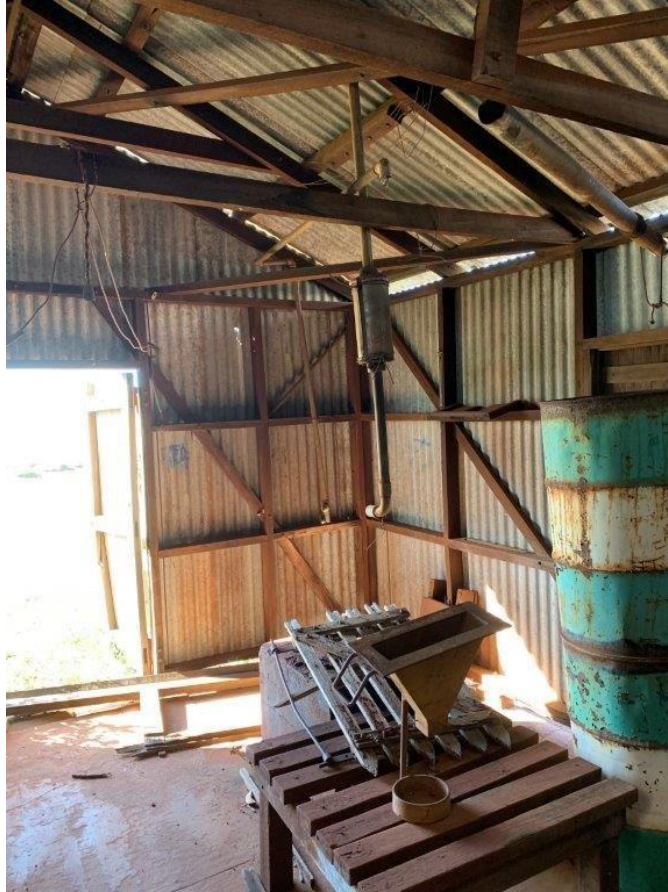
Figure 46: Engine room showing slab that engine was mounted on and exhaust still in place. (Photograph: Bart King)

On the eastern side of the building is the engine room and shear sharpening area. This room contains a concrete pedestal that supported the engine that drove the shaft for the shears. The wool cleaning and classing area is all concrete floored, while the rest of the building has a raised timber floor. This is a standard design in shearing sheds, allowing sheep droppings to fall through widely spaced timber slats. The roof and wall supports and frames are all timber, with a corrugated iron outer.

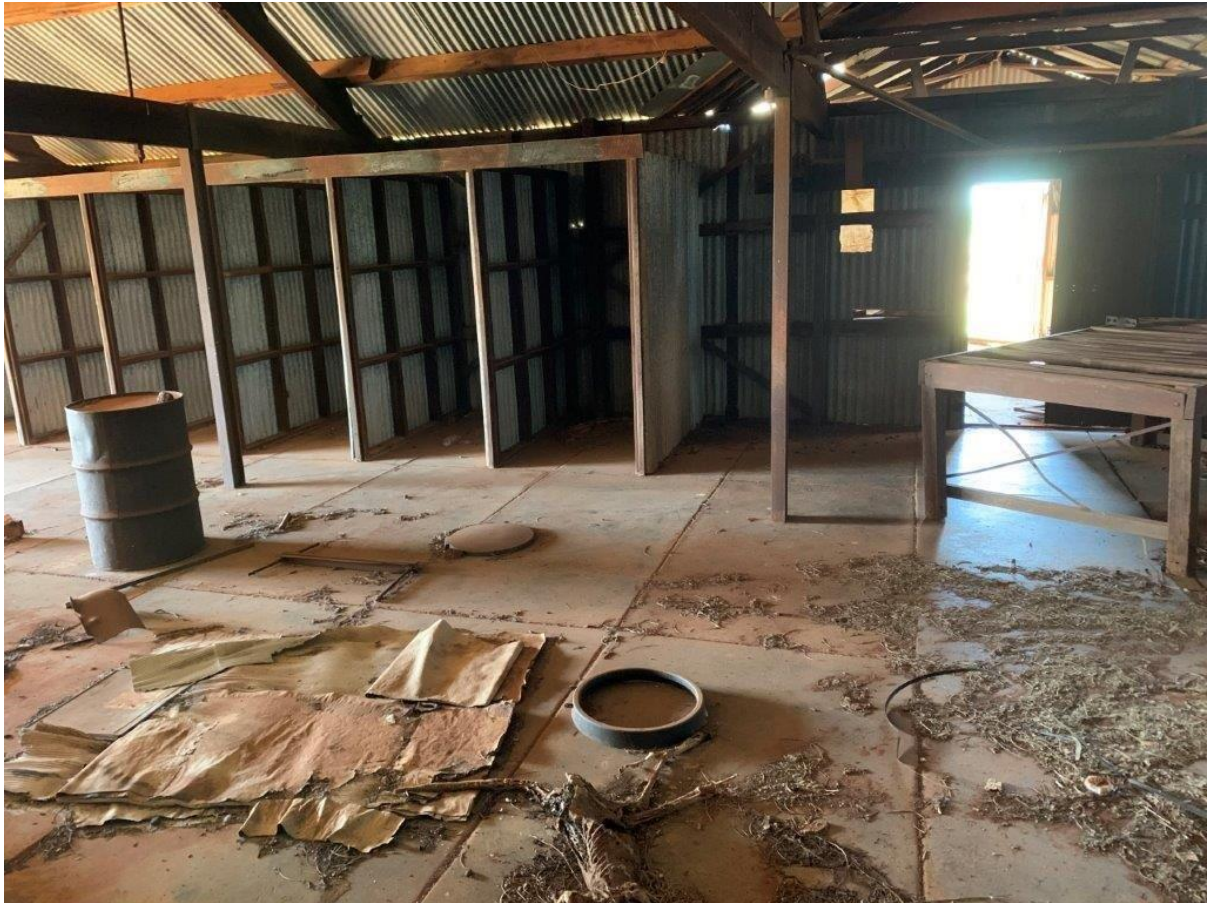
Figure 47: Wool bin with wool table area in the foreground. (Photograph: Bart King)
