CHAPTER FIVE

TORPEDO STATIONS AND TORPEDO STATION ABANDONMENT IN AUSTRALASIA, 1885-1924

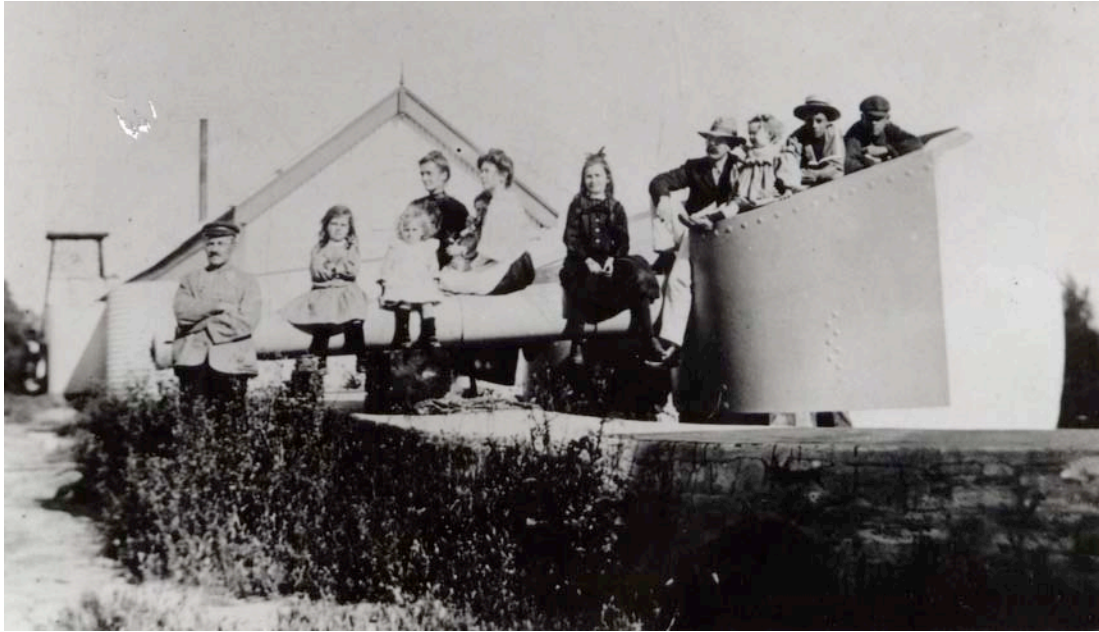
Figure 10. Undated photograph showing the Perry family and guests posing with the EOC/Armstrong cannon at the North Arm Torpedo Station. The workshop/storeroom building and water tower are visible in the background. Image courtesy of Jan Perry.

During his 2004 survey of the site, Wimmer (2008: 35-36) noted the presence of a large concrete object he postulated was a portion of the pedestal or platform that once accommodated the Armstrong cannon. Part of this structure is visible in at least one archival photograph of the torpedo station (see Figure 10) and appears fairly robust—an attribute that would be expected, given the gun's five-tonne (5,080-kilogram) weight. When documented in 2004, the concrete feature was completely exposed above ground (it would have been almost completely buried when in use) and located on the southwest side of the tramway, directly opposite the Armstrong gun's original position at the torpedo station. Wimmer (2008: 35) hypothesized it was dug up as a consequence of 'brine pipe trench construction' and subsequently 'broken up and rolled or dragged clear' to the other side of the dirt track.

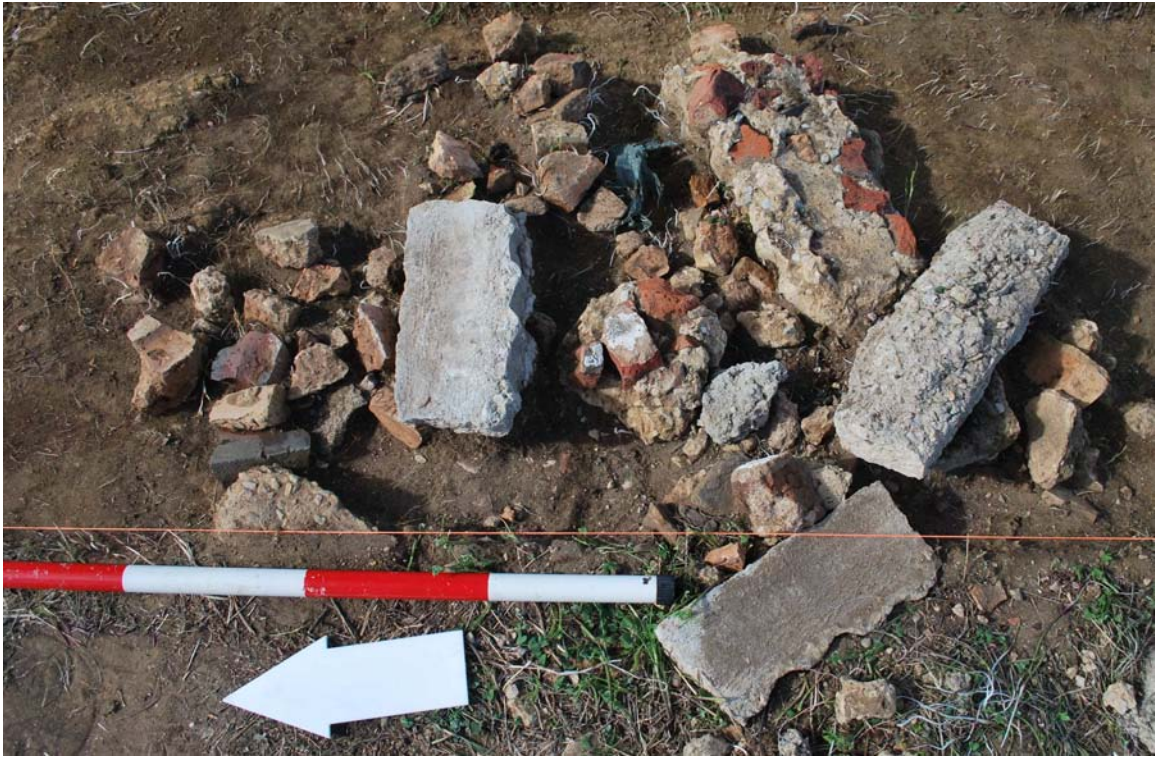
Figure 13. Surface scatter of building rubble within Trench 2, showing concrete fragments with corrugated sheet metal impressions. Scale in 20-centimetre increments.

December 1917 (NAA: D292, 14/1/3, pt. 1, SA 17/7015). Included among the items transported from the site were approximately 130 sheets of galvanised iron cladding, 64 of which were subsequently reused in the construction of a Naval Guard shelter overlooking Port Adelaide's Outer Harbour. What remained was incorporated in the refurbishment of a Naval Guard house in the South Australian coastal town of Port Pirie (NAA: D292, 14/1/3, pt. 1). During his survey, Wimmer (2005: 49, 2008: 35-36) observed that the only visible evidence of any of the station's corrugated metal structures was a drastic change in sediment colour and consistency at the projected boundary between the tramway footprint and the western wall of the main building/caretaker's cottage. It was at this point that the 'dark grey colouration' of a fine-grained ash layer associated with the tramway 'stopped abruptly along a straight line' and changed to sediment of much lighter colour and coarser composition (Wimmer, 2005: 49, 2008: 36).

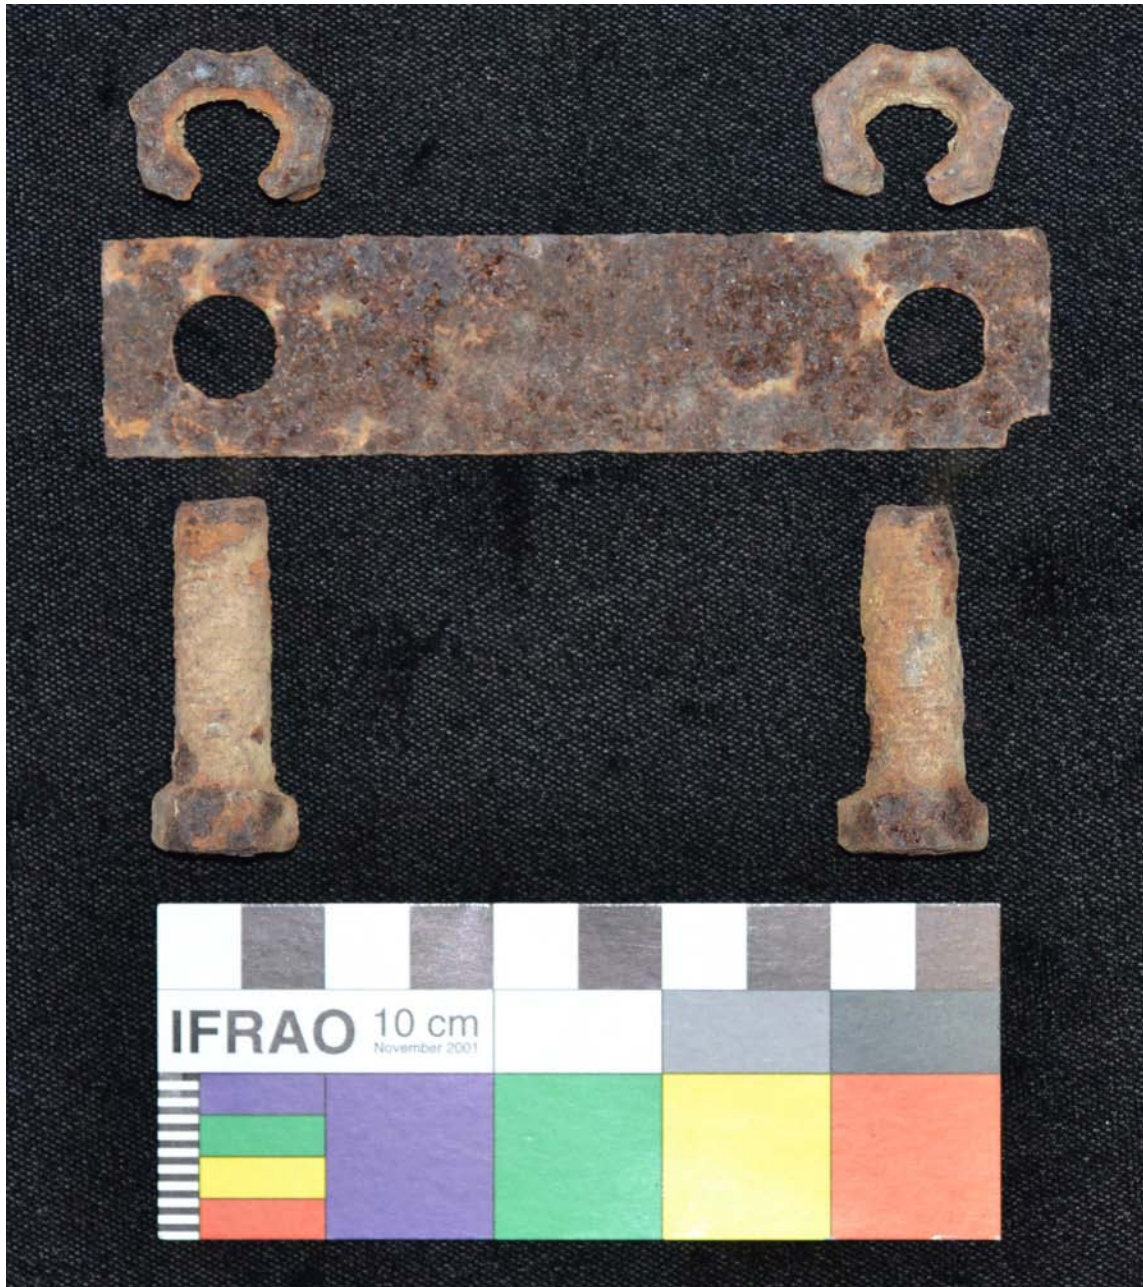
Figure 14. Iron hardware used to fasten structural elements of the torpedo station's main building/caretaker's cottage to one another. Note that both nuts have been intentionally broken. Scale in centimetres.

Additional evidence of efforts to dismantle wood-framed/corrugated metal structures at the North Arm Torpedo Station was noted through the presence of other forms of material culture. During the 2010 investigations, six identical threaded iron bolts were recovered from Trench 2 within a hypothesized demolition layer associated specifically with the caretaker's cottage. All were found in direct association with a concentration of building rubble (including fragmented brick, mortar, and stone) and broken historic artefacts, including window and bottle glass, and ceramics. Hardware associated with the bolts was also recovered, including three iron nuts and two thin iron plates (Figure 14). The threaded openings in each nut correspond exactly to the shaft diameters of the bolts, as do a

pair of holes situated at either end of the plates. Interestingly, all three nuts have been 'opened' (i.e., broken) as a consequence of one or more strikes from a cold chisel or similar implement.

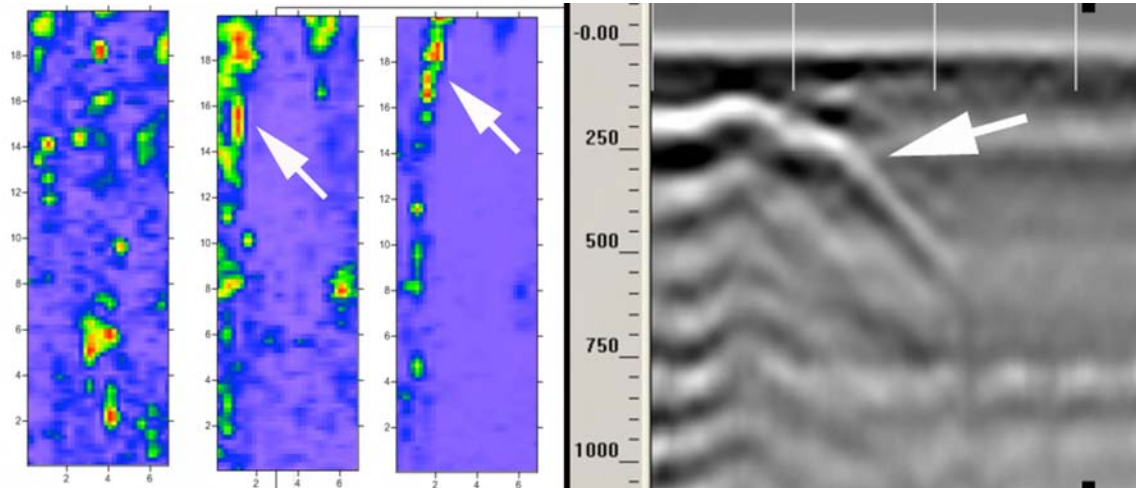
Figure 16. Ground Penetrating Radar imagery of the North Arm Torpedo Station's earthen embankment (indicated by arrows). *Left*, plan view, showing the embankment as a linear feature captured at 20-centimetre depth intervals; *right*, profile view, showing angled southern face of embankment. Images courtesy of Dave Ross.

Results of a GPR survey within the sand brick magazine's projected footprint revealed the presence of a linear feature that exhibited attributes consistent with a wall (Figure 16). Initially, this appeared to justify Wimmer's hypothesis; however, subsequent excavation within Trenches 1 and 3 revealed the linear feature actually represented the top and side of the earthen embankment's southern face. While the embankment ultimately proved to be a dominant feature of the site (see below), identifiable articulated remnants of the magazine's foundation and/or walls were clearly absent from both excavated areas. Even the addition of multiple extensions to Trench 3 along the magazine's proposed footprint failed to uncover evidence of intact structure (Figure 17).

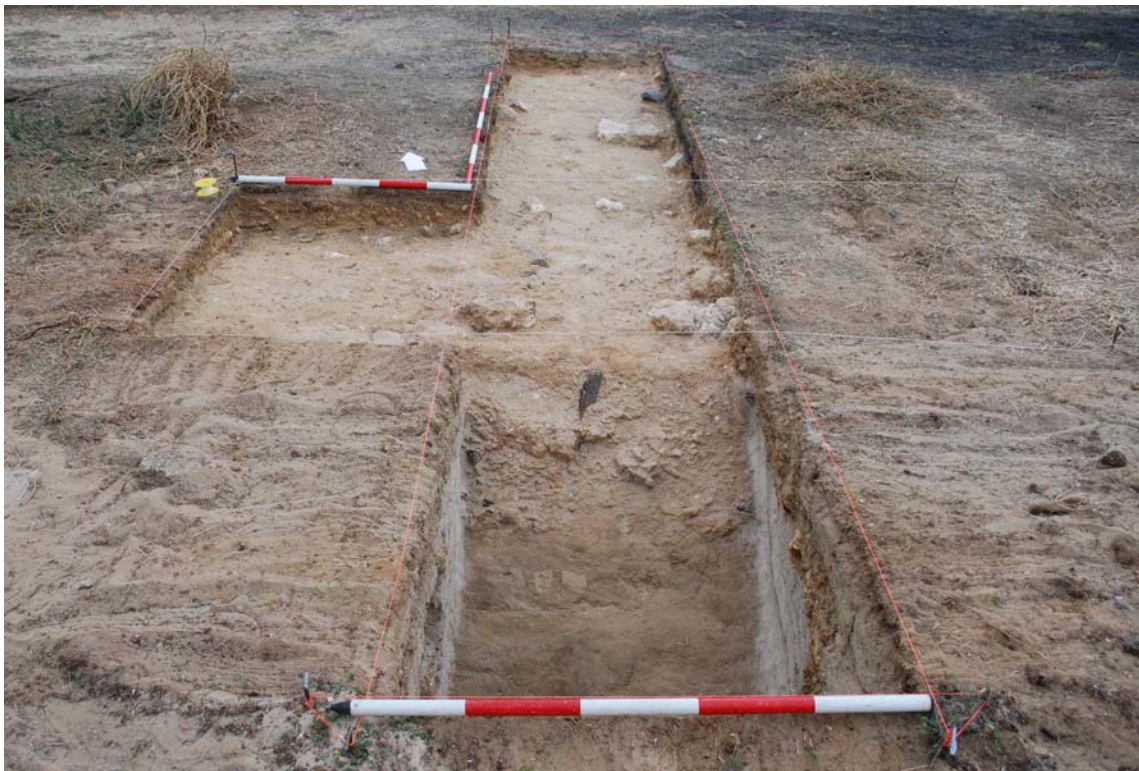
Figure 17. Overview of Trench 3 at fullest extent of excavation, showing the original land surface atop the North Arm Torpedo Station's earthen embankment. Note the absence of identifiable articulated structure associated with the station's sand brick magazine, as well as the southern edge of the embankment (in foreground). Multiple fragments of calcrete (generated as a byproduct of modern soda ash production) are visible atop the embankment along the eastern wall of the trench. Scale in 20-centimetre increments.

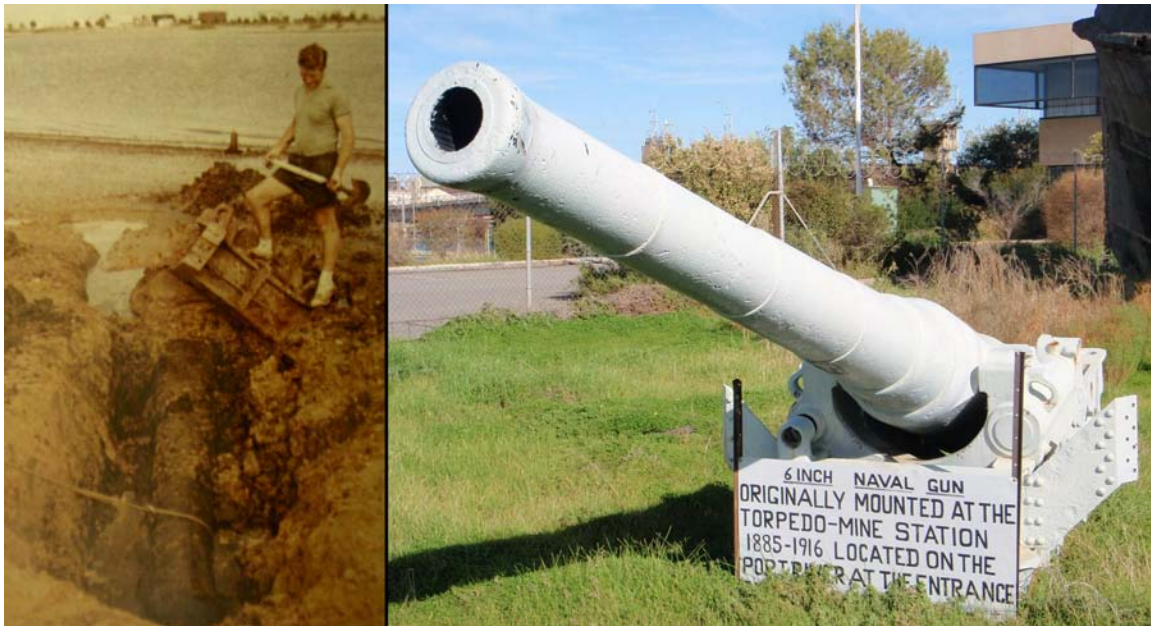
Figure 20. *Left*, the North Arm Torpedo Station's EOC/Armstrong gun embedded in the foreshore fronting the torpedo station site, ca. 1961; *right*, the Armstrong gun at its current location in Birkenhead, South Australia. Image at left courtesy of the Port Adelaide Historical Society.

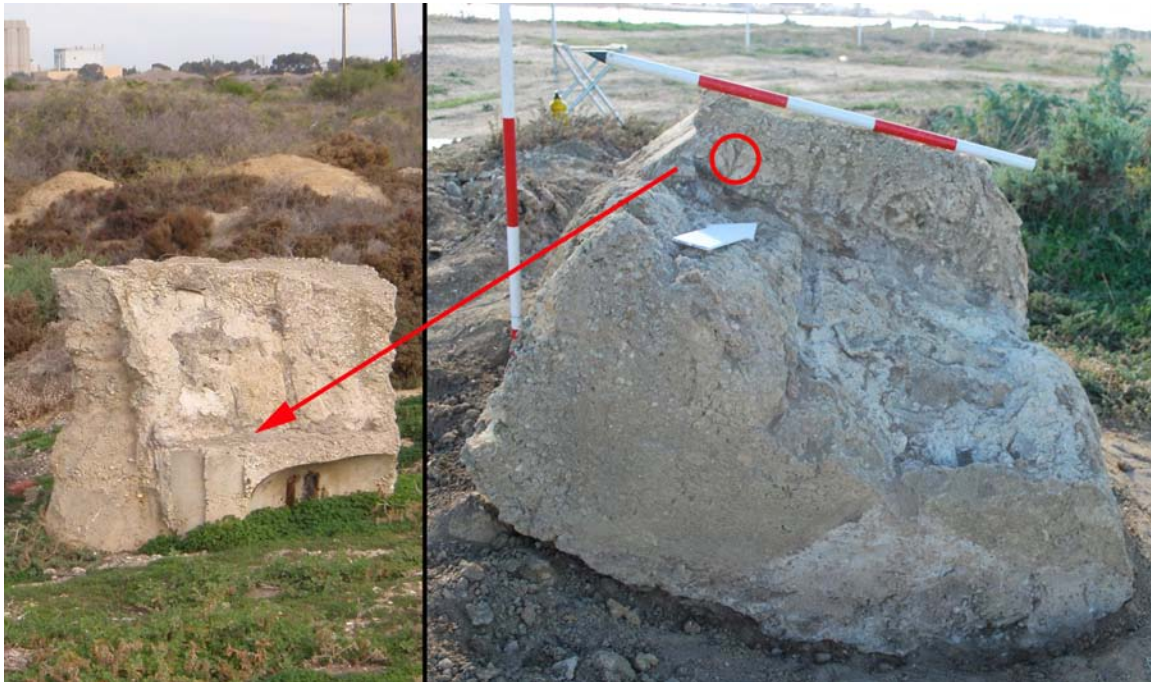
Figure 21. The surviving section of the EOC/Armstrong gun pedestal as it appeared in 2008 (*left*) and 2010 (*right*). The Broad Arrow device is circled; the red arrow indicates the location of the Broad Arrow and other inscribed characters on the pedestal when it was upright. Scale in 20-centimetre increments.

Between 2008 and 2010, this object was moved further away from the tramway footprint and tipped on its side, almost certainly via the use of heavy equipment (Figure 21). As a result of this process, formerly intact portions of its concrete structure were either broken or removed entirely. In an effort to mitigate further data loss stemming from potential future on-site development activities, its surviving elements were cleaned and documented during the 2010 investigation. Attributes uncovered during this process included approximately half of an iron-lined, capsule-shaped depression that was identified as the recess that accommodated the heavy iron counterweight attached to the base of the Armstrong gun. Additionally, a wooden sleeper and two wooden wedges utilised in the object's manufacture were noted, as was a crude inscription that appears to include a British 'Broad Arrow' device (see Figure 21).

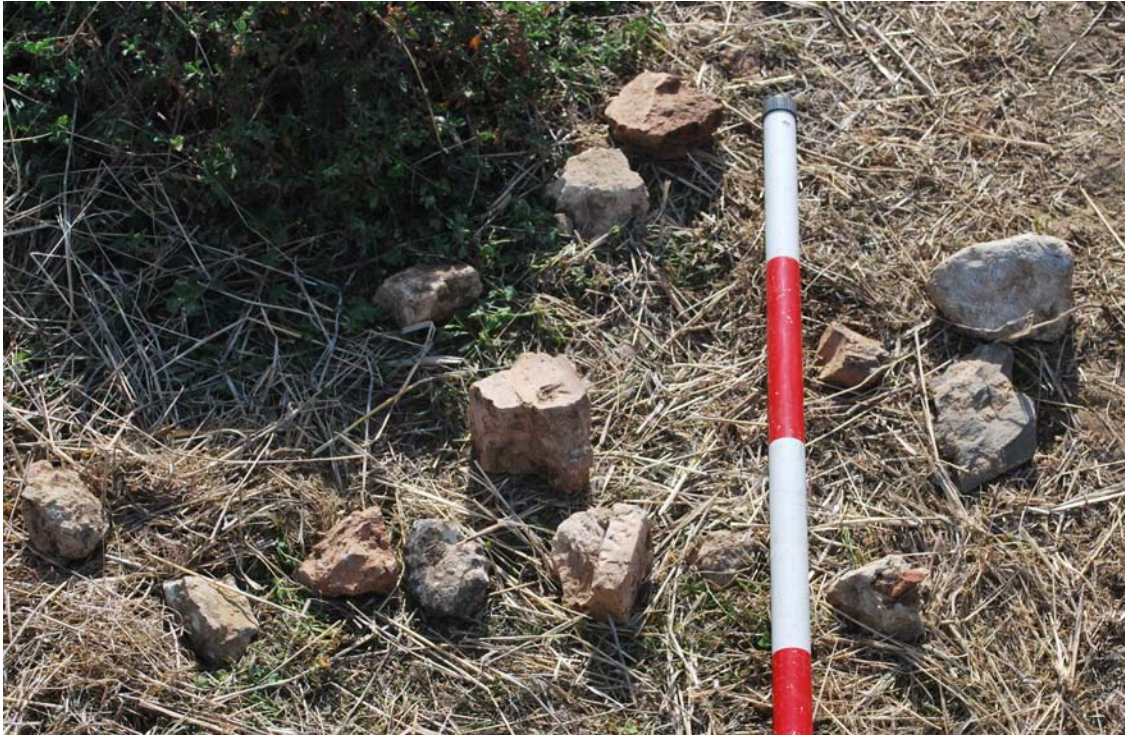
Figure 22. Cluster of broken brick and concrete immediately adjacent to the brine main footprint that transits the northern periphery of the torpedo station's earthen embankment. Scale in 20-centimetre increments.

Both the 2000 and 2004 surveys recorded the presence of broken masonry in isolated scatters or clusters at several locations along the site's western and northern peripheries (Figure 22). The majority of this assemblage comprised red brick, and almost all diagnostic examples were later identified as having been manufactured after the torpedo station's closure (Treloar and Treloar 2001: 9; Wimmer 2005: 45-46, 2008: 31-33). Other forms of building material, including concrete debris that may have been associated with the installation's water tank stand and gunner's store foundation, were noted approximately halfway along the length of the embankment's northern side. Like the gun pedestal, these structures appear to have been abandoned largely *in situ*, only to be later uprooted and broken up during installation of the brine main (Wimmer 2008: 34).

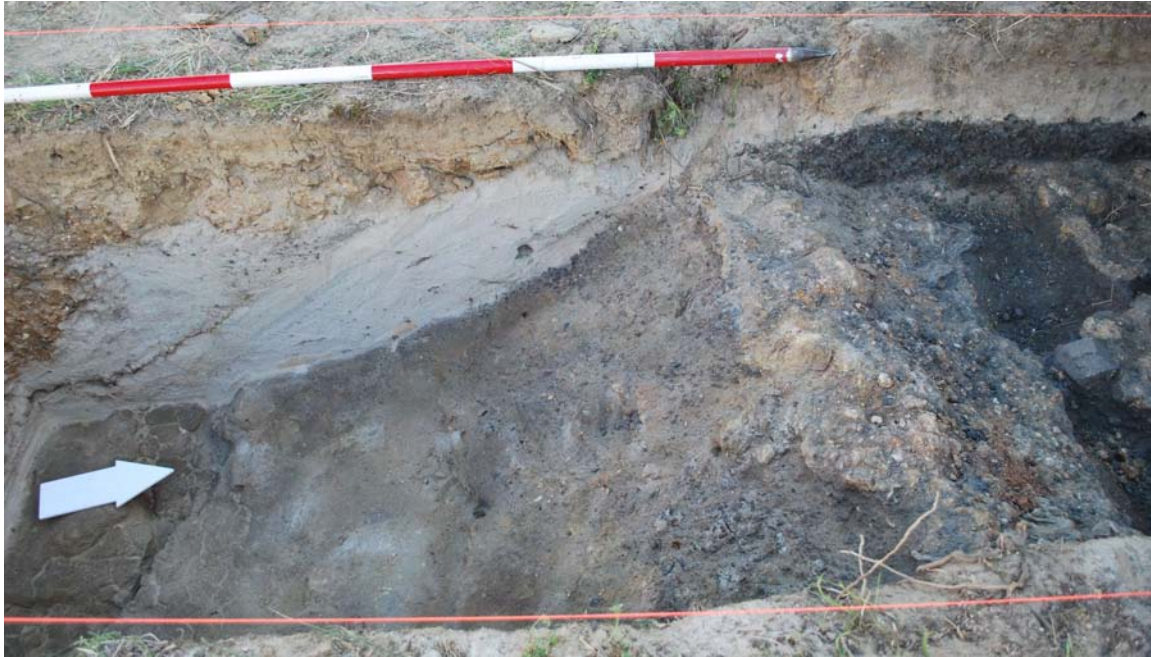
Figure 23. The western profile of Trench 1 at extent of excavation, showing the earthen embankment and successive layers of infill material—including multiple layers of wind- and waterborne beach sand—deposited over it. Note dark-coloured tramway bed deposit at far right of photograph. Scale in 20-centimetre increments.

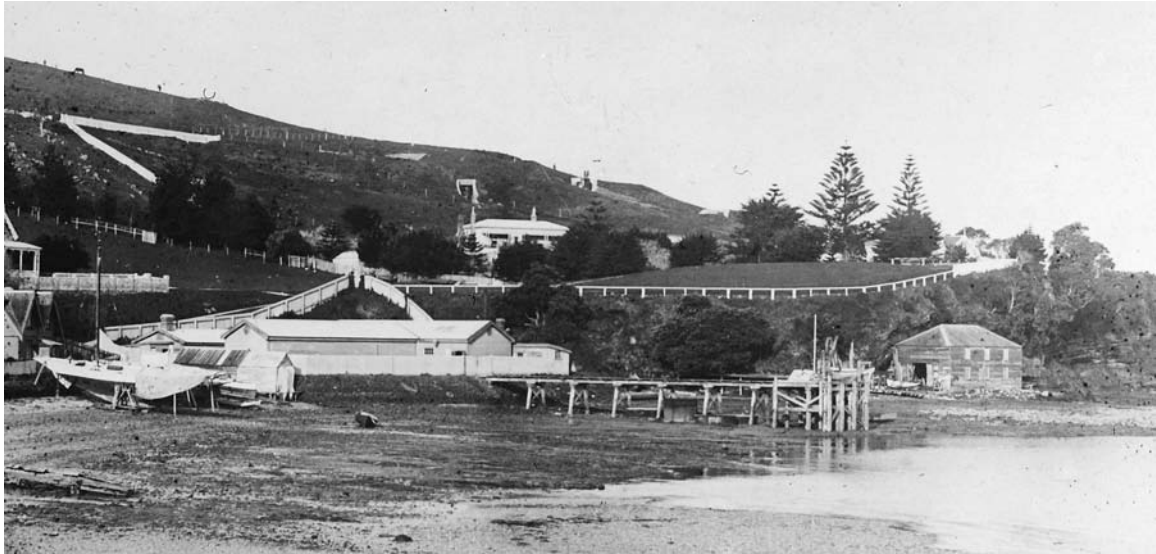
Figure 24. Torpedo Bay Submarine Mining Station, ca. 1888. Note the water level at the jetty head (in centre-right of image), and reclaimed land upon which the station's buildings were constructed. Image courtesy of the Sir George Grey Special Collections, Auckland Libraries (Accession No. 4-2970).

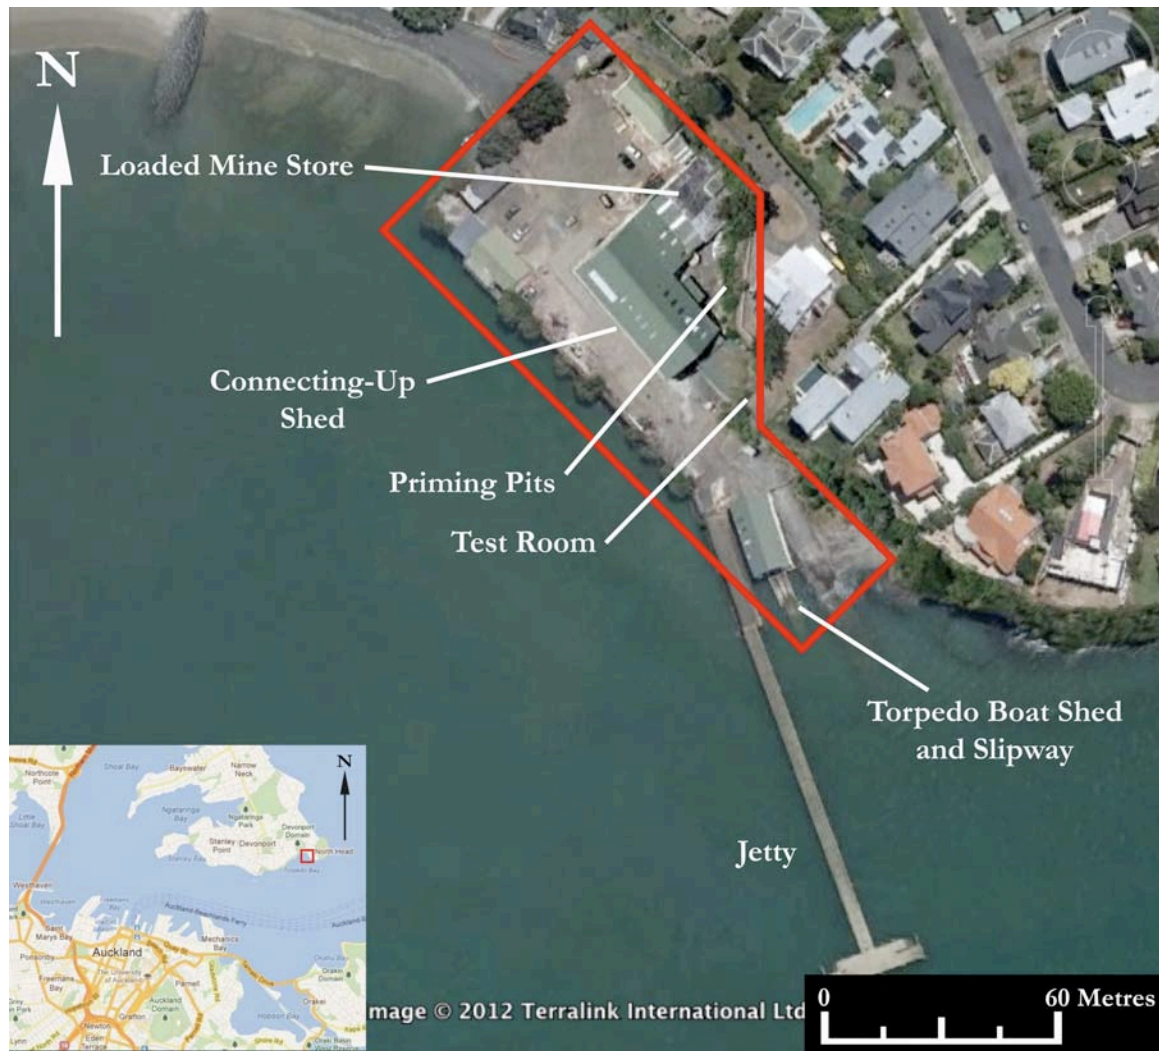
Figure 27. Aerial photograph of the Torpedo Bay Submarine Mining Station, showing the facility's perimeter (outlined in red) and extant structures documented during the 2008 survey. Inset map shows the site's proximity to Auckland. Base images courtesy of Google Maps and Google Earth.

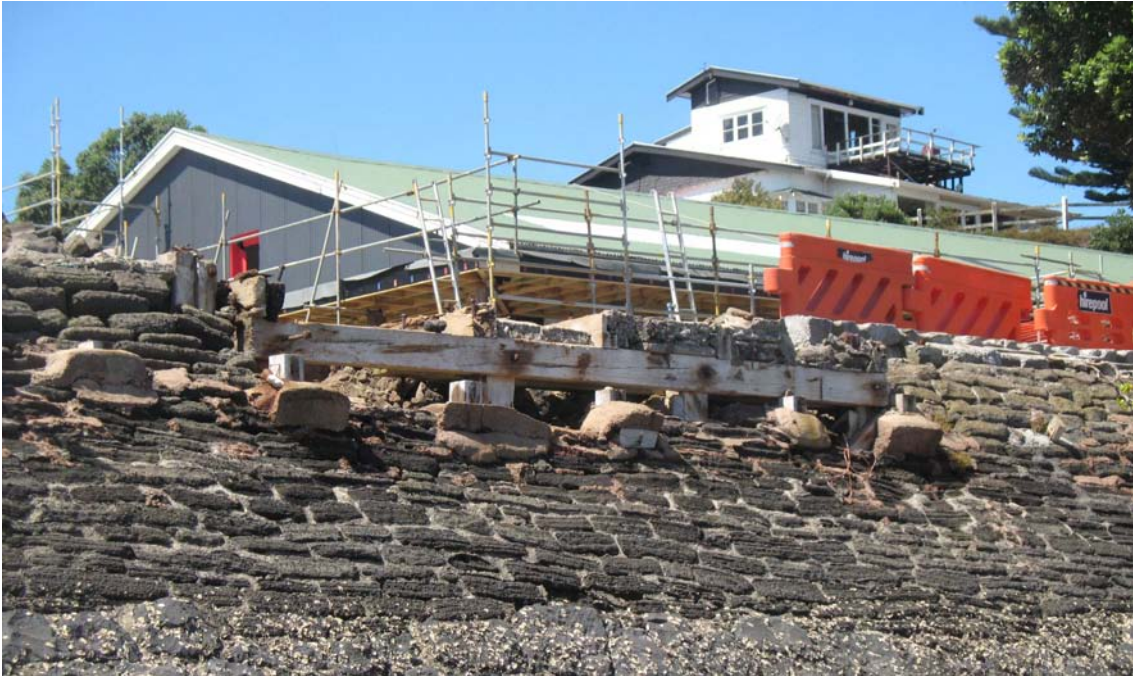
Figure 28. Remnants of the Torpedo Bay Submarine Mining Station's 1886 wooden jetty head, as exposed during archaeological investigations in 2009. Image courtesy of Opus International Heritage Consultants.

After 1958, the torpedo station's remaining 1886 buildings were demolished to make way for new facilities associated with the RNZN Band and Naval Auxiliary Sailing Club. It was at this time that surviving elements of the jetty head were buried and incorporated into the foundation of the clubhouse constructed for the latter organisation (see Figure 28). The same development activities also resulted in the demolition of multiple structures associated with the torpedo station's 1899 expansion, such as the barracks and torpedo priming pits. Significantly, none of the 1886 and 1899 structures were utilised in primary defensive roles following the station's transfer to RNZA control in 1907, and instead appear to have been relegated to secondary functions, including use as detention cells for prisoners of war or storehouses for various forms of military matériel. Ironically, much of the latter included the former torpedo station's complement of static mines, mining cable, and wet and dry guncotton (Mitchell 1995: 660-661). As time progressed, these items appear to have been largely overlooked or abandoned. Although decried for its general obsolescence and uselessness in the early 1920s, a large percentage of the guncotton remained at the station until well into the next decade. By the 1950s, when the installation reverted to naval control, all vestiges of submarine mining equipment and matériel had been removed, and the buildings that remained on site were either derelict or used as storage and/or office space.

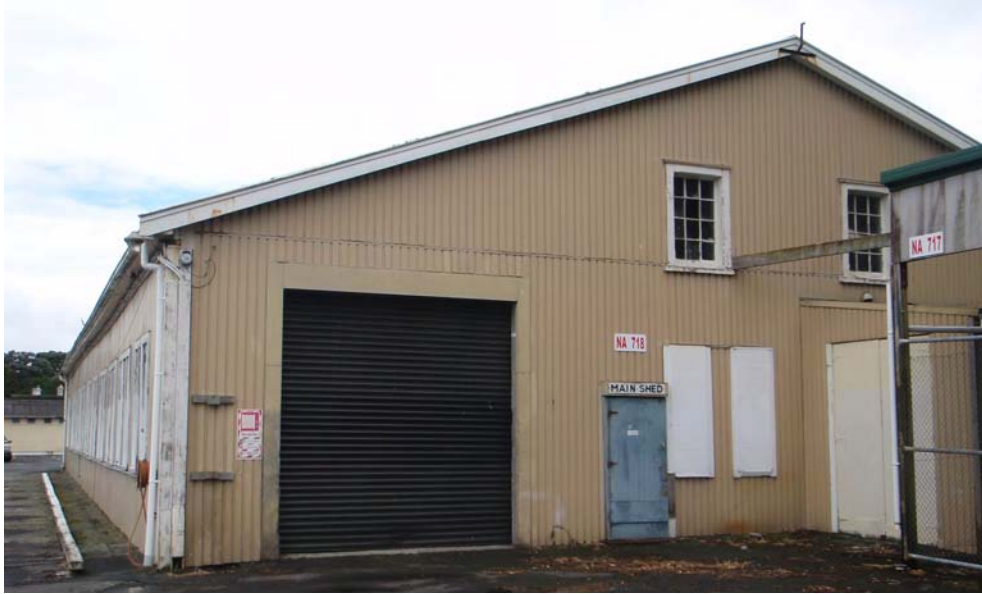
Figure 29. The former connecting-up shed at Torpedo Bay as it appeared in November 2008, showing wood-framed/corrugated sheet metal construction typical of most of the submarine mining station's 1886- and 1899-era standing buildings.

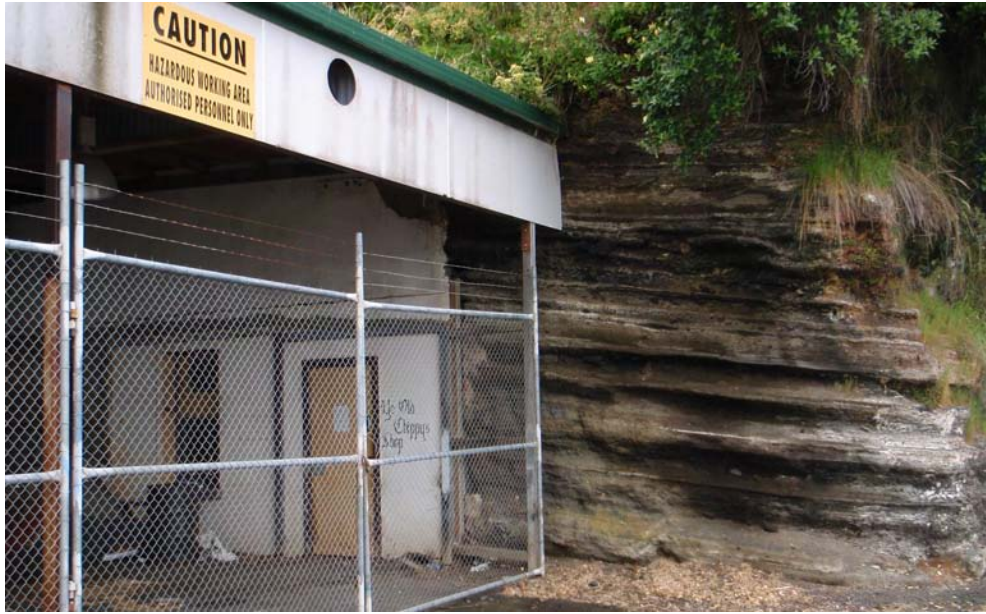
Figure 30. The Torpedo Bay station's former test room, as it appeared in November 2008. This subterranean structure was built into the cliff face and originally used to test torpedo detonators and other explosive devices. Entrance to the test room was through the yellow door just inside the fenced enclosure.

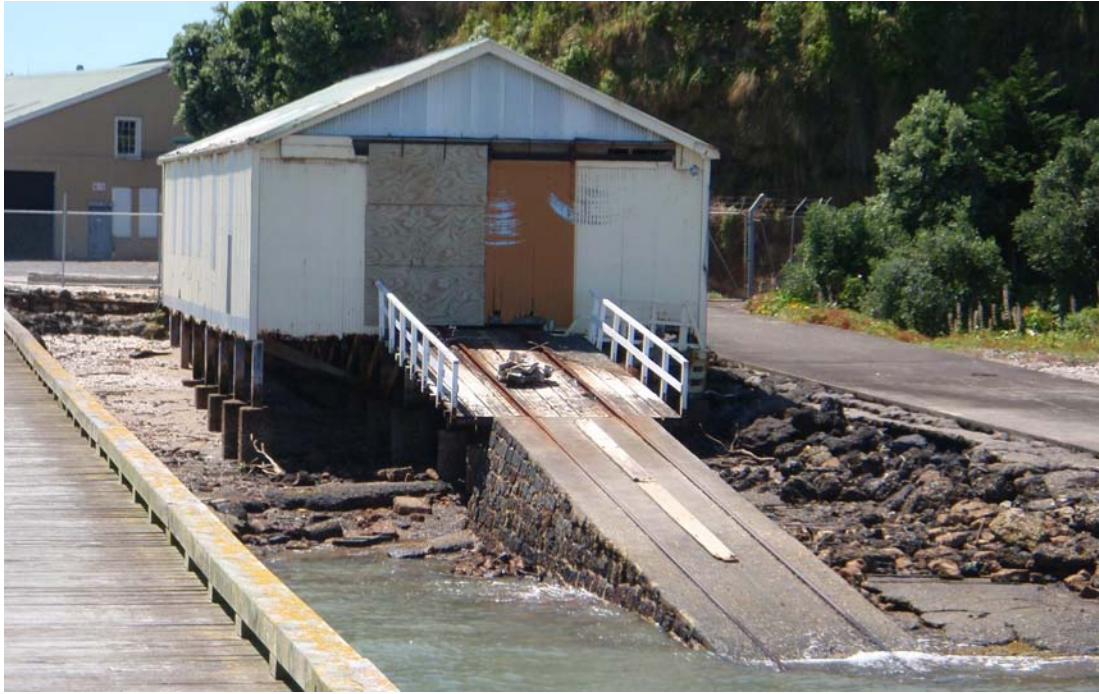
Figure 31. The second boat shed and slipway constructed for the Torpedo Bay Submarine Mining Station, as it appeared in November 2008. Note heavy corrosion along the base of the shed's corrugated metal walls, the use of metal sheeting and plywood to seal the windows and front door, and the presence of rubbish and other debris on the slipway.

By contrast, the boat shed and slipway located at the southeast corner of the submarine mining station were still largely intact in 2008, although these structures also bore obvious signs of disrepair, salvage, and subsequent abandonment (Figure 31). Advanced corrosion of the shed's corrugated metal fabric was clearly evident along the base of each of its walls, as well as among portions of the roof eaves. Additionally, its original complement of roof-mounted skylights was absent and the apertures that once housed them closed to the elements with rough-cut sections of corrugated iron sheeting. Corrugated metal 'patches' were also used to close off all of the shed's wall-mounted windows, while the loading doors at either end of the building were sealed shut with plywood sheets (see Figure 31).

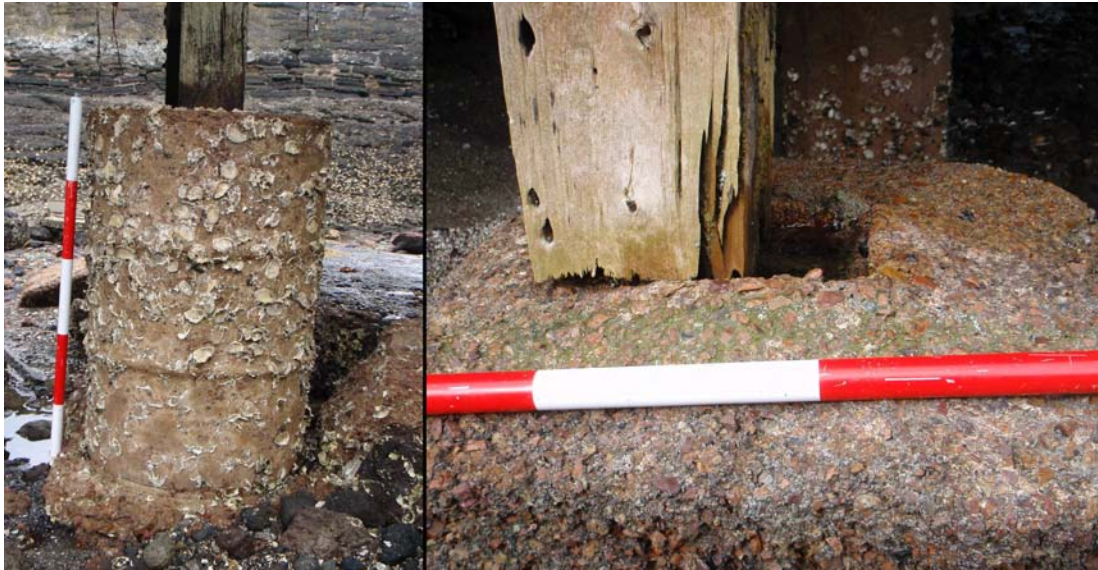
Figure 32. *Left*, concrete boat shed pile footer, as it appeared in November 2008, showing impression of steel 50-gallon drum ‘mould’; *right*, broken and partially dislodged wooden boat shed pile. Note deteriorated condition of wooden pile in the latter photograph. Scales in 20-centimetre increments.

The boat shed's derelict state is perhaps best represented by its wooden support piles, a number of which exhibit evidence of rot and subsequent breakage (Figure 32). Each pile features a corresponding footer formed from concrete poured into a steel 50-gallon (189-litre) drum. As a consequence of continual exposure to seawater, the metal fabric of these containers eventually disintegrated; however, their impressions survive today in the concrete footers they once encased (see Figure 32). During construction of the pile/footer assembly, each pile was either placed within its respective footer 'mould' first and then surrounded with wet concrete, or inserted into a drum already filled with the semi-hardened concrete mixture. Although seemingly protected by their footers, several of the piles nonetheless appear to have decomposed rapidly as a consequence of protracted exposure to alternating wet and dry tidal conditions. Degradation was particularly acute at the interface

where wood met concrete, and in a handful of instances this resulted in complete structural failure of the pile.

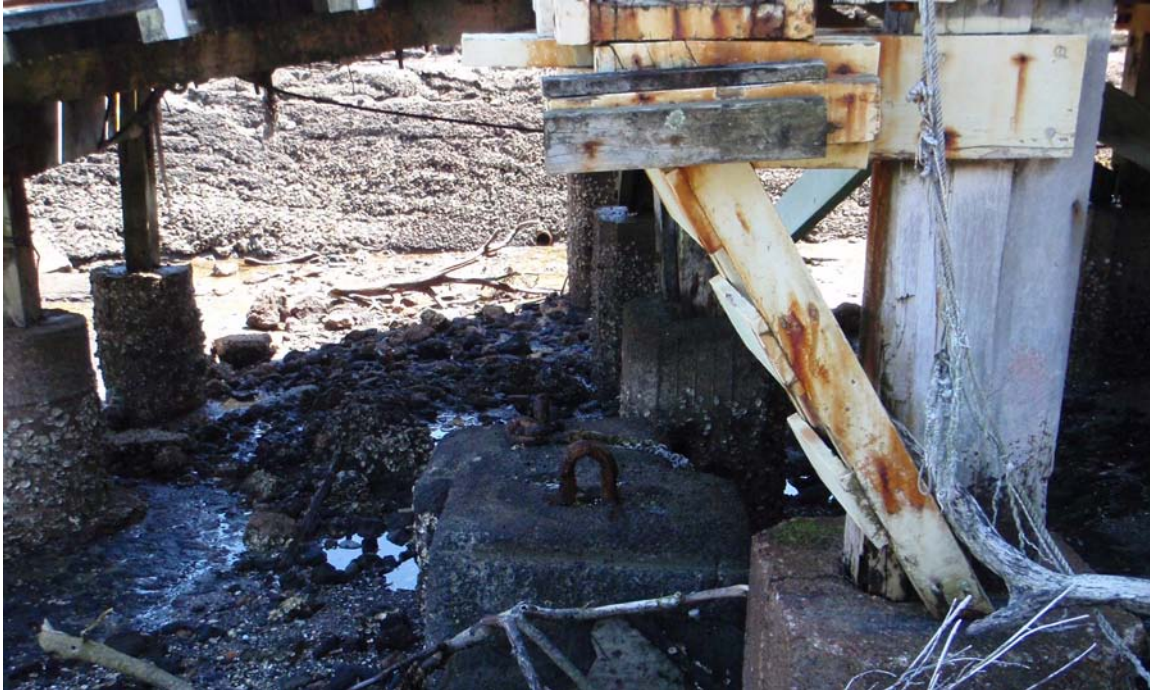
Figure 33. Underside of the Torpedo Bay Submarine Mining Station's extant slipway as it appeared in November 2008, showing deteriorated and damaged wooden pile (in centre of image). Note extensive iron staining on structural supports in foreground, as well as accumulated debris and rubbish.

Similar damage was noted for at least one support pile associated with the slipway. The pile in question supports a section of slipway that is constructed entirely from wood and connects the front of the boat shed with a stone and concrete ramp that extends the slipway into the waters of Torpedo Bay. In addition to the damaged support pile, many of the slipway’s other surviving architectural components exhibited signs of deterioration and disrepair (Figure 33). These included several heavily corroded iron fasteners, a variety of warped, cracked, and partially rotted wooden structural elements (including a skid plate that had become disarticulated from the stone and concrete ramp), and the slipway’s rusted iron rails. An accumulation of rubbish and other debris along much of the slipway’s length (where exposed above water) provided additional evidence of its protracted disuse and abandonment (see Figure 31). Mitchell (1995: 669) observes the boat shed and slipway were

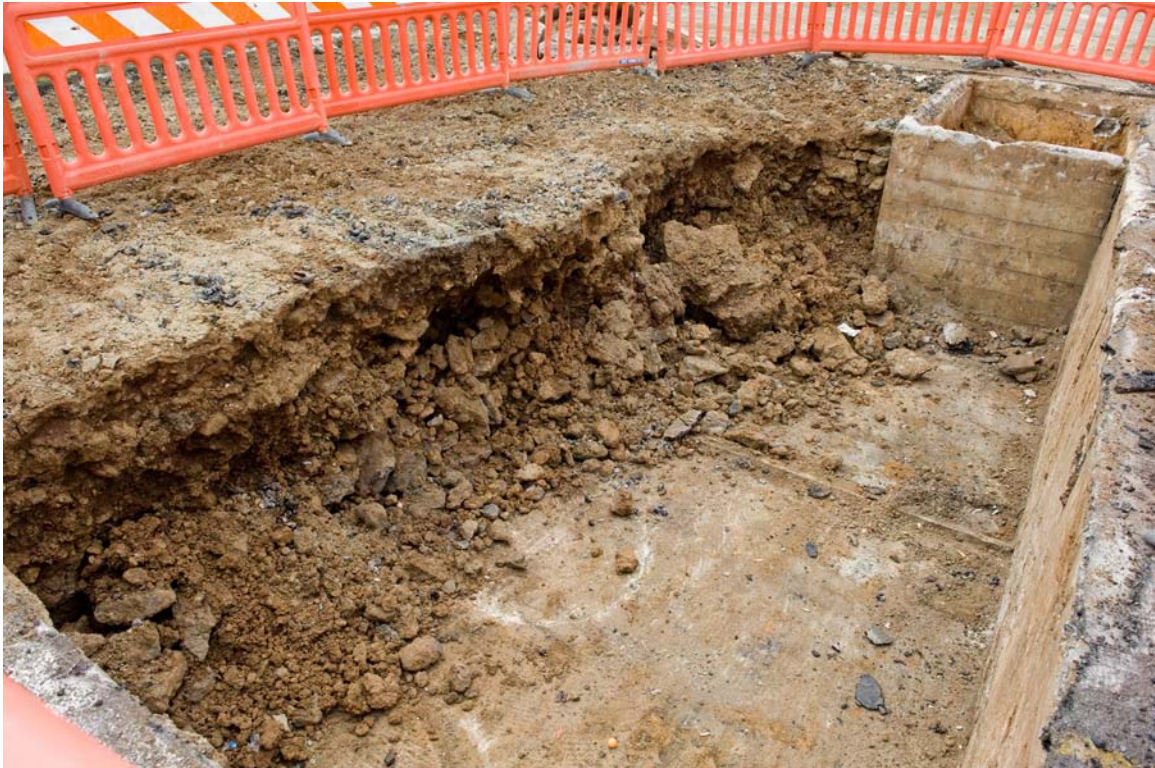
Figure 34. Remnants of the Torpedo Bay station's submarine mining cable pond, as partially exposed during archaeological investigations of the site in 2009. Image courtesy of Opus International Heritage Consultants.

progressed, underwater ordnance technologies changed, and the Torpedo Bay station shifted from a primary to secondary (and eventually inactive) defensive function. Ultimately, what amounted to large useless holes in the ground were filled in and paved over in an effort to eliminate potential safety hazards and create space for car parks and modern buildings associated with the facility's later development phases.

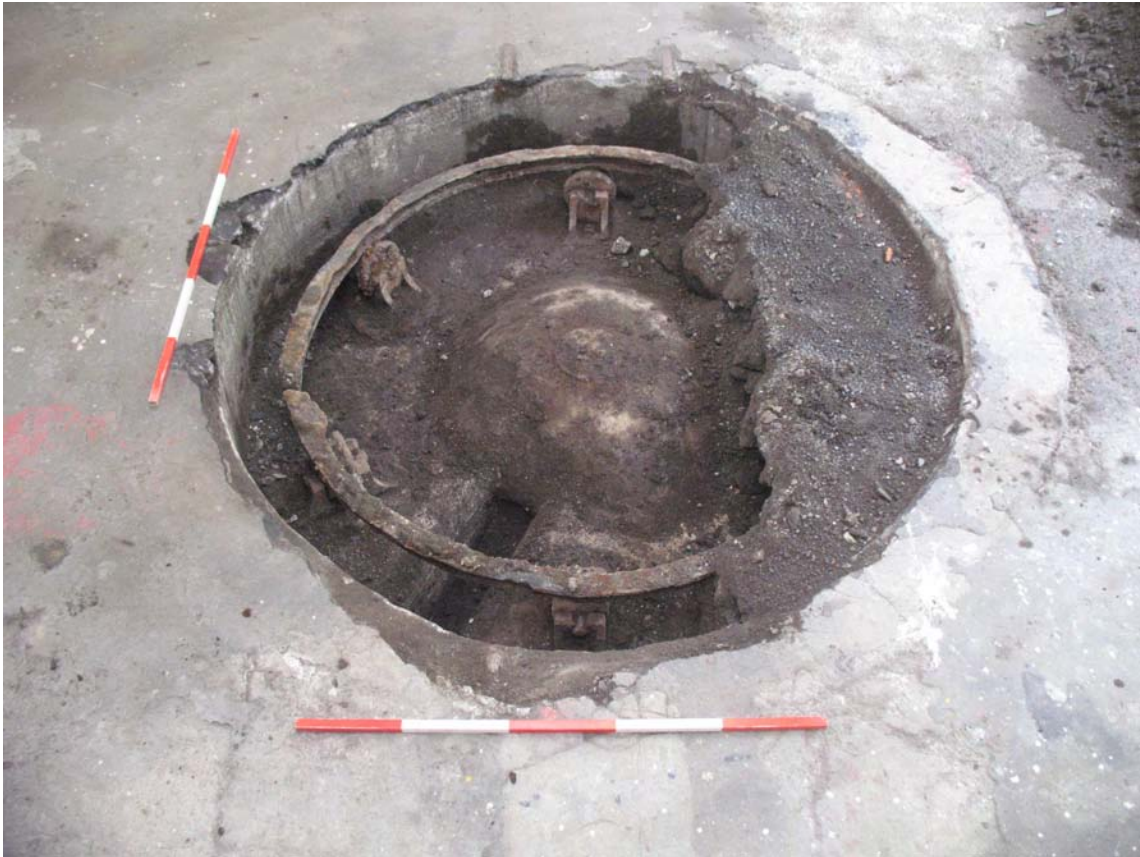
Figure 35. Intact iron tramway 'turntable' uncovered during 2009 archaeological investigations at the Torpedo Bay Submarine Mining Station. Scale in 20-centimetre increments. Image courtesy of Opus International Heritage Consultants.

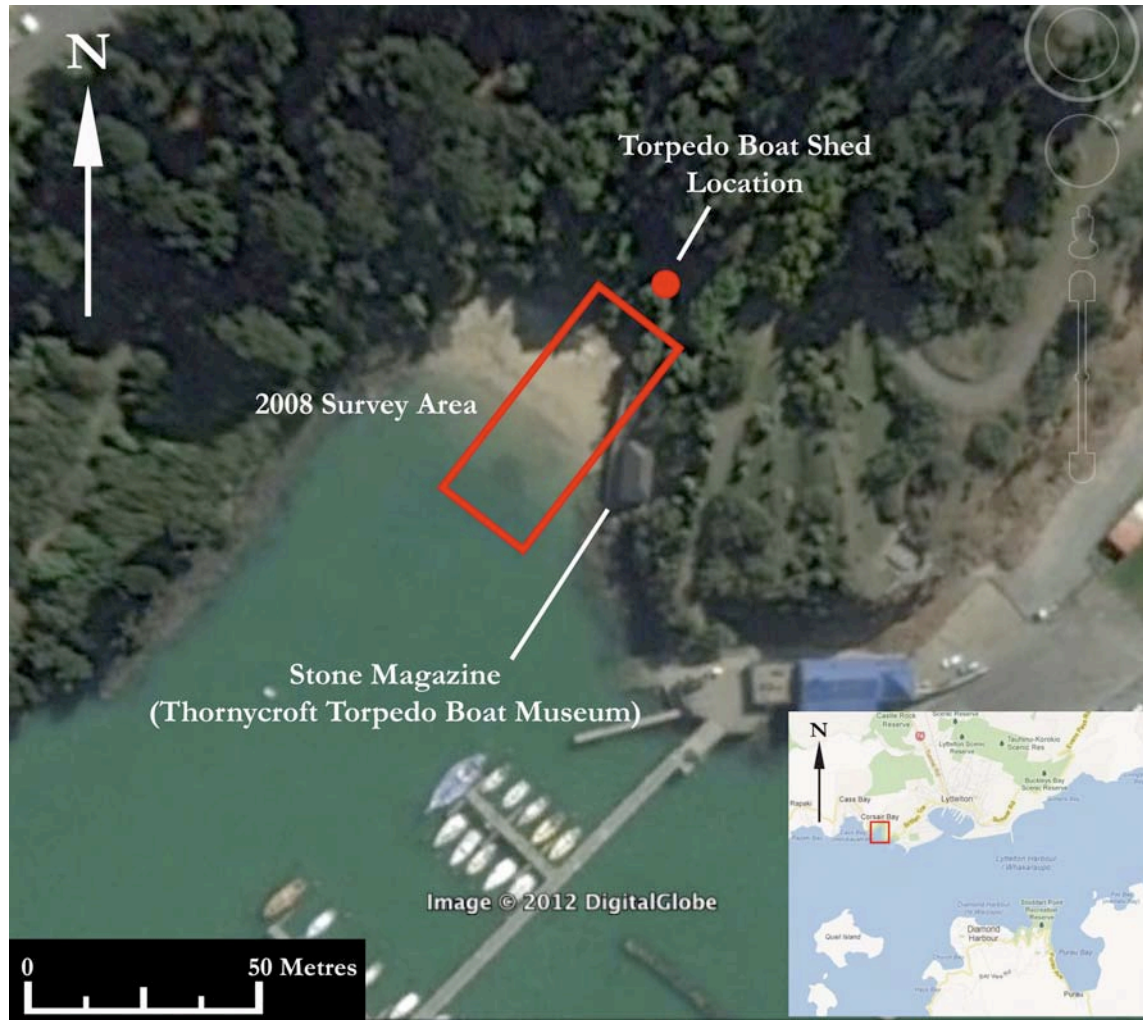
Figure 38. Aerial photograph of the Magazine Bay Torpedo Boat Station, showing the boundaries of the 2008 survey area, the location of the torpedo boat shed excavated in 2001 and 2002, and the historic stone magazine. Inset map shows the site's proximity to Lyttelton. Base images courtesy of Google Maps and Google Earth.

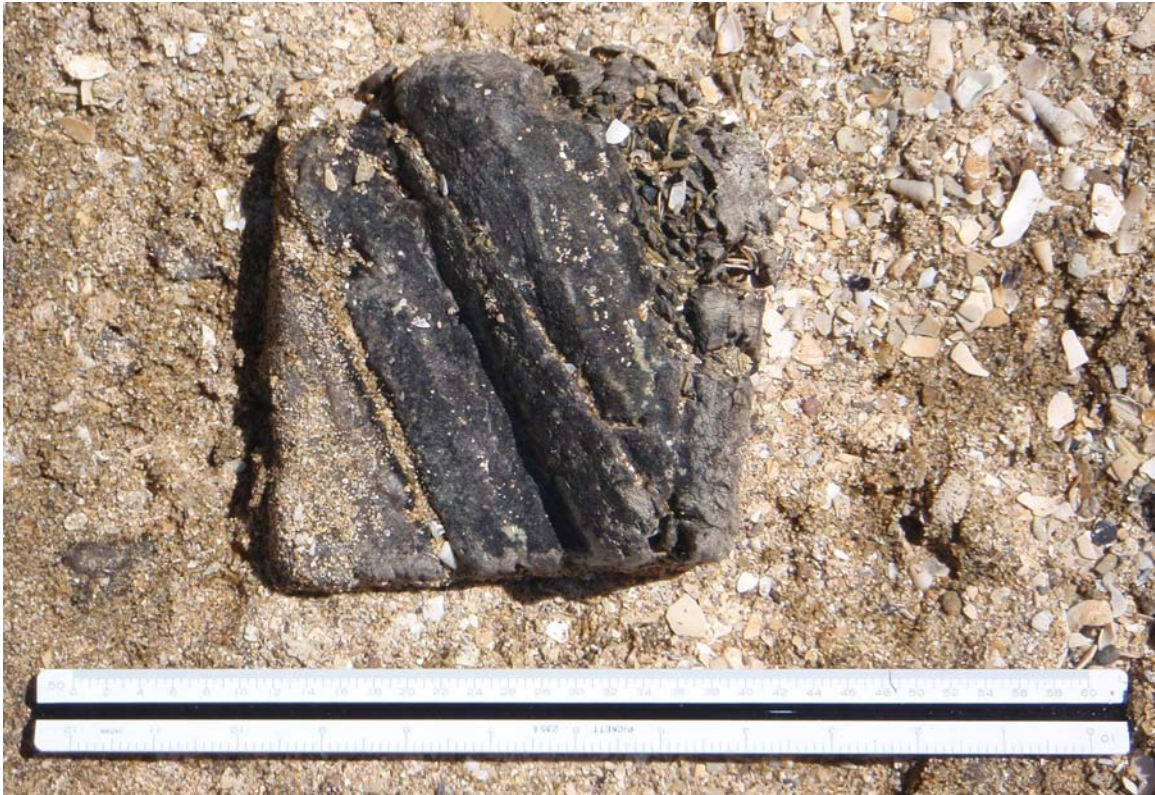
Figure 39. Wooden pile remnant associated with the Magazine Bay Torpedo Boat Station's slipway, showing cut marks indicative of intentional lowering. Scale is 30 centimetres in length.

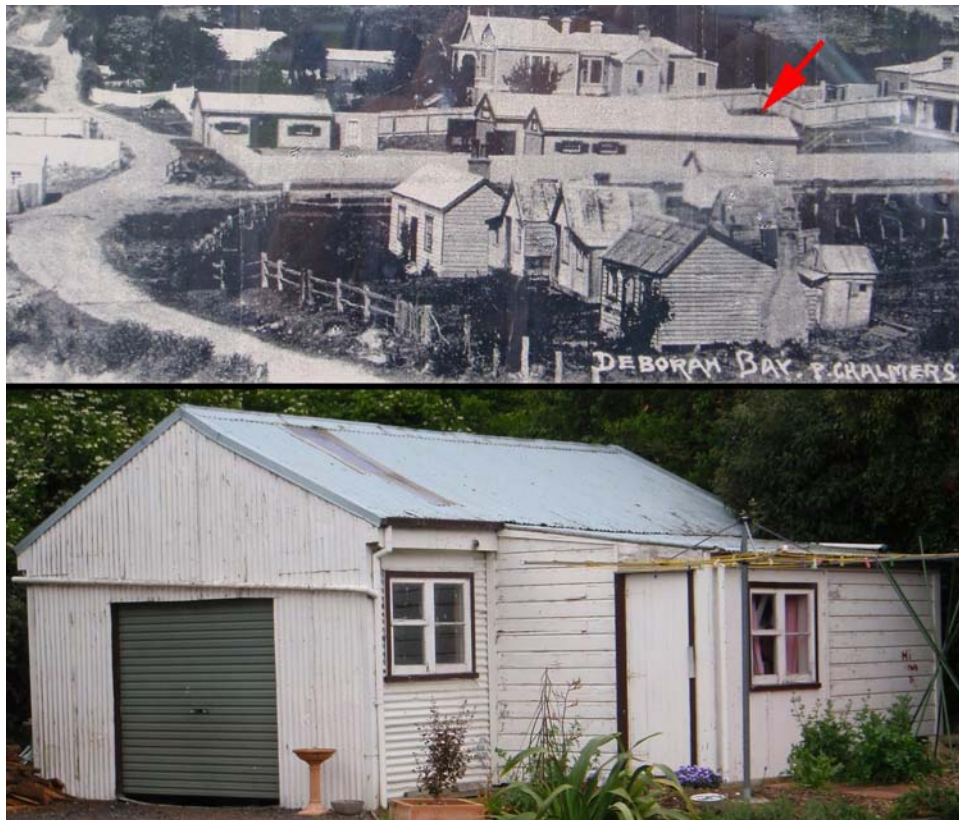
Figure 45. *Top*, Deborah Bay Submarine Mining Station during the first decade of the twentieth century. Red arrow indicates the storehouse that was later converted into a community hall by the Deborah Bay Presbyterian Church; *bottom*, the surviving section of the former storehouse and community hall, as is appeared in November 2008. Top image courtesy of Ian Church.
