CHAPTER FIVE

TORPEDO STATIONS AND TORPEDO STATION ABANDONMENT IN AUSTRALASIA, 1885-1924

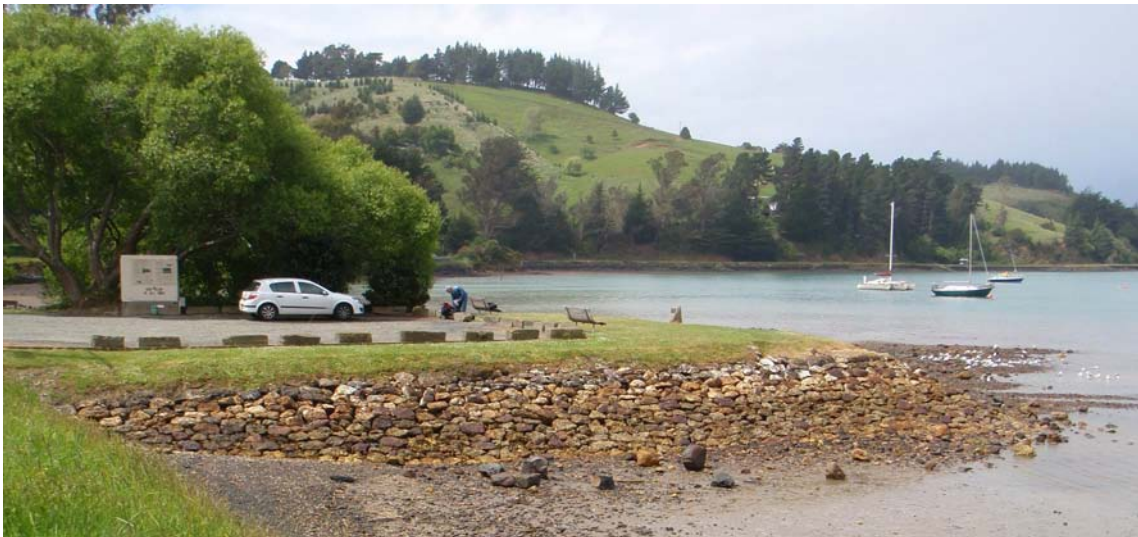
Figure 46. The Deborah Bay Submarine Mining Station mole, as it appeared in November 2008. Note the structure's robust stone and earthen construction, as well as its current use as a car park (signage describing the mole's historic role as an element of the submarine mining station is located immediately to the left of the white car).
