# End of the Line: Analysis of Economic Changes and its Effects on the Red Line Schooner Fleet of Northeastern Michigan

A thesis submitted in partial fulfillment of requirements for the degree of Masters of Maritime Archaeology

Flinders University of South Australia

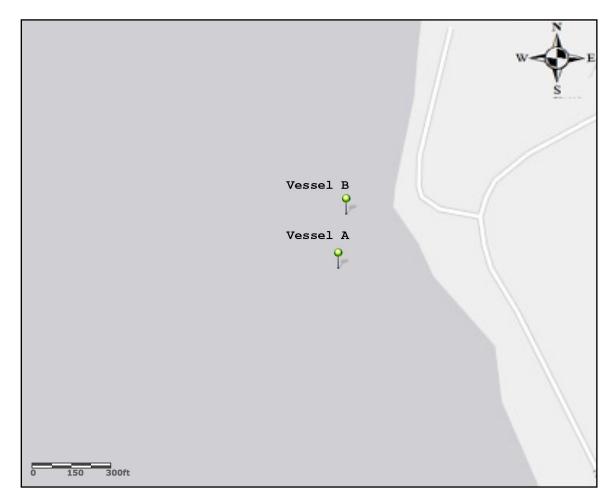
Figure 3.1: ArcGIS image of survey site of Whitefish Point Boneyard (La Barre 2016).

Both sites currently rest near a rock reef just 50 m to 100 m from the coastline (Figure 3.1). This reef system helped researchers easily locate both sites to place marker buoys on both sites. An initial swim survey, using snorkels, was implemented to identify the boundaries of each site. Once the initial survey was completed, a visual inspection using Self Contained Breathing Apparatuses (SCUBA) commenced. The minimum number of participants undertaking research on any of the two sites was two divers to insure safety. The first site surveyed and mapped was that of Vessel A, which was mapped using data

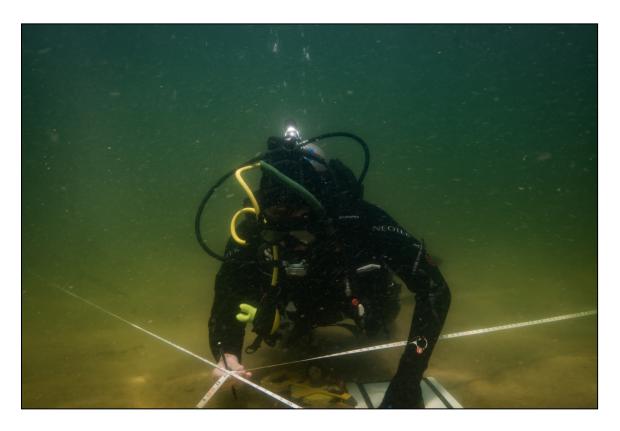
Figure 3.2: Maritime archaeologist Donald La Barre using baseline-offset (NOAA 2016).

Minimal current, as well as the site's calm and protected conditions, provided the suitable environment for the use of baseline-offset recording. Trilateration was also used to record a disarticulate section of the hull on the starboard side that had broken apart from the main structure of Vessel B, along the disarticulated hull. Several teams were able to record trilateration measurements to connect the adjacent section to the main structure.

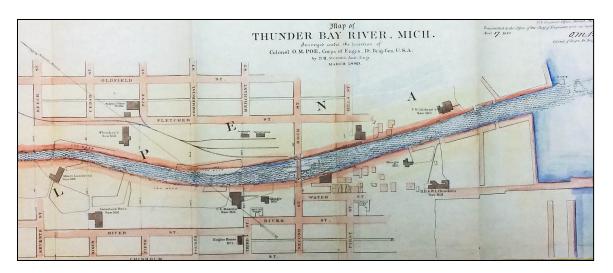
Figure 4.2: Map of Thunder Bay River and lumber mills from March 1889; Gilchrist Mill is the farthest on the right (Alpena County Library Special Collections, TBRC-5 "Ports" Box 1: A-AR, Folder 7).

Frank W. Gilchrist first came to the Alpena region to locate lands to harvest white pine in 1863 with subsequent visits in 1864 and 1865 (HR Page and Co. 1883:243). After building the Gilchrist Mill on the north side of the river towards the mouth of the Thunder Bay River in 1867, Gilchrist began processing lumber for contracts in the spring of 1868 (HR Page and Co. 1883:243) (Figure 4.1). At first, the single circular saw mill produced approximately 5,000,000 ft. (1,524,000 meters) of lumber. Most mills operated along the river; in Figure 4.2 Gilchrist's mill is located on the farthest right side and Fletcher's docks farther up the river.

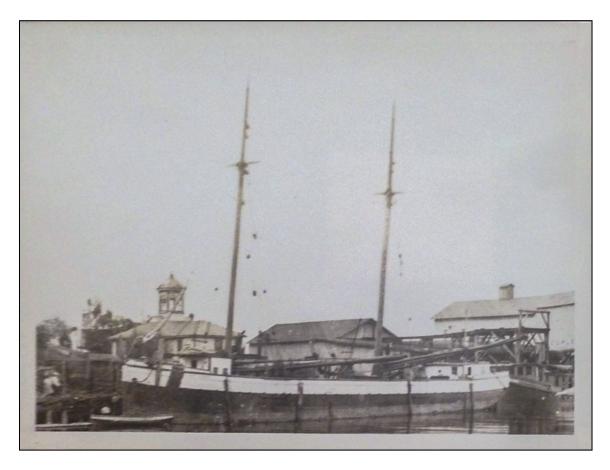
Figure 4.4: Photo of *Light Guard* (Alpena County Library Special Collections, Fletcher Collection FLC-5 Box 14, Folder 11).

J.M. Jones built *Light Guard*, described as a barge with a plain head and a square stern (Appendix A) in Detroit, MI in 1866. It measured 142 ft. 6 inches (43.43 m) in keel, 26 ft. 6 inches (8.07 m) in beam and 10 ft. 8 inches (3.29 m) in depth ([DFP], 24 May 1865). Originally employed to transport wheat across the Great Lakes, Frank W. Gilchrist purchased the schooner in 1879 for use in the lumber industry (see Appendix A for Bill

of Sale). While employed by Gilchrist, *Light Guard* transported lumber alongside other barges in his Red Line (Figure 4.4). After a successful career hauling lumber for Gilchrist's mills, the schooner barge was abandoned around 1903 near Whitefish Bay ([AEN], 23 July 1903:4).

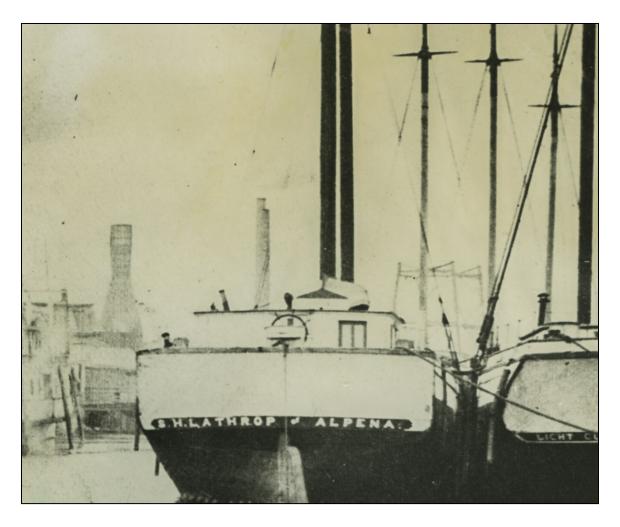
Figure 4.5: Photo of *S.H. Lathrop* at dock (Alpena County Library Special Collections, Fletcher Collection FLC-5 Box 14, Folder 11).

Francis N. Jones in Oswego, NY built *S.H. Lathrop* in 1856. Similar to the two aforementioned schooners, *S.H. Lathrop* (Figure 4.5) was a double-masted schooner measuring 137 ft. (41.76 m) in length, a beam of 26 ft. 1 inches (7.96 m), and a depth of 10 ft. 3 inches (3.14 m) (U.S. Bureau of Navigation (USBN) 1899). It was involved in several crashes and even sank on one occasion. On July 20, 1862, *S.H. Lathrop* sank from a collision with the bark *Sturgis* ([BDC], July 21, 1862). Several days later, the owners raised and placed the schooner in port for repairs ([BDC], 30 July 1862). Several months later, *S.H. Lathrop* was rebuilt by shipwrights and reported to be in better condition than it was originally built ([BDC], 28 October 1862). Frank W. Gilchrist bought the ship in 1876 where it served a career as part of the Red Line schooner barge fleet until it had its valuable parts stripped and was subsequently abandoned in George Fletcher's dock in Alpena in 1902 (Port Huron Daily Times [PHDT], 20 May 1902) (see Appendix C for Bill of Sale).

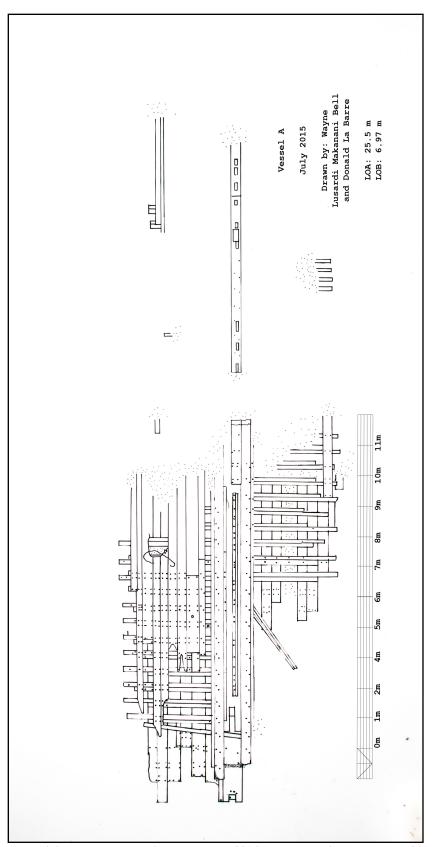
Vessel A is buried in more sediment than Vessel B, with the majority of its remains covered by several feet of sand. The bow section of the ship is missing. The most prominent sections of the ship that remains visible today are its keelson assembly as well as a section of hull between the bow and amidships with ceiling planks, frames, and hull strakes measuring approximately 13.7 m in length. During the first field season, the sternpost was visible but by the second field season, the sternpost became buried in sediment. The site map was created by updating the pre-existing site plan from the NABS, which was originally created as part of a NAS training course led by State DNR staff, Wayne Lusardi in 2010. According to records and the 2010 site map, the sediment levels were lower at the time, therefore exposing more of the ship. The increase in sediment level is due to the decrease in ice coverage, caused in part by warmer winters. Currently, the remains are visible over a length of 25.5 m and width of 6.97 m (Figure 4.6).

Figure 4.6: Vessel A site map, drawn 2016 (Bell, Lusardi, and La Barre 2016).

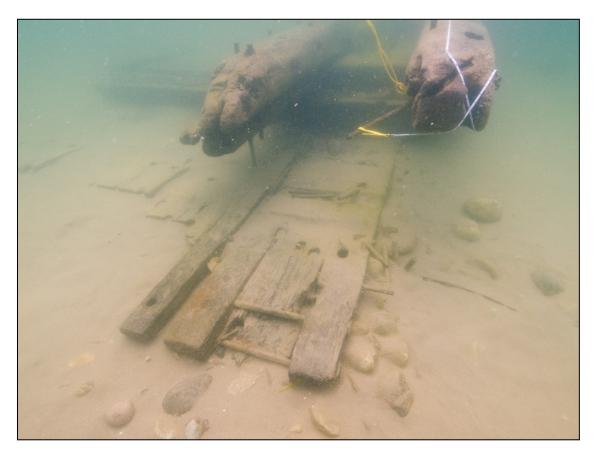
The most prominent feature of Vessel A is its remaining keelson and associated timbers (Figure 4.7). The remains are consistent with assistant keelson structures of 200–300 ton vessels. The assistant keelson was fastened with two through bolts to each frame, clenched on the interior of each frame timber. The main and assistant keelsons are also fastened with through bolts that are clenched in a similar method between frames.

Figure 4.7: Photo of Vessel A's remaining bow section of keelson structure and outside planking, not to scale (La Barre 2015).

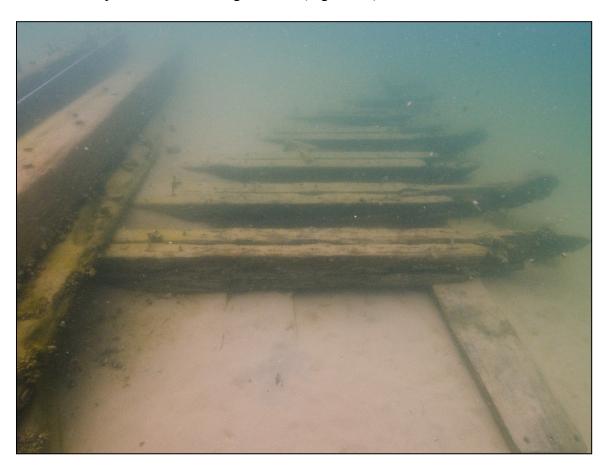
Two frames are edge-bolted to form a singular support frame set. The compound frame measures 2.9 m and the largest 3.2 m in length. The nine forward starboard frames have the compound frame on the bow side of the two frames, and the remaining three visible starboard frames have the compound frame placed on the stern side of the first futtock. On the port side, remains of the frames have suffered more deterioration than those on the starboard side, averaging 2.35 m and 3.02 m in length. Fastened in four places on every ceiling plank, each plank has two bolts on each of the two joined frames. The space between each pair of frames averages 30 cm (Figure 4.8).

Figure 4.8: Image of portside frame and keelson structure on Vessel A (La Barre 2015).

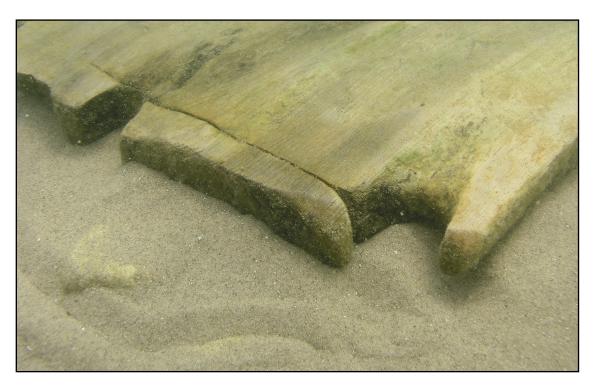
Figure 4.9: Evidence of saw marks on outside planking of Vessel A, measures 15 cm (La Barre 2015).

Located on top of the ceiling planking is a length of wire. The hull strakes at the bow have seen extensive sawing, as noted in Figures 4.9 and 4.10. It is uncertain when these cuts and grooves were created; it could have been shortly after abandonment or more recent.

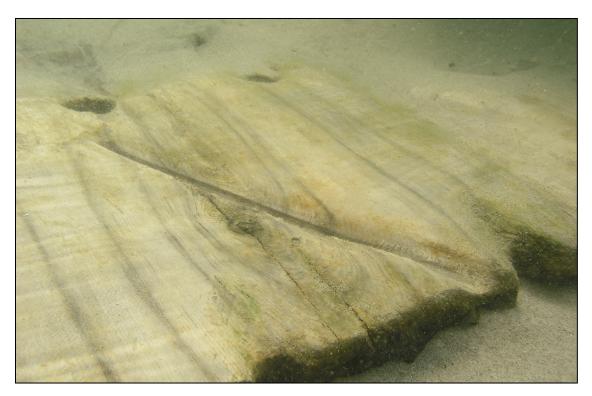
Figure 4.10: Additional evidence of salvage on Vessel A, grove measures 14 cm in length and 1 cm in width (La Barre 2015).

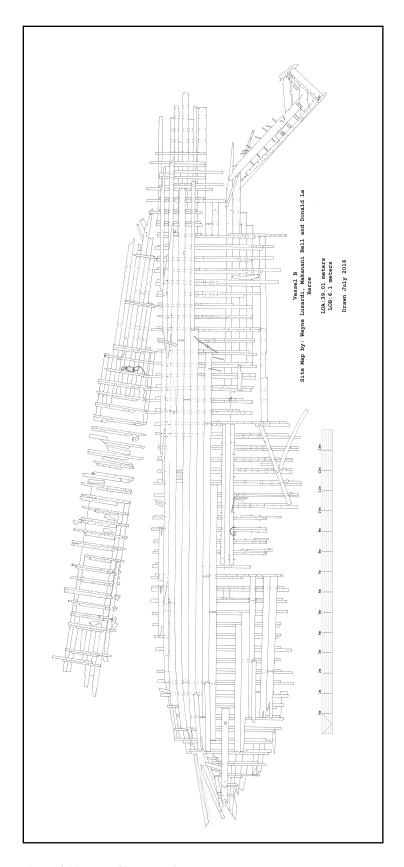
The end of the fragment of keelson is 36 cm wide and tapers towards the stem to 25 cm. The frames, bolted between the keelson and keel, fit into a notch between the keelson and keel. An important difference between both ships in the Whitefish Boneyard is that the construction of Vessel B's keel and keelson differs greatly from the construction of the assistant keelson structure of Vessel A.

Figure 4.11: Site map of Vessel B, drawn by Bell, La Barre, and Lusardi 2016.

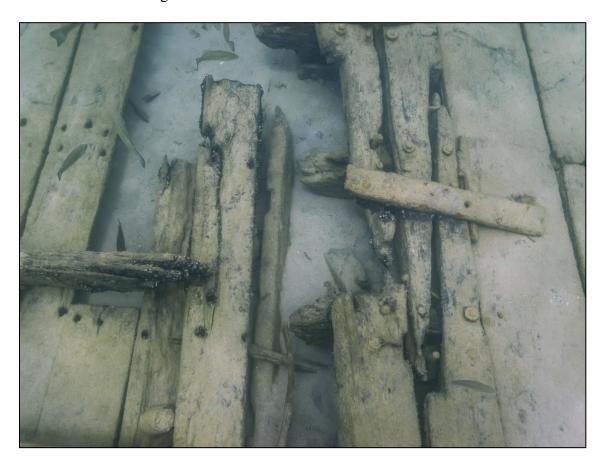
Seven strakes of ceiling strakes extend from the keelson and centreboard case on the starboard and four ceiling planks remain on the ship's port side. The majority of ceiling planking measures 36 cm in width and 3 cm in thickness. There are two stringers just before the break at the start of the bilge to the light water line, both measure 23 cm in width and 1 cm in thickness and are both flat scarphed. These scarphs on the two stringers are parallel to each other in two known places. On two of the parallel flat scarphed is a metal plate bolted over both scarphs (Figure 4.12). This metal plate measures 98 cm in length and 15 cm in width.

Figure 4.12: Attached supportive metal plate on Vessel B, measures 98 cm x 15 cm x 3 cm (La Barre 2015).

Both vessels' ceiling planking is typically butt jointed with metal fasteners (Figure 4.12), and positioned on each ceiling plank through the frames underneath, which adheres to construction standards of the times (Board of Lake Underwriters 1866:Ceiling). The joints of the ceiling planking on the sides are flat scarphed, although their orientation along the planks indicate a weak point. On Vessel B, the ceiling planking at the turn of the bilge are flat scarphed and are directly above each other. Such construction creates a longitudinal weakness. The reasons for such a deviation in standard construction practices in error are explained in the next section.

Aforementioned is the evidence of a metal reinforcement plate, measuring 71 cm in length, over a flat scarphed pair of planks around midship. Such a plate adds strength in the scarph on adjacent stakes, thereby reinforced. Such a use of a reinforcement plate illustrates the type of repairs done on this ship.

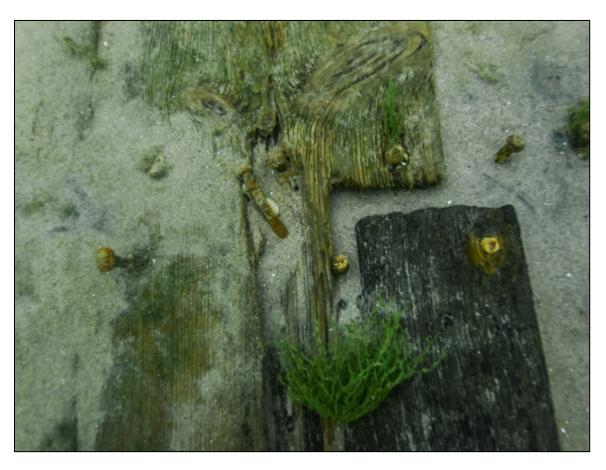
Towards the bow there is a significant change in construction of the ceiling planking. The most forward ceiling planks are made of oak, but then change to pine. This change is seen on both the starboard and port sides of the ship. Accompanying the change in wood material, the scarphing techniques used to join the ceiling planks utilizes an unusual method in which to join planks (Figure 4.13). The way in which the pine ceiling planking joins with the oak planking indicates a repair that sought to salvage the few oak planks. Two construction methods exist on the site to fasten the ceiling planking to the pair of frames. One of the joining techniques used is of two fasteners for both joined parallel frames; second, the use of six bolts for the butt joints that join two ceiling planks together with three in each frame.

Figure 4.13: Intersection of changing ceiling planking material on Vessel B, darker plank measures 9 cm sided and 2.5 cm molded (La Barre 2015).

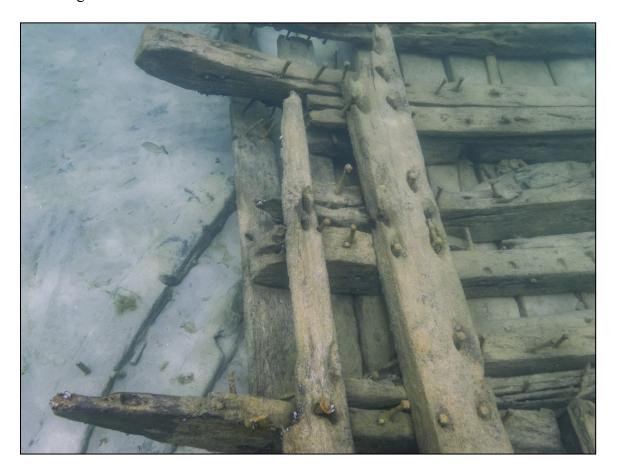
Hull strakes are most present at the bow where the hull begins to curve to a point and aft of the centreboard case. The outside planning begins at the average measurement of 46 cm sided and 2 cm molded (Figure 4.14). There are indications of repair, especially on the port side of the keel towards the sternpost. Just visible at the end of the existing hull strakes is a 10 cm wide plank insert. On the starboard side of the ship, towards the sternpost, the hull strakes beginning to taper as they come closer to the bilge strake, measuring from 23 cm to 15 cm in width.

Figure 4.14: Outside planking on Vessel B, not to scale (La Barre 2016).

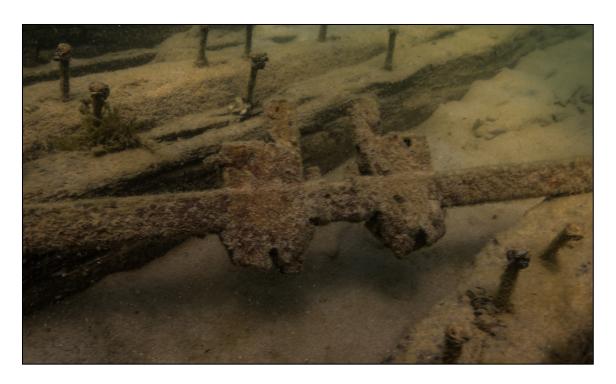
Figure 4.15: Unidentified metal clamp on Vessel B, 1.22 m in total length, not to scale (La Barre 2016).

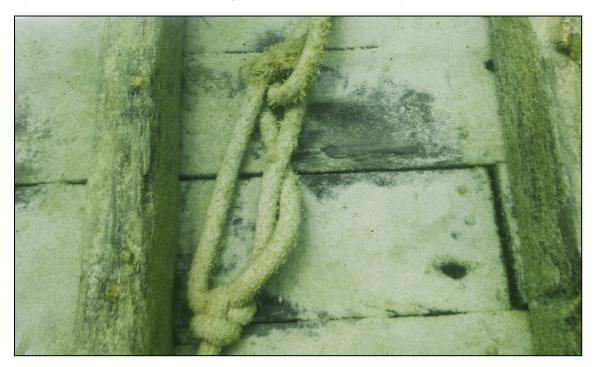
Found entangled around the hull starboard section of Vessel B is a rope (Figure 4.16). This rope is not from the time of the abandonment of the ship, as it resembles a more modern rope. The rope, tied around several large sections of hull strakes frames and ceiling planking, shows signs of fraying indicating a break.

Figure 4.16: Modern rope, tied using a bowline knot on Vessel B, wrapped around the disarticulated hull section of Vessel B, not to scale (La Barre 2016).

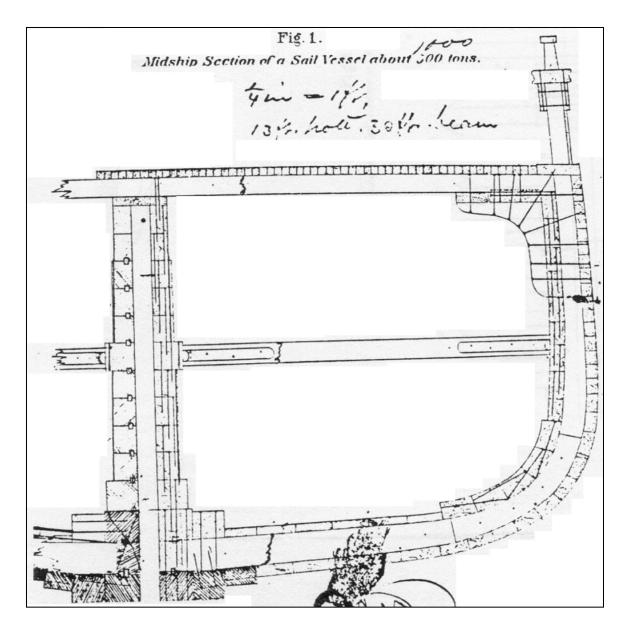
Figure 5.1: Cross-section of 500-ton vessel with rider keelson (Board of Lake Underwriters 1866:Figure 1).

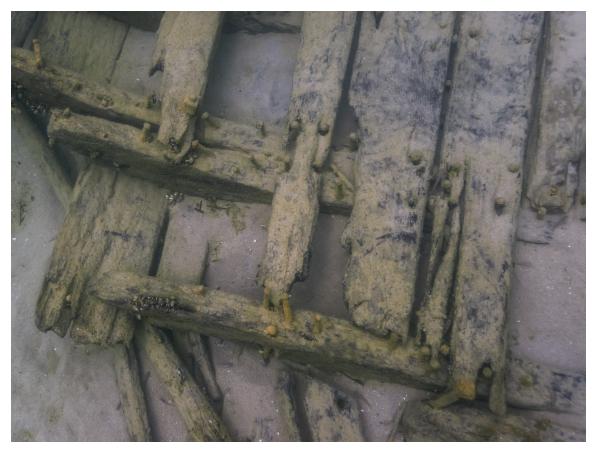
Figure 5.2: Bird's eye view of bow ceiling planking made of oak on Vessel B, not to scale (La Barre 2015). Someone with the means and access to an abundance of pine, such as Frank Gilchrist, could easily provide carpenters or shipwrights the necessary materials to repair a vessel just enough for it to be considered lake worthy, and without investing too much money on an old ship. The largest anomalies are the remains of the oak planks towards the bow. These oak planks have purposely been preserved, and the pine planks fitted into the irregular scarphing at the intersection of both timbers. One conclusion is that the intact remains of oak sections were left for a less skilled craftsperson to place new planks in without having to steam the planks to fit the curve towards the stem.

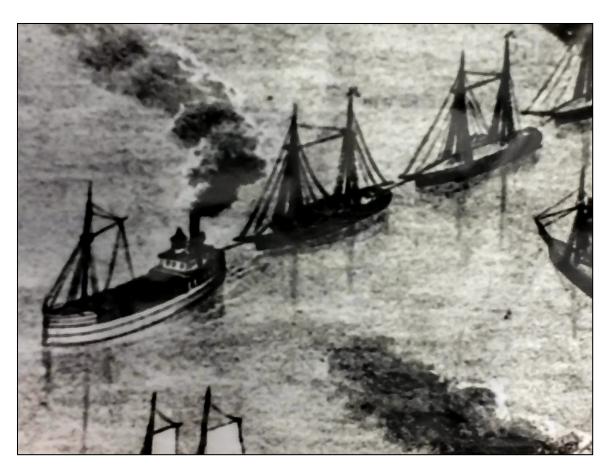
Figure 5.3: Image of steamer towing lumber barges from Alpena harbor (Alpena County Library Special Collections, TBRC-5 "Ports" Box 1: A-AR, Folder 8).

did not use steamers to tow schooner barges during the lumber boom in 1880. By removing the masts and any equipment not seen as essential, the steamers provided the power while the schooner barges provided the cargo space. Figure 5.3 illustrates the use of steamers to tug schooners around, similar to a train, although this image shows the masts of the schooner barges still attached. Such a practice reduced the amount of experience personnel needed to crew the vessel. The decrease in crew and increase in the amount of timber being shipped resulted in greater financial rewards. Even this strategy did not forestall the end of the White Pine Era in Alpena around the 1890s.
