HMS *Endymion*

Past, Present, and Future

HMS Endymion
Past, Present, and Future

Alexandre Hinton, BA
MA candidate
Master of Maritime Archaeology

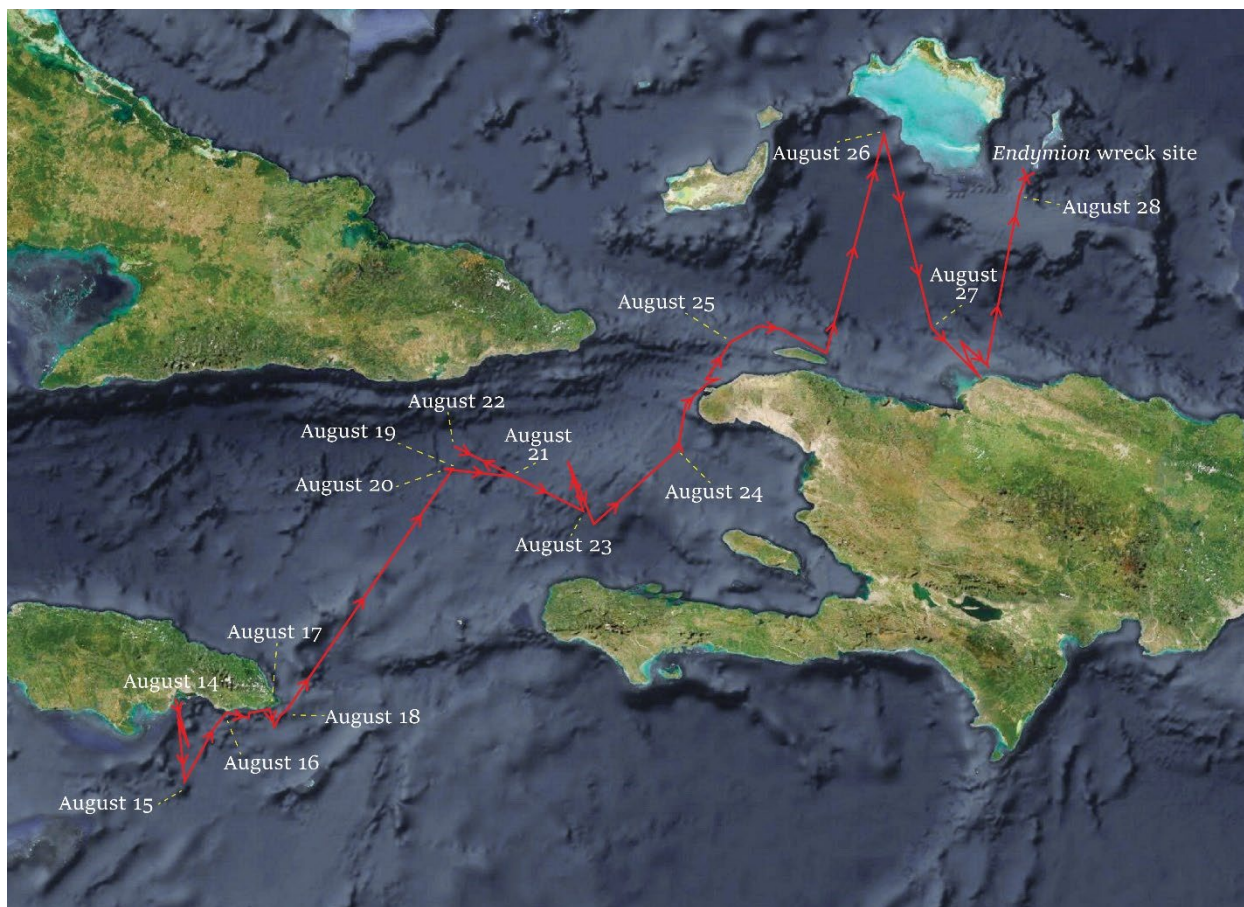
Fig. 6. HMS *Endymion*'s final journey in 1790 reconstructed from the positions given in the logbook (created by the author).

The vessel's final journey can be reconstructed on a map based on the compass bearings and distances from certain landmarks noted in the logbook (Fig. 5; Fig. 6). All distances were converted to modern measurements, as mentioned above (league = 18,360 ft; nautical mile = 6,120 ft). The bearings given relayed the direction from the ship towards an identifiable terrestrial landmark on the 32-point compass. These were converted to degrees for each entry and then inverted by 180 degrees to calculate their reciprocal heading. With this information, the heading from the landmark mentioned in the log was taken and the distance calculated was measured, producing the vessel's location. These locations were plotted and the route was further confirmed by the courses noted during each day in the logbook.

It should be noted that there is a variable degree of accuracy from these determined locations for various reasons. Distances given by the crew were determined by estimation and are by no means precise (Schotte 2019:80). Additionally, multiple locations mentioned throughout the log are large and general landmarks, allowing for a greater degree of variation in distance. This is especially true of the bearings determined in the instances where land was sighted from a considerable distance, and as such these points are not included in the map due to the uncertain nature of the landmark. Although the logbook does provide latitudes and longitudes, these were not used as the degree of accuracy is unknown, making plotting these unreliable (Schotte 2019:80). In summary, although the recreated route shows the *Endymion*'s final journey, the map created depicts the most accurate generalization of the vessel's path.

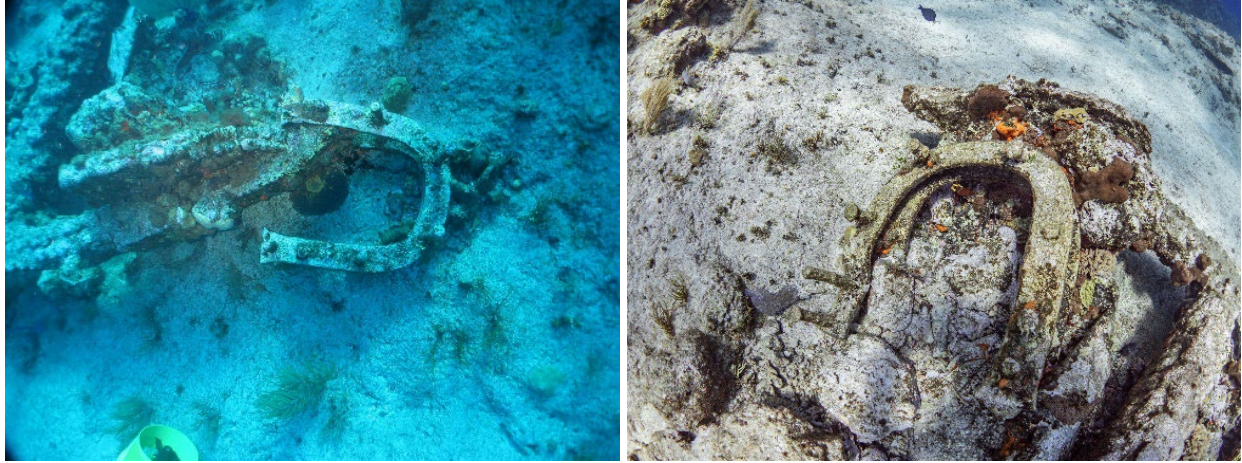
Fig. 20. (Left) The horseshoe clamp from Keith's 2007 investigation (courtesy of Donald Keith). (Right) The horseshoe clamp photographed during Stelten's 2019 visit (courtesy of Ruud Stelten).

One of the more distinctive artefacts at the site is a large horseshoe clamp (Fig. 20). This clamp is an iron plate used in vessel construction to connect the junction between the stem and forefoot (Steffy 2011:273). This double clamp is comprised of two pieces of U-shaped bronze that are held together with eight bolts. In Bound's chapter, the clamp is not mentioned but is photographed on the tip of the northern fluke of anchor 2 (Fig. 16). This is again seen in Keith's 2001 and 2008 papers, in the same position as seen in the 1990s (Fig. 16). Keith mentions the clamp and its purpose along with recording its location on the 2001 site plan (Fig. 10). By 2019, although still present, the clamp had moved from its previous position to in between the right fluke and shank. During the 2023 investigation, although the site was fully surveyed, the horseshoe clamp was not located.

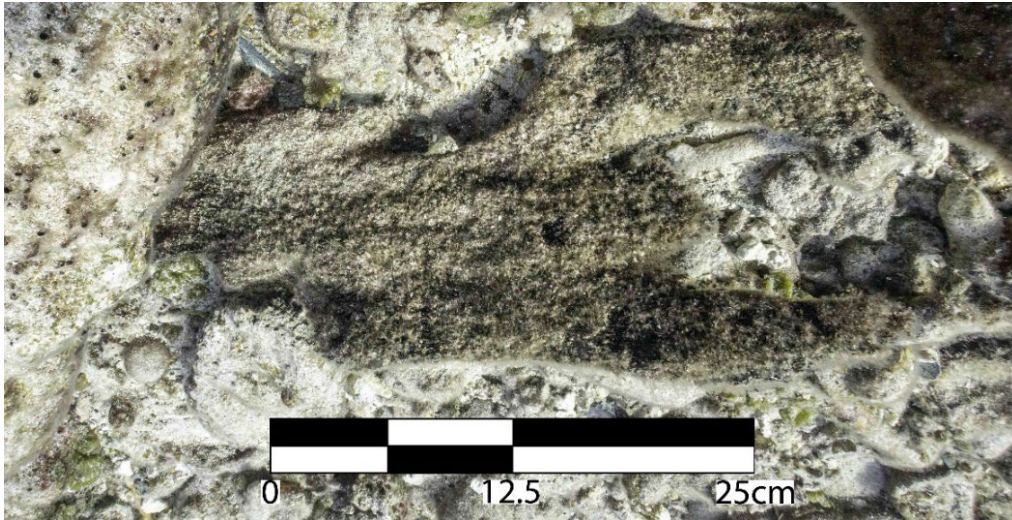
Fig. 22. Timber fragment from *Endymion* (image taken by the author).

As *Endymion* was a wooden vessel, it is possible that wood remains have been preserved under the right conditions. Fragments from the wooden hull were not mentioned during Bound's brief visit. Keith addressed the wood remains after his visit in 2000. He stated that he identified hull fragments underneath the ballast, a large section of wooden planks on the southern side of the area, and outer hull planking at the northern end of the site between the cannon line and ballast mound (Keith 2001:55). The only image of these remains provided is the cross-section of a portion of hull sheathing, but the identification of the wood in the image is difficult (Fig. 21). No mention of the wood remains are mentioned during Keith's later visit. Based on Stelten's 2019 model, the hull remains are primarily seen under the ballast pile with few fragments in the southern section of the wreck site.
