Assessing the Efficacy of Anti-Submarine Measures in Broken Bay for Safeguarding the Hawkesbury River Railway Bridge.

This thesis submitted to Flinders University for the degree of Masters in Maritime Archaeology.

Paul Edward Gale

2 January 2024

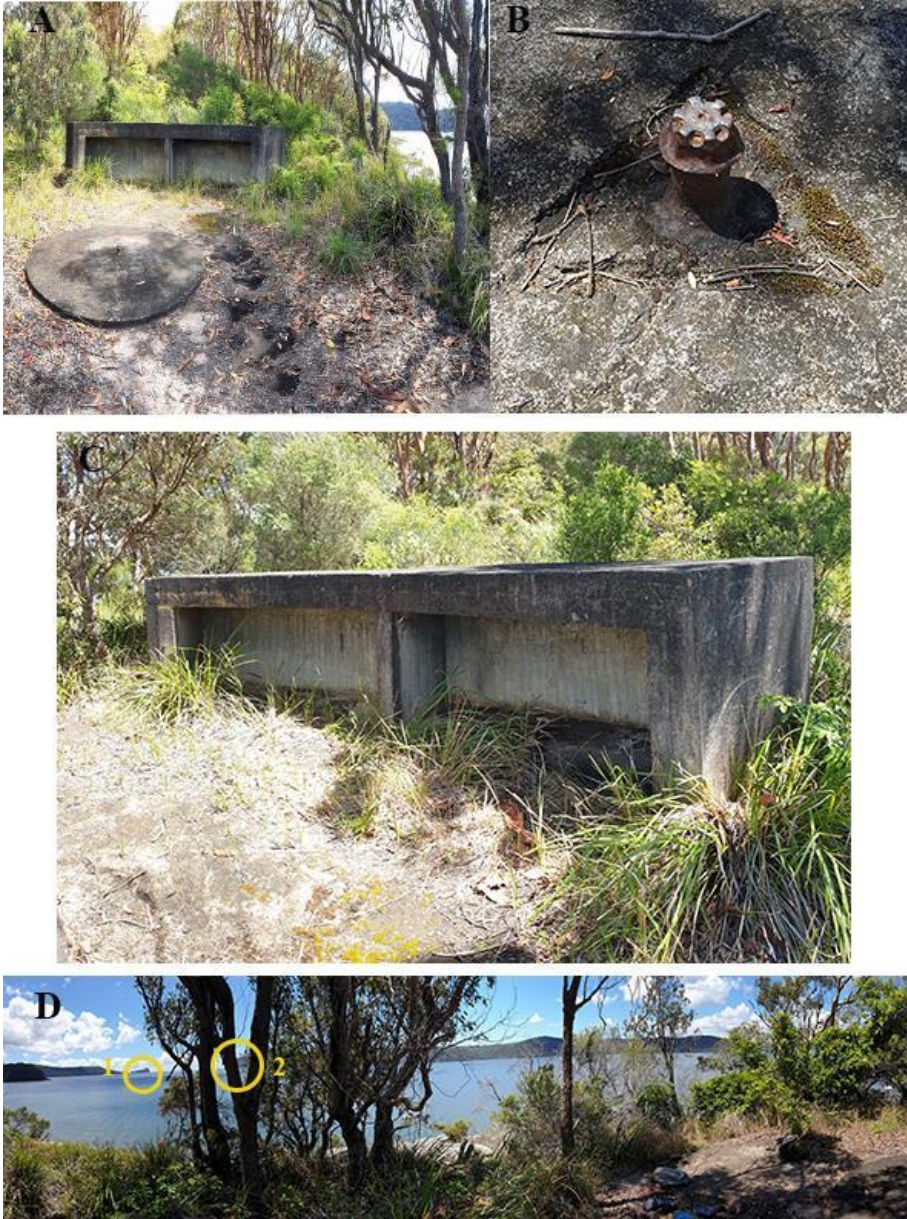
Figure 4-1: Gun position 1 situated near the point of Juno Point. A- Overview of the gun position and storage bunker. B- Close-up of the centre-notch pin with a possible survey mark. C- Ammunition storage bunker. D- View from the gun overlooking Broken Bay to the e east. 1- Lion Island. 2- Barrenjoey Head.

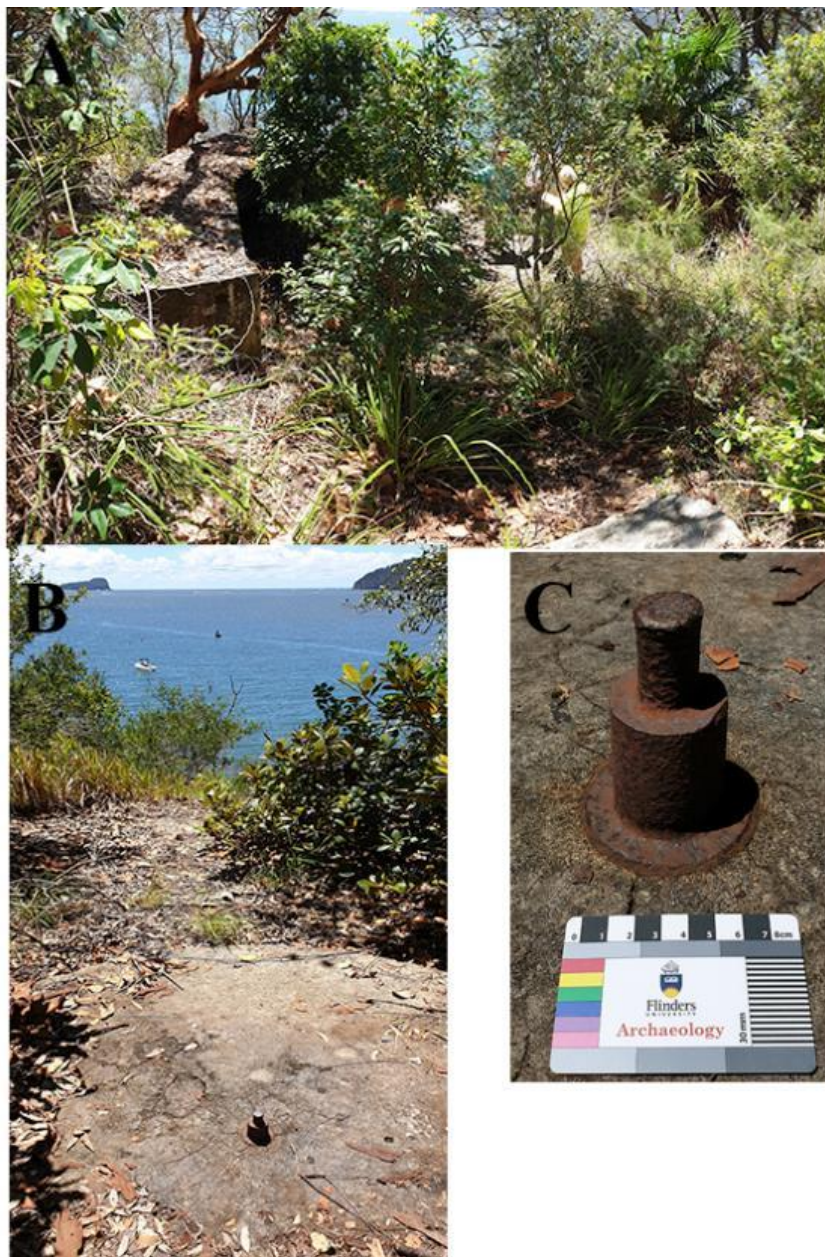
Figure 4-3: Gun position 2. A- Overview of the gun position displaying how overgrown it is compare to gun position 1. The ammunition bunker is to the left of the photographs. B- Overlooking Broken Bay. Lion Island (left) and Barrenjoey Headland (right). C- Centre pin for gun mounting. Different design and unknown why this is the case.

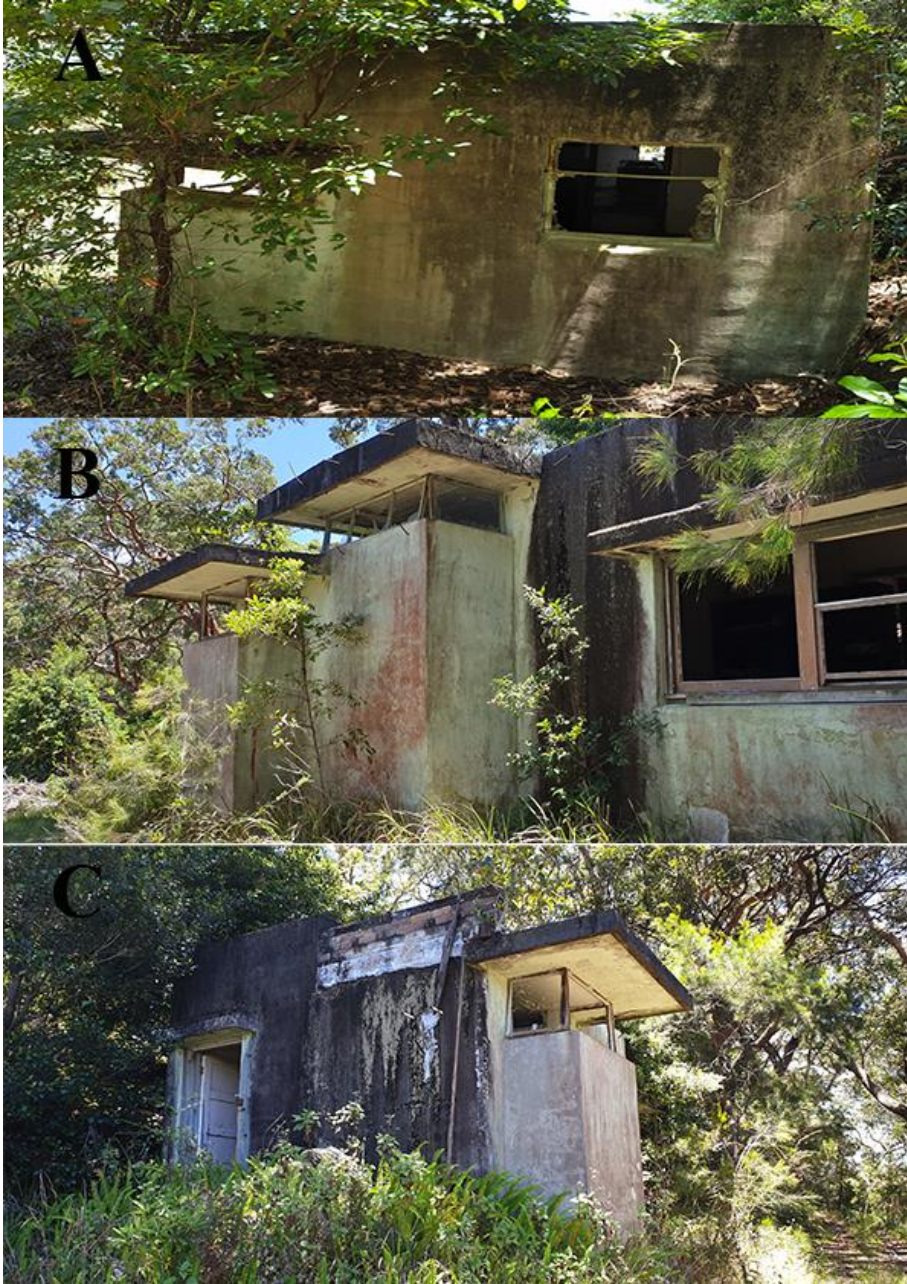
Figure 4-5: Exterior of control hut displaying the state of dis-repair and construction type. A- North wall. B- East wall with observation windows. Evident are the metal rod protrusions for camouflage/blackout curtains. C- South wall with entry door. Exposed brickwork on the roof area.

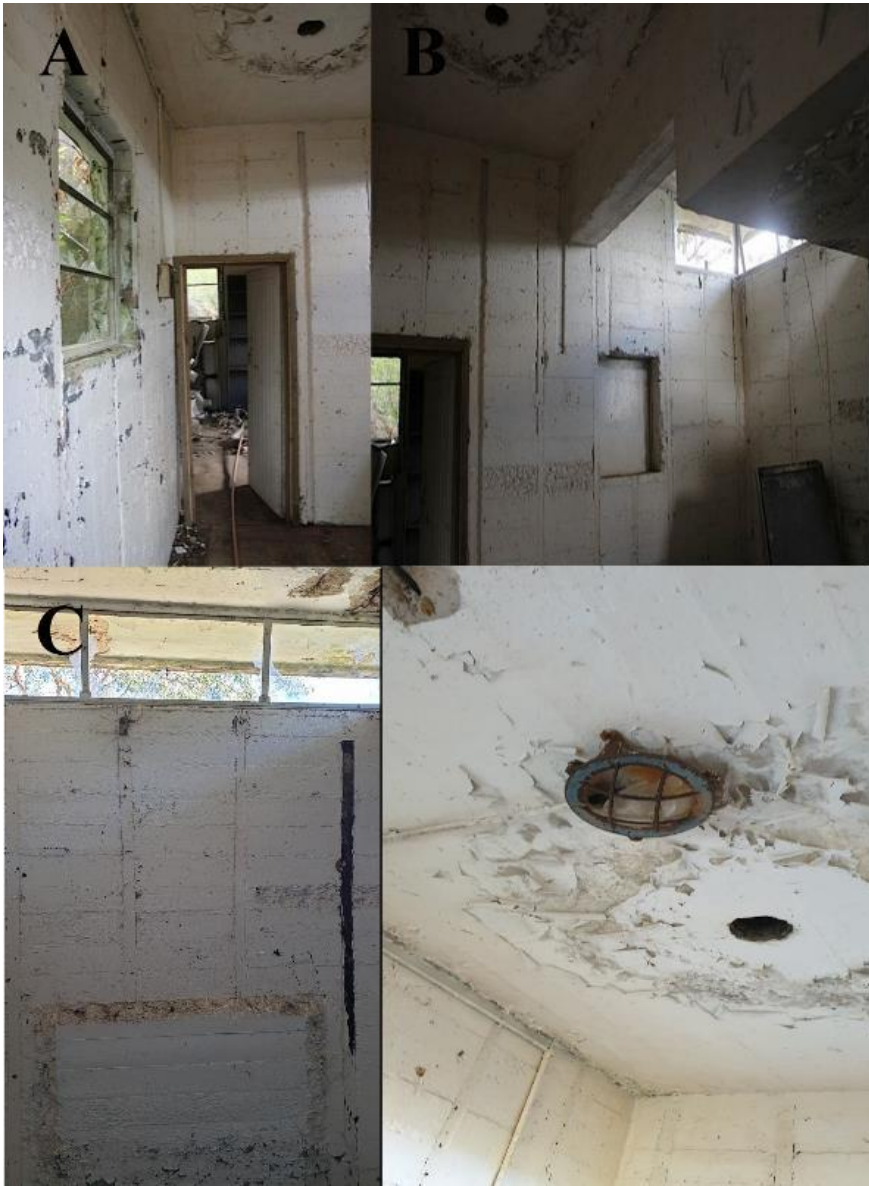
Figure 4-6: Inside the control hut. It is considered all paint is original and hence lead-based. **A-** Looking north from the entry door through to 2nd room. The floor is lined with masonite over the original floorboards; the construction method is evident with the negative of the original framework when concrete was poured. **B-** Looking northeast, showing a 'pass through' window now blocked. **C-** Upper observation window and the scar of an observation platform. It is likely used to mount ranging optics. **D-** Original light fixture. Also evident is some concrete cancer and rusting reinforcement. The round hole in the roof extends to the outside, and further investigation into its use is needed.

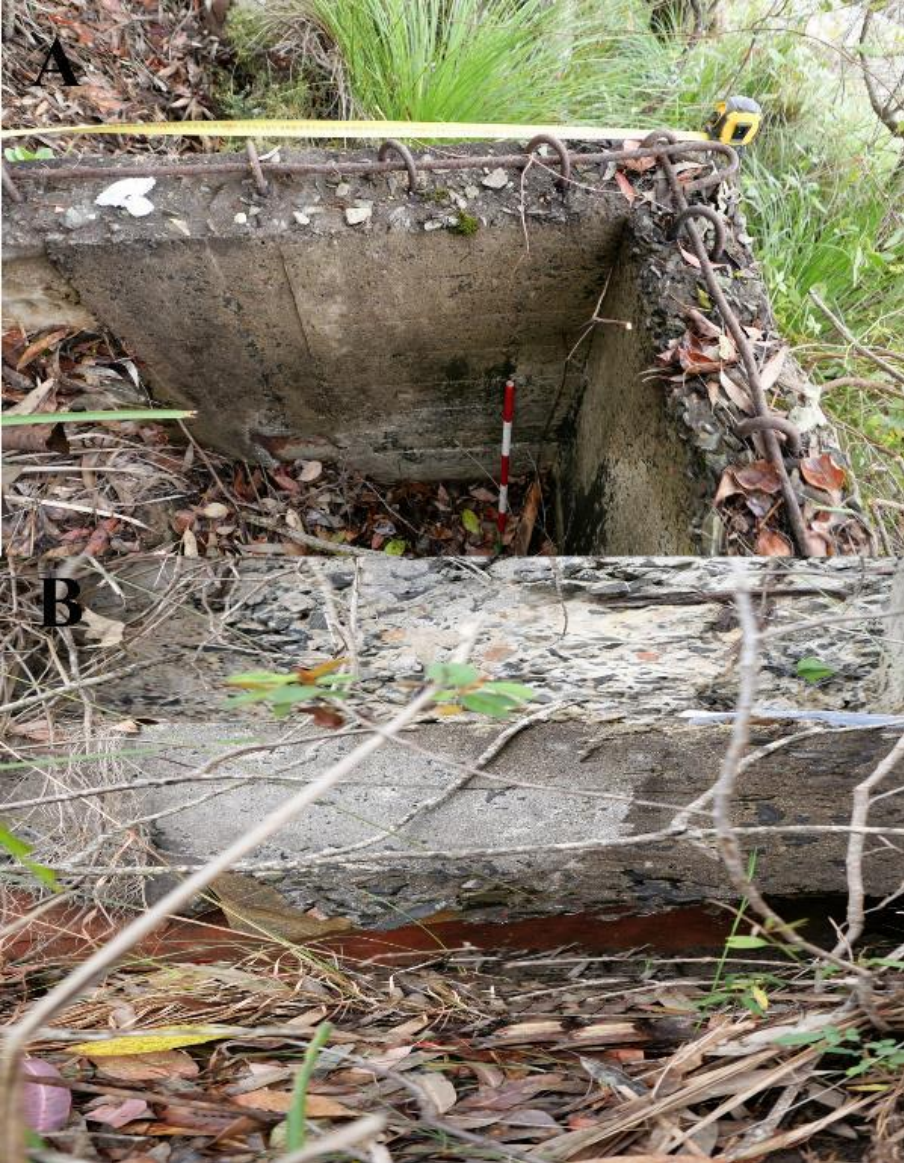
Figure 4-8: Looking into the CASL bunker. A- Showing the depth. Range pole is 10cm increments. Heavy steel loop and wire on the top of a 15cm wide wall. B- Bottom of the outside wall. Red brick supports the concrete wall.

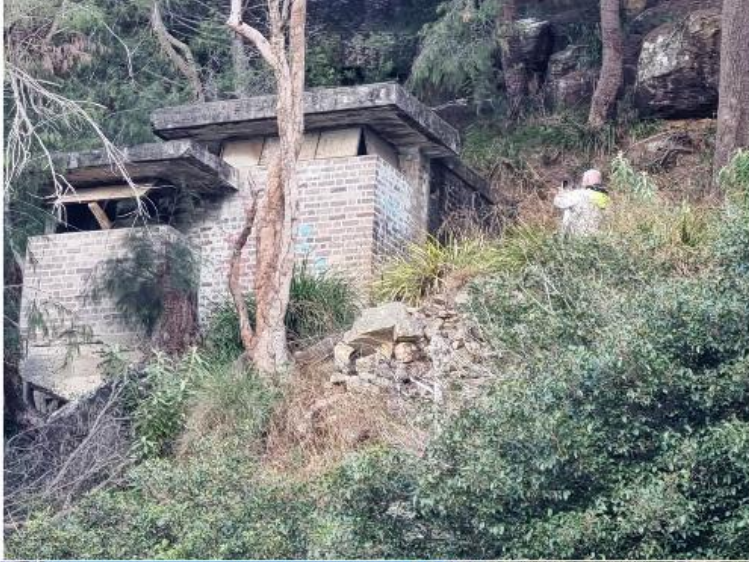
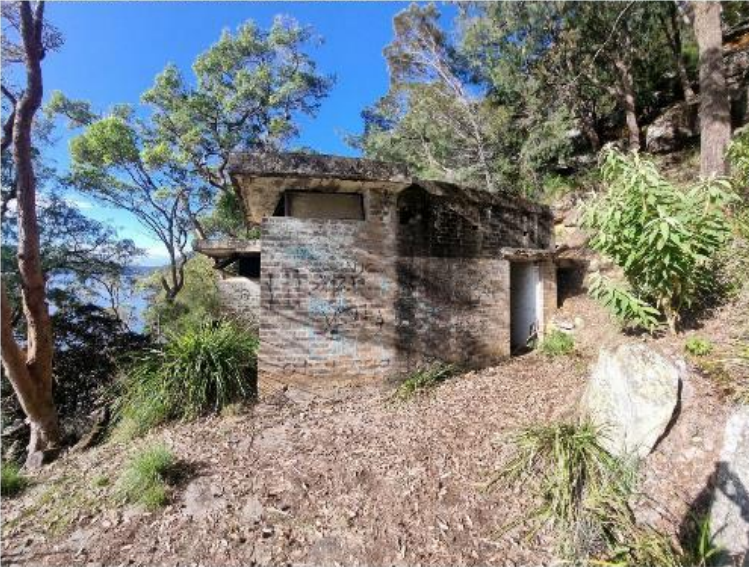
The building has been extensively damaged inside and out by graffiti, fire, and other forms of vandalism, although it is possible to ascertain the function of the control hut. Due to the black walls, there is no corporate/unit graffiti. Homelessness re-use is evident due to tents and other domestic items situated about the area and around the control hut, as well as a large amount of drug paraphernalia.

Figure 4-10: External photographs of Hungry Beach control hut. Similar design to Juno Point however does not have an extra room attached. The hut is built up on the side of a cliff using dry walling and concrete foundations are evident on the top photograph. Metal has replaced the glass, this appears to be a recent addition however as with Juno Point they are cantilevered opening outward. The back of the hut is cut into the mountain with the access door having a large concrete lintel over it, though no hinged door is attached.

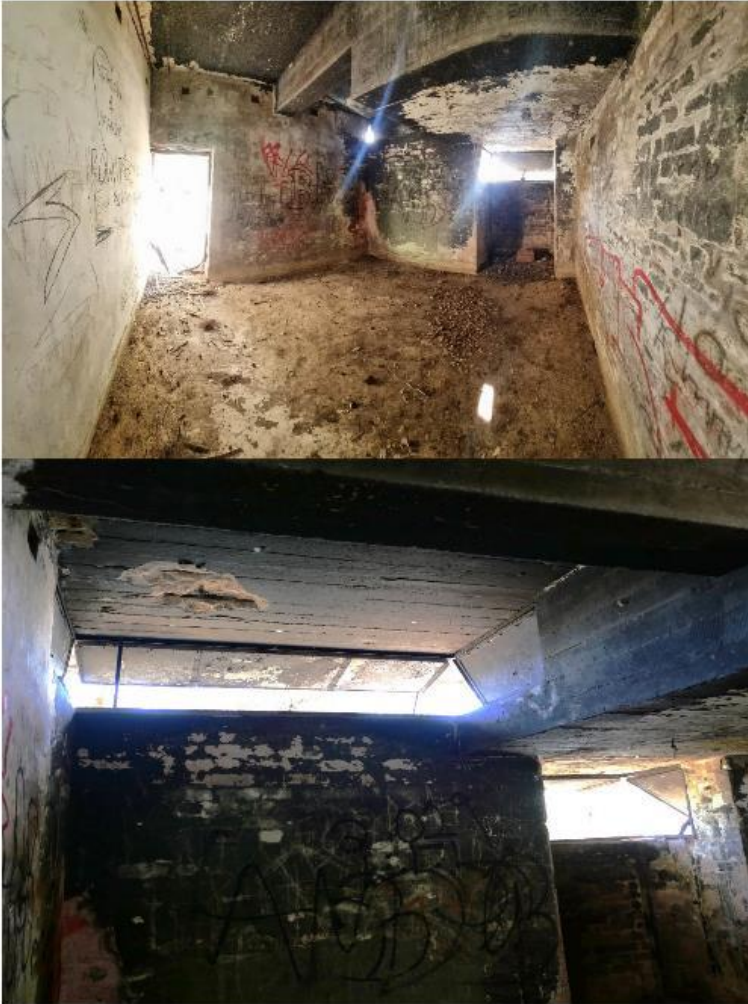
Figure 4-11: Hungry Beach control hut internal. There is a plain concrete floor and evicent brickwork behind the render type walls. The windows are set on two levels, similar to Juno Point though no scar of a mounting structure was evident. The roof is riddled with cancer and rusting reinforcement steel and it is evident that it has been on fire or exposed to fire at least once. Hungry Beach is a public accessible location whereas Juno Point is Government Land where permission is required to enter. The difference in the condition of the sites is this limiting access factor and National Park Service not recognising the significance of Hungry Beach.

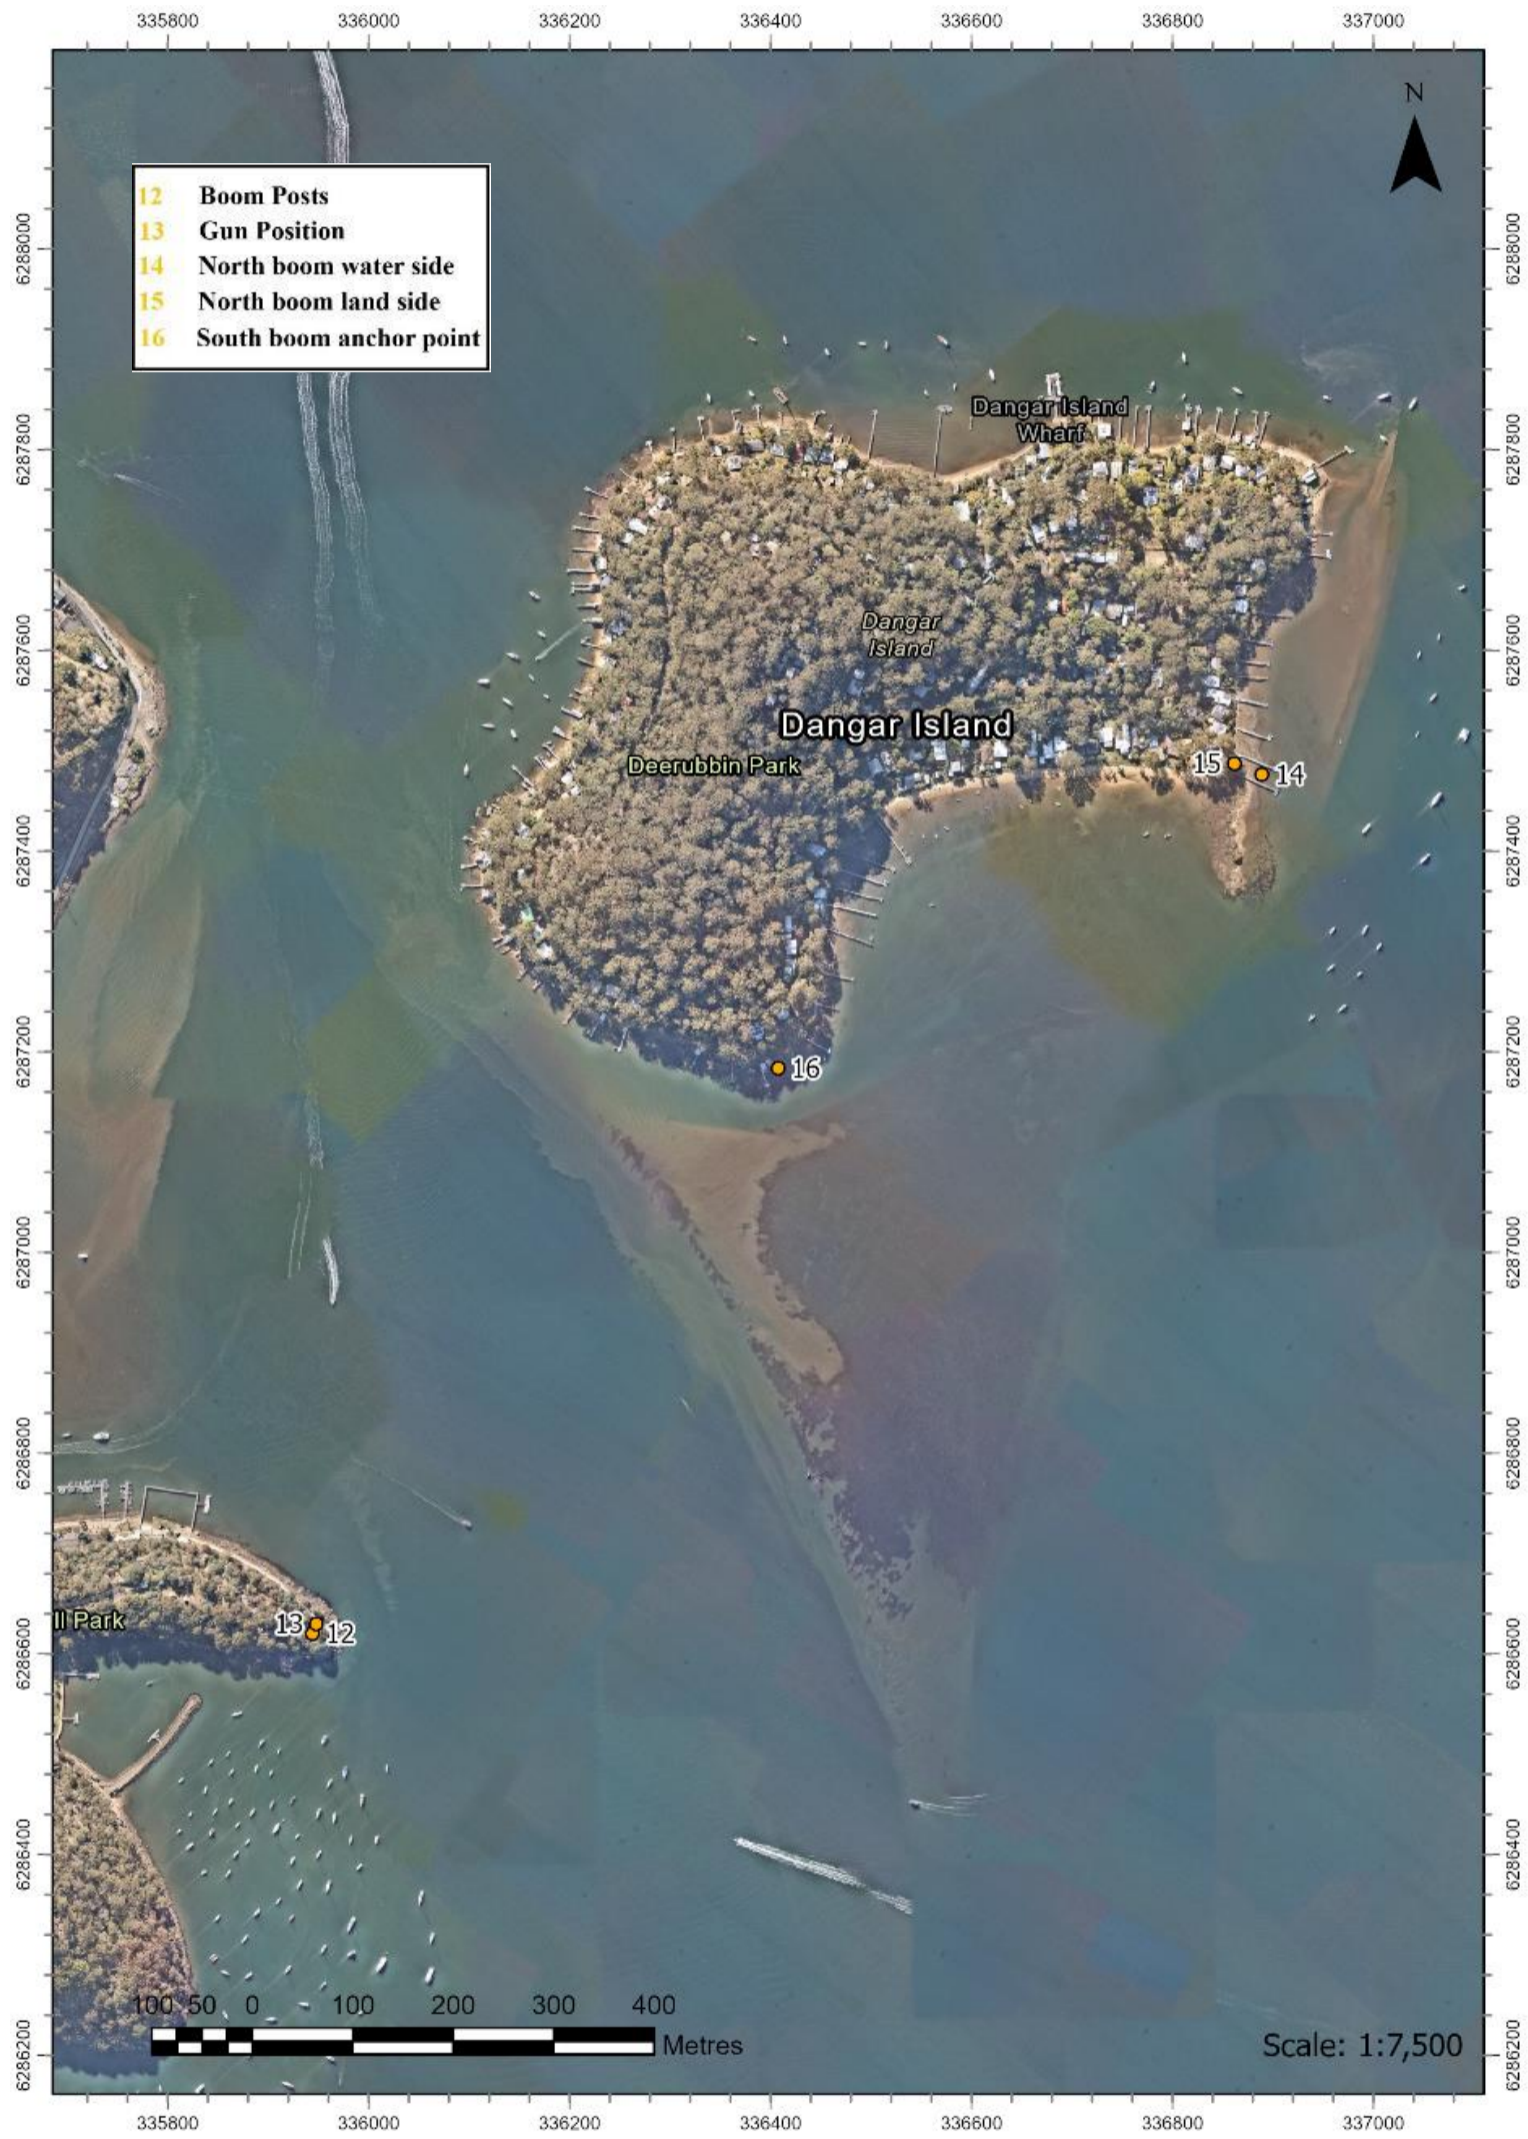
Map 4-3: Flat Rock and Dangar Island overview with defensive archaeology marked.

Flat Rock contributed to shielding the Hawkesbury River Railway Bridge from submarine incursions by providing a last line of defence. Flat Rock is a spur, east of the township of Brooklyn and southwest of the southern tip of Dangar Island. The location housed two defensive infrastructures, gun emplacement and shoreline boom securing.

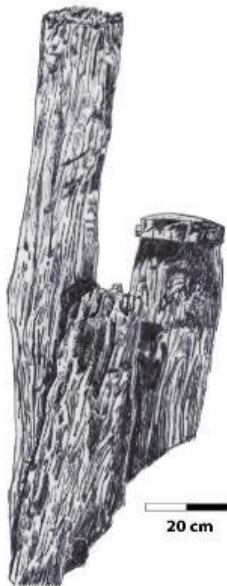
Figure 4-12: Ink drawing of the posts to details weathering. (Author)

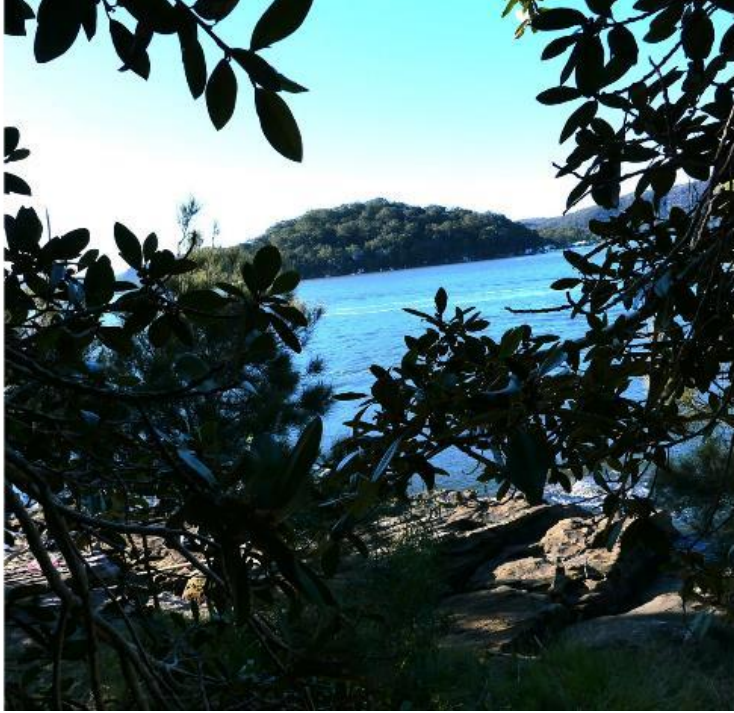
Figure 4-14: View from the boom support posts across to Dangar Island through dense vegetation.

Flat Rock (Figure 4-14, 4-15) and Dangar Island North (Figure 4-18, 4-19) also demonstrate reuse in the modern era and examination of this can answer other research questions.

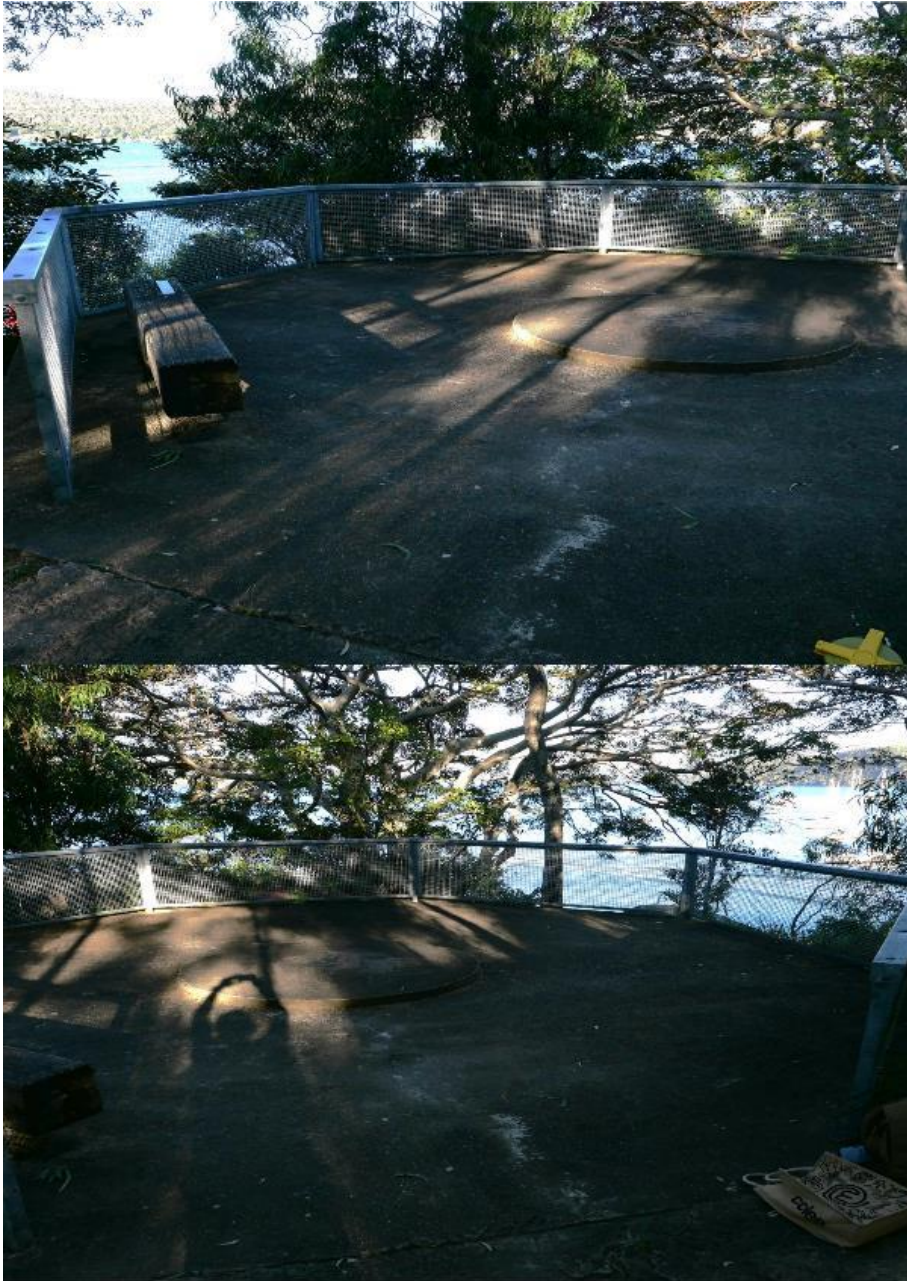
Figure 4-15: Gun position with modern safety barriers installed. The pin in the centre has been replaced brass capping plate flush with the concrete. The round inner circle is the same diameter as Juno Point within 10cm.

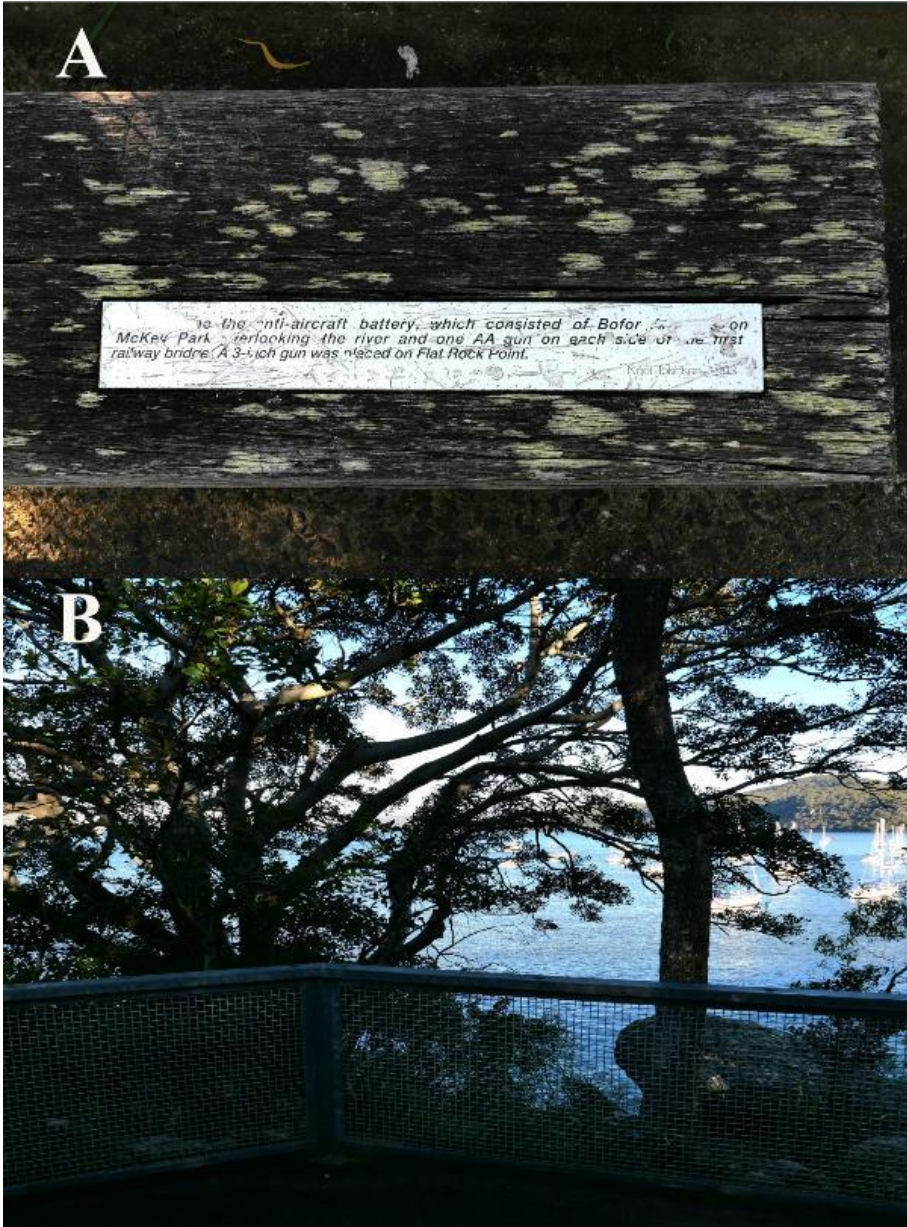
Figure 4-16: (Top) Wooden seat with a mounted plaque claiming the location was for anti-aircraft guns during the war. All anti-aircraft guns were mounted north and south of the bridge by the pylons (Anonymouts 1943j). (Bottom) View from the gun position looking towards Juno Point. With no vegetation un restricted views of any incoming vessels would be available.

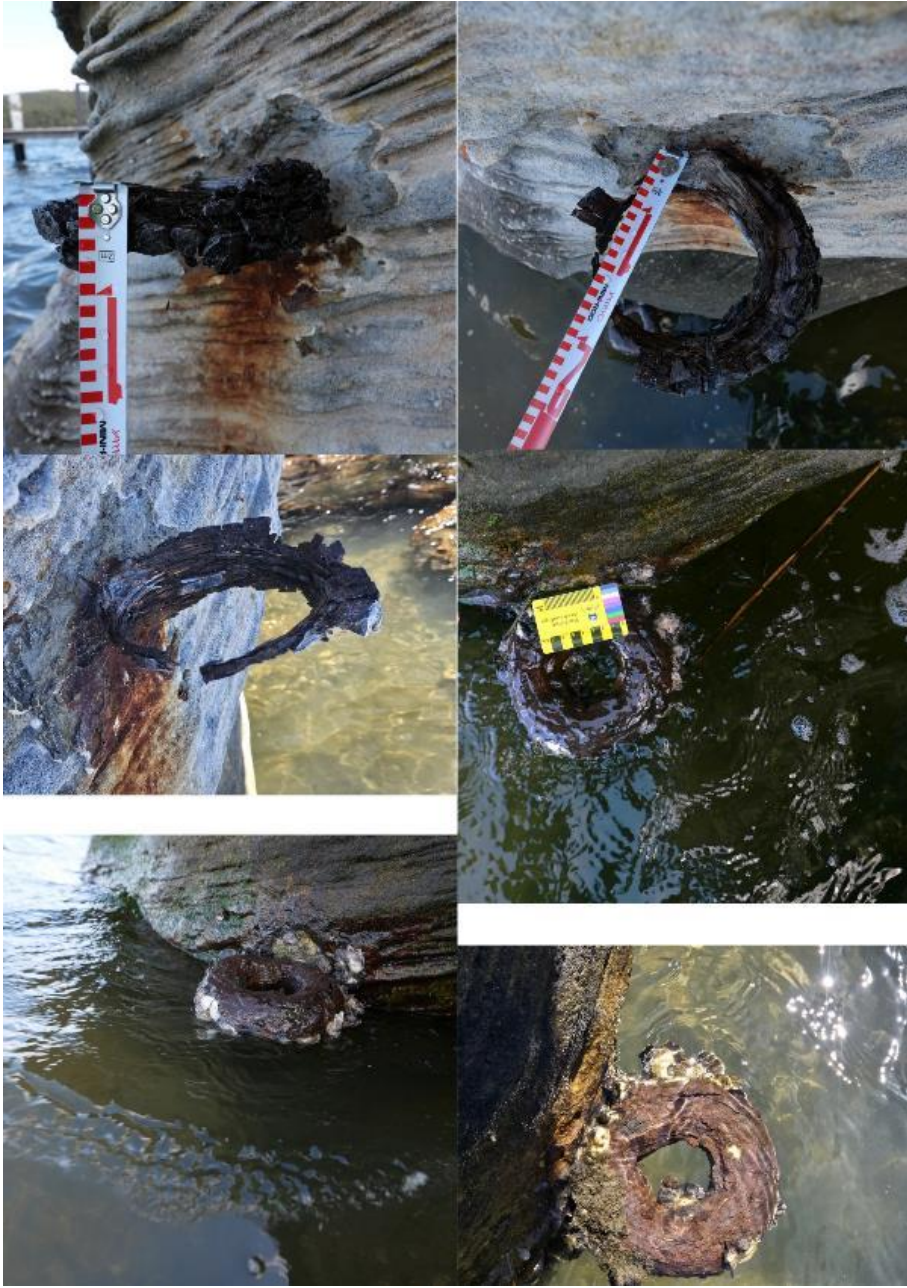
Figure 4-18: Close up of the securing rings. Upper ring (1-3) shows extensive corrosion and laminating, it is not affected by tidal movement since it is 1m above the bottom ring. Bottom ring (4-6) still remains in near original form, though some

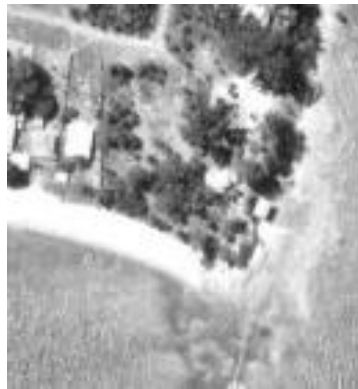
Figure 4-19: : Northern Dangar Island with a square structure near the boom cable anchoring point. This structure is no longer visible and due to the extensive construction work carried out by occupants any previous archaeology has been destroyed. Photograph from NSW Government Spatial Services, film CCC61,1/01/1947.

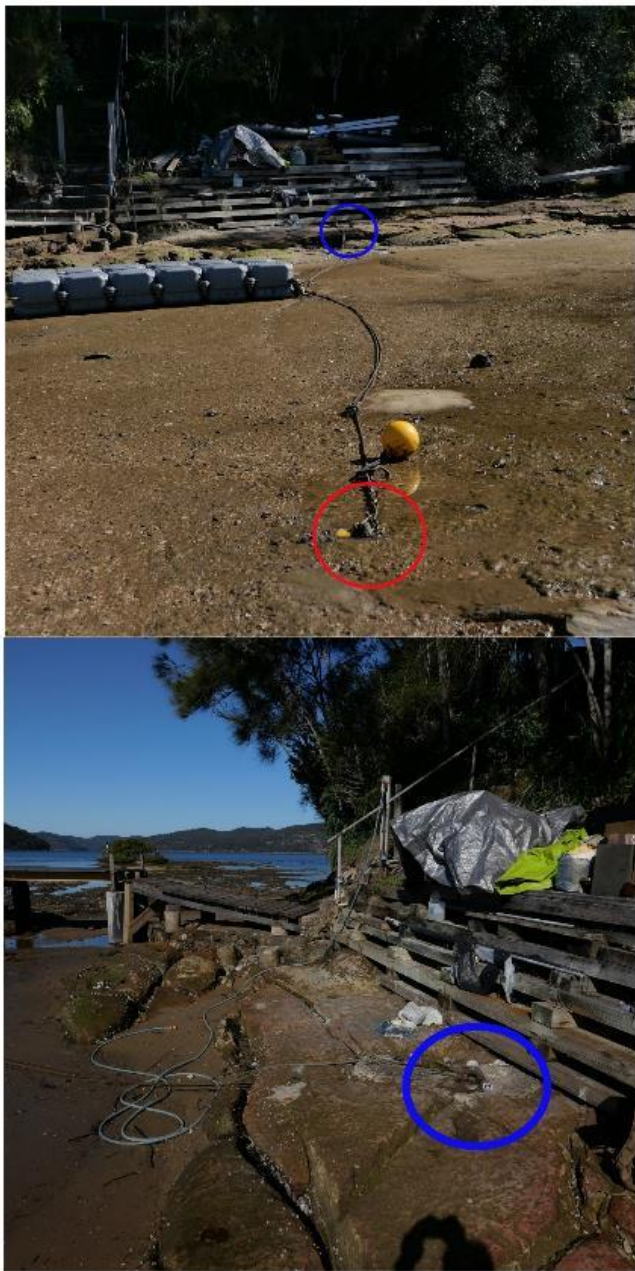
Figure 4-20: Location of two securing rings for the northern boom at Dangar Island. The rings are being reused with marine securing lines running from them. Building on the foreshore has possible destroyed or hidden any further archaeology at the location.

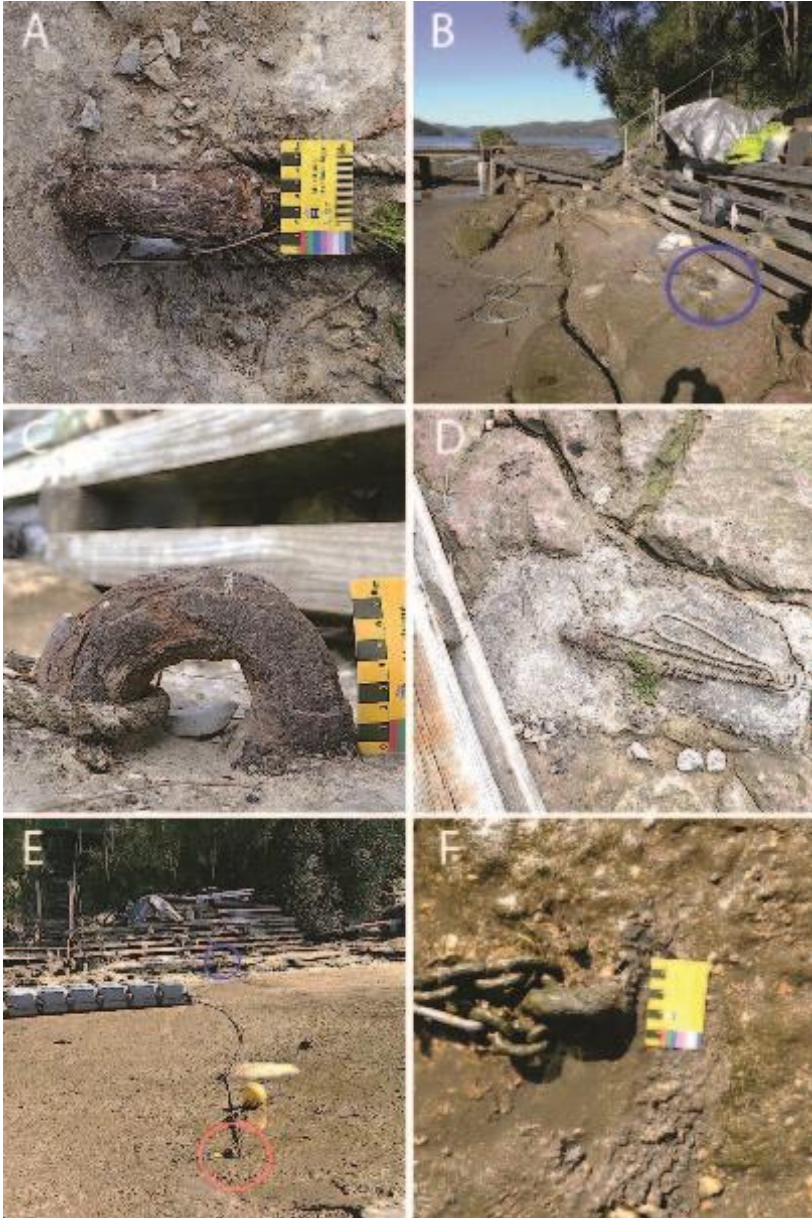
Figure 4-21: Close up of the securing rings with associated sizing. Securing ring F is only above water a very low tides. Photograph D shows a large amount of concrete around the shore ring, with diameter and depth of each hole unknown. There was a gate on the northern boom.

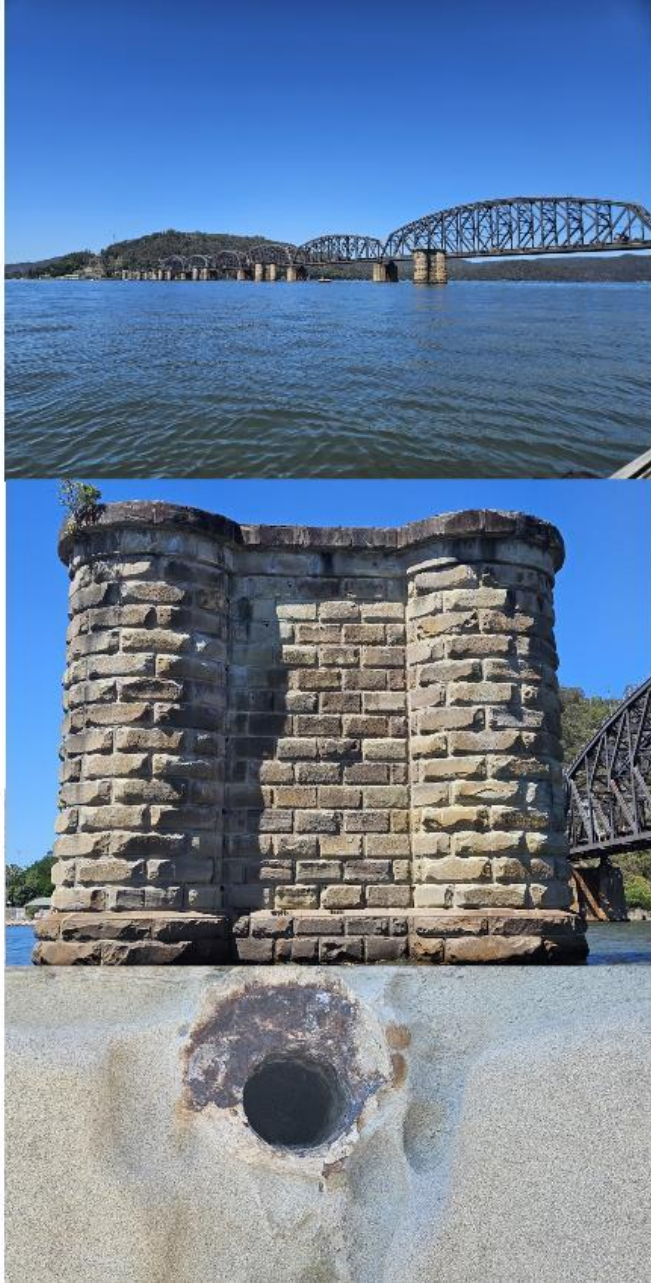
Figure 4-23: The span of the old Hawkesbury River Railway Bridge front of new bridge (top), photograph of a single pylon that has six holes drilled between the round and flat sections with random holes drilled in the face of the flat section (middle). Clos up of a hole drilled in flat sections of the pylons (bottom). Hole diameter 100mm, depth unknown.

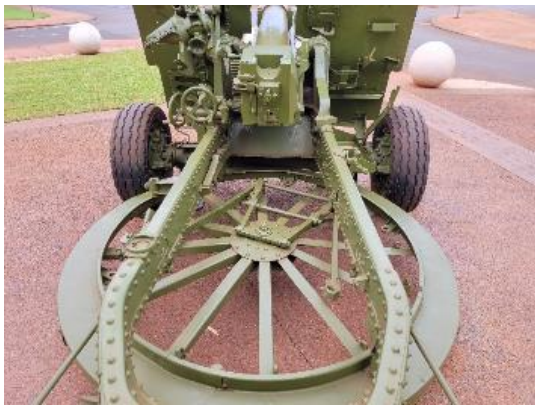
Figure 4-24: 25 pounder field artillery gun mounted on rotating ring. (located Port Hedland).

traverse different angles. A tangible visualisation of such a platform is provided by a 25-pounder gun still affixed to a platform at Port Hedland RSL (Figure 4-24). Information derived Photograph by author. from this source details the area of fire, effective ranges, and the concept of "dead water," signifying areas beneath the guns where submarine attacks are unfeasible. The 18-pounder field gun's rate of fire ranges between a sustained level of 4 rounds per minute (one every 15 seconds) and a maximum rate of 20 rounds per minute (one every 3 seconds), with a muzzle velocity of 492 m/s (Fisher and His Majesty's Stationary Offices, 1914: 56).

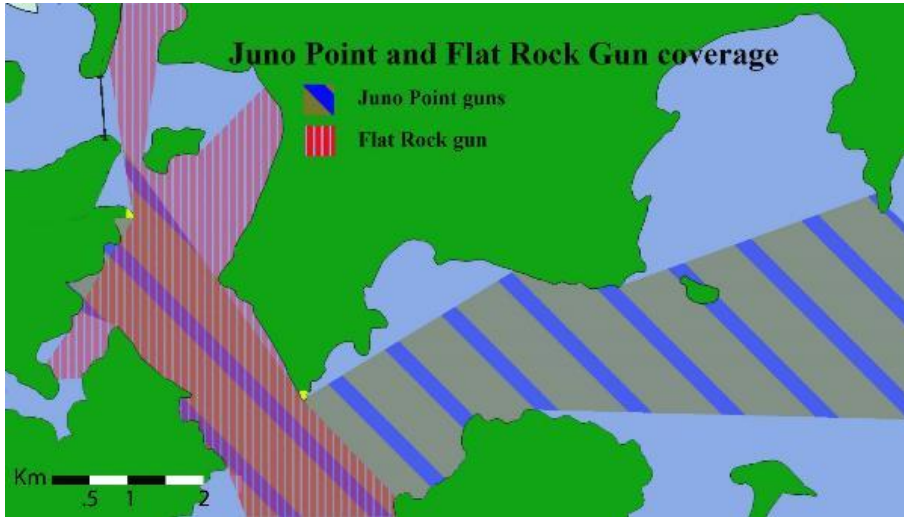
Figure 4-25: The coverage of all the guns relative to their positions. Dead zones not included since they are relatively small (50m) maximum. At all times until past Dangar Island south heading NE there are a minimum of two 18 pounder guns firing on the target (Fisher and His Majesty's Stationary Office 1914).

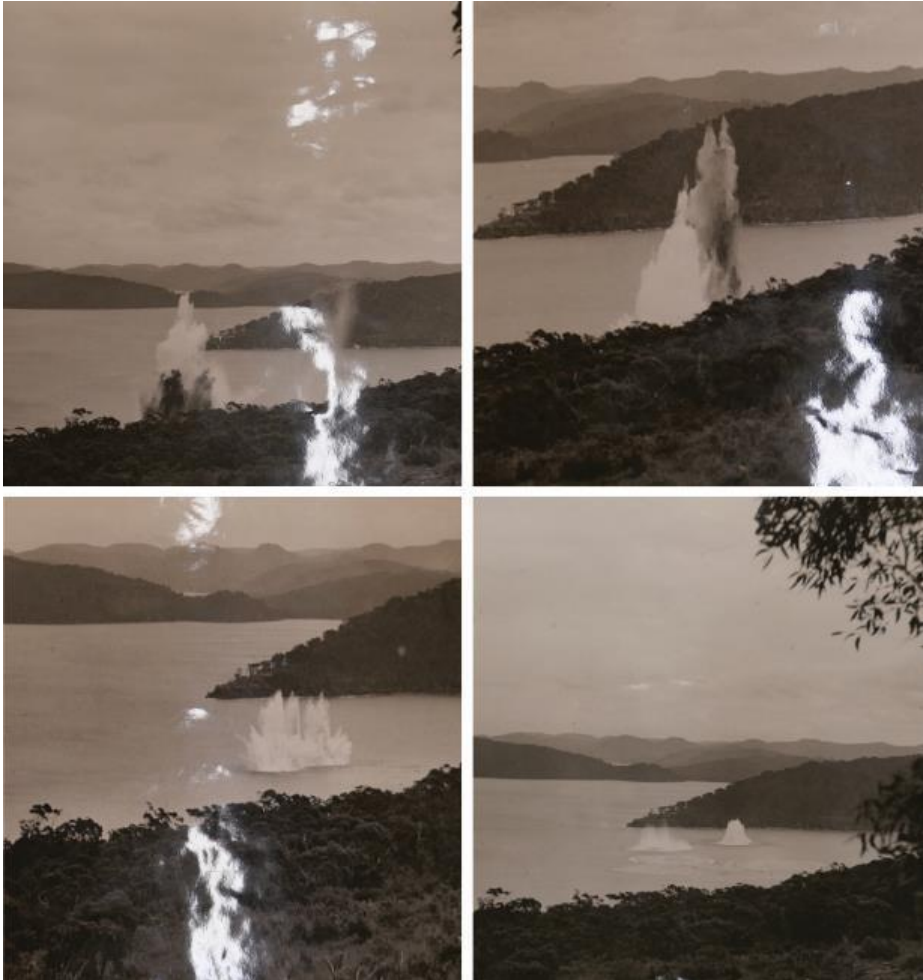
Figure 4-27: As reported (Anonymous 1943m) the minefield/s were decommissioned over two days as two groups failed to detonate. Juno Point is the middle of the photograph and decommissioning occurred in Little Patonga Bay. The explosive nature of the three mines in group is evident in the photographs. No indication of Hungry Beach's minefield being decommissioned has been located.

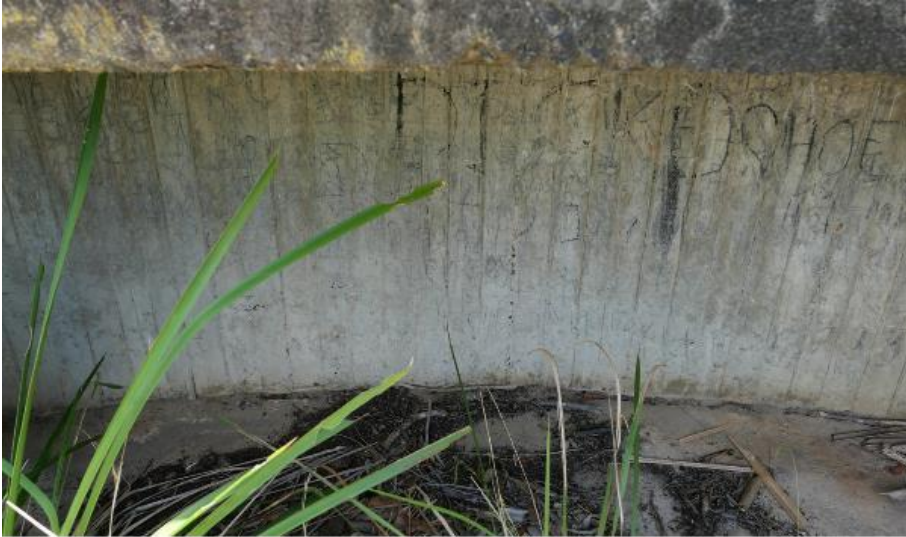
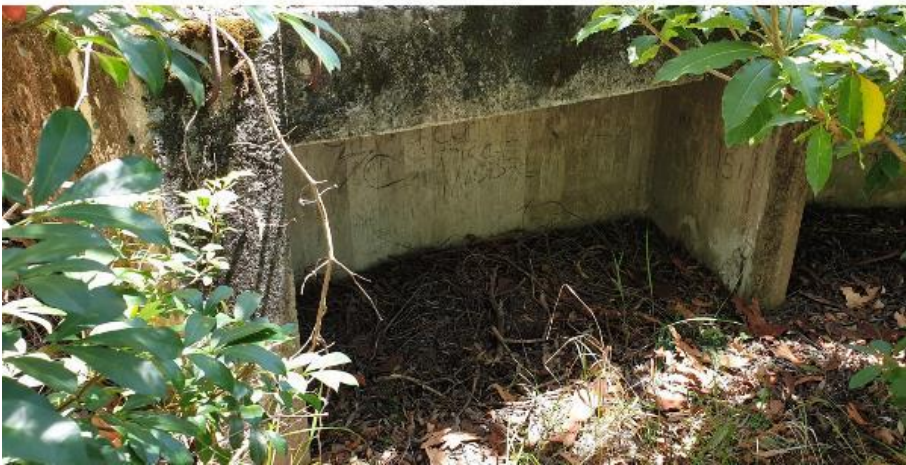
Figure 4-30: Example of graffiti in the ammunition bunker at Juno Point. Further study into the area around the isolated graffiti in a protected area might shed light on the people/students who left their mark for the future.

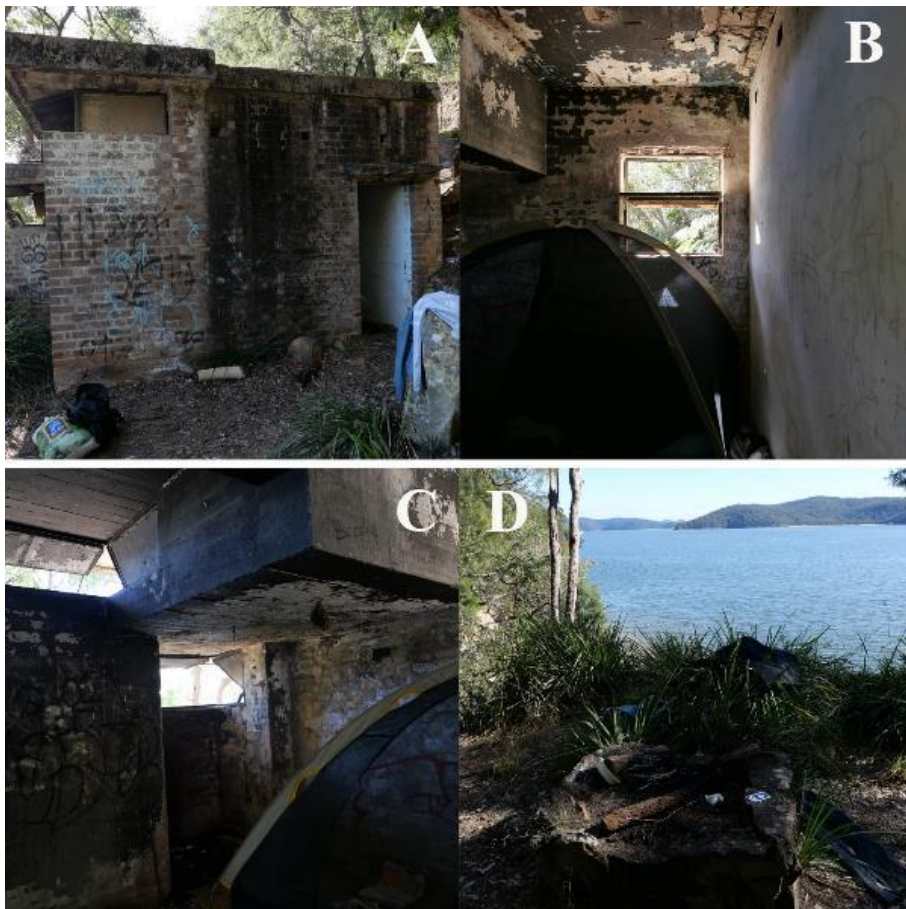
Figure 4-31: Reuse by vagrants. A- Shows clothes hanging to dry, a backpack with male clothing inside as well as the Aldi bag containing female clothing. B- Tent set up inside the control hut. C- Tent and personal belongings within the tent. Over at the far lower window a large amount of drug paraphernalia was located. D- Possible mount for WW2 signal light now being used as a firepit with refuse within and without.
