Assessing the Efficacy of Anti-Submarine Measures in Broken Bay for Safeguarding the Hawkesbury River Railway Bridge.

This thesis submitted to Flinders University for the degree of Masters in Maritime Archaeology.

Paul Edward Gale

2 January 2024

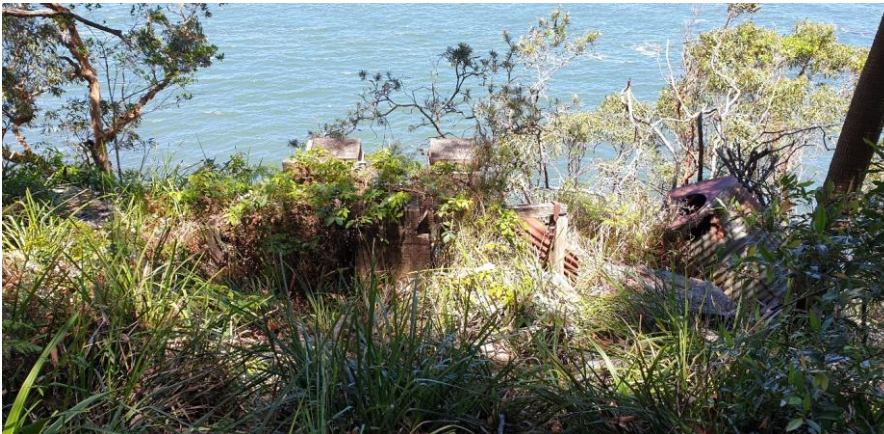
Figure A2-1: Feature overgrown. A set of bricked stairs leads from the control hut area. It is not considered the water tank is associated with the feature because of the location to the control hut.

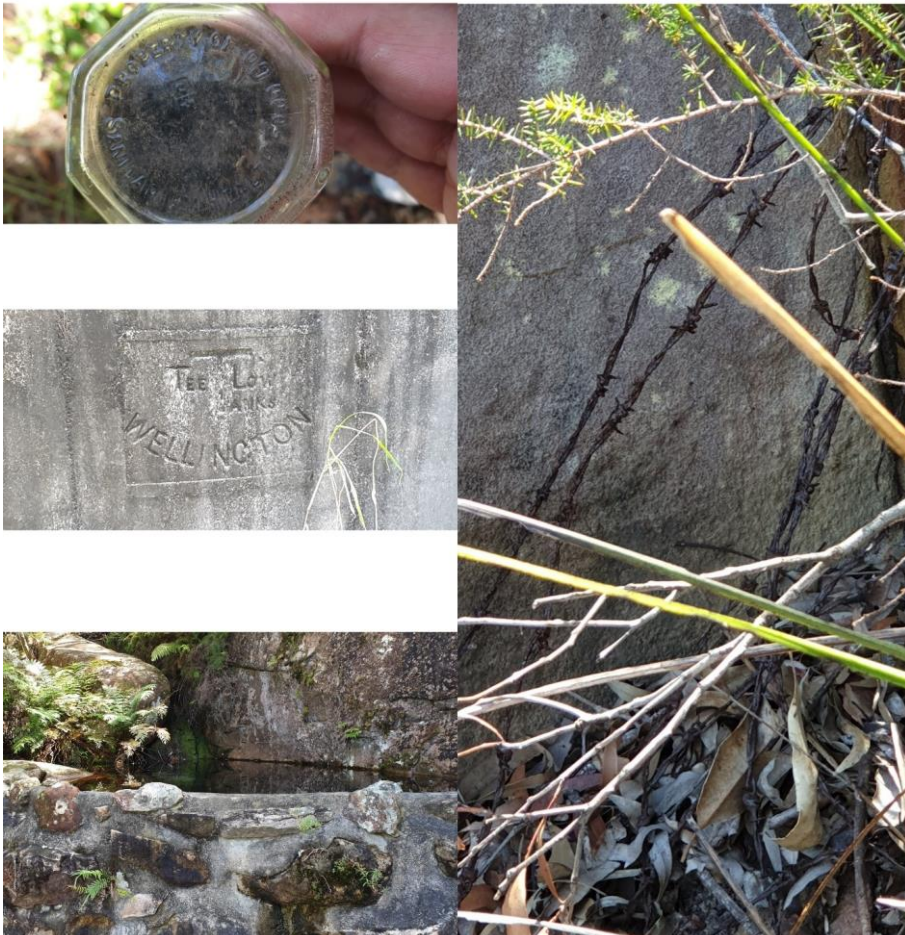
Figure A2-3 comprises a series of images, each offering unique insights into distinct features within the archaeological site:

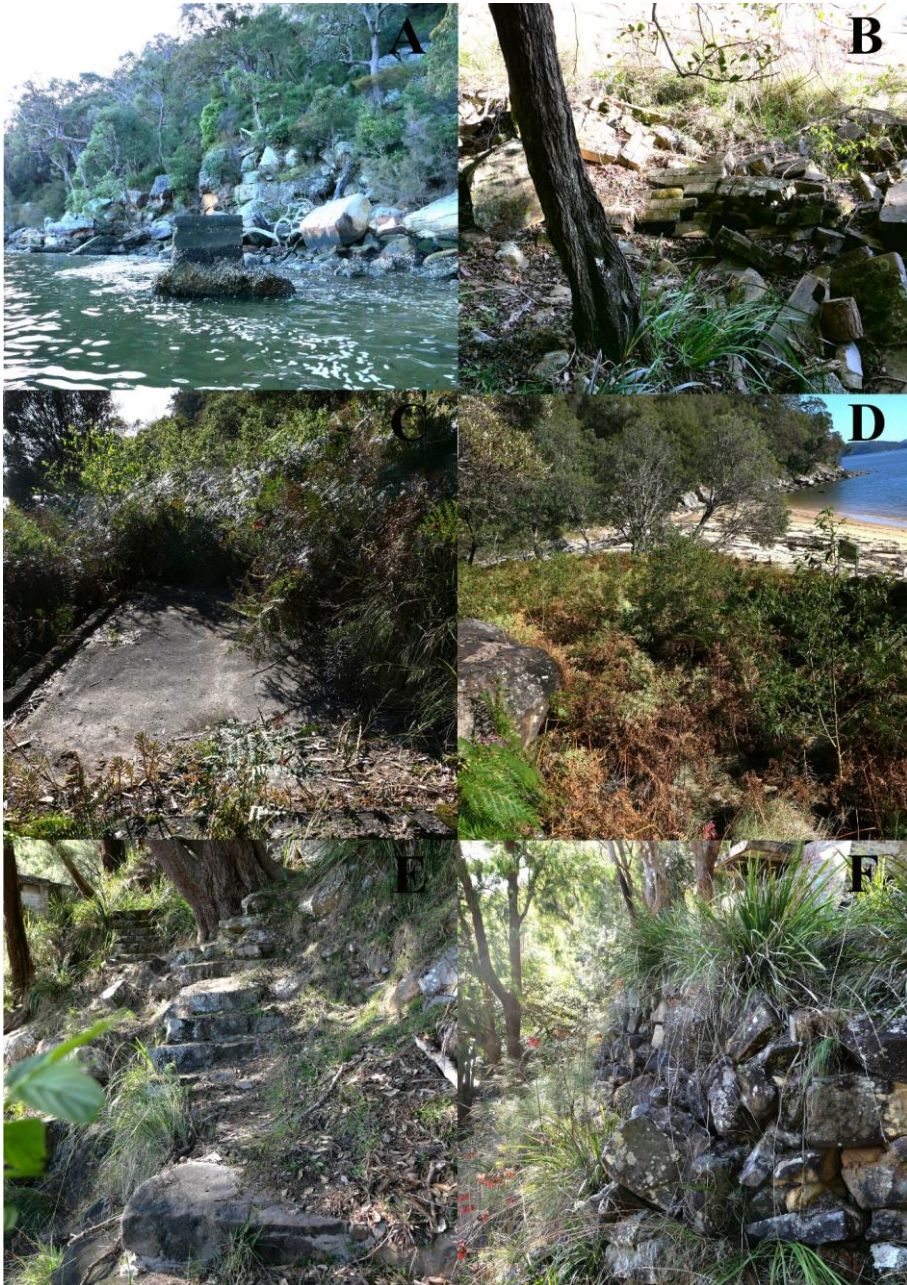
Figure 3-2 provides a comprehensive visual documentation of various features within the archaeological site:
A- A prominent and sizable concrete structure positioned in close proximity to the former wharf facility. It is hypothesised that this structure may have supported a derrick, facilitating the unloading of substantial supplies such as diesel drums for the generator.
