# Preliminary analysis of timber and metal remains from *Shah Muncher* Shipwreck

*Thesis submitted to Flinders University in partial  
fulfilment for the degree of*

**MASTER OF MARITIME ARCHAEOLOGY**

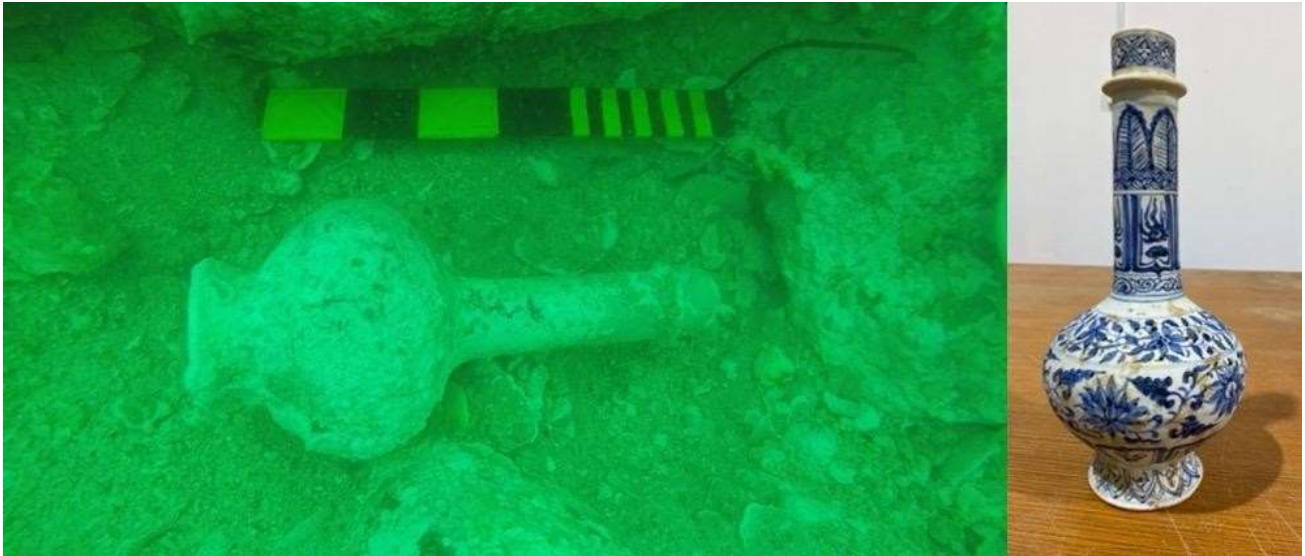
Figure 1: Fourteenth-century blue and white hookah bottle found at the Temasek Wreck. Artefact found in- situ (Left) and artefact after conservation treatment (Right) (M. Ng, 2022).

In 2015, a shipwreck was found around Pedra Branca. Archaeological surveys and excavations took place between 2016 to 2019 on what is now known as the Temasek shipwreck. The shipwreck was the first site found along the Singapore Straits that dates to the fourteenth century. The recovered artefacts from the site contained largely ceramics, small quantities of glass beads and metal artefacts related to the fourteenth century. Most of these ceramics are consistent with those found at fourteenth-century terrestrial sites in Singapore (Miksic 2013; Flecker 2022b:47). These cargo items indicate the associations between fourteenth-century Singapore, the shipwreck and long-distance socio-economic value chains from China and Asia-Pacific to the west (Figure 1). The implications are local and global. According to a preliminary analysis, the wreck's cargo consisted of Chinese ceramics similar to other contemporary wrecks in Southeast Asia. These shipwrecks include the Sinan wreck in Korea; Jade Dragon wreck in East Malaysia; Turiang wreck in West Malaysia; Dalian Island wreck in Fujian, China; Bin Chau wreck from central Vietnam; Shiyu 2 wreck at the Paracel islands, near Hainan Island, China; Red Sea wreck in the Red Sea; Nilaveli wreck near Trincomalee, Sri Lanka; and the Samar wreck found in the Philippines (Flecker 2022b:55–58). These shipwrecks carried ceramic cargo typical of the fourteenth century, but the quantity and variety of blue-and-white Chinese ceramics were much lesser than the Temasek shipwreck (Flecker 2022b:55–58). These ceramics are unique from a maritime trade perspective, as pre-Ming blue-and-white wares dating to the Yuan dynasty are rare. It intimates a technological, production and socio-economic exchange system not well understood to date.

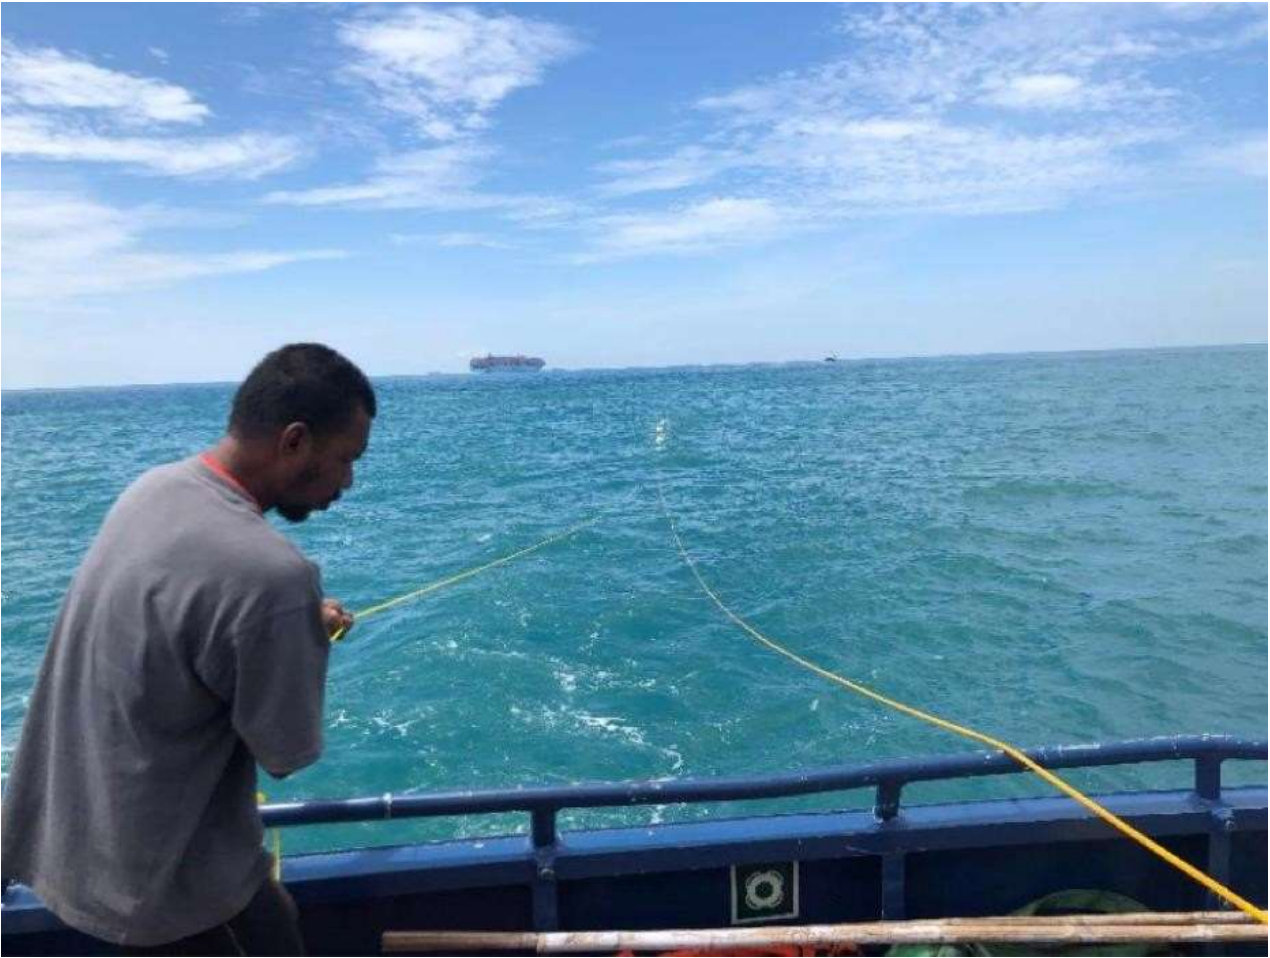
Figure 2: Magnetometer survey in search of shipwrecks around the vicinity of Pedra Branca (M. Ng, 2019).

In 2019, the local authorities approved a project to ascertain the possibilities of other underwater archaeological sites around the Temasek shipwreck area (Flecker 2022a). After a series of geophysical and diver visual surveys, the team found another shipwreck near a modern wreck (Figure 2 and 3). The surveys at the site revealed artefacts such as ceramics and two admiralty anchors. Archival research and analysis of artefacts from the site suggest that the wreck was *Shah Muncher*, a Country ship which sank in 1796 (Flecker 2022a). Further excavations in 2020 and 2021 revealed large quantities of ceramics, semi-precious stones, zinc ingots, timber fragments, two additional anchors, 24 cannons, and other remains, yielding essential data about the shipwreck.

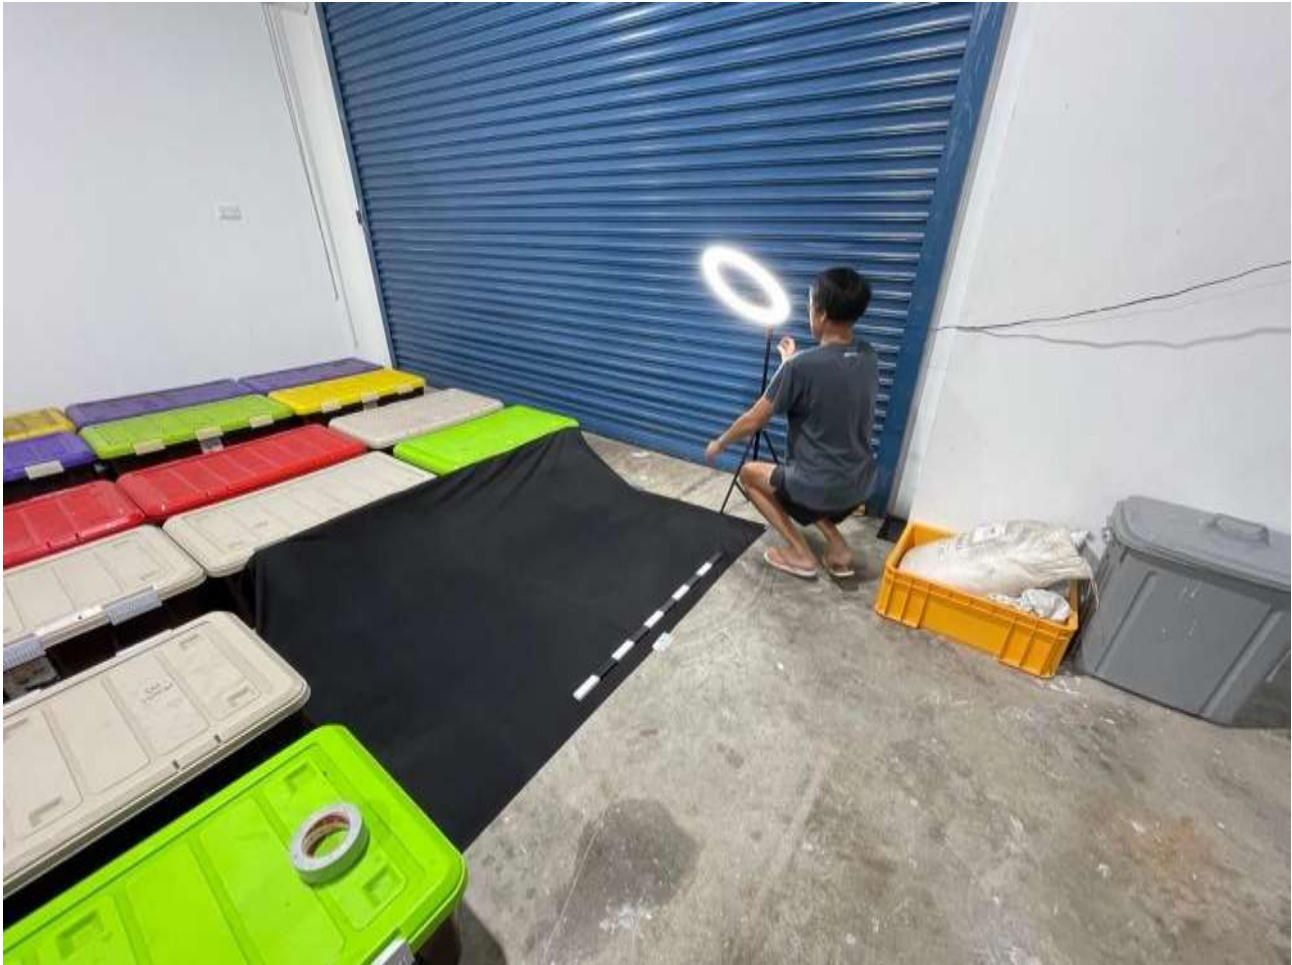
Figure 12: Setting up the photography area (M. Ng, 2022).

A Sony A7II camera with a 24–70mm lens was used during the photography of the timber and metal samples. Photographs were taken with a black cloth or a cleaned area of the facility's grey flooring to achieve a neutral background for the artefact photography. A ring light was used to provide the appropriate lighting to cancel out shadows (Figure 12). The lighting used was neutral white, and the white balance on the camera was set to auto to ensure colour accuracy in the photos. Black and white photographic scales with different lengths were used. It consists of 1m scales with 10cm increments; 50cm scales with 10cm increments; 30cm scales with 5cm increments and 8cm scales with 1cm increments. Photographs of the timber and metal remains were then processed using Adobe Illustrator. The timber photographs were used to trace the remains and create detailed sketches with written descriptions.

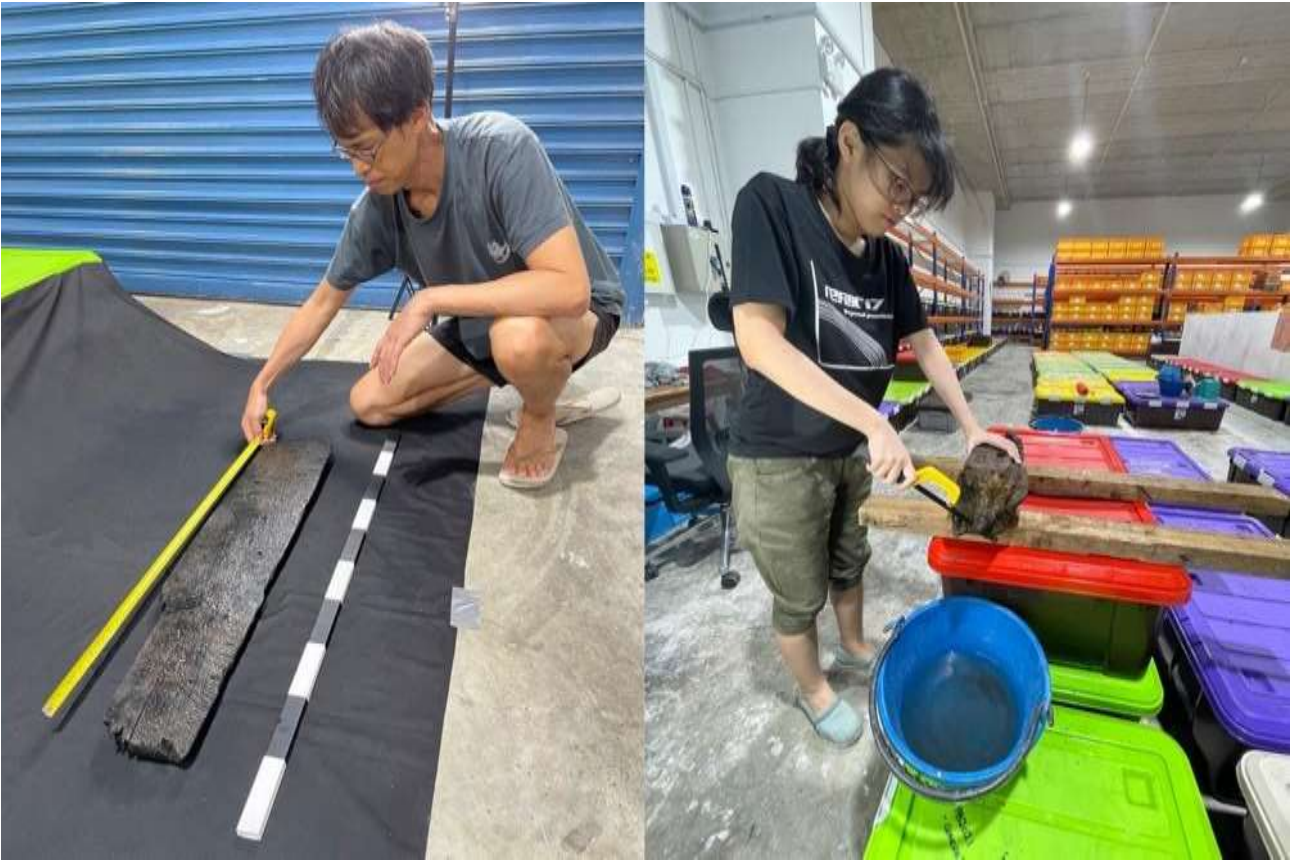
Figure 13: Measuring the timber artefacts by Jason Khoo (Left) and retrieval of timber samples by Kyna Khoo (Right) (M. Ng, 2022).

A total of 25 timber fragments were obtained for wood identification. A timber chisel, mallet and a handsaw were used to extract the samples (Figure 13). Each sample measures approximately 2cm<sup>3</sup> to provide enough material to be examined under a microscope (Figure 14). These samples were extracted from an area on the timber which does not exhibit any diagnostic feature. Samples would preferably be taken from the side of the timber, which shows a broken edge. These considerations were made to reduce the damage or dramatically modify the samples. Once the 2cm<sup>3</sup> samples were extracted, it was placed in a small plastic container filled with the solution from the conservation box. As there is no laboratory in Singapore capable of conducting wood identification, the samples were sent to the laboratory at Kementerian Lingkungan Hidup dan Kehutanan Republik Indonesia (Ministry of Environment and Forestry of the Republic of Indonesia). The timber specialist would sand the samples using sandpaper to expose the wood cell structure. The exposed cell structure would then be examined under the microscope.

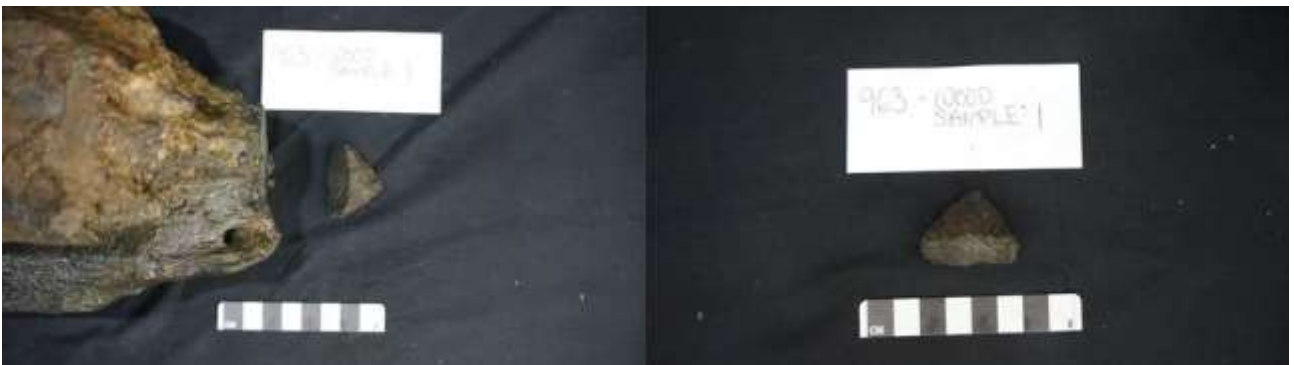
Figure 14: Timber sample prepared for analysis (M. Ng, 2022).

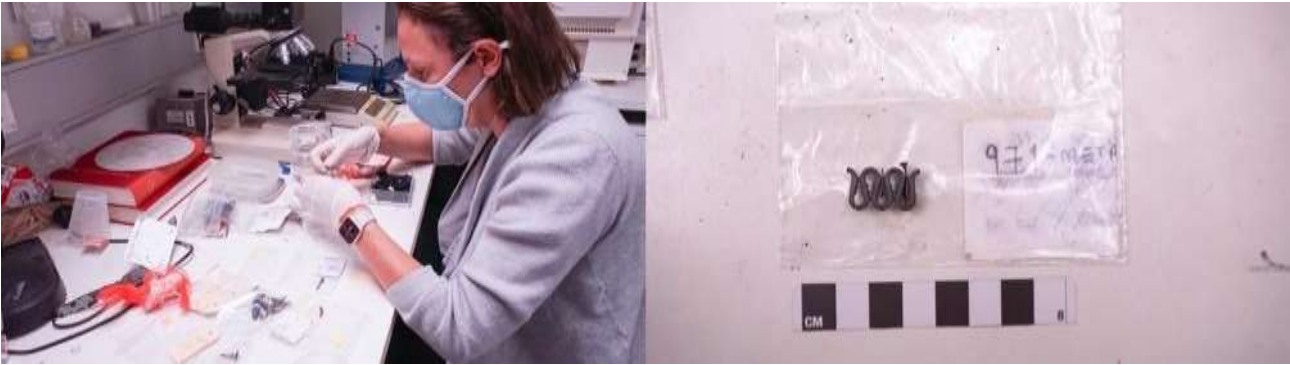
Figure 15: Metal sample preparation done by Wendy Van Duivenvoorde (M. Ng, 2022).

The metal samples were first cut samples into  $<1\text{cm}^3$  pieces (Figure 15) and embedded into a Struers MultiFast phenolic hot mounting resin. Resin was added onto the mounting resin before using a Struers CitoPress-10 hot mounting machine to set them. To attain a clean, uncorroded surface for analyses, a Struers TegraPol-11 diamond polisher was used to polish the samples (Figure 16).

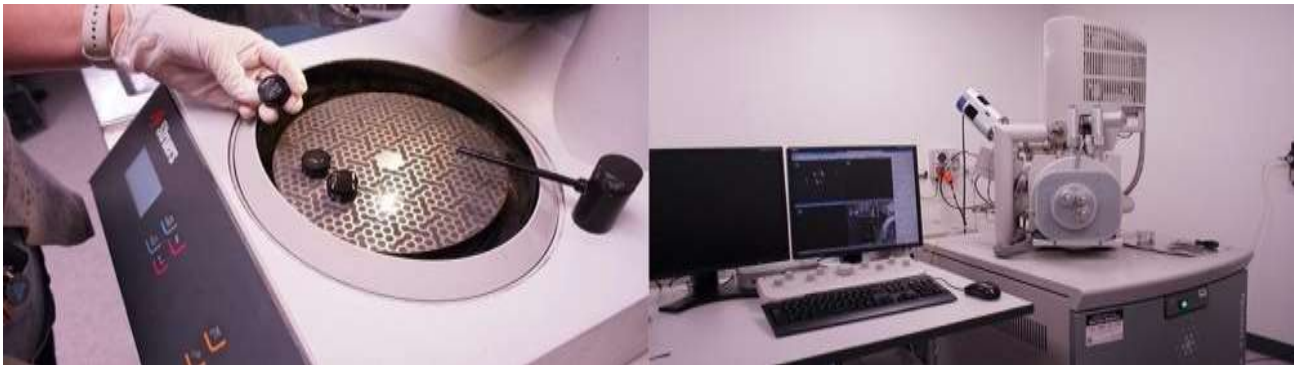
Figure 16: Samples were polished using the Struers TegraPol-11 diamond polisher (Left) before they were analysed using a FEI Quanta 450 SDD EDS detector (Right) (M. Ng, 2022).

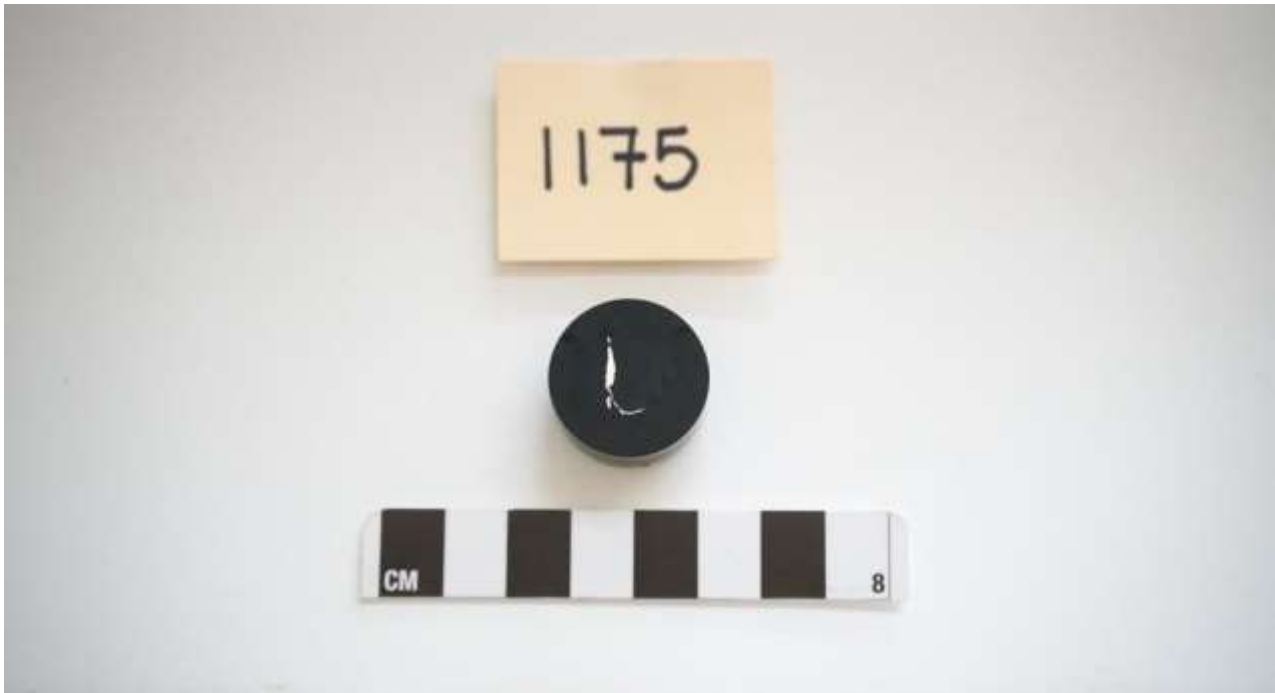
Figure 17: Metal sample prepared for analysis (M. Ng, 2022).

Once the samples were prepared, they were analysed using a FEI Quanta 450 with SDD EDS detector (Figure 17). The detector uses a semi-quantitative analytical method of elemental composition by spot or area testing. This is a localized testing method therefore the results may not represent the composition of an entire sample. This problem can be negated by testing three areas per sheathing and strap sample. Tack samples only require one spectrum as their cross-sectional shape easily offers a spot for testing. Setting on the Scanning Electron Microscope is set to high-vacuum, Kilovoltage: kV 20, Element Normalized, SEC table: default, standardless. The amount of time allotted for the sample analysis was automated as the Quanta 450 is the fastest SEM-EDS collector in Australia.

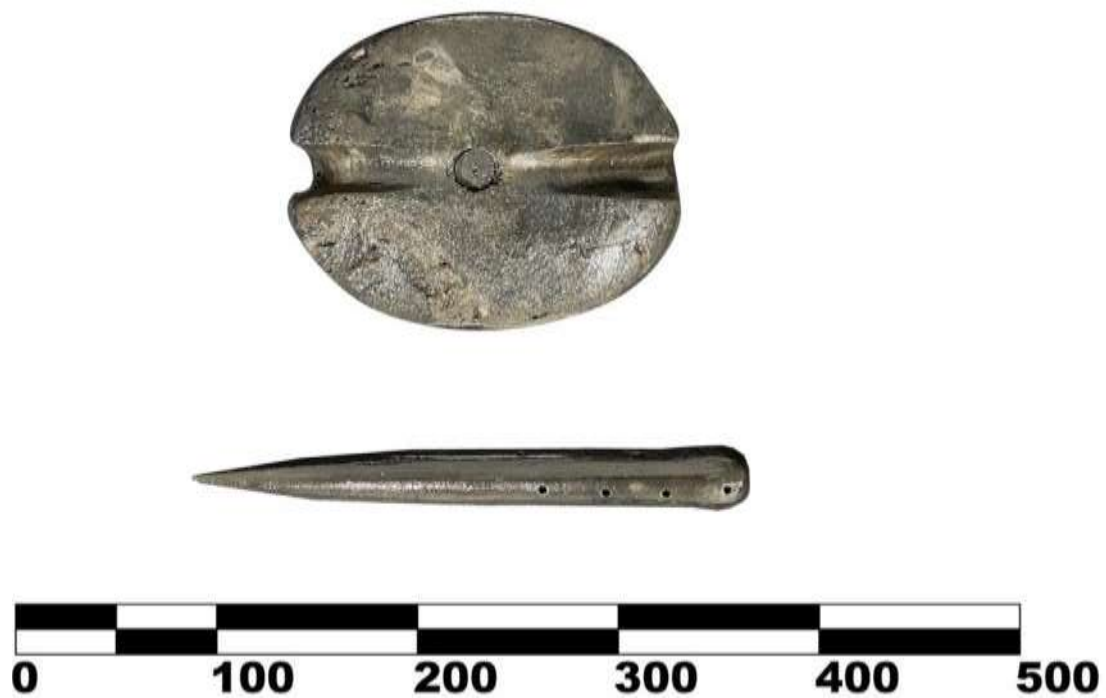
Figure 19: Pulley block and a wooden splicer found at the site (M. Ng, 2022).

A total of 170 timber and wood artefact were inventoried (Figure 18). The inventory is incomplete as other timber and wood artefacts have not been accounted for because of the ongoing conservation process. Some of the timber artefacts were identified as the pulleys (Figure 19) and runners (Figure 20), which were part of umbrellas. These umbrellas were identified as cargo under the ship's manifest; however, most timber and wood artefacts were unidentifiable. The chart below illustrates the quantities of each type of timber and wood artefacts relative to the overall quantity.

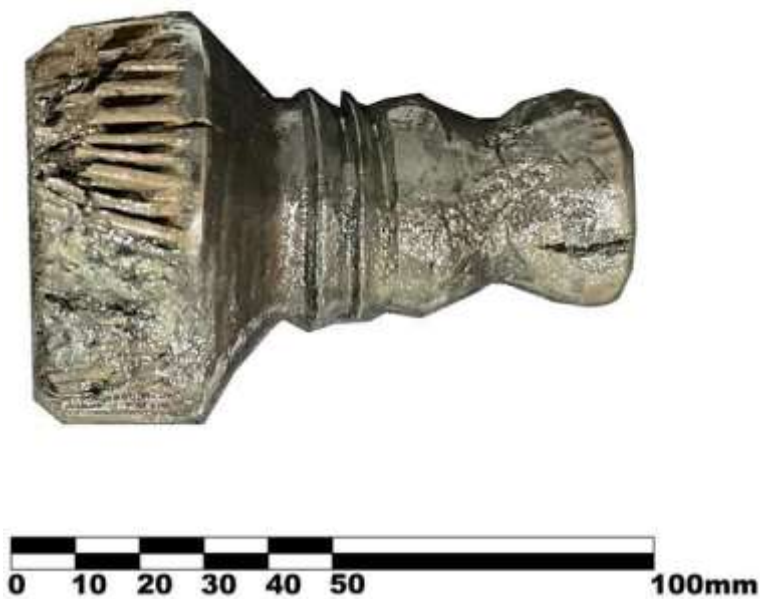
Figure 20: A wooden runner portion of an umbrella found at the site. Umbrellas were indicated in *Shah Muncher's* final cargo manifest before it sank (M. Ng, 2022).

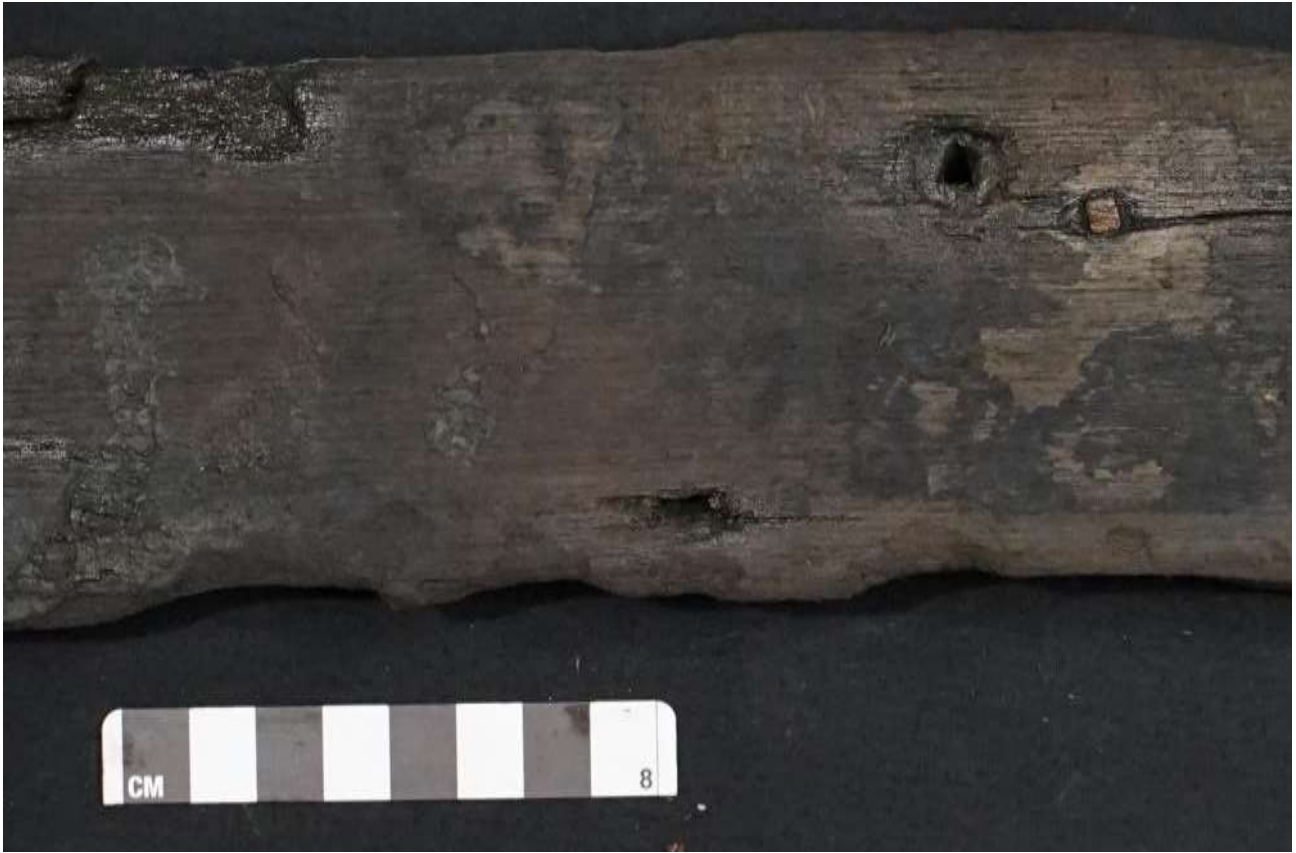
Figure 29: Close up image of an extant tack and a fastening hole. The fastening hole consists of a square hole within a circular impression (M. Ng, 2022).

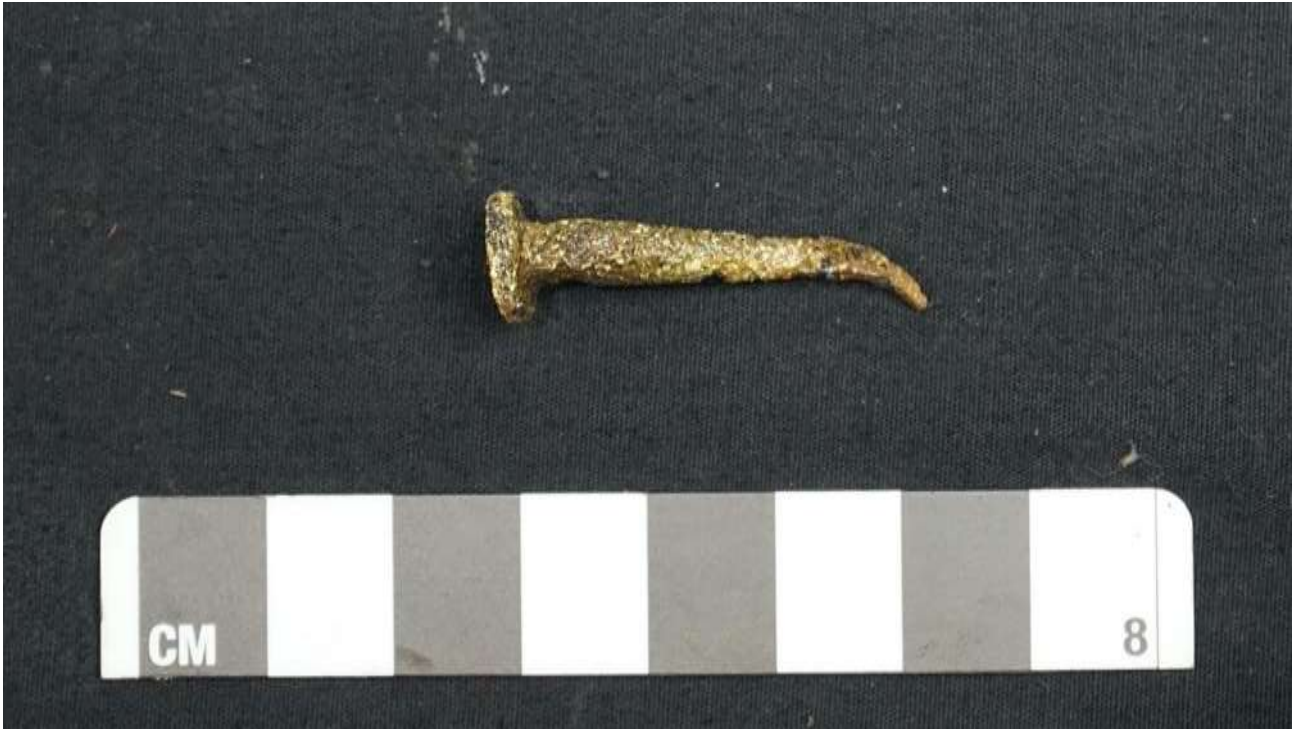
Figure 34: Extant tack from PB2\_1056 (M. Ng, 2022).

Table 31 provides a summary of the extant tacks found on the timber. Most of the extant tacks still retain the tack head, which is round, and all have square shank. The diameter of the roundheads of the tack ranges from 6mm to 14.4mm. Most tacks have diameters between 10mm to 12mm. Tacks without the heads have dimensions between 4mm by 4mm to 5mm by 5.6mm. The average length of the tacks found on PB2\_972 and PB2\_974 is 70mm. Tables 32 to 34 provide a summary of the tacks and metal sheaths that were sent for elemental compositional analysis. PB2\_983 (Figure 33), PB2\_1056 (Figure 34), PB2\_1069, and PB2\_971 (Figure 35) are metal samples obtained from the timbers, while PB2\_1175 (Figure 36) was a loose sheath. The analysed results of the collected samples are presented in tables 35 to 37. The full metal compositional analysis report can be found in Appendix 3.

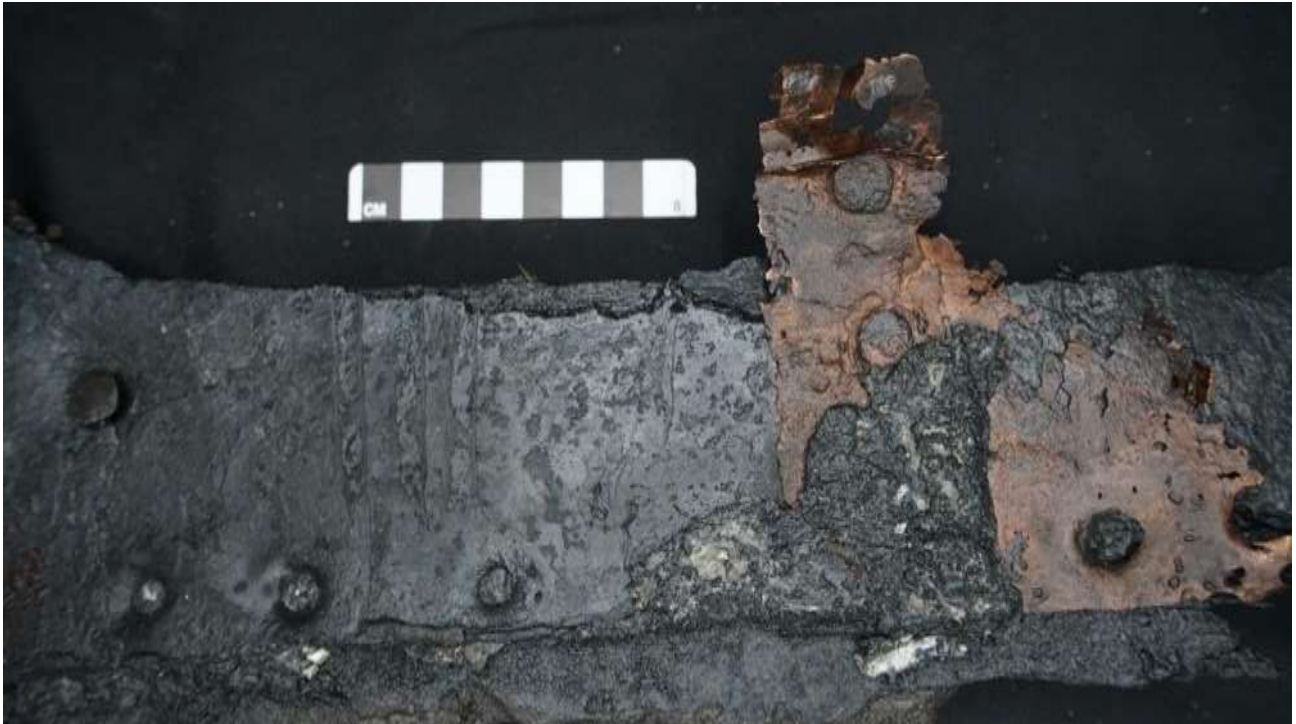
Figure 35: Section of PB2\_971 sheathing where sample was retrieved (M. Ng, 2022).

Artefact No.	Length (mm)	Width (mm)	Thickness (mm)
PB2_971	-	-	0.4
PB2_1175	150	90	0.5

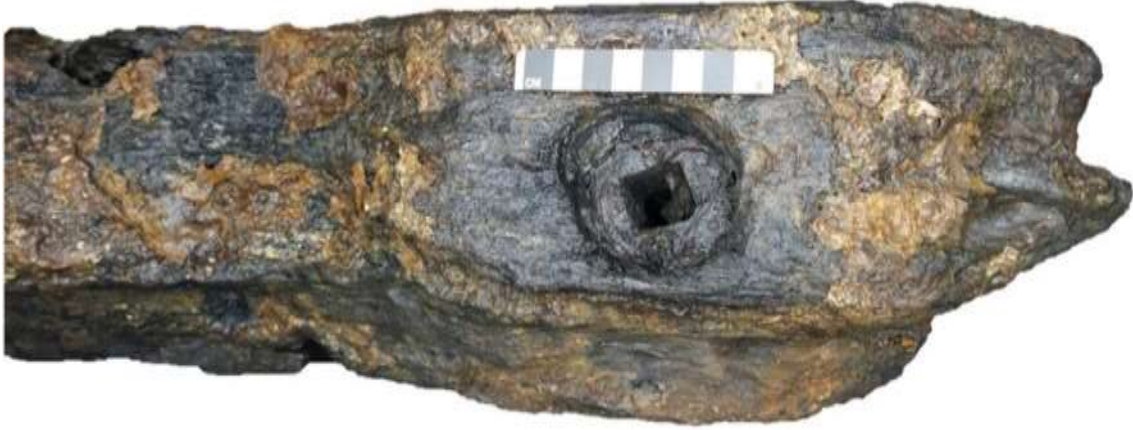
Figure 37: Close up of the hole made by a spike with round head or with washer on PB2\_963 (M. Ng, 2022).

The first key evidence to suggest that the timbers PB2\_949, PB2\_950, PB2\_959, PB2\_963, PB2\_964, and PB2\_965 are related to the ship structure were the holes found on the timbers. These timbers exhibited square holes and some of these square holes were found to be in the middle of a circular impression. The square holes were roughly measured 17mm by 17mm to 25mm by 25mm in section. The dimensions of the circular fasteners measured between 38.7mm to 61mm in diameter. The large difference in the circular dimensions could be attributed to the deterioration of the timber. The size of these holes and their shape suggest a spike would have been used on these timbers. Spikes found on these ships has a round head and a square shank. Historical records mentioned that the bolts on Bombay country ships are mostly square, and the bolt heads were smoothed with a composition. This description coincides with the holes found on *Shah Muncher* structural timbers (Bulley 2000:27). Evidence of similar fastenings can be found on *Endeavour*, HMS *Buffalo*, and *Sydney Cove*. They exhibited similar shapes albeit different in size.

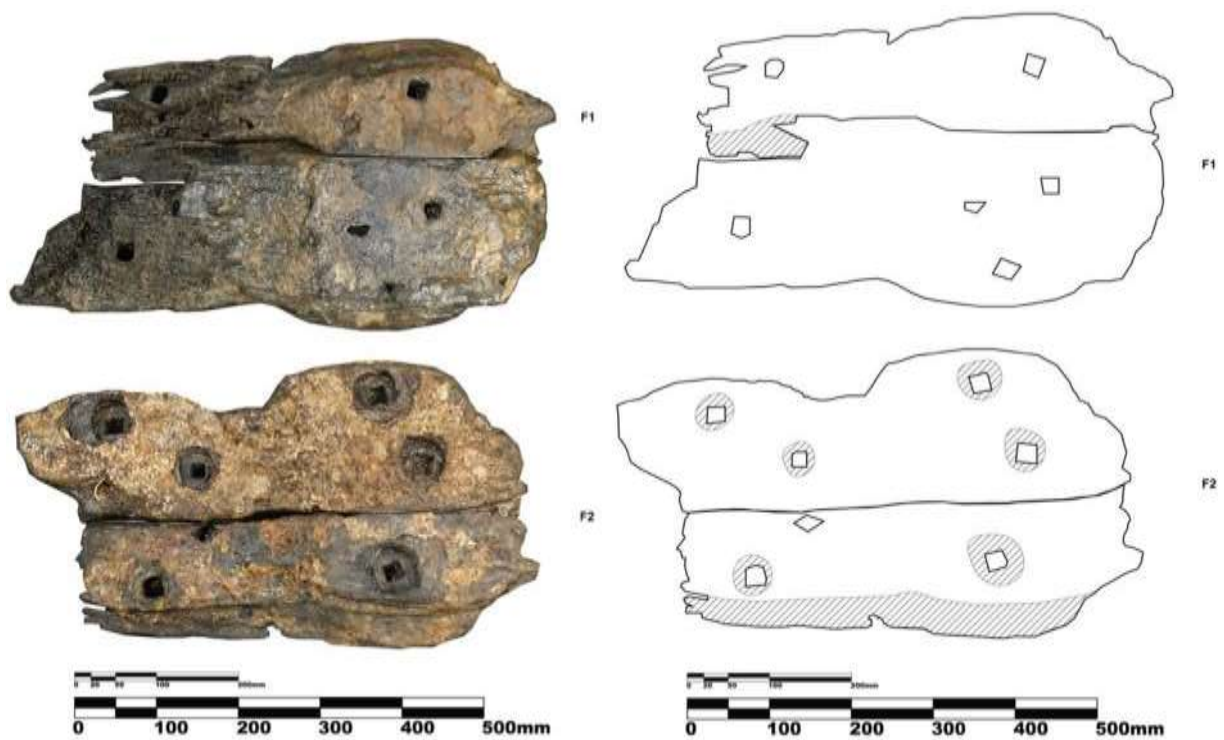
Figure 38: PB2\_963 and PB2\_964 fitted together (M. Ng, 2022).

These rabbeted planks could be found as high as the second or third plank above the bands. The rabbet joint or seam was poured with boiling hot dammer, a kind of pitch, with a covering of fine, clean cotton wool. Ships were never caulked. Bolts were square and bolt heads were smoothen using a composition. These descriptions were obtained from various first-hand accounts during the eighteenth and nineteenth centuries (Stravorinus 1798:20, 22; Phipps 1840:23, 24; Wadia 1957:189). Similar joinery can also be found in *Quedagh Merchant*. In addition to the similar joinery, an iron fastening was used for the edge-to-edge plank joinery (Hanselmann 2016:98). This fastening could be related to the square hole located at the rabbet recess of PB2\_963 and PB2\_964. This type of joinery was not observed on *Endeavour*, *HMS Buffalo*, *Edwin Fox*, and *Sydney Cove*. The joinery method could be a key characteristic of Bombay-built ships.

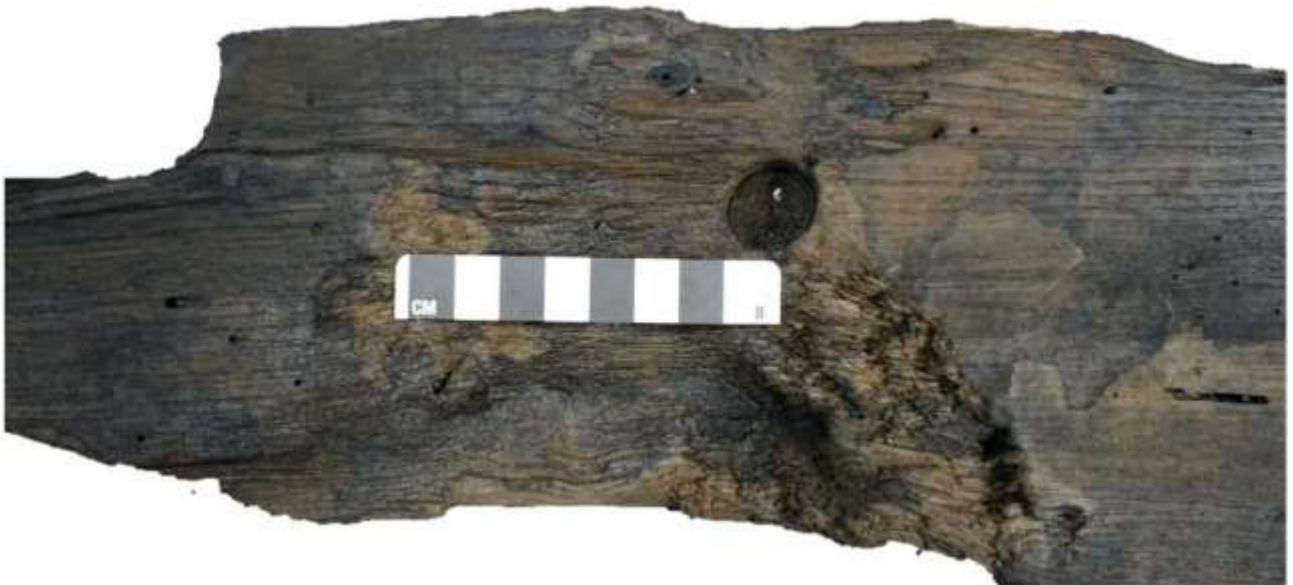
Figure 41: Close up of the treenail on PB2\_904 (M. Ng, 2022).

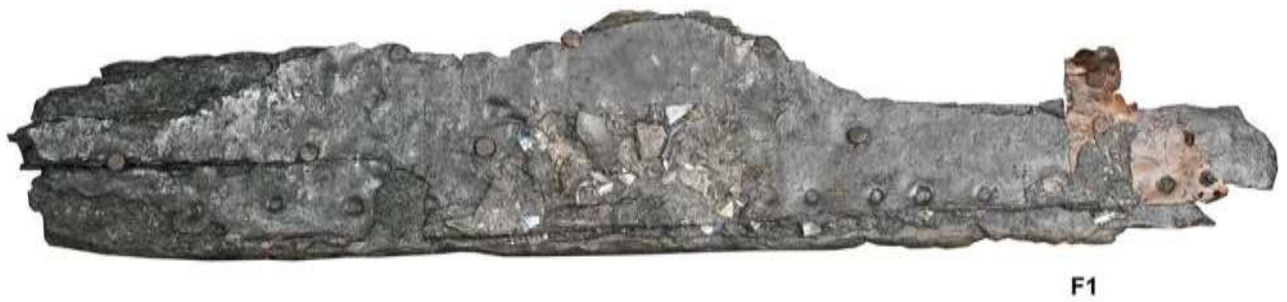
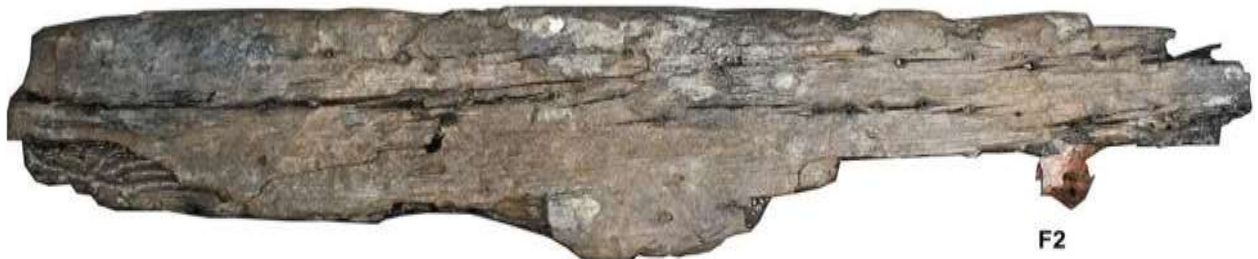
Figure 43: PB2\_971 (M. Ng, 2022)

The findings obtained from the sheathing plank PB2\_971 are interesting. It exhibited features of sacrificial planking such as the presence of copper sheathing and copper alloy tacks, but the wood species, cassia, is an atypical wood for such feature. Based on archaeological and historical ship data obtained from this research, Country ships relied on teak, cedar, or pine as sacrificial timber. This suggests that sheathing plank was added when the ship was repaired at an unknown location during its life (Figure 43)

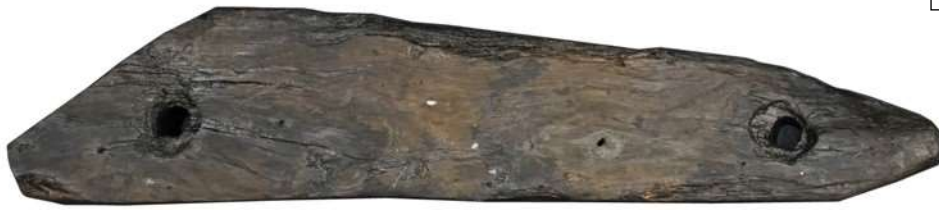
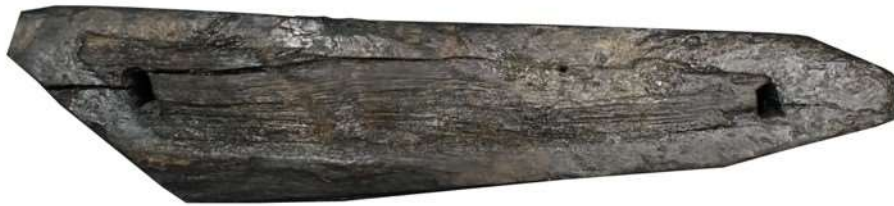
**900**

<b>COMMENTS:</b>  The timber has a trapezoidal shape have two holes which extends through the timber. There are two holes observed on the timber which extends from Face 1 to Face 2. The holes on Face 1 have a square hole in the middle of a circular depression. Holes on Face 2 are square. A smaller square hole was observed on both Face 1 and Face 2. On Face 1, the smaller square hole seemed to have some form of encrustations acircular its edge.

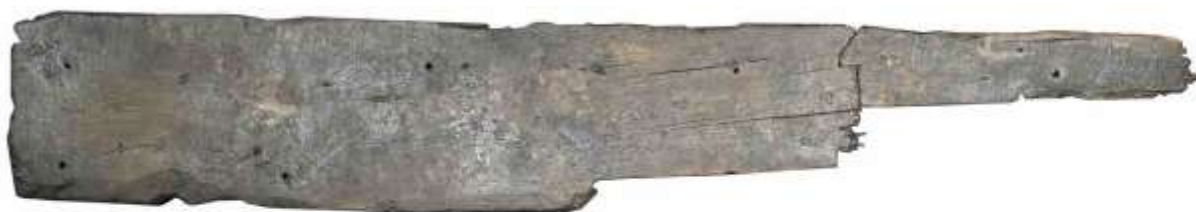
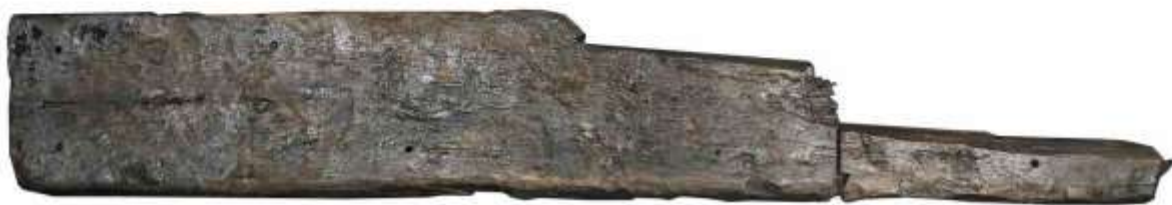
901 + 903

901 and 903 came from the same timber but it was broken to fit into the conservation tank. Six square holes were observed on Face 1 and the holes exit on Face 2. The holes on Face 2 are circular. There seemed to be a pattern in the spacing between the tacks as there is a horizontal and vertical alignment to their placements. 1 square fastening hole on 903.

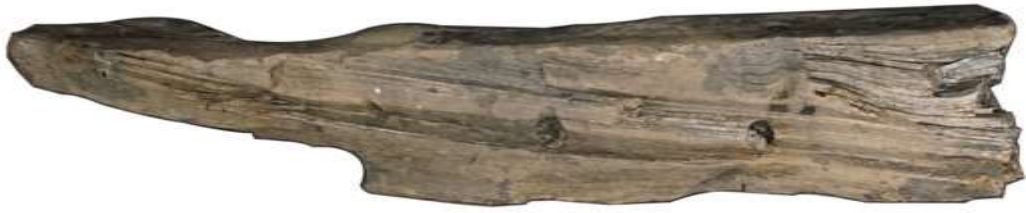
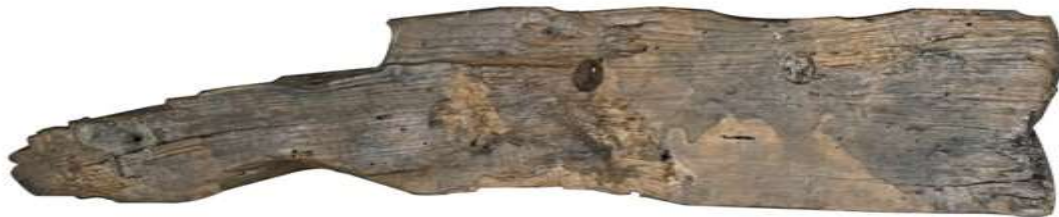
**904**

Timber exhibits broken edges on most of its profiles. Only one profile showed a straight flat profile. There are no obvious signs of carpentry or joinery. Two circular holes can be identified on the two sides of the timber, at the mid-section. Extant treenails can be found in both holes.

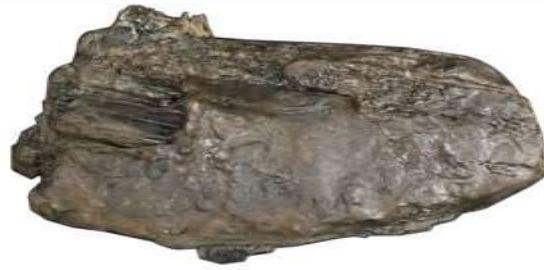
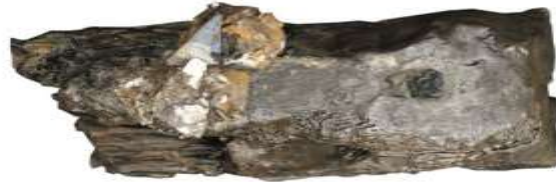
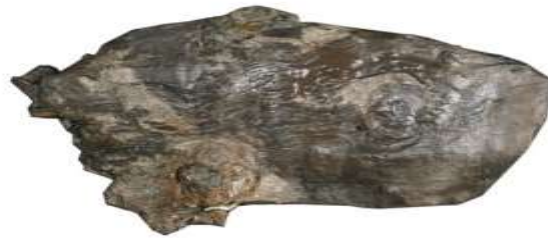
**945**

<b>JOINERY:</b>  Nil			
<b>FASTENINGS:</b>  2 square extant fastening. 33mm x 32mm, 26mm x 29mm			
<b>MARKS AND COATINGS:</b>  Nil			
<b>COMMENTS:</b>  Encrustations with ceramic sherds can be found on Face 2. There is also a square depression which seem to have a squarish metal extant. The hole seemed to align with the hole on Face 4 which was observed to also have a similar squarish metal extant. Encrustation can also be observed on Face 4. Face 3 has a encrustation on its edge and an extant circular head tack with a diameter of 12mm. Face 3 also shows a knot on the timber.

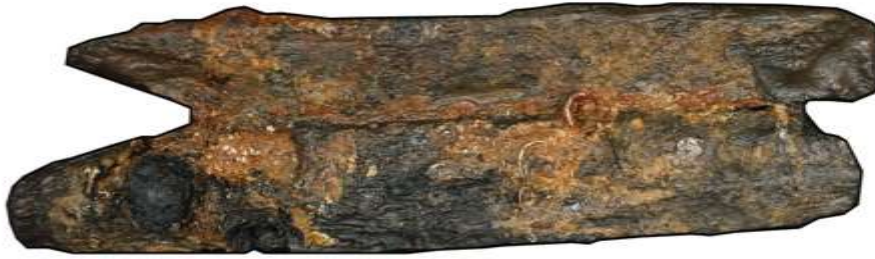
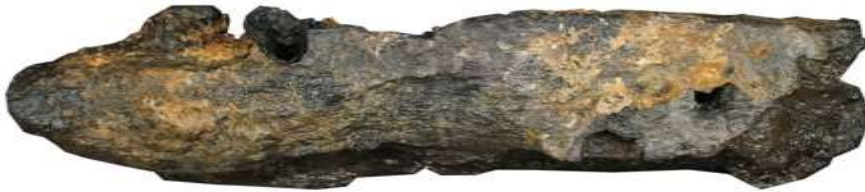
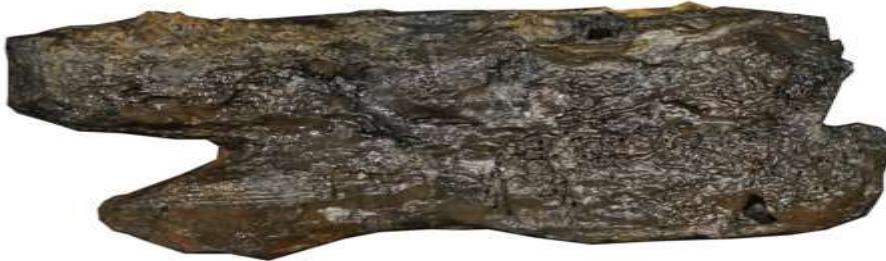
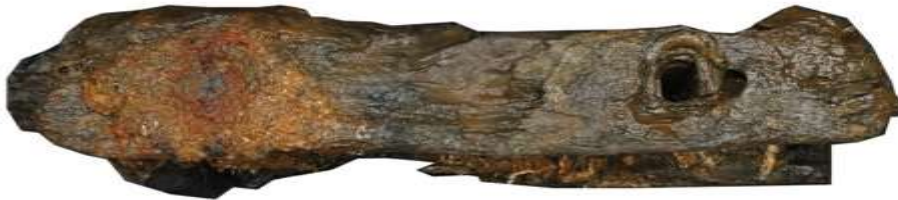
**949**

<b>JOINERY:</b>  Nil			
<b>FASTENINGS:</b>  Nil			
<b>MARKS AND COATINGS:</b>  1 fastening hole. Square hole within circular impression. Square hole: 22mm x 21.6mm, Circular impression: 38.7mm Diameter			
<b>COMMENTS:</b>  Face 1 has a two circular impression near one of the end of the timber. One of the impressions forms a complete circle on Face 1. There were encrustations observed within the circle while the other impression was a semi-circle impression with a square hole in its centre. No holes were observed on the other side of the timber (Face 2). On Face 4, a square hole with a circular depression was observed. The hole extends through the timber and exits on Face 3 maintaining a square shape. Two other holes were observed on Face 3, one of them is semi-circular while the other hole or notch is squarish. A timber sample was extracted to be analysed for its wood species.

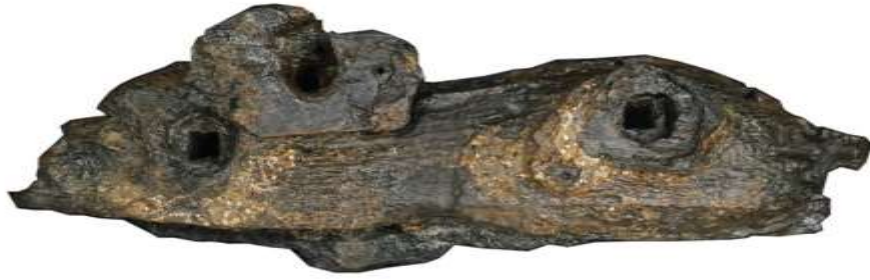
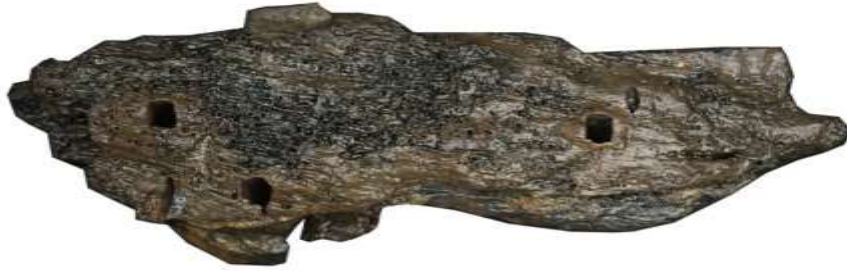
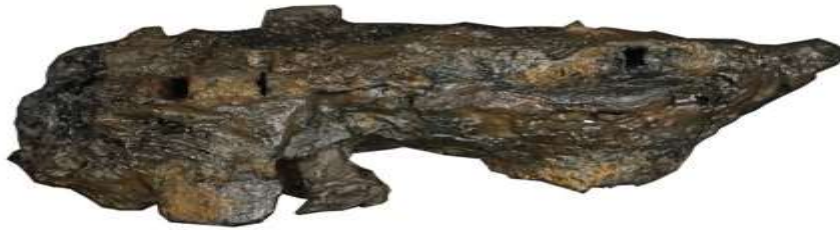
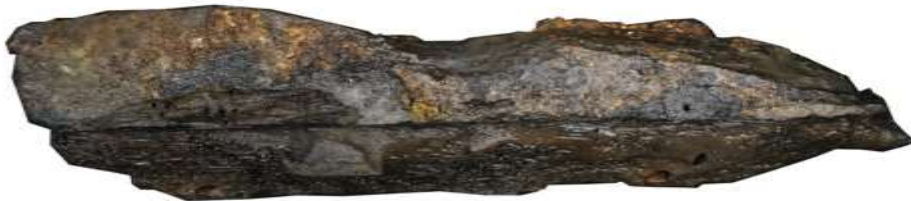
**950**

<b>JOINERY:</b>  Nil			
<b>FASTENINGS:</b>  Nil			
<b>MARKS AND COATINGS:</b>  2 types of fastening hole. Square hole within circular depression. 19.1mm x 18mm, 19.1mm x 18.2mm, 19.2mm x 18.8mm, Diameter: 49.5mm, 40.5mm, 48.5mm. Vertical Spacing: 31mm, Horizontal spacing: 293mm. Small square fastening holes: 5.7mm x 5.7mm, 4.3mm x 4.2mm, 4.2mm x 4.2mm.			
<b>COMMENTS:</b>  Six holes were observed on Face 1. The larger holes have a square hole in the middle of a circular depression. Two of the holes were close to each other while the other hole was situated 290mm away. The other three holes were square and smaller in size. The three large holes extends through the timber and exit on Face 2 maintaining a square shape. Two other square holes 300mm apart can be found on Face 3.

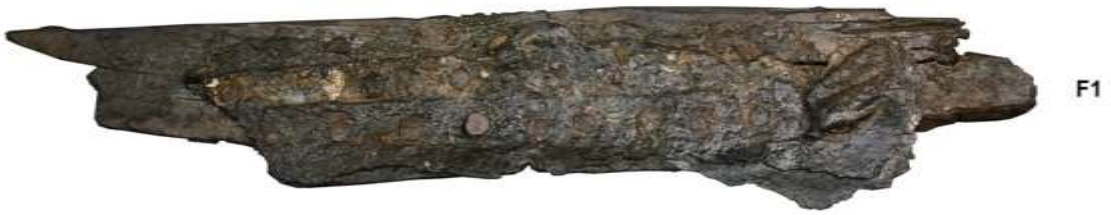
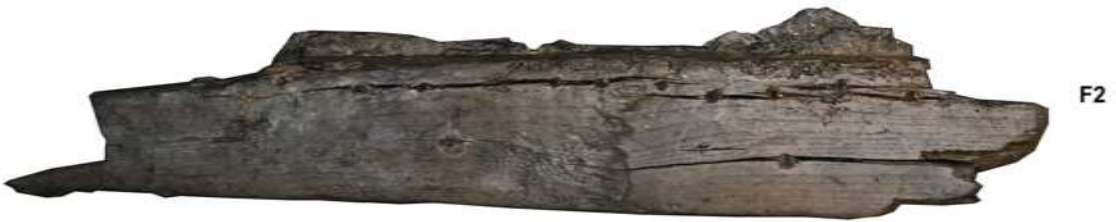
953

The timber has metal sheathing and extant circular tacks. The metal sheathing seemed to exhibit two layers but it cannot be confirmed. Horizontal spacing between the tacks range between 28.2mm to 77.6mm. Vertical spacing is approximately 26.4mm.

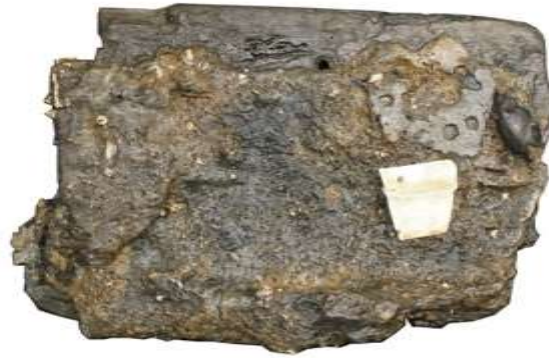
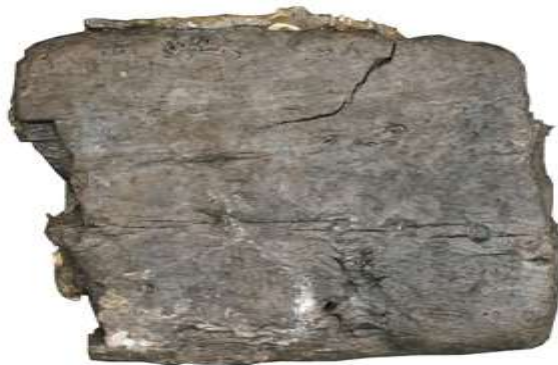
956

<b>MARKS AND COATINGS:</b>  Vertical spacing: 31.2mm, 33.4mm Horizontal spacing: 56.9mm, 58.2mm, 29.2mm, 35mm, 37.9mm. Circular impression: 11mm.			
<b>COMMENTS:</b>  There are metal sheathings on one of the timber's surface and eight headless extant tacks on the timber. The metal is heavily encrusted and a ceramic piece was found concreted on the encrustation. There seemed to be a pattern in the spacing between the tacks as there is a horizontal and vertical alignment to their placements

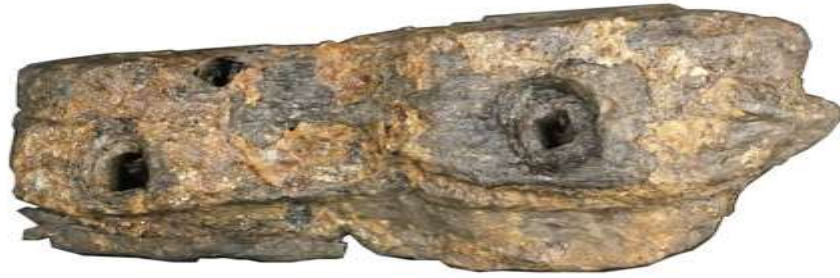
F1

Two of the holes have a square hole in the middle of a circular depression and 350mm apart along a horizontal axis. The other hole is square and located near one of the aforementioned two holes. The two square holes with the circular impression extends through the timber and exits at Face 2 maintaining a square shape. A small square hole was observed on the rabbet recess at Face 3. Face 4 has one distinct square hole. A timber sample was extracted to be analysed for its wood species. Connects with 964.
