# Preliminary analysis of timber and metal remains from *Shah Muncher* Shipwreck

*Thesis submitted to Flinders University in partial  
fulfilment for the degree of*

**MASTER OF MARITIME ARCHAEOLOGY**

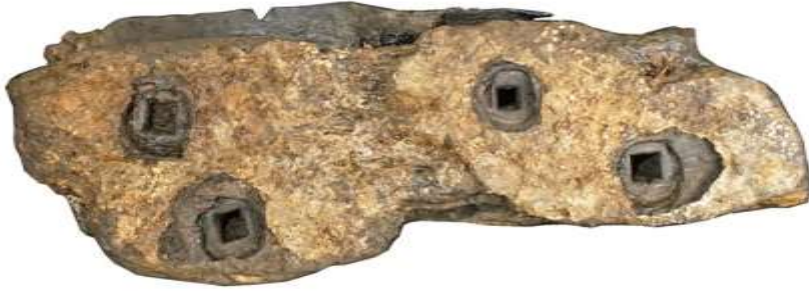
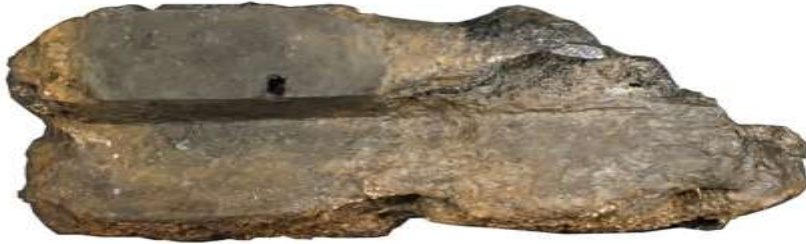
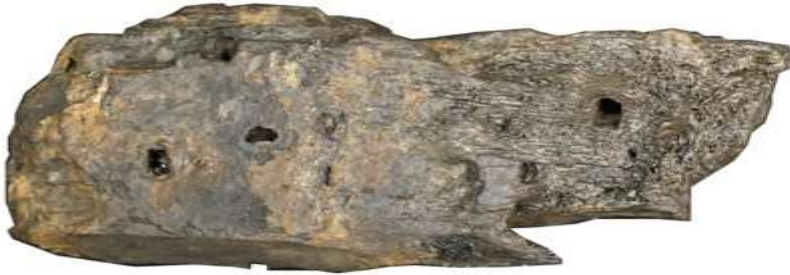
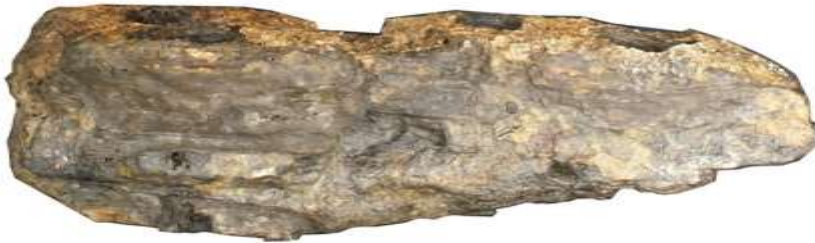
964

<b>CONDITION:</b> Timber is degraded on all sides with signs of breakage and marine borers. Waterlogged, impregnated with 10% peg, +0.05% biocide.	<b>DIMENSIONS:</b>	<b>WOOD TYPE:</b>	<b>CONVERSION:</b>
	<i>Length (mm):</i> 615	<i>Uncertain</i> <input checked="" type="checkbox"/>	<i>Whole</i> <input type="checkbox"/>
	<i>Width (mm):</i> 216	<i>Sapwood</i> <input type="checkbox"/>	<i>Halved</i> <input type="checkbox"/>
	<i>Thickness (mm):</i> 144	<i>Bark</i> <input type="checkbox"/>	<i>Quartered</i> <input type="checkbox"/>
			<i>Tangential</i> <input type="checkbox"/>
			<i>Radial</i> <input type="checkbox"/>
			<i>Uncertain</i> <input checked="" type="checkbox"/>

Face 1 has four holes. Two holes near each end of the timber. The holes have a square hole in the middle of a circular impression. Face 2 has a rabbet recess and a small square hole on one of the rabbet's side. Face 3 has four square holes while Face 4 has two square holes and a extant tack. The extant tack has a circular head with a diameter of 9mm. Connects with 963.

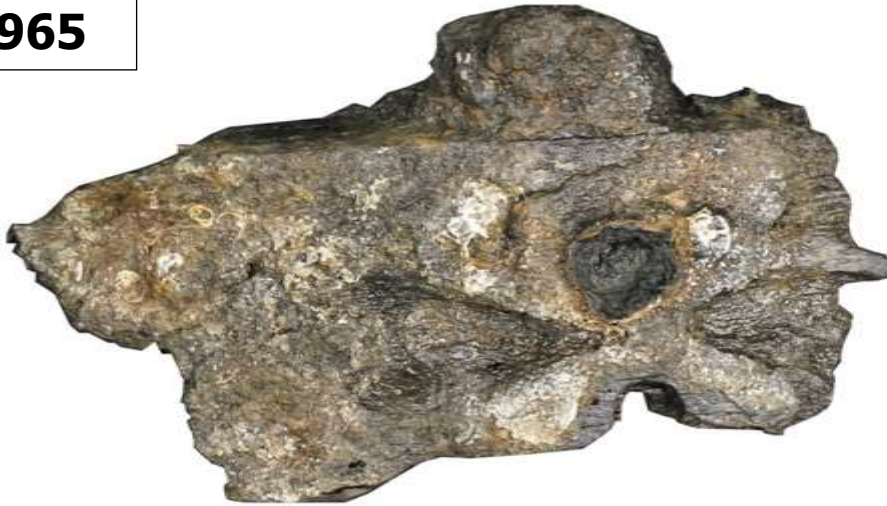
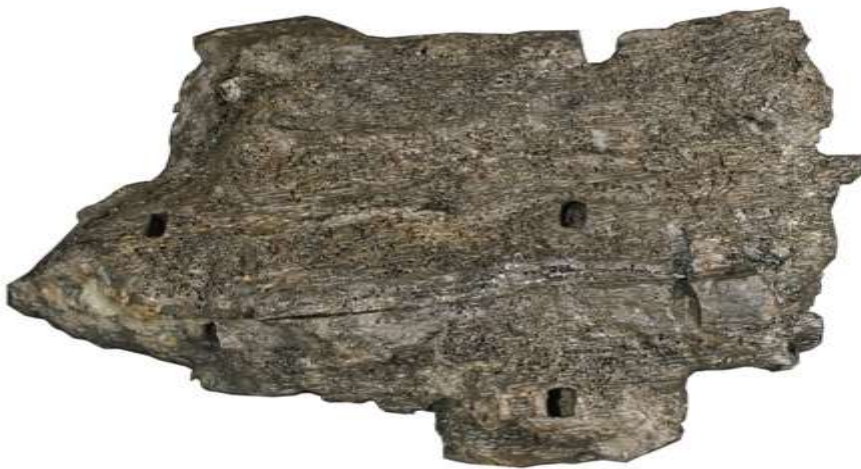
965

Face 1 has one circular depression and a semi-circular hole on its edge. The circular depression seemed to be composed of some form of encrustation. The semi-circular hole has a squarish hole within it. Face 2 have four square holes. Three of the holes were aligned on a vertical axis and spaced 10mm to 11mm apart. The fourth hole is situated along a similar horizontal axis with the middle of the three holes and is 300mm apart. Face 3 provides a profile view of the semi-circular hole observed on Face 1.

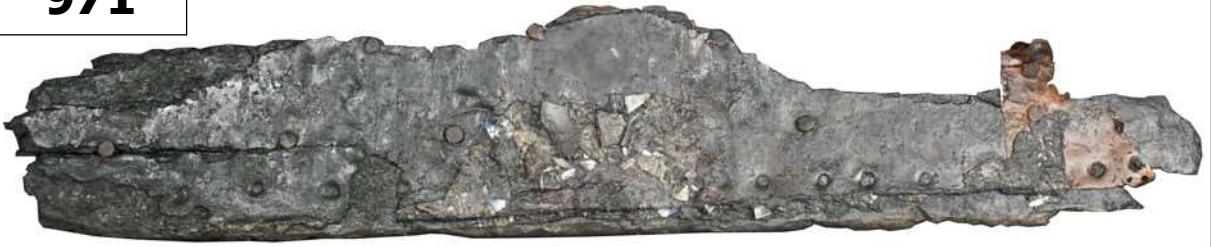
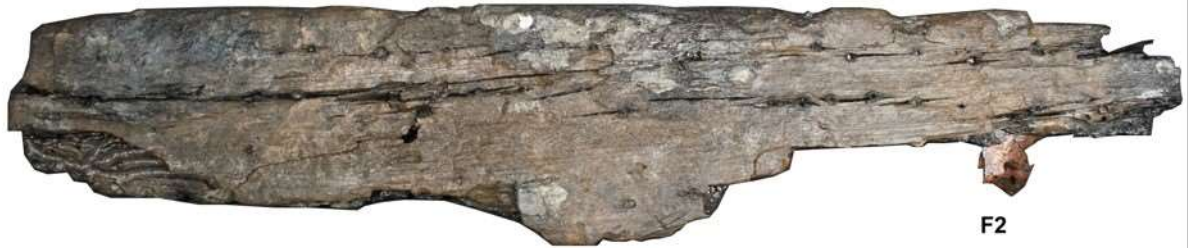
**971**

There are metal sheathings, 28 extant tacks on the timber. There seemed to be two sheathing overlapping each other. The sheath directly applied on the wood is overlapped with a smaller strip of sheath which is broken. There seemed to be a pattern in the spacing between the tacks as there is a horizontal and vertical alignment to their placements.

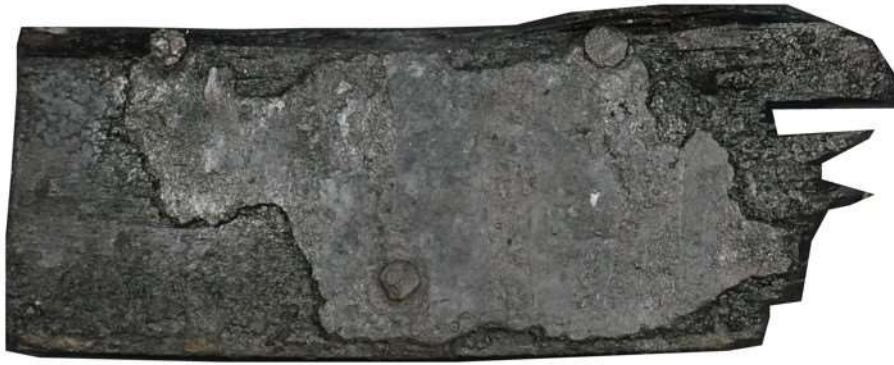
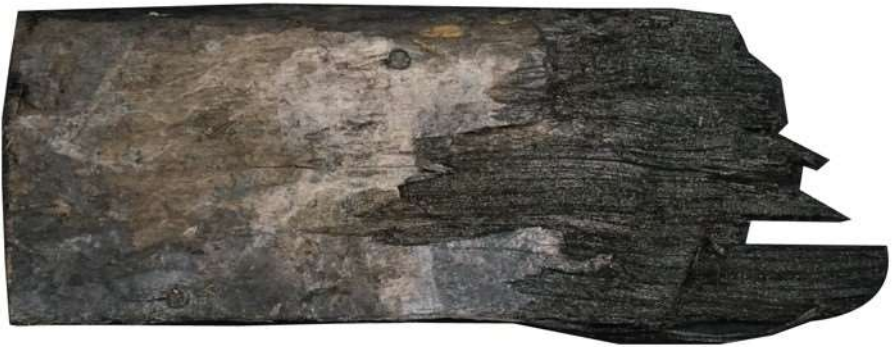
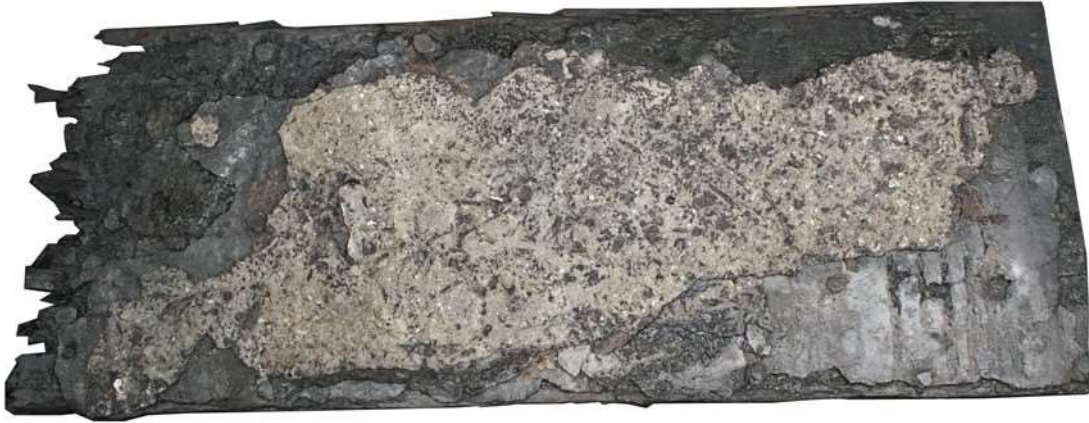
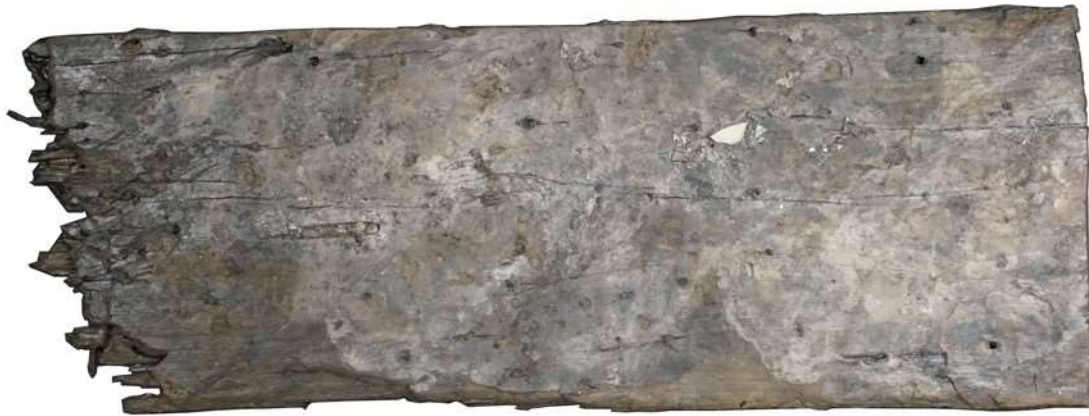
**972**

<b>JOINERY:</b>  Nil			
<b>FASTENINGS:</b>  30 and 3 extant tacks were observed on 974 and 972 respectively. Tack head diameter = ~11mm, ~12mm, ~11.3mm.			
<b>MARKS AND COATINGS:</b>  Circular impression diameter: 50mm. Vertical spacing: 55mm, 40mm, 58mm. Horizontal spacing: 90mm, 115mm, 120mm, 118mm, 134mm, 119mm, 105mm, 12mm, 113mm, 154mm, 131mm. Greyish white coating on 972 and 974. Tack hole dimension: 6 x 6mm,			
<b>COMMENTS:</b>  972 and 974 came from the same timber but it was broken to fit into the conservation tank. There are metal sheathings on the timber's surface. The extant tacks have a circular head and square shank. The surface of 974 exhibits two possible overlapping sheathing however it could be an encrustation layer. There is no pattern to the placement of the tacks.

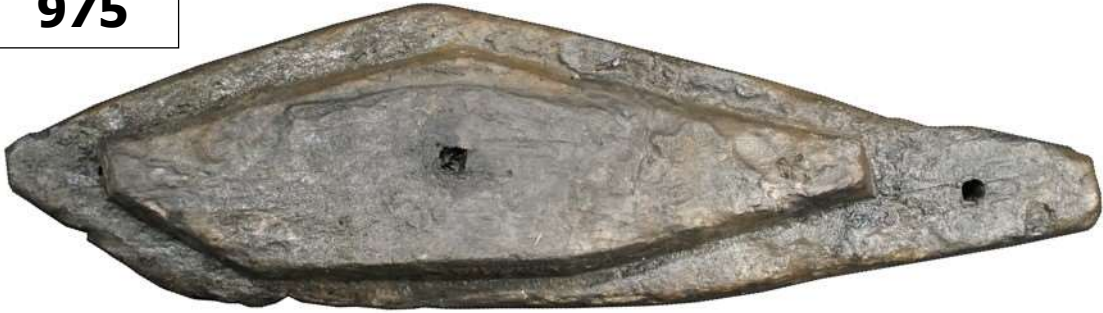
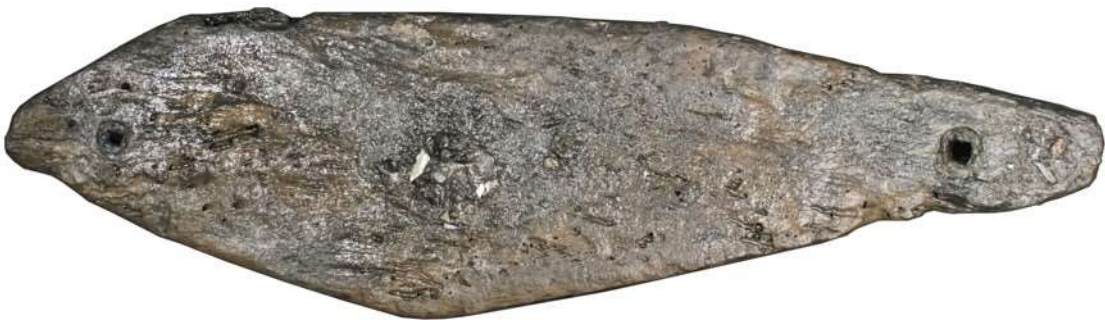
975

The shape of the timber is trapezoidal with seven sides. Face 1 has a raised portion of the timber also exhibits a trapezoidal shape which is angled similarly to the overall timber borders. The raised portion is 418mm in length, 116mm wide and 33mm to 45mm thick. Three square holes can be found on the timber. Two holes are located near both ends of the timber and one hole is situated in the middle. On the other side of the timber, Face 2, three holes are also observed. The three holes consist of a square hole in the middle of a circular depression.

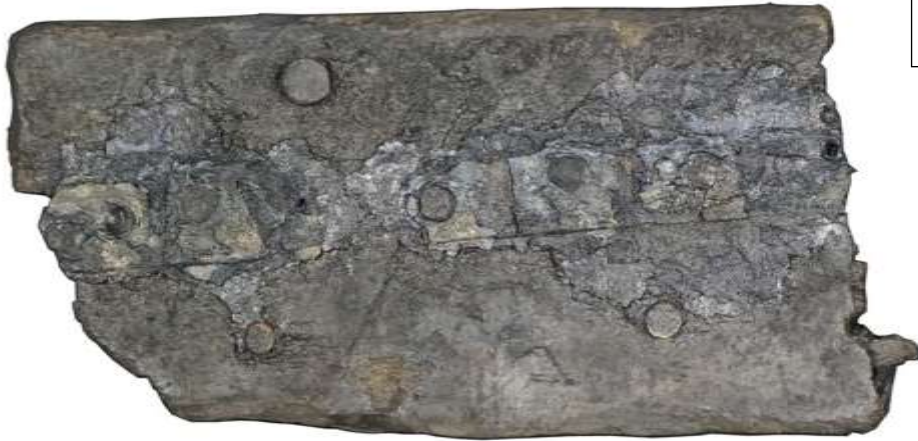
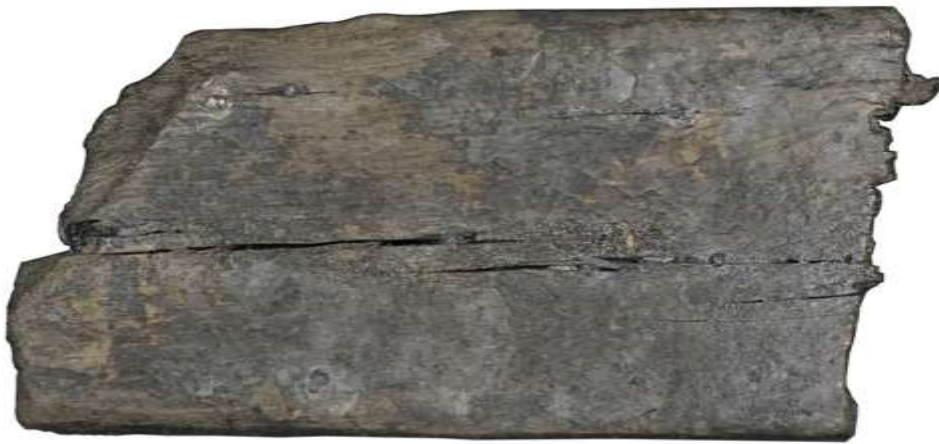
980

<b>JOINERY:</b>  Nil			
<b>FASTENINGS:</b>  8 extant tacks were observed. Diameter of tack head: 11.1mm, 13mm, 11.4mm, 10mm, 10mm, 10mm, 12mm, 11mm.			
<b>MARKS AND COATINGS:</b>  Tack hole dimension: 3 x 3mm, 4 x 4mm. Tack hole spacing = Vertical spacing: 39mm, Horizontal spacing: 21.6mm, 33.7mm, 43.9mm, 43mm, 43mm, 43mm, 139mm			
<b>COMMENTS:</b>  There are metal sheathings on one of the timber's surface and nine extant tacks on the timber which have circular heads. There seemed to be two sheathing overlapping each other. The sheath directly applied on the wood is overlapped with a thinner strip of sheath. There seemed to be a pattern in the spacing between the tacks as there is a horizontal and vertical alignment to their placements.

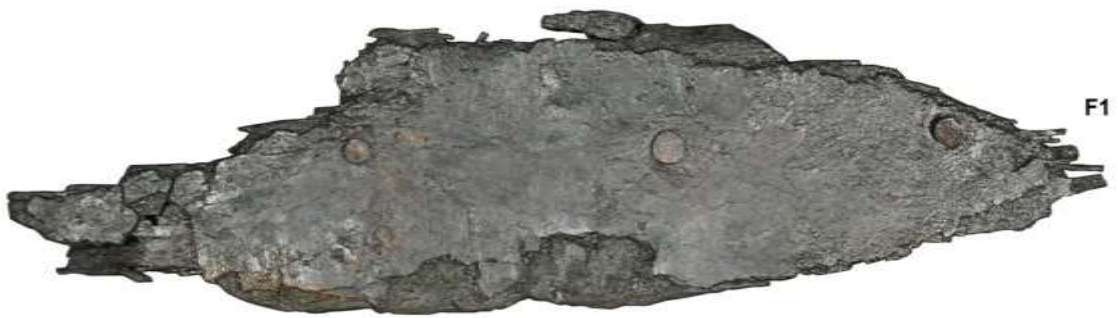
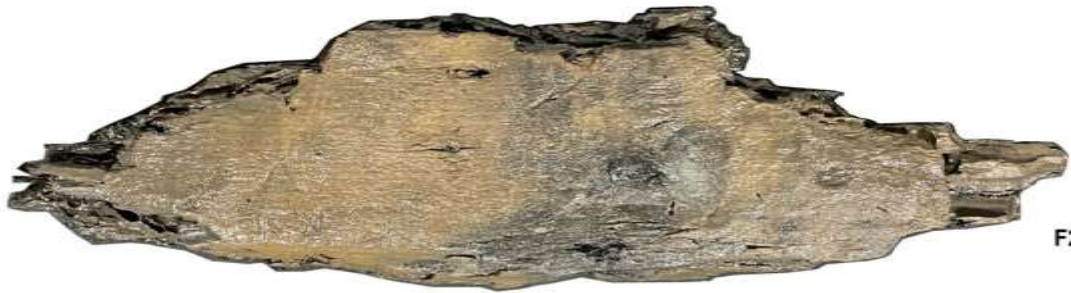
983

<b>JOINERY:</b>  Nil			
<b>FASTENINGS:</b>  3 extant tacks were observed. Fastening dimension: 4 x 4mm. Diameter of tack head: 10.5mm, 14.4mm, 13mm			
<b>MARKS AND COATINGS:</b>  Fastening hole spacing = Horizontal spacing: 120mm, 132.7mm			
<b>COMMENTS:</b>  There are metal sheathings and 3 extant tacks on the timber's surface. The tacks seemed to be evenly spaced horizontally.

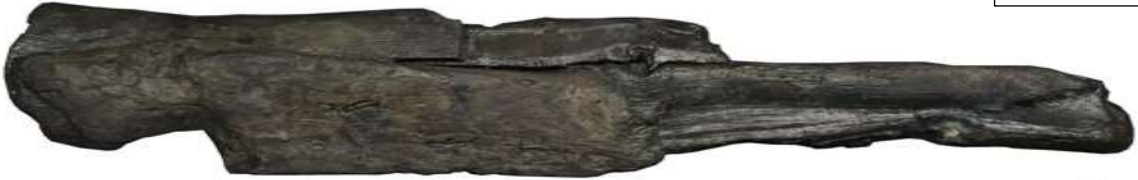
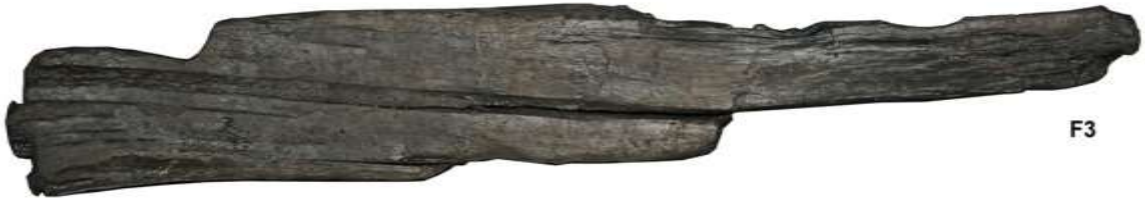
985

<b>MARKS AND COATINGS:</b>  Tack hole: 4 x 4mm, Circular impression diameter: 12.7mm			
<b>COMMENTS:</b>  It is degraded and there are broken edges on five of its profiles. The timber is thicker at one end and narrows from the midpoint. There are no obvious signs of carpentry or joinery. The only noticeable feature is a single square hole. The hole consists of a square hole in the middle of a circular depression.

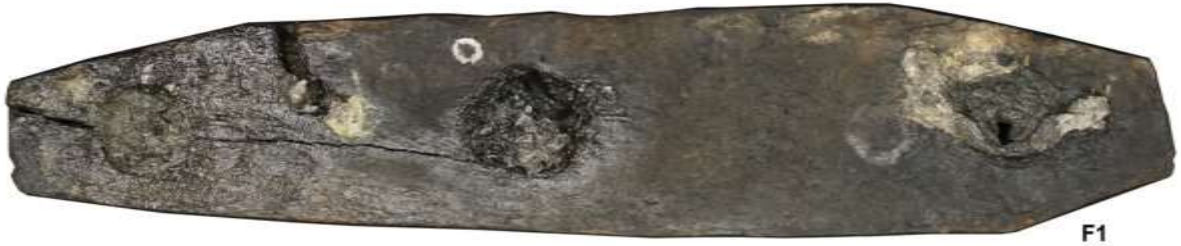
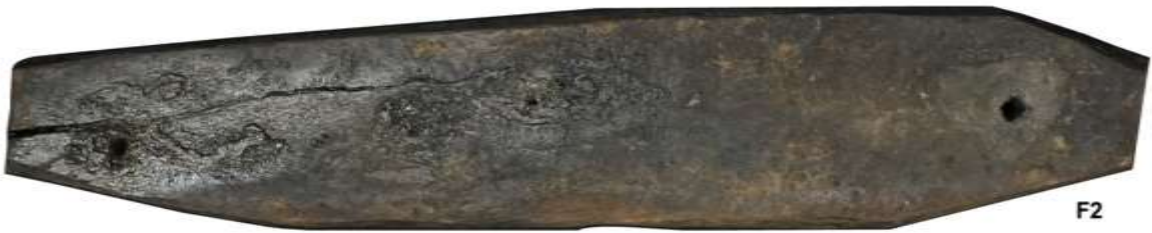
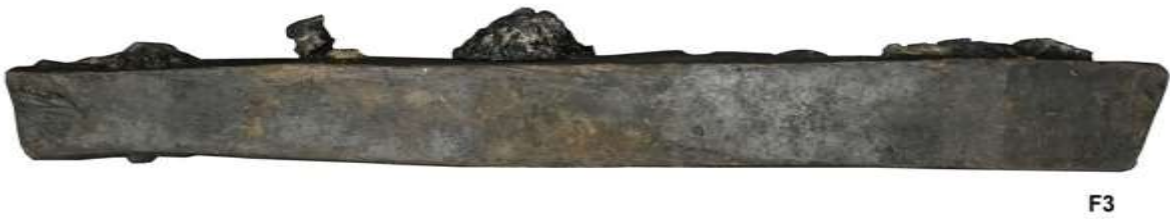
**1017**

<b>FASTENINGS:</b>  Nil			
<b>MARKS AND COATINGS:</b>  Tack hole: 8 x 4mm, 8mm x 5mm, 6mm x 7mm. Circular encrustation diameter: 30mm, 40mm, 60mm. Horizontal spacing: 128mm, 153mm			
<b>COMMENTS:</b>  The timber has a trapezoidal shape. There are three circular encrustations found on Face 1 of the timber. On Face 2, there are three small square holes which may be related to the circular encrustation found on Face 1. The holes seemed to be aligned on a horizontally.

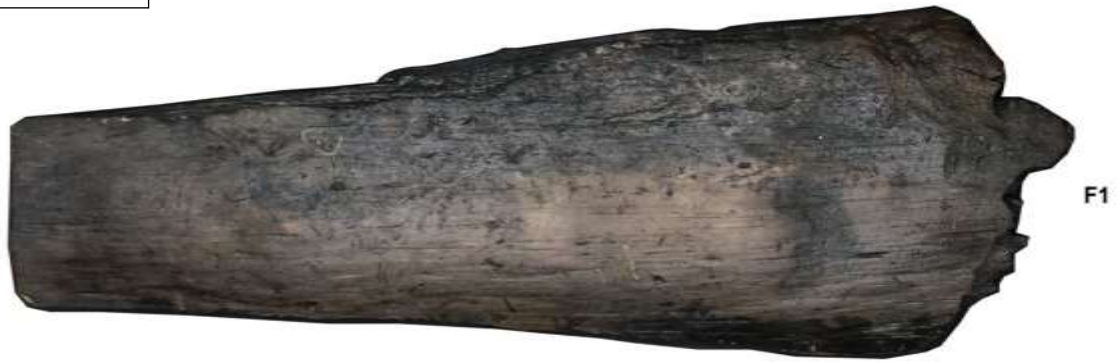
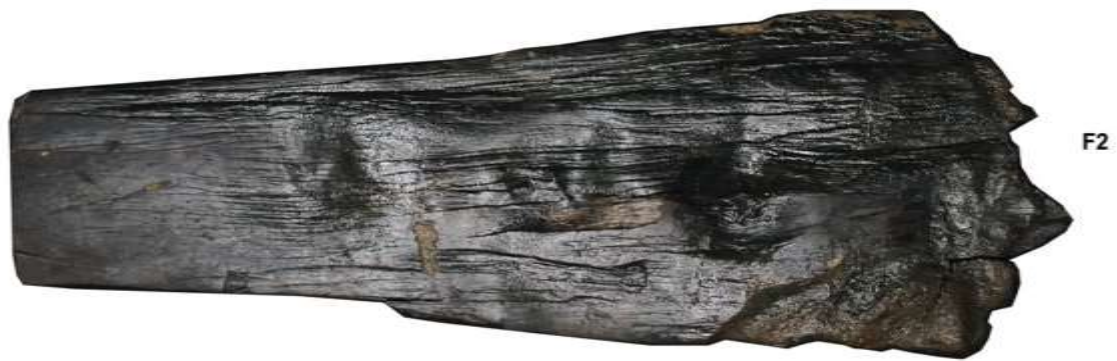
**1018**

It seemed to be have been shaped. It is flat on Face 1 and slightly curved on Face 2. No observable diagnostic features.

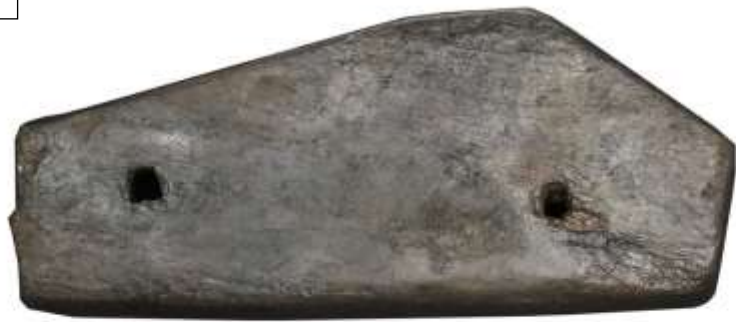
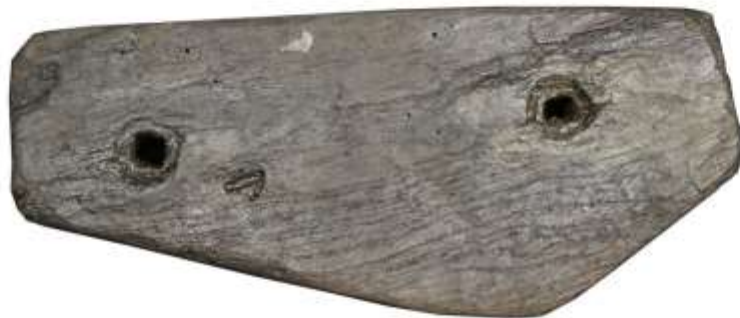
**1019**

<b>FASTENINGS:</b>  Nil			
<b>MARKS AND COATINGS:</b>  2 tack holes observed. Tack hole dimension: 7 x 7mm, Circular diameter impression: 8mm, 8mm			
<b>COMMENTS:</b>  The timber has a trapezoidal shape have two holes which extends through the timber. On Face 2, the two holes are square within a circular depression. On Face 1, the holes are square.

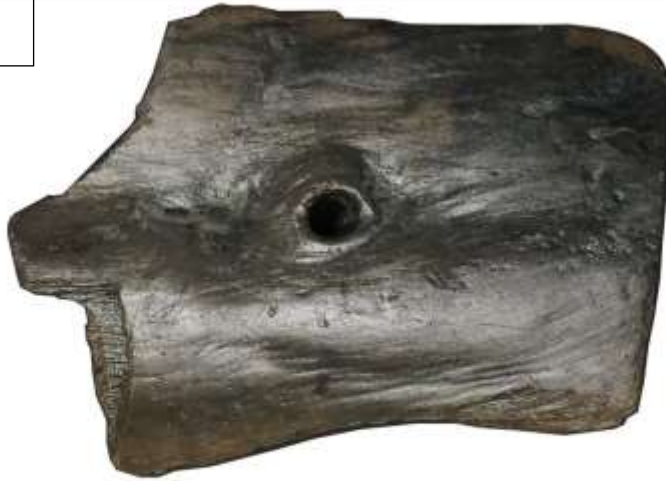
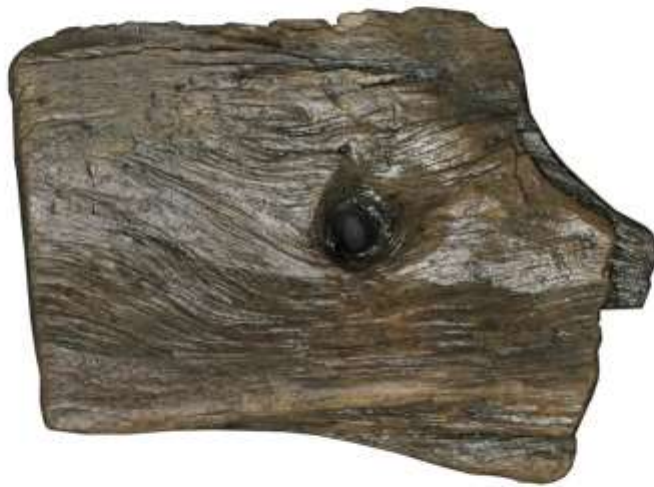
1038

<b>JOINERY:</b>  Nil			
<b>FASTENINGS:</b>  Nil			
<b>MARKS AND COATINGS:</b>  1 holes observed. Diameter on F1 = 15mm, Diameter on F2 = 20mm			
<b>COMMENTS:</b>  There is a hole in the timber which could be formed from a knot or from a tack. Face 1 shows the curved surface of the timber while Face 2 shows a flat surface.

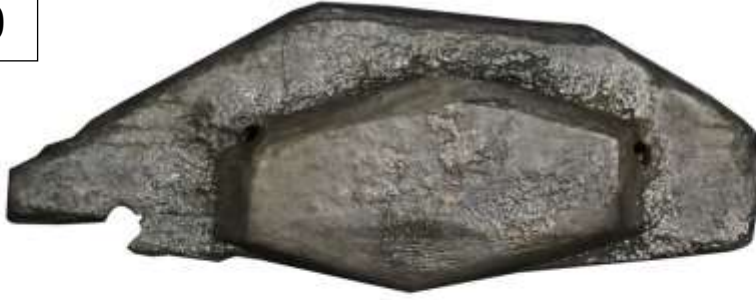
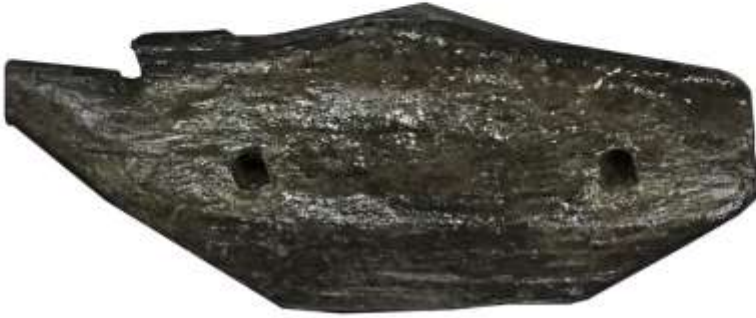
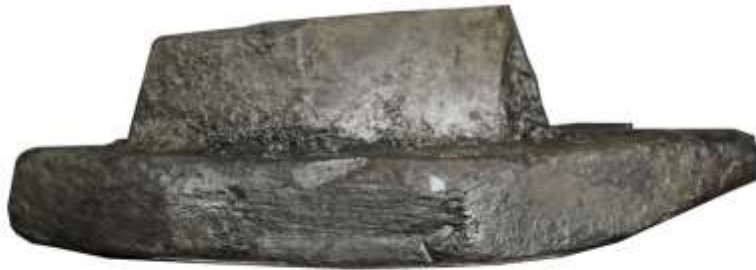
**1040**

<b>FASTENINGS:</b>  Nil			
<b>MARKS AND COATINGS:</b>  2 holes observed. Square tack holes: 9 x 9mm, 9 x 9mm. Diameter on F1 = 4mm, 8mm. Horizontal spacing = 84mm.			
<b>COMMENTS:</b>  The timber has a trapezoidal shape with a raised portion in the middle. The raised portion is also trapezoidal, 84mm long, 70mm wide and has a height between 26mm to 32mm. There is also a round hole on one of its edge and 2 round holes on the surface of Face 1. Face 2 has two square holes which are related to the 2 round holes on Face 1.

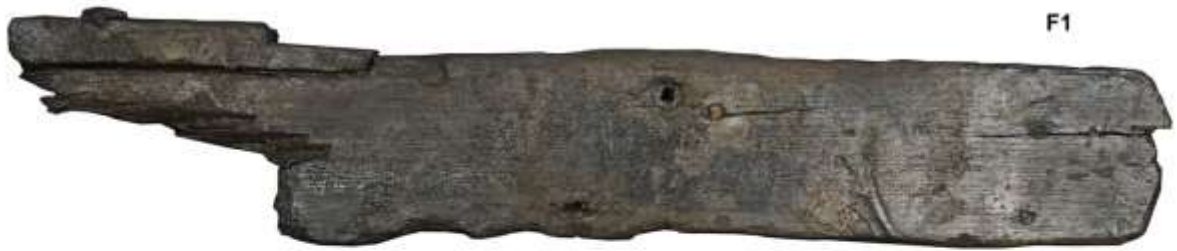
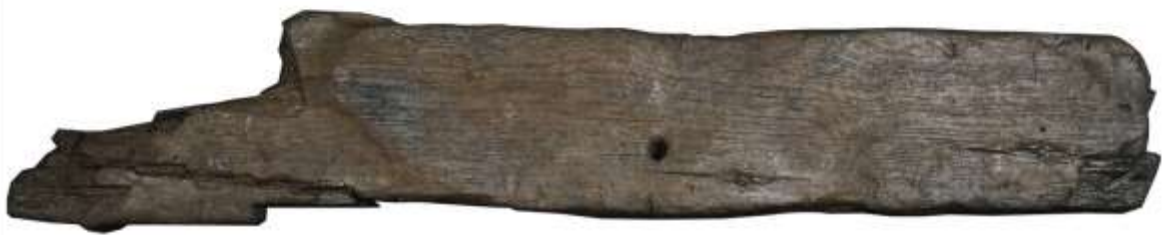
**1045**

<b>FASTENINGS:</b>  3 extant tacks with missing heads. Dimensions of 2 tacks: 6mm, 5mm, 5.6mm.			
<b>MARKS AND COATINGS:</b>  4 holes observed. Circular hole impression = 11mm. Vertical spacing = 34mm, Horizontal spacing = 155mm, 188mm. Tack hole dimensions: 5 X 6mm, 5 X 7mm, 4 X 9mm, 6 X 6mm.			
<b>COMMENTS:</b>  It has three extant tacks with missing head which seem to have some indications of alignment. In additional, a square hole with a circular impression was observed. The extant tacks can also be observed on Face 2. Face 2 also have a round hole.

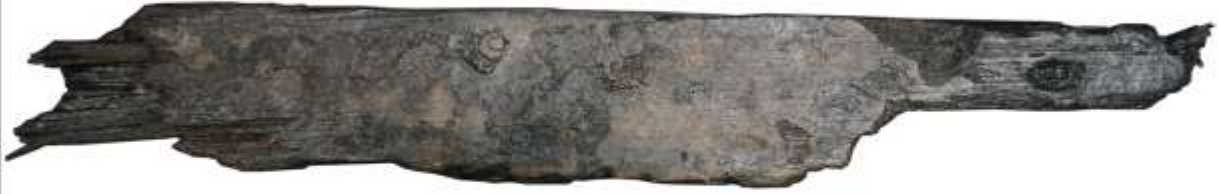
1048

<b>FASTENINGS:</b>  1 extant tack. Tack head diameter = 11mm.			
<b>MARKS AND COATINGS:</b>  One of the edges on the timber exhibited nine notches which were approximately 4mm wide and spaced 20mm apart.			
<b>COMMENTS:</b>  It also have two broken ends. A rectangular depression, an extant tack with a round head, and a metal piece with two holes were found on Face 1. A round hole on Face 2 could be an related to the rectangular depression on Face 1.

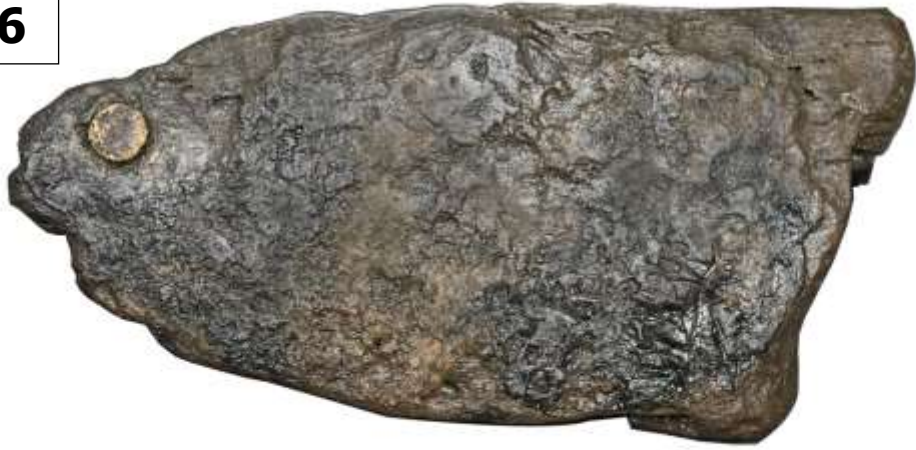
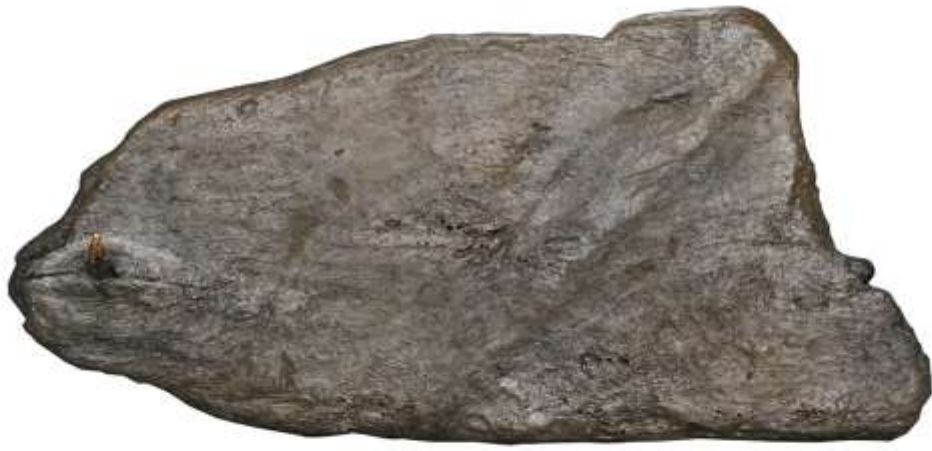
**1056**

<b>FASTENINGS:</b>  1 extant tack. Tack head diameter = 10.4mm.			
<b>MARKS AND COATINGS:</b>  Tack hole dimension: 3 x 3mm,			
<b>COMMENTS:</b>  It has one extant round head tack on one of the ends of the timber.

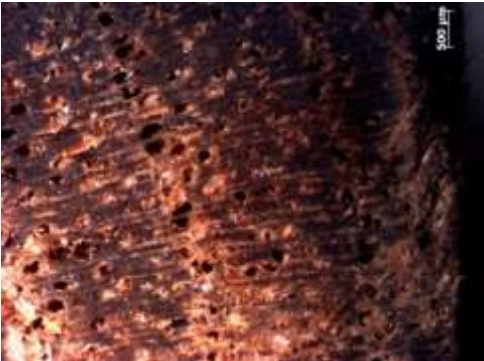
<p data-bbox="1048 320 1240 352">(Cross Section)</p>

No	Artefact No	Macroscopic Features	Microscopic Features	Notes	Wood Species
1.	903

5, 13, 30, 56, 65, 69, 104	Teak ( <i>Tectona grandis</i> Linn.f)

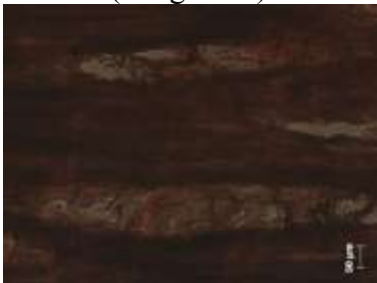
<p>1, 5, 13, 22, 30, 56, 79, 97,98, 104 Very close/narrow growth ring</p>	<p>Teak (<i>Tectona grandis</i> Linn.f)</p>

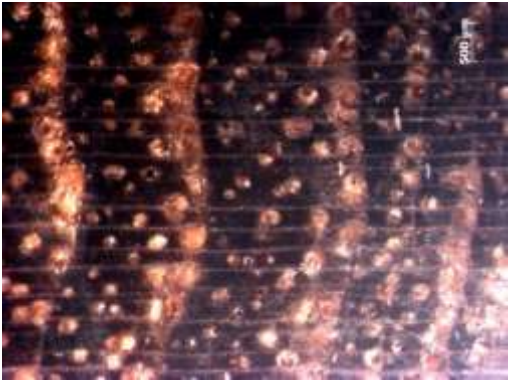
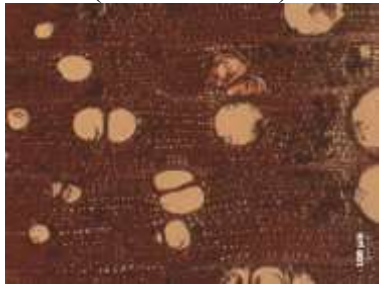
No	Artefact No	Macroscopic Features	Microscopic Features	Notes	Wood Species
3.	906

<p>1,5,13,22,30,56,65,89,92,93,97,104</p> <p>The most clear growth ring (normal)</p>	<p>Teak (<i>Tectona grandis</i> Linn.f)</p>

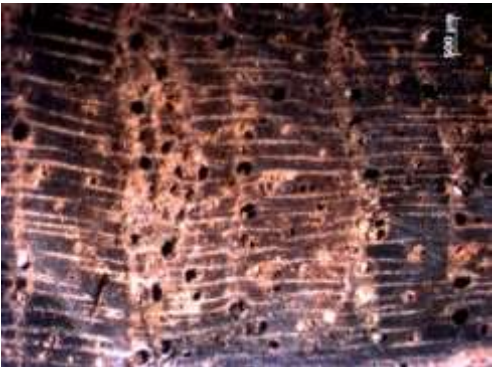
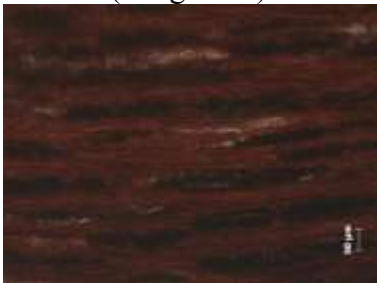
No	Artefact No	Macroscopic Features	Microscopic Features	Notes	Wood Species
4.	945

1,5,13,56,65,97,98,104,106 Knots	Teak ( <i>Tectona grandis</i> Linn.f)

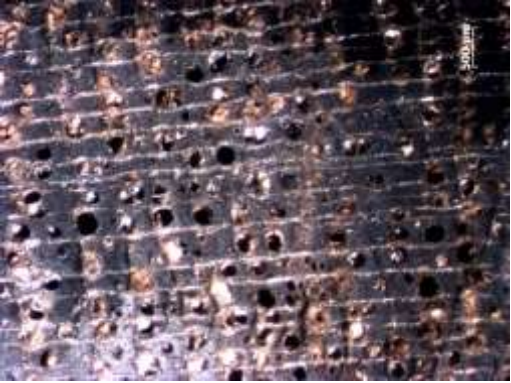
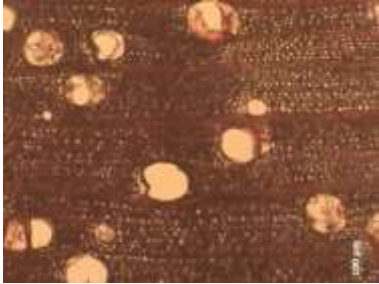
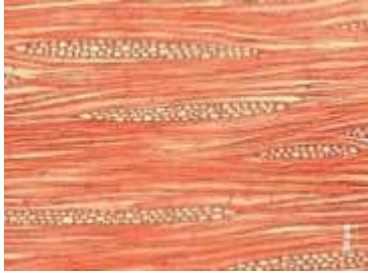
No	Artefact No	Macroscopic Features	Microscopic Features	Notes	Wood Species
5.	949

<p data-bbox="1093 1265 1205 1297">(Radial)</p>	1,4,5,30,56,65,97,98,93,104 Normal	Teak ( <i>Tectona grandis</i> Linn.f)

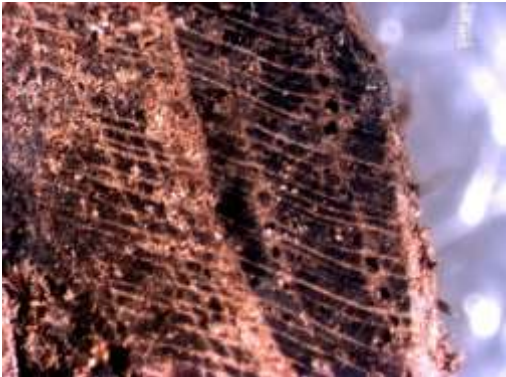
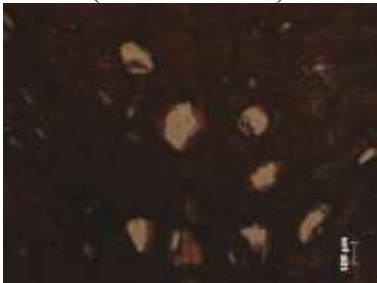
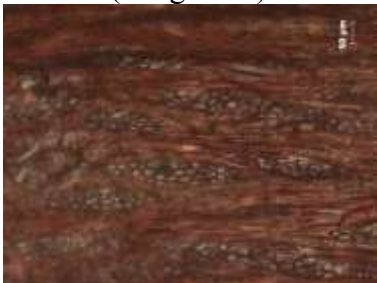
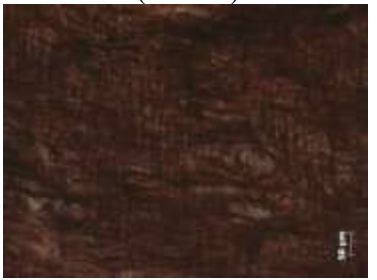
No	Artefact No	Macroscopic Features	Microscopic Features	Notes	Wood Species
6.	950-1

104 Knot	Teak ( <i>Tectona grandis</i> Linn.f)

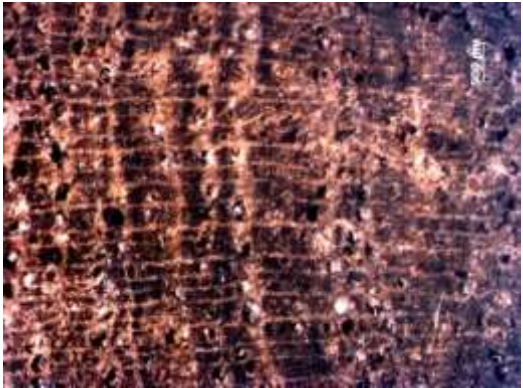
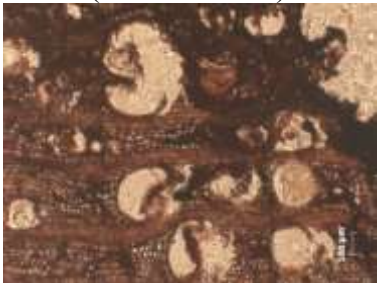
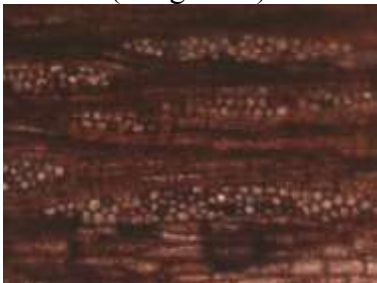
No	Artefact No	Macroscopic Features	Microscopic Features	Notes	Wood Species
7.	950-2

<p data-bbox="1357 320 1615 427">1, 4,13,22, 56, 69,79,89,104,106 Narrow growth ring</p>	<p data-bbox="1727 320 2123 352">Teak (<i>Tectona grandis</i> Linn.f)</p>

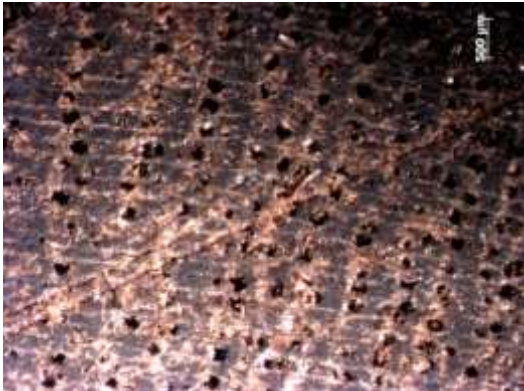
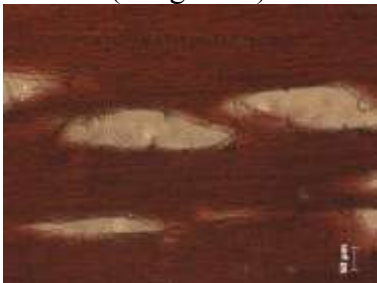
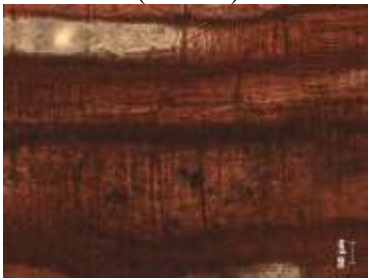
No	Artefact No	Macroscopic Features	Microscopic Features	Notes	Wood Species
8.	956

1,4,5,13,22,31,56, 97,104 Twisted, black deposit (hypo?)

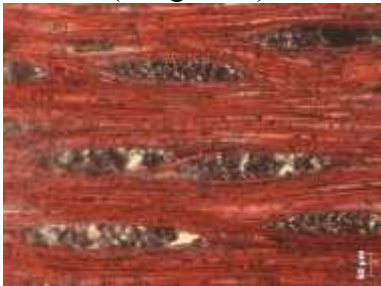
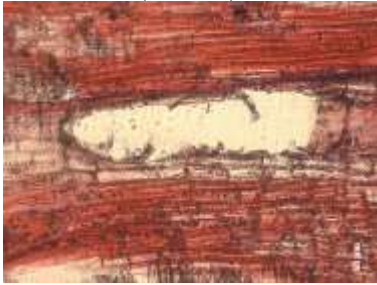
1,4,5,65,97,98,106 Twisted	Teak ( <i>Tectona grandis</i> Linn.f)

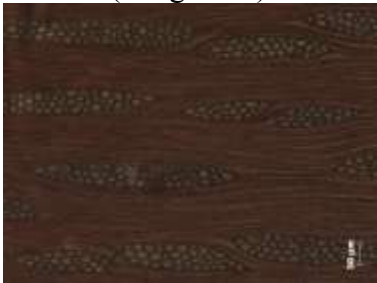
<p data-bbox="1093 671 1198 707">(Radial)</p>

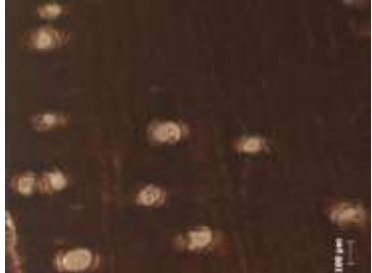
26.	1067		<p data-bbox="1043 1023 1245 1054">(Cross Section)</p>

<p data-bbox="1357 1023 1704 1118">2 Growth ring boundaries indistinct or absent</p> <p data-bbox="1357 1126 1704 1182">5 Wood diffuse-porous</p> <p data-bbox="1357 1190 1704 1246">9 Vessels exclusively solitary (90% or more)</p> <p data-bbox="1357 1254 1704 1286">13 Simple perforation plates</p>	<p data-bbox="1727 1023 2157 1214">ZYGOPHYLLACEAE - <i>Guaicum officinale</i> L. (COMMONER LIGNUM VITAE, GUAYACÁN/ <i>Guaicum sanctum</i> L. (HOLYWOOD LIGNUM VITAE, LIGNUM VITAE)</p>

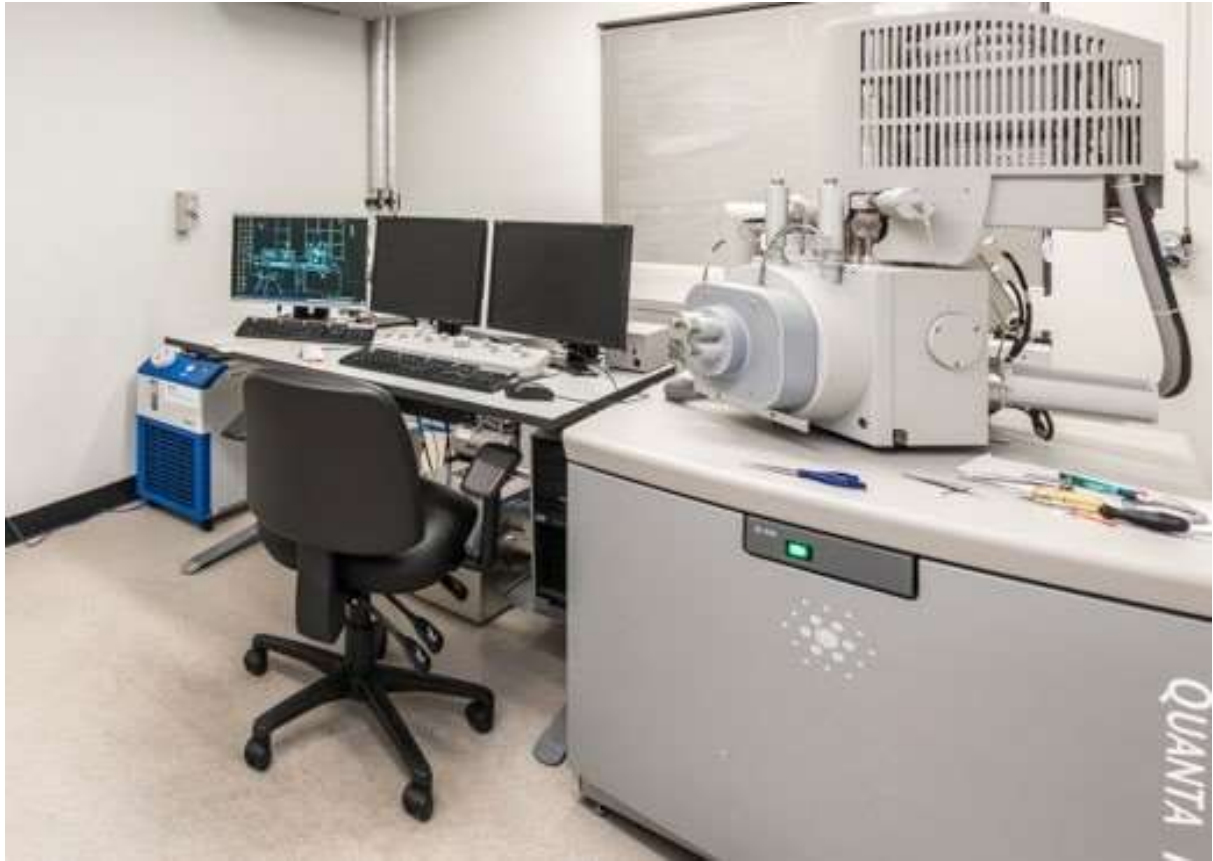
**Fig. 1.** FEI Quanta 450 FEG Environmental Scanning Electron Microscope, Adelaide Microscopy, University of Adelaide. Photograph by Wendy van Duivenvoorde.

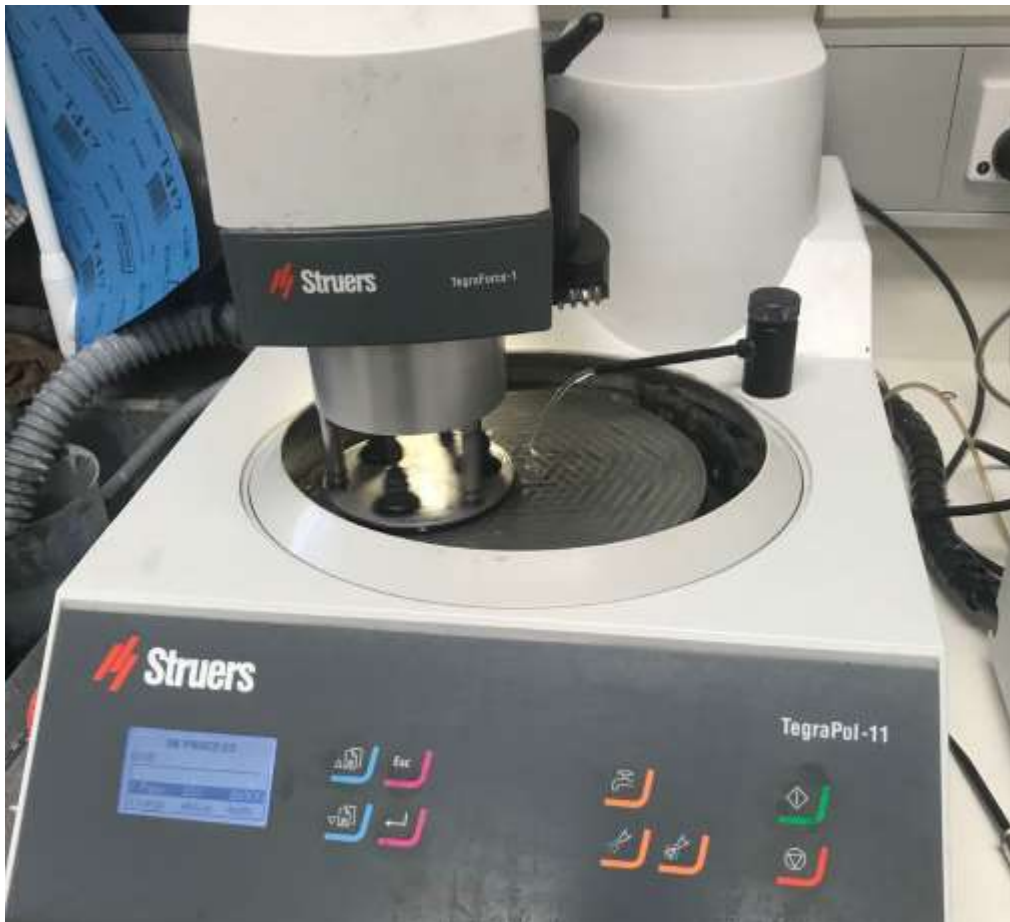
**Fig. 3.** Struers TegraPol-11 polisher. Photograph by Wendy van Duivenvoorde.

Sample preparation for the sheathing and tacks from the *Shah Muncher* shipwreck included embedding a small fragment of each tack and sheathing sample in phenolic hot mounting resin for general use (brand: Struers MultiFast). The resin was added and set in a Struers CitoPress-10 hot mounting machine (Fig. 2). The mounted samples were then polished using a Struers TegraPol-11 diamond polisher to get clean, uncorroded surfaces for analyses (Figs 2–4).

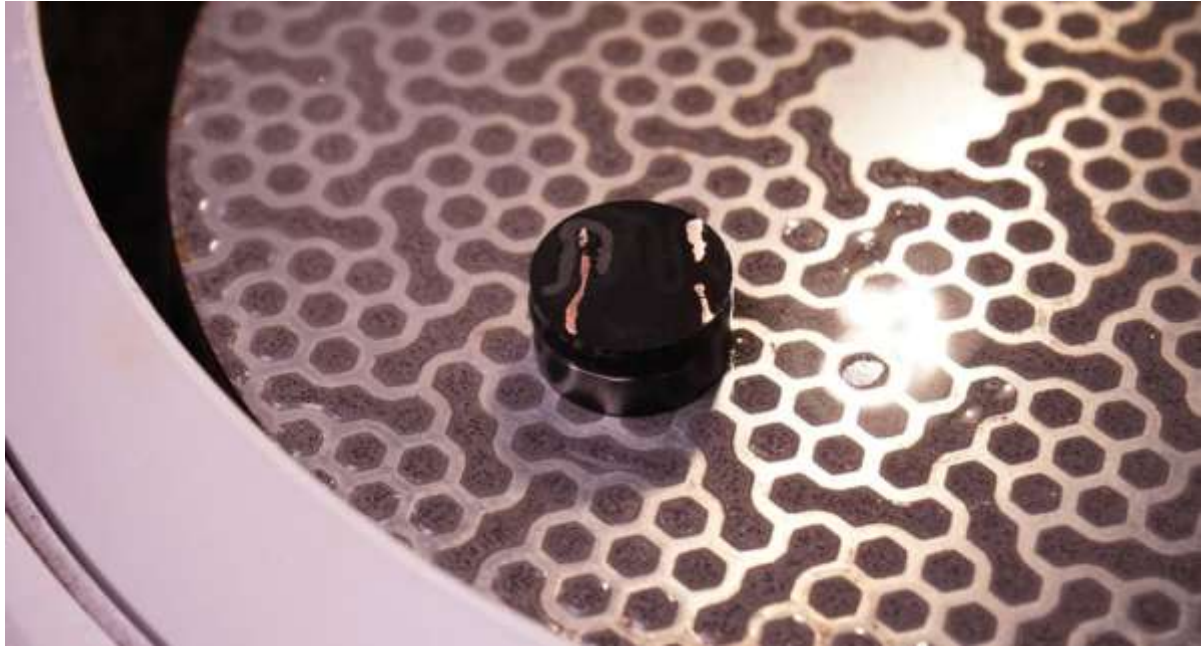
**Fig. 4.** *Shah Muncher* sample of strap embedded in a black-coloured resin mount, Sample 1156, after polishing. Photograph by Mike Ng.

tested to ensure they are characteristic (Figs 4–5). The areas chosen for elemental determination are those that display solid metal and are relatively free of any surface corrosion (Figs 4–6). For tacks only one spectrum is collected as their cross-sectional shape is easily selected in its entirety.

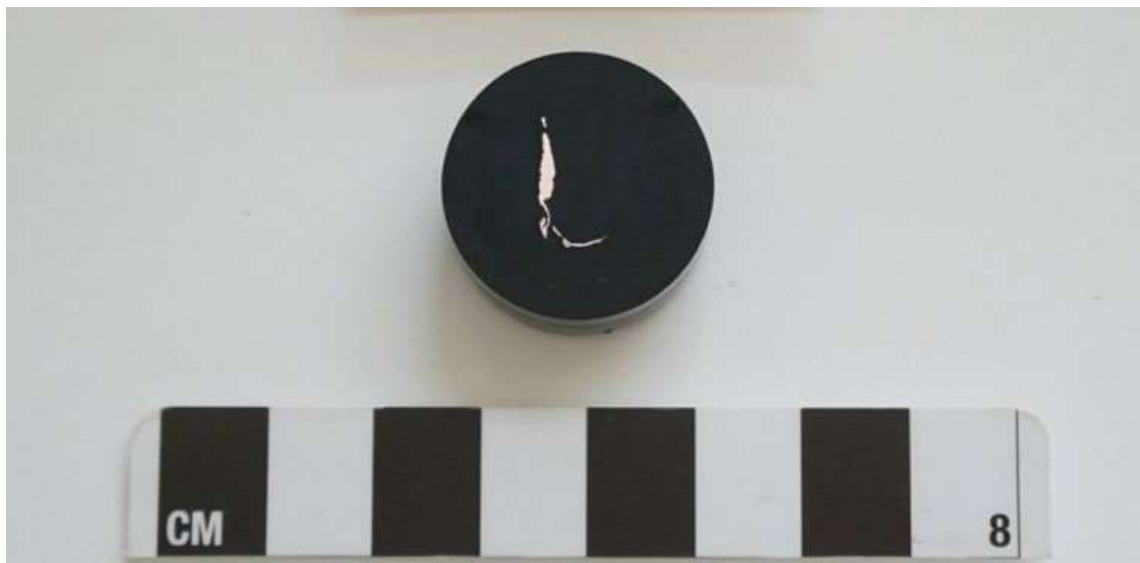
**Fig. 5.** *Shah Muncher* sample of sheathing fragment embedded in a black-coloured resin mount, Sample 1175. Photograph by Mike Ng.
