How and to what extent can Historical Ship Structural Components be Observed in a Shallow Dynamic Environment?

The Case Study of SS *Admella*

A thesis submitted in fulfilment of the requirements for the degree of: Masters of
Maritime Archaeology.

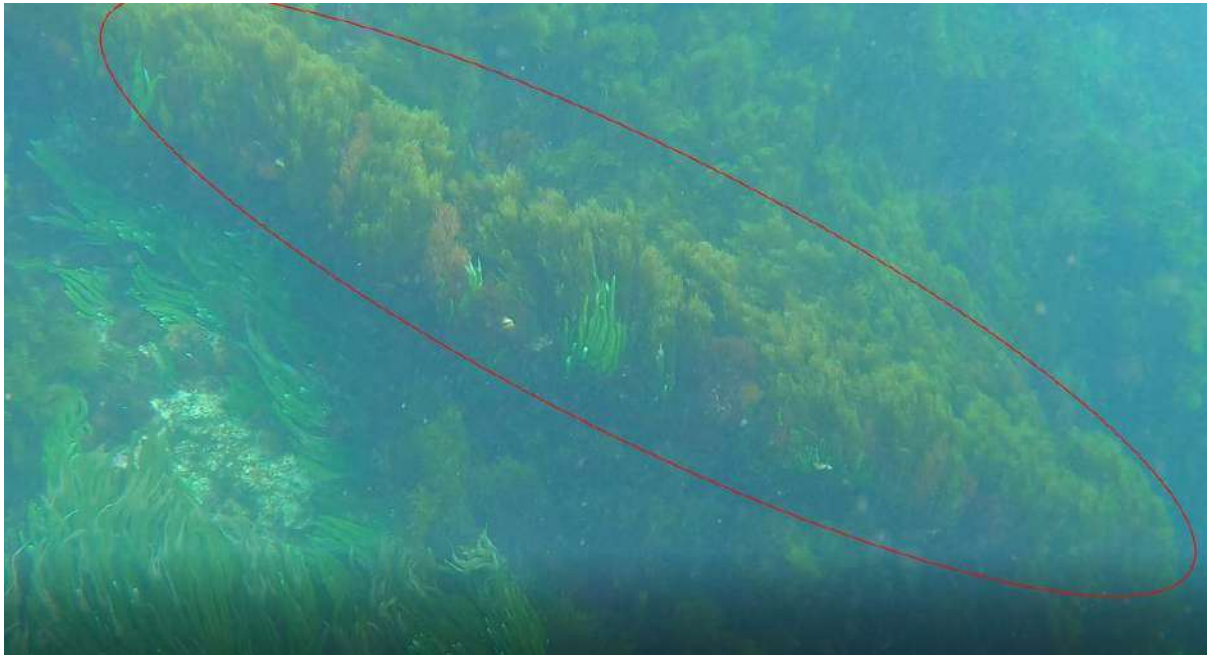
1G.1. ADM1-001 ferrous material with 'U' shaped culvert (2022-01-12, P. Kermeen)

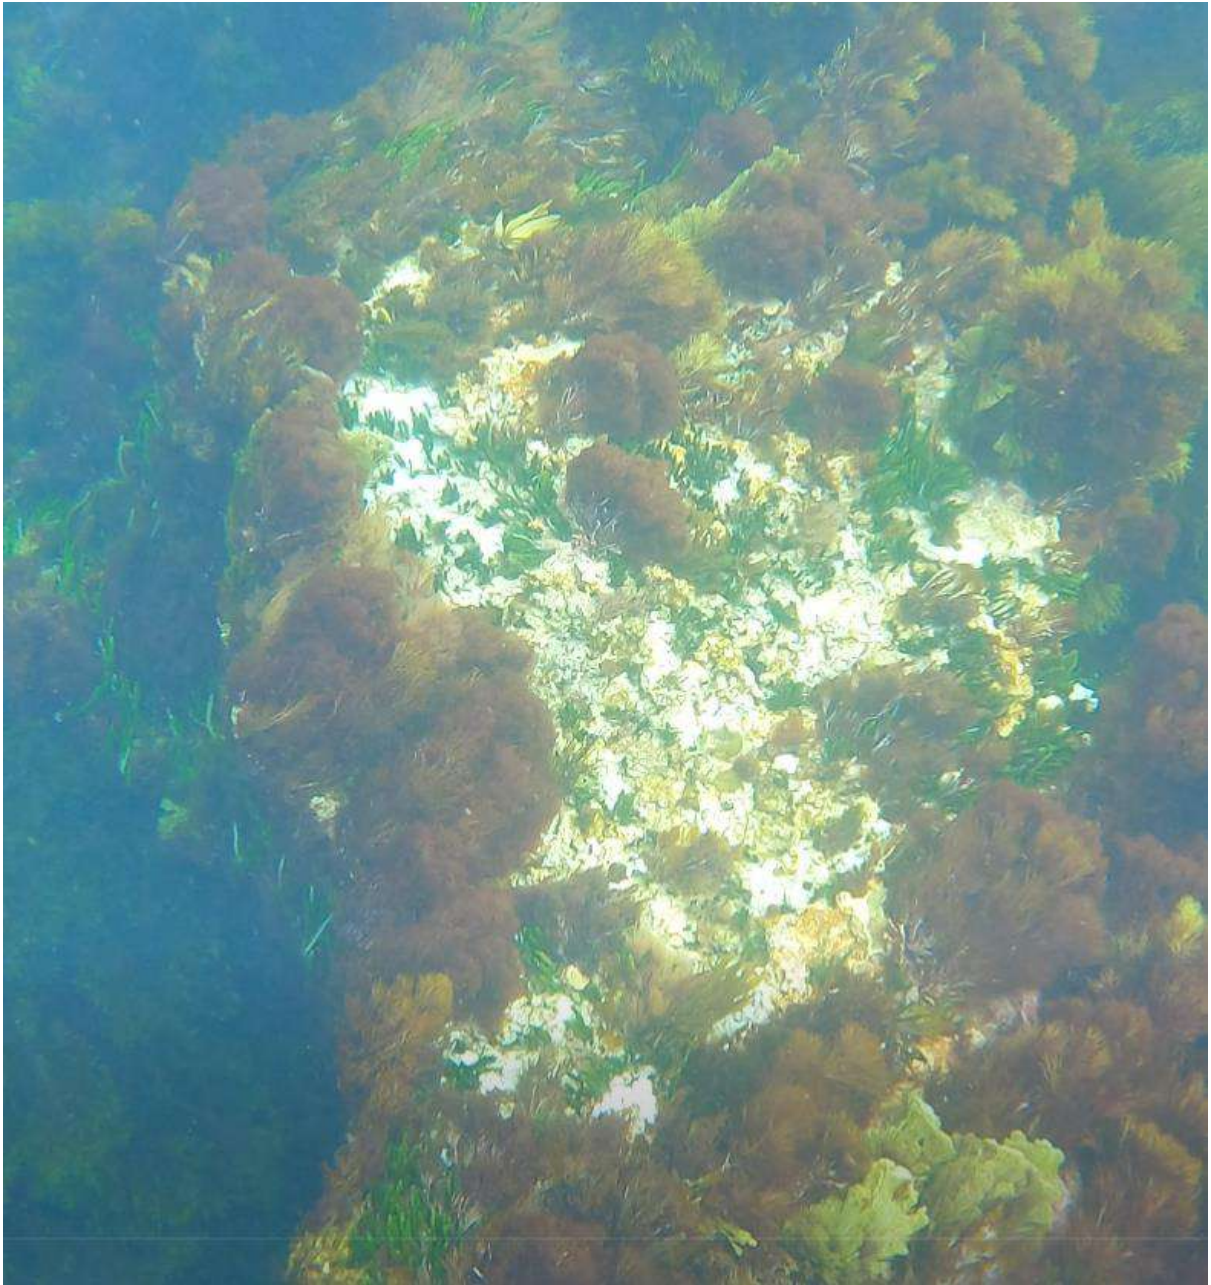
1G.6. ADM1-005 Flat object with narrow jutting base, potentially limestone (2022-01-12, P. Kermeen)

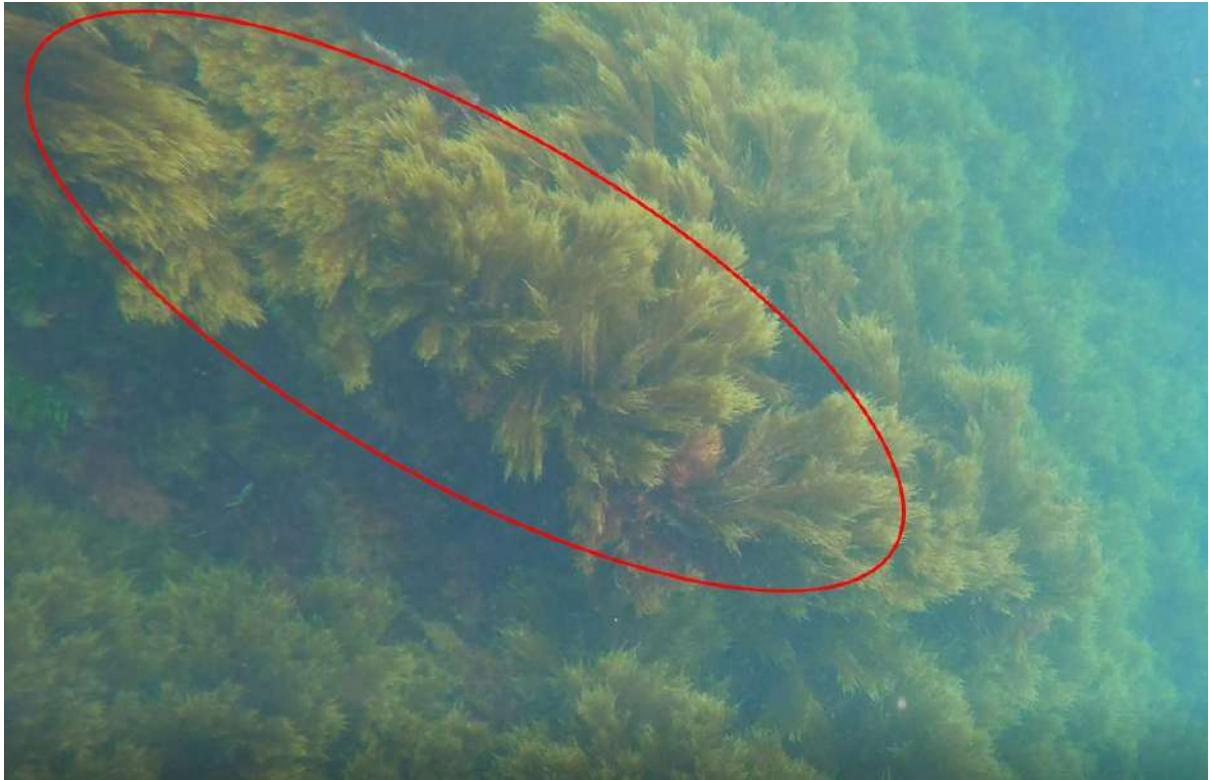
1G.12. ADM010 middle single angle beam's end point and oblique view height reference (2022-01-13, P. Kermeen)

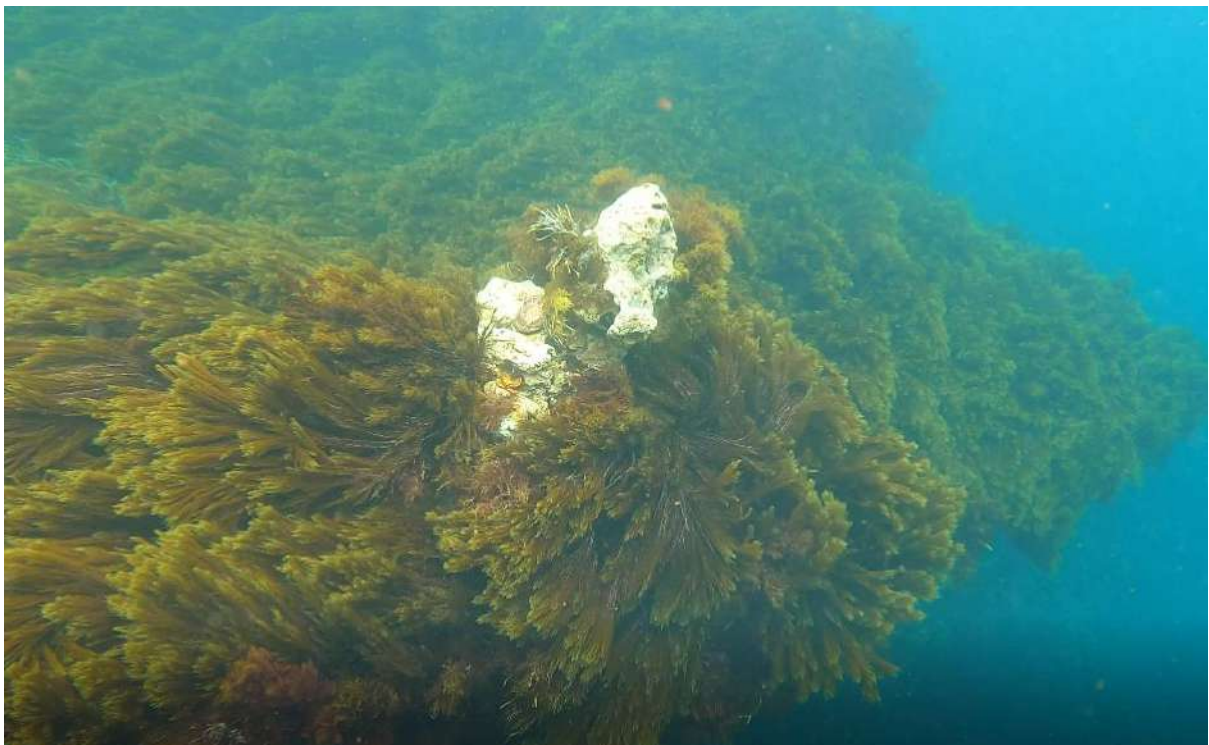
1G.18. ADM1-017 Upright structure with two small cylindrical shapes jutting out either side (2022-01-12, P. Kermeen)
