## CHAPTER SIX

### TORPEDO BOATS AND TORPEDO BOAT DISCARD AND ABANDONMENT IN AUSTRALASIA, 1884-1924

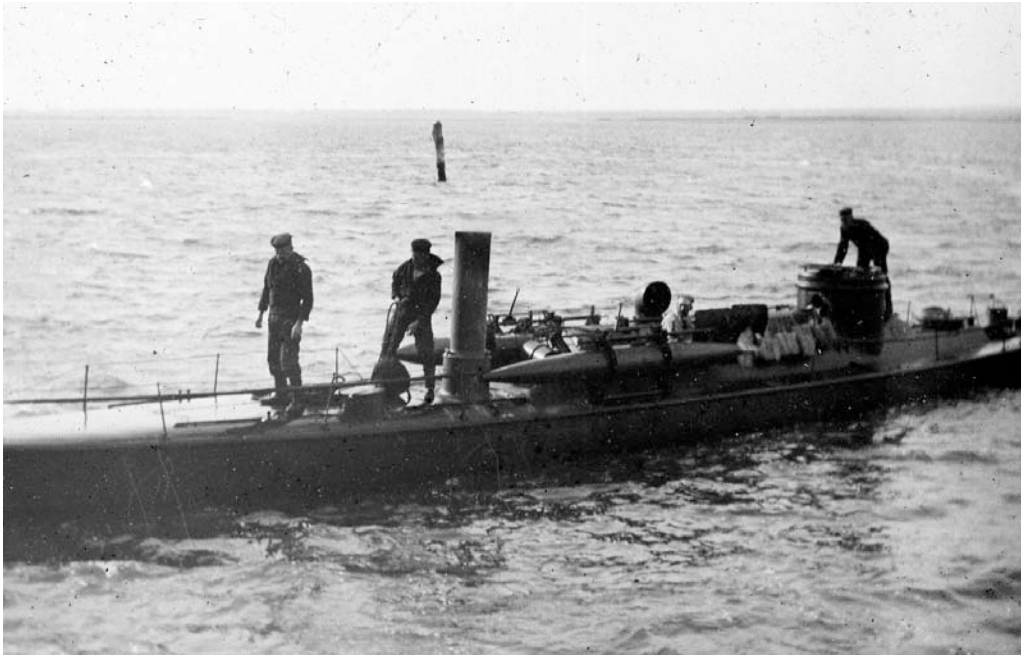
**Figure 49.** *Lonsdale* underway in Port Phillip Bay ca. 1905, showing Whitehead torpedoes mounted on dropping gear amidships. Image courtesy of the Queenscliff Maritime Museum (no accession number).

Aside from a stylised illustration of a ‘Victorian second-class torpedo boat’ that appeared in the *Australasian Sketcher* on 27 August 1883, none of the archival photographs consulted for this study depict either *Lonsdale* or *Nepean* with the bow-mounted torpedo launcher described by Jones.

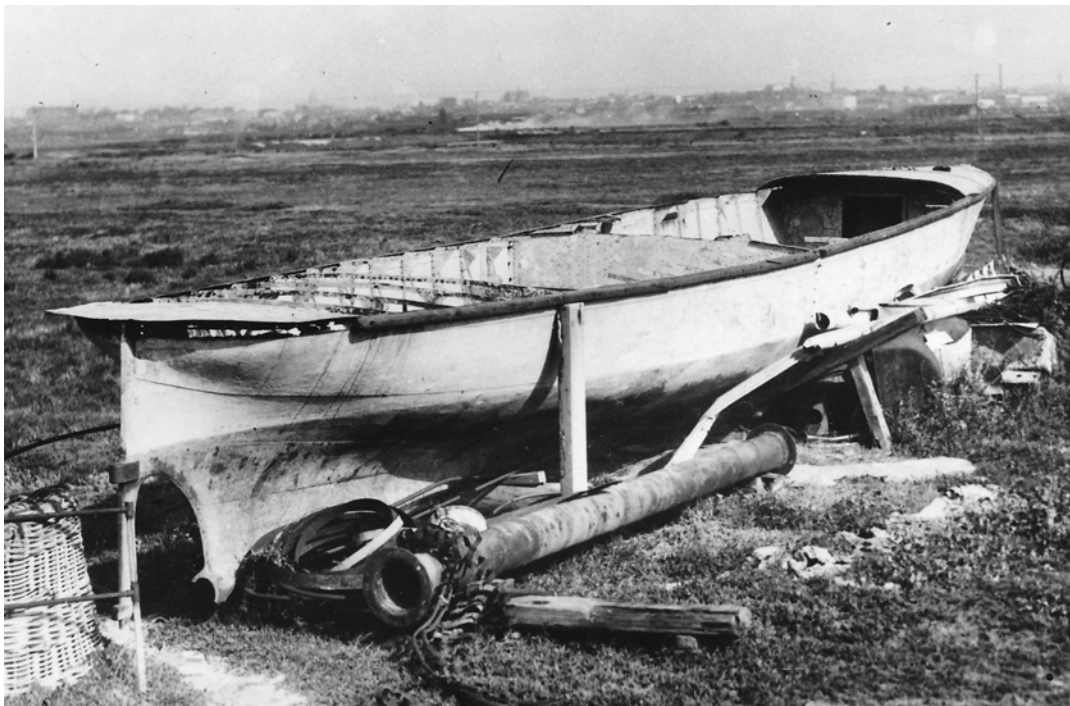
**Figure 50.** Abandoned vessel purported to be the torpedo boat *Nepean* at Fisherman's Bend, Port of Melbourne ca. 1929-30. Image taken by Peter Williams and courtesy of Ross Gillett.

once again for sale and available for inspection (*The Age*, 4 June 1914). Neither vessel received a suitable tender, and following the outbreak of the First World War in July 1914, the RAN's efforts to sell them ceased (Gillett 1982: 119). The final disposition of both torpedo boats is unclear, although at least two overview histories claim they were broken up on the Yarra River during the 1920s (Gillett 1982: 119; Jones 1986: 165). One of these sources (Gillett 1982: 119) includes an archival photograph (Figure 50) that purports to show *Nepean* abandoned 'at Fisherman's Bend [in the] Port of Melbourne about 1929-30'.

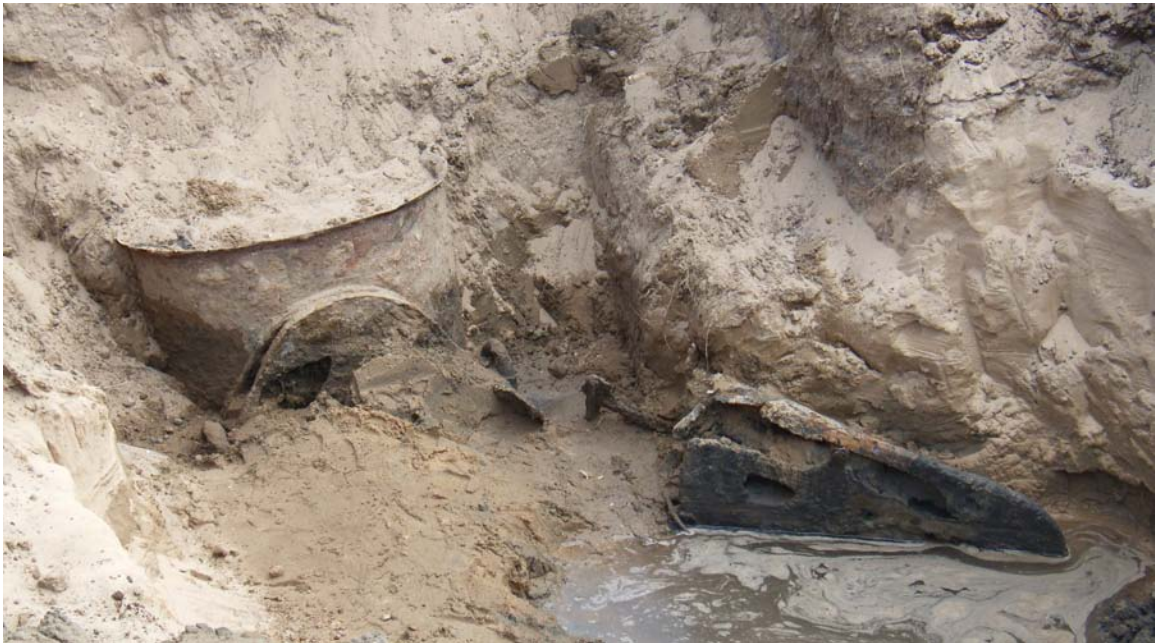
**Figure 51.** *Lonsdale's* conning tower and disarticulated bow section *in situ*, as they appeared during the 2006 excavation. Image courtesy of Geoff Hewitt and TerraCulture Heritage Consultants.

lower during this phase of the project than previous investigations, allowing archaeologists to uncover the conning tower to its junction with the vessel's casemate superstructure. Additionally, other hull features, including a portion of the engine compartment after bulkhead and lifting rings mounted just forward of the conning tower, were accessible for the first time and subsequently documented. As excavation proceeded forward from the conning tower, all recognisable contiguous hull structure disappeared, save for a 1.73-metre disarticulated section representing the extreme fore end of *Lonsdale's* distinctive 'ram' bow (Figure 51).

The bow section was discovered immediately forward of—and adjacent to—the conning tower, oriented 45-degrees to the run of the hull and with its keel facing upwards (Hewitt and Tucker 2009: 27). Attempts to locate additional structure closer to the projected forward extremity of the vessel only encountered a 'dark planar mass' and disarticulated framing components suggesting the torpedo boat's foreship had collapsed into 'incoherent

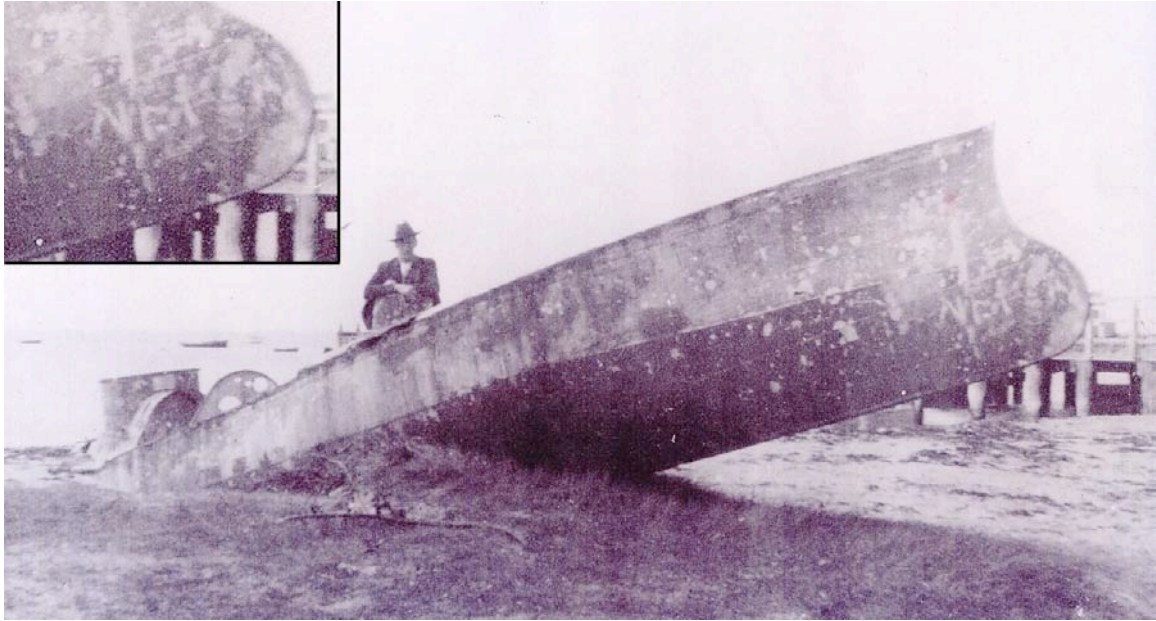
**Figure 52.** *Lonsdale's* abandoned hull at Queenscliff, Victoria ca. 1915; *inset*, apparent graffiti etched into surviving paint on the cutwater bow. Image courtesy of the Queenscliff Maritime Museum (no accession number).

The three archival photographs known to exist that depict *Lonsdale* after it was decommissioned from naval service all show the vessel abandoned on the beach at Queenscliff (Figures 52, 53 and 54). Although the exact day, month, and even year that each was captured on film is currently a matter of some dispute, the sources from which they were acquired generally agree that all date to a ten-year span between 1915 and 1925. In each instance, the torpedo boat is shown with its hull exposed from the conning tower (just aft of midships) to the cutwater bow. Two images clearly reveal that the hull aft of the conning tower was completely buried at the time it was photographed. Given the presence of what appears to be live vegetation growing from the ground immediately adjacent to the embedded hull, this burial episode may have occurred some time prior to when it entered the visual archival record.

In each photograph, *Lonsdale* is positioned with its bow angled upwards and facing away from Port Phillip Bay. The hull's stern-down orientation resulted in approximately the first quarter to one-third of the foreship standing completely proud of the beach. At the

intersection between the upper face of the bow weather deck and cutwater, the hull appears to have protruded nearly two metres above the ground, and where exposed the vessel's underside beneath the waterline is characterised by a distinct colour contrast that almost certainly represents *Lonsdale's* surviving coat of anti-fouling paint. The paint is chipped and pitted in several areas along the visible (starboard) bow, and even seems to have been marked with graffiti near the curve of the cutwater (see Figure 52, inset).

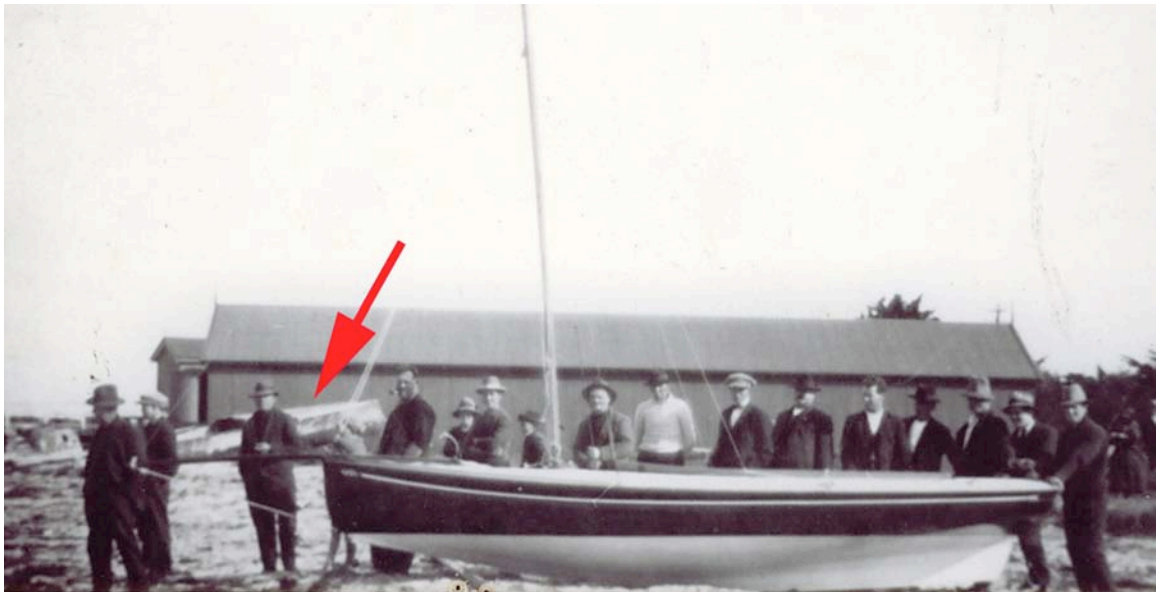
**Figure 53.** Launch of a 'Couta' boat at Queenscliff, with the abandoned hull of *Lonsdale* (highlighted by arrow) in the background. Image courtesy of the Queenscliff Maritime Museum (no accession number).

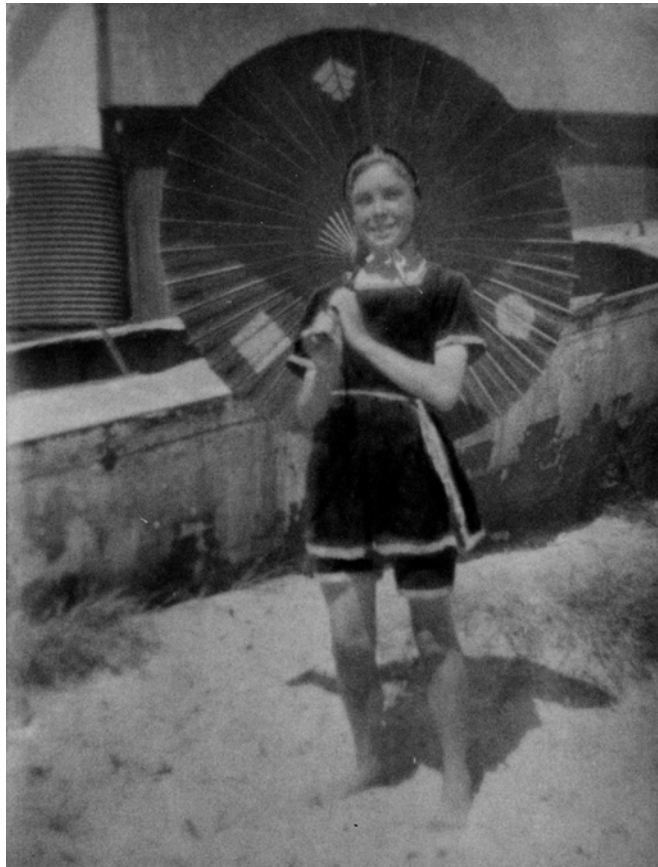
**Figure 54.** 1920s-era photograph of an unidentified girl standing in front of *Lonsdale's* abandoned hull. Note cut away deck plates, as well as lifting lug immediately to the right of the girl's parasol. Image courtesy of Des Williams.

Perhaps the most remarkable feature revealed by these photographs is the degree to which *Lonsdale's* hull still appears as it did when in operational service. Outwardly, the shell of the torpedo boat is clearly intact to the gunwales, and various hull components including internal framing, casemate support structure and the conning tower, are all still in their

original positions. The only obvious exception is the steel plating that comprised the weather deck and armoured casemate. These architectural elements appear to have been either removed entirely or cut open in an effort to facilitate removal of the torpedo boat's engine, boiler, internal fittings, and machinery. The conning tower hatch cover and majority of external fittings are also absent, although at least one deck-mounted lifting lug is visible immediately to the right of the girl's parasol in Figure 54.

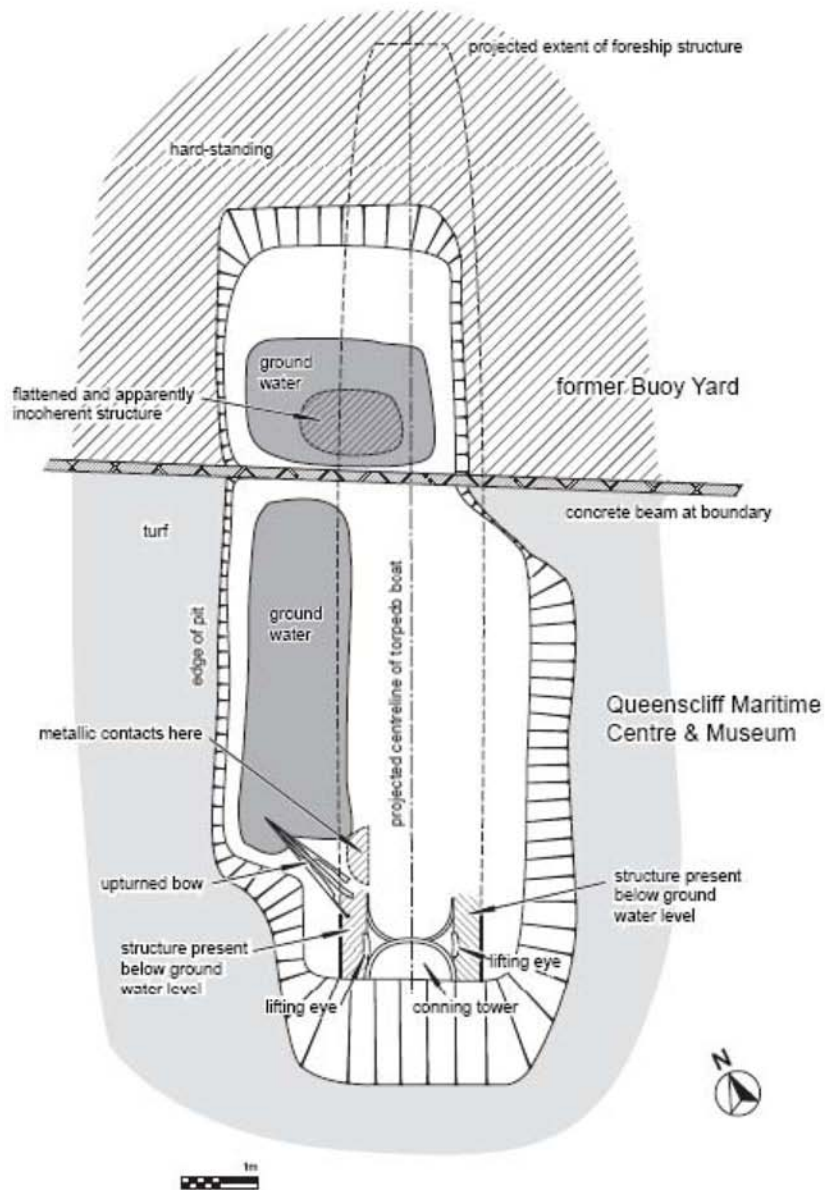
**Figure 56.** Site plan of *Lonsdale*, showing close proximity between conning tower and disarticulated bow section, as well as ‘flattened and...incoherent structure’ representing remnants of the forward extent of the hull. Image courtesy of Geoff Hewitt and TerraCulture Heritage Consultants.

Archaeological data acquired between 1983 and 2006 reveals that *Lonsdale's* conning tower and the hull beneath it were still largely intact and—with the exception of corrosion on most of their metallic surfaces—appeared much as they did when photographed during the early twentieth century. The same can be said of the hull aft of the conning tower, which remains deeply buried in the beach sand and appears to have retained its overall structural integrity (D. Cahill, as cited in Hewitt and Tucker 2009: 32). By contrast, the foreship and bow, once the preeminent features of the exposed hull, are no longer articulated with the remainder of the vessel (Figure 56). Indeed, as noted by Hewitt and Tucker (2009: 32), the

vast majority of *Lonsdale's* forward section disintegrated into largely incoherent structure as a consequence of 'gross corrosion' and collapse of the hull, as well as unspecified ground disturbance that occurred subsequent to its complete burial.

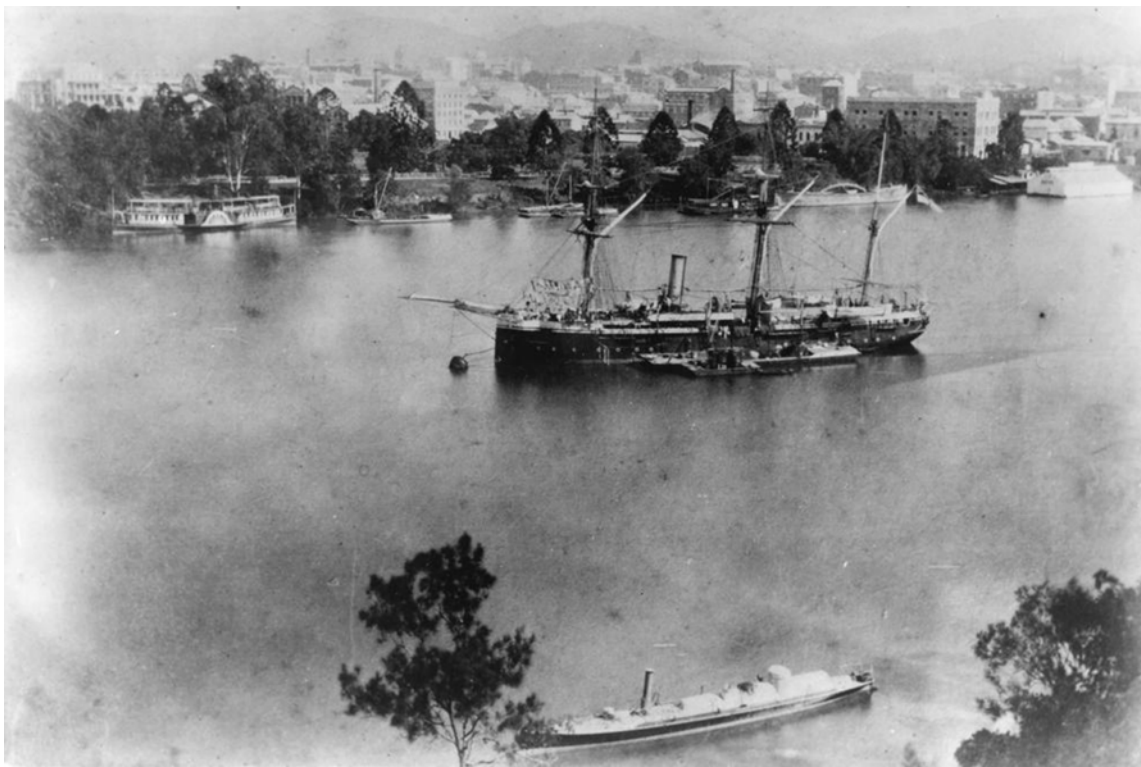
**Figure 57.** *Mosquito* (foreground) moored in the Brisbane River near the naval depot at Kangaroo Point, ca. 1889. The British Royal Navy sloop-of-war *Egeria* lies at anchor in the middle of the river. Image courtesy of the State Library of Queensland (Accession No. 102640).

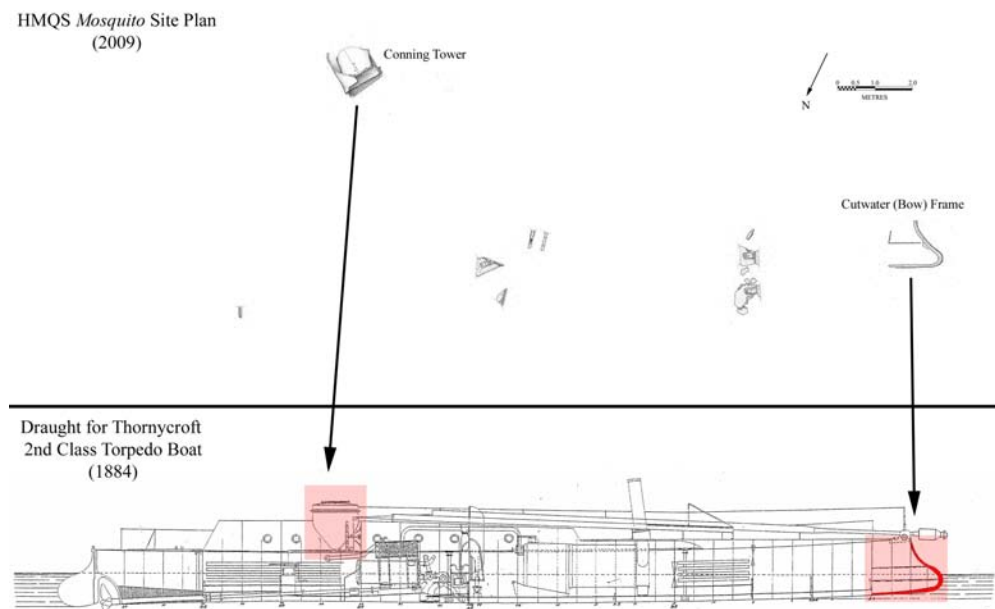
**Figure 60.** Comparison of *Mosquito's* 2009 site plan and the Thornycroft draught for *Torpedo Boat Nos. 168-171, 191 and 193*, showing the relative positions of the conning tower and cutwater frame. Thornycroft draught courtesy of the Thornycroft Torpedo Boat Museum (Accession No. TTBM/FILE 3/30).

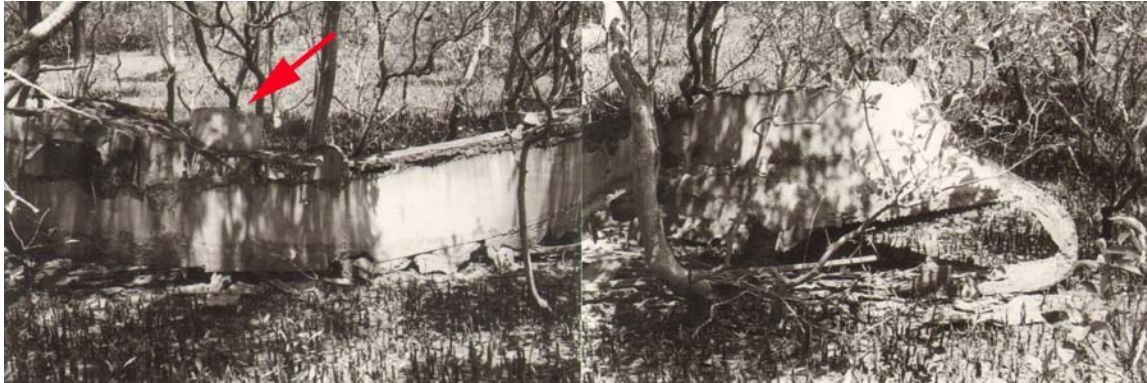
**Figure 61.** Mosaic produced from two photographs taken of *Mosquito*'s abandoned hull in 1966, showing the starboard bow section. Note the articulated ram bow (far right) and smokestack aperture (highlighted by arrow). Image courtesy of S. Prior and the Queensland Maritime Museum (no accession number).

When Prior captured *Mosquito's* hull on film, it was still surprisingly intact. The bow and stern sections, in particular, were largely articulated, in an upright position, completely exposed above the mud line, and seemingly still retained paint on most of their visible surfaces (Figures 61 and 62). As with *Lonsdale*, elements of steel plating that comprised the weather deck appear to have remained in their original positions, but only in areas where they did not restrict access to the vessel's engines, machinery, or internal fittings. The degree to which some deck structure survived is perhaps best represented by *Mosquito's* intact smokestack aperture, which emerged from the stokehold just forward of the casemate and is clearly visible in a profile photograph of the vessel's starboard side (see Figure 61).

beached roughly perpendicular to the existing shoreline, with its bow facing away from Boggy Creek. Most of the hull appears to have rapidly settled into the swamp floor to the waterline, suggesting sufficient water movement around and beneath the hull to facilitate this process. The bow, by contrast, was largely exposed above the mud but still subject to tidal fluctuation, as evidenced by a line of corrosion visible along its starboard side in several of Prior's photographs (see Figures 61 and 64).

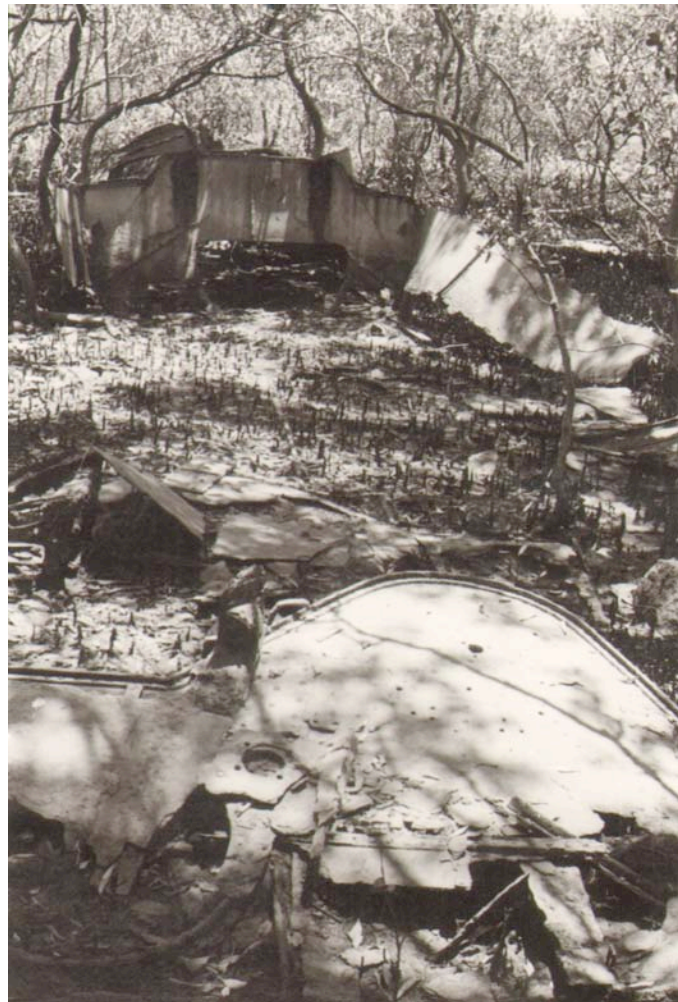
**Figure 62.** 1966 photograph of *Mosquito*'s partially intact stern section. Note Bulkhead 5 in foreground and Bulkhead 7 in centre background. Image courtesy of S. Prior and the Queensland Maritime Museum (no accession number).

or outside the hull and become partially or completely buried in mud by 1966. One of these architectural elements, Bulkhead Number 5, was clearly visible above the swamp floor at the time Prior took his snapshots and still exhibited *Mosquito*'s trademark 'turtleback' casemate profile (see Figure 62). The single articulated bulkhead, Bulkhead Number 7, is a distinct background feature in Figure 62, and seems to have played a significant role in holding the torpedo boat's surviving stern structure together. Another diagnostic feature easily recognisable in the photographs is the vessel's conning tower, which by the 1960s was disarticulated from the rest of the hull and laying on its side, but almost completely intact as an architectural element (Figure 63). Attached to the conning tower was a surviving—but heavily corroded—section of its hatch cover.

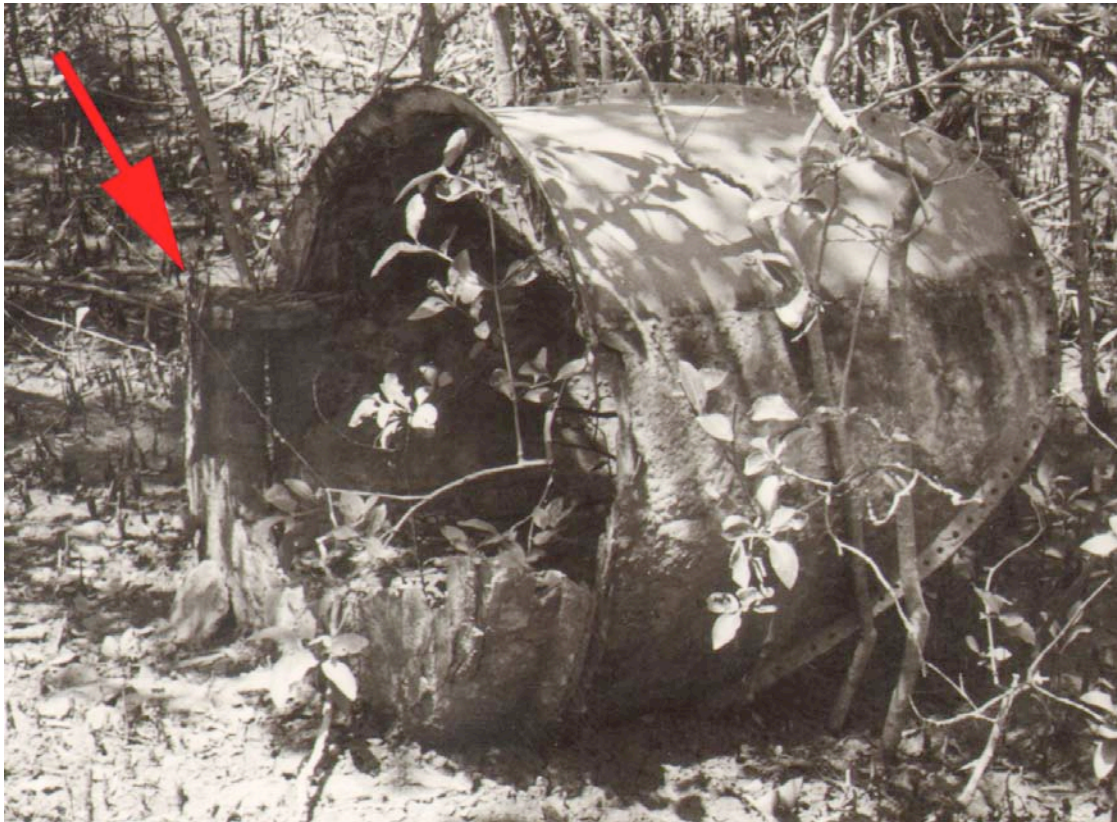
**Figure 63.** *Mosquito*'s disarticulated but largely intact conning tower, as photographed in 1966. Arrow highlights remnants of articulated conning tower hatch cover. Image courtesy of S. Prior and the Queensland Maritime Museum (no accession number).

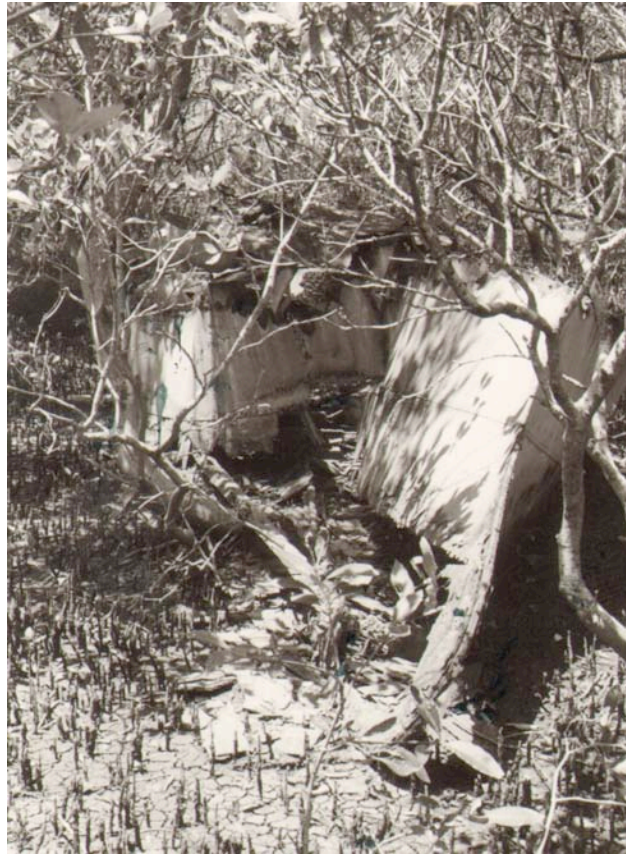
**Figure 64.** 1966 bow-on photograph of *Mosquito's* forward section, showing corrosion-generated separation of the bow (at right centre) from the midships hull. Image courtesy of S. Prior and the Queensland Maritime Museum (no accession number).

Prior's photographs also reveal that *Mosquito's* hull was oriented on a fairly level plane fore-and-aft, but may have exhibited a slight list to port when discarded. By 1966, the list was exacerbated at the bow, likely as a consequence of corrosion-generated separation between it and the vessel's midships section at Bulkhead Number 3 (Figure 64). The detrimental effects of corrosion on the hull's galvanised steel fabric, particularly in areas alternately exposed to the mangrove's tidally influenced wet and dry conditions, are evident in the majority of images. The mangrove trees themselves were clearly another critical factor in the torpedo boat's deterioration, penetrating or enshrouding the hull at multiple points along its length. Taken as a whole, the swamp's environment appears to have acted as the single most important catalyst for *Mosquito's* gradual disintegration during the next four decades, and eventually the last vestiges of the hull collapsed and disappeared beneath mud and mangrove.

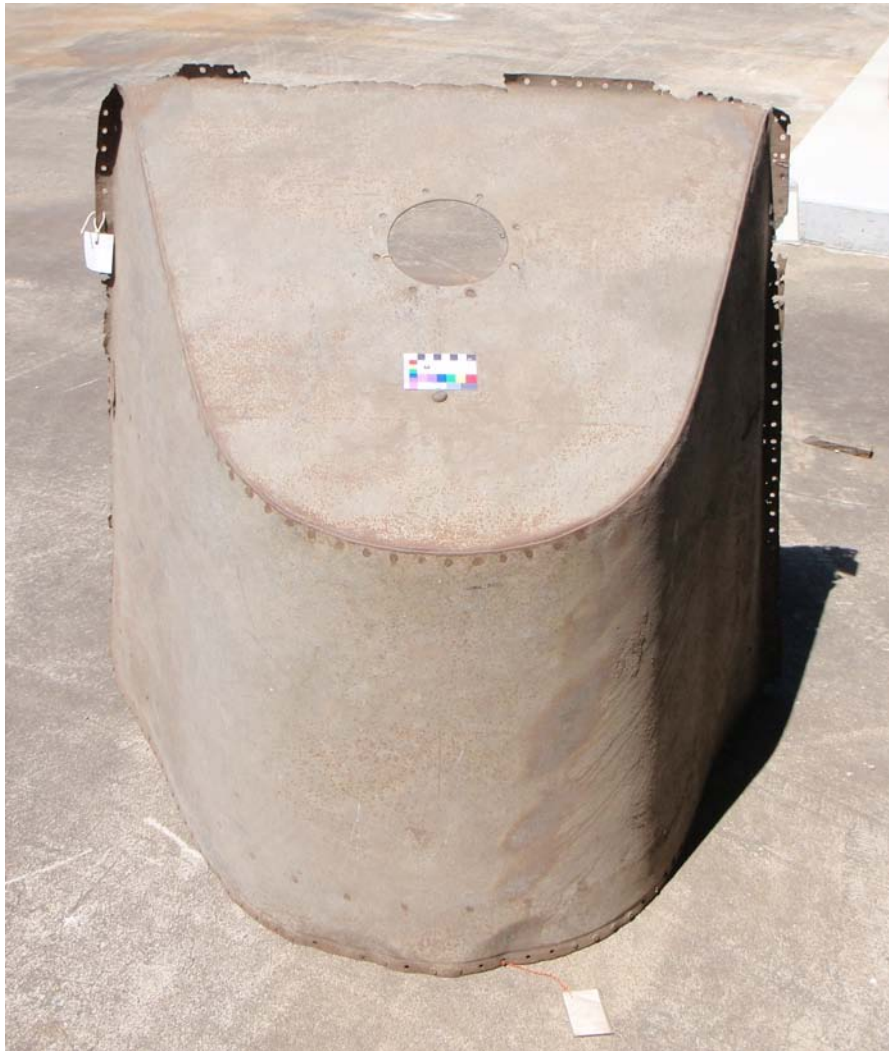
**Figure 66.** *Mosquito's* intact stern casemate, currently housed in the collection of the Queensland Museum, South Bank. Note the overall excellent condition of the casemate's painted galvanised steel fabric.

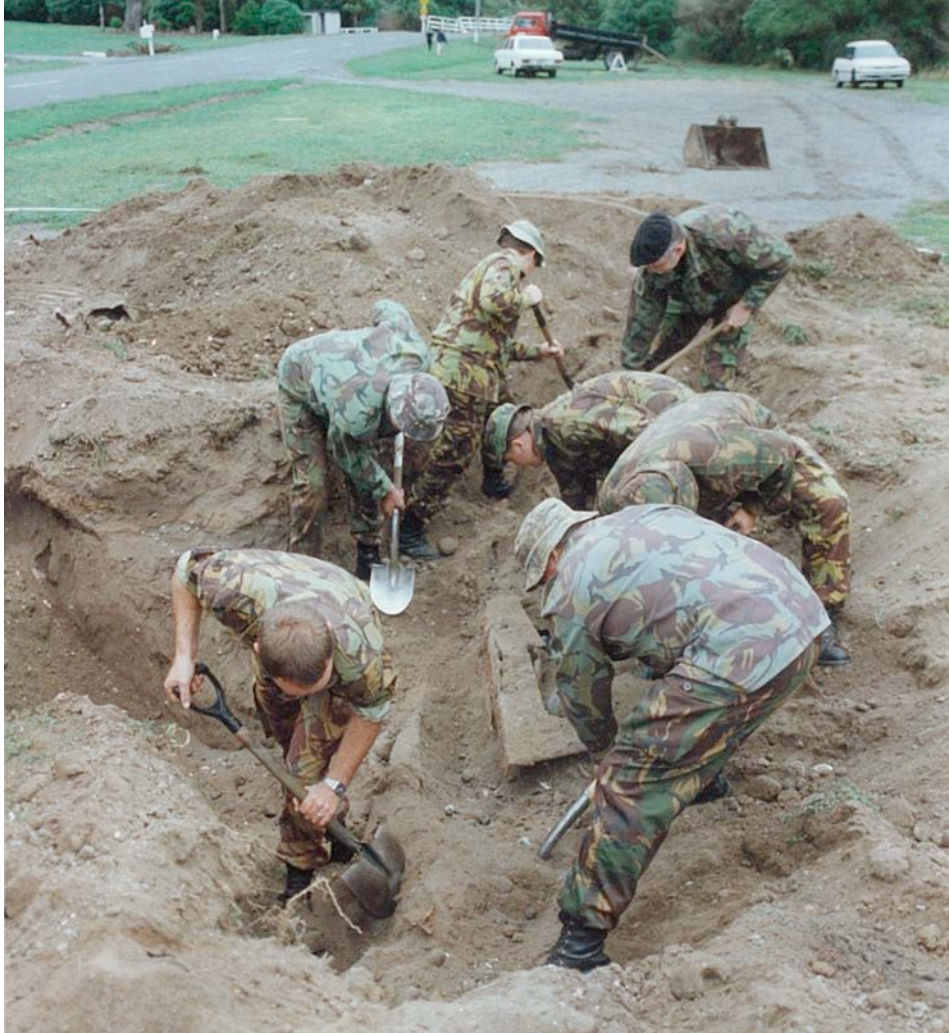
**Figure 68.** Royal New Zealand Army personnel uncover portions of *Defender's* hull at Purau Beach during 1998 efforts to locate and recover the torpedo boat's surviving remnants. Image courtesy of David Bundy.

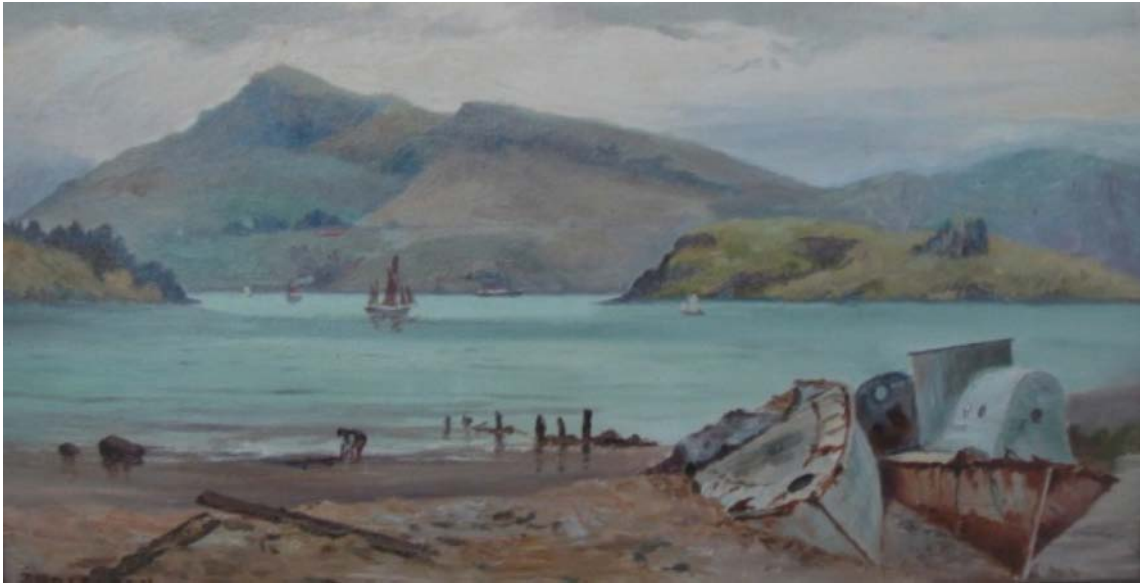
**Figure 69.** Watercolour painting *Purau Beach*, showing *Defender's* abandoned and broken hull, ca. 1930. Image courtesy of David Bundy.

*Purau Beach* depicts *Defender* in a secondary discard context, after its largely intact hull was split into two sections and subsequently removed from the Purau Bay foreshore. As revealed in the painting, these halves were dragged some distance from the shoreline and placed atop an elevated area overlooking the beach. When re-deposited, they were positioned immediately adjacent and parallel to one another, and oriented on an approximate north-south axis. Both hull sections exhibit a noticeable list to starboard, with the result that they heel away from each other. The stem and sternpost, once located at opposite ends of

One particularly noteworthy aspect of *Defender's* hull, as captured by Hollobon, is the degree to which it was still largely intact approximately 30 years after being abandoned. Aside from the obvious break amidships, and flash rusting at various points along both surviving sections, the visible hull and deck plates at both the bow and stern are complete and in their original positions. The same can be said for the vessel's conning tower and adjacent casemate structures fore and aft. What appears to be reflected light in one of the stern casemate's port side viewport apertures suggests that it—and possibly others—may still have retained a glass pane insert at the time the painting was rendered.

Elements missing from *Defender's* formerly intact hull include the conning tower hatch cover and deck fittings such as the steel cable handrails, bow bollards and chain locker hatch cover. Similarly, deck plates and casemate superstructure at the after end of the bow section appear to have either been removed or cut away, almost certainly as a result of Mark

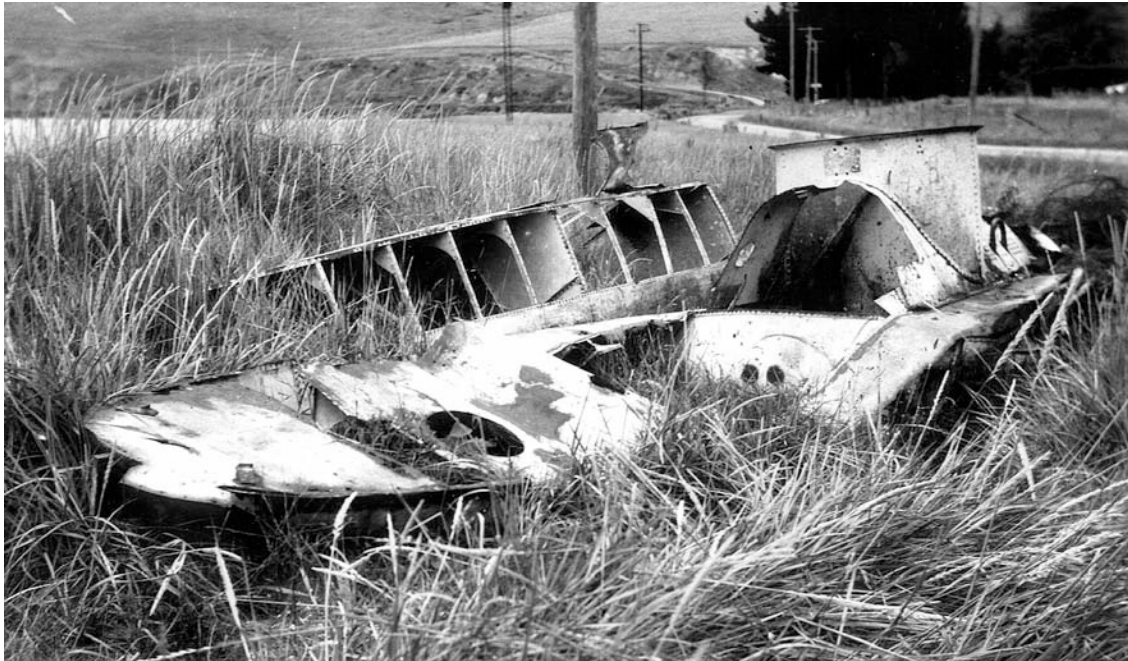
**Figure 70.** Remnants of the torpedo boat *Defender* at Purau Beach, ca. 1941. The stern and midships section (with intact conning tower) are in the foreground. The bow section behind it is lying on its side. Image courtesy of the Alexander Turnbull Library, National Library of New Zealand (Accession No. F-66786-1/4).

By 1941, when *Defender's* remains were documented in the first of only two known close-up photographs of the secondary discard site, their appearance and orientation had changed drastically (Figure 70). The site still comprised two distinct hull sections positioned adjacent and parallel to one another, but both were rotated approximately 180 degrees so that the stem and sternpost now pointed towards Purau Bay. The surviving bow, formerly upright and largely intact, was now heeled well over on its port side and missing the vast majority of its deck plating. The stern appears to have fared slightly better, but was now absent the intact casemate structure visible in Hollobon's painting. Surviving deck plating aft was clearly in an advanced state of degradation and collapse, and the entire site was overgrown with vegetation.

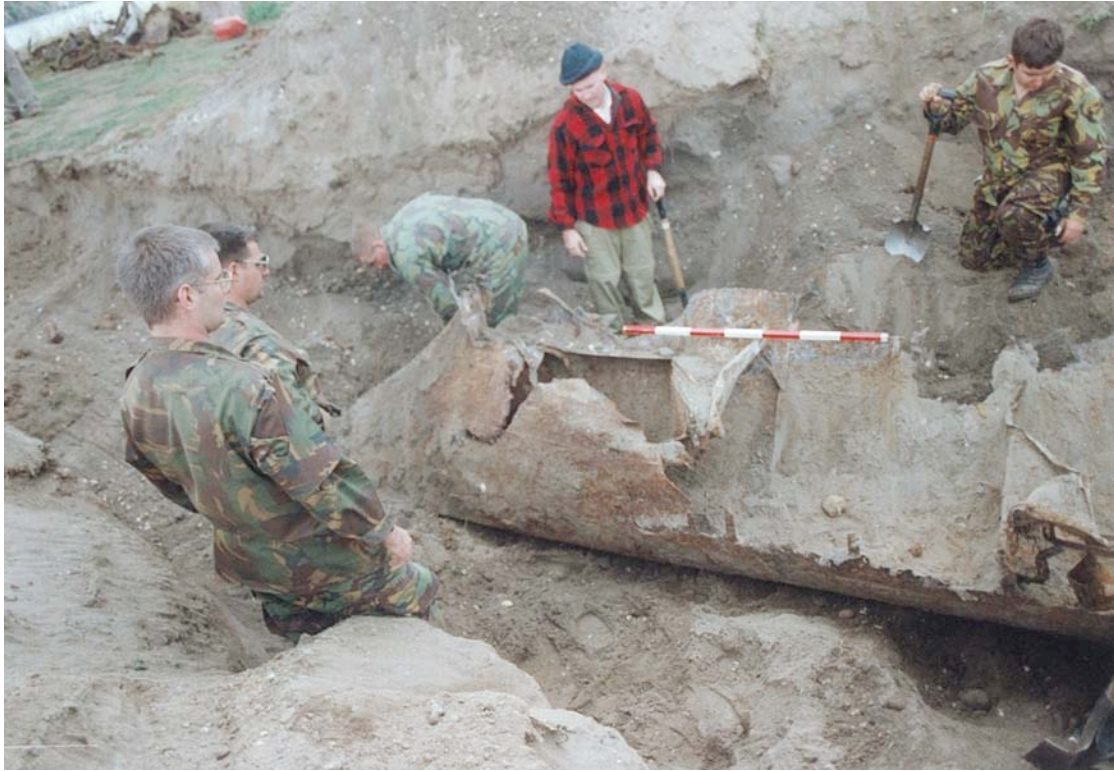
**Figure 71.** *Defender's* bow section *in situ* during the 1998 recovery project. The ram bow is located immediately to the right of the Royal New Zealand Army personnel in the left foreground. Image courtesy of David Bundy.

The bow and midships were the largest, most intact sections and were buried deepest; by contrast, the stern appears to have been repeatedly run over and crushed with heavy machinery, and was ultimately deposited at the shallowest observed depth of any of the site's excavated burial pits (Figures 71 and 72). According to David Bundy (pers. comm., 13 November 2008) the bow section comprised 11 metres of contiguous hull structure, retained most of its keel, and was positioned with the stem facing southwest. The surviving midships section was located a short distance away to the east, and was oriented approximately parallel to the bow. The mangled remains of the stern were discovered in an area between and slightly south of the other sections, but crushed and twisted to such an extent that the run of the hull was impossible to determine.

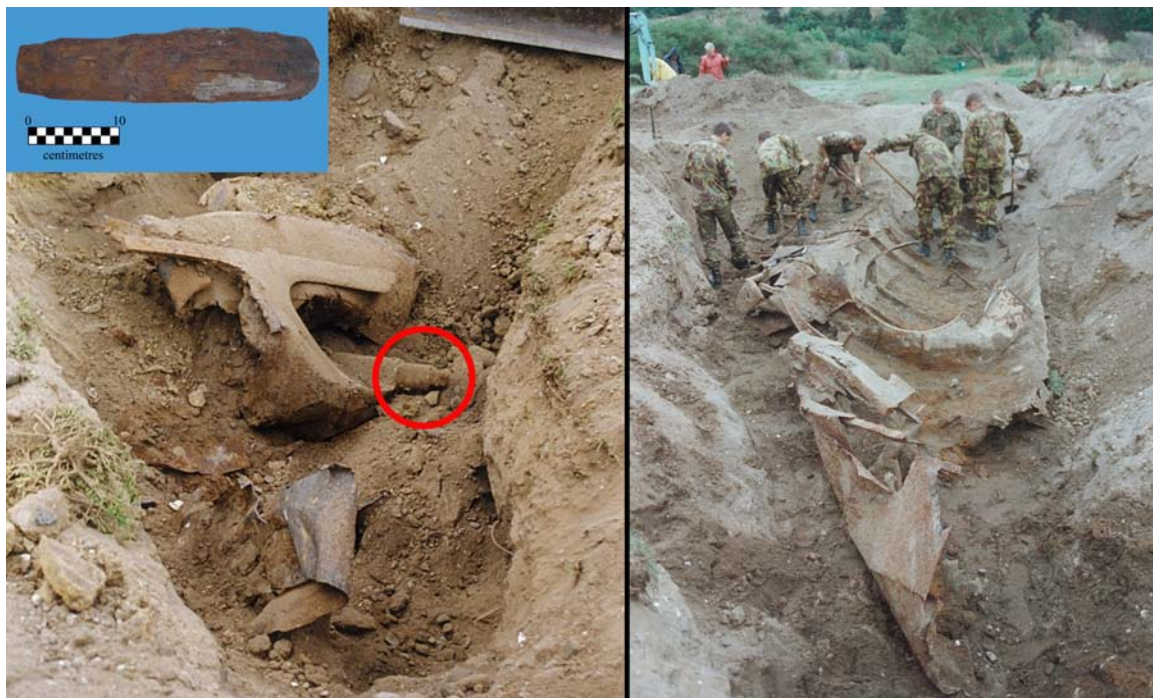
**Figure 72.** *Left*, *Defender's* crushed stern section. Circle highlights wooden plug embedded in exterior screw aperture at the time of recovery; *right*, *Defender's* midships section *in situ*; *inset*, wooden plug removed from the interior propeller shaft bushing. Images courtesy of David Bundy.

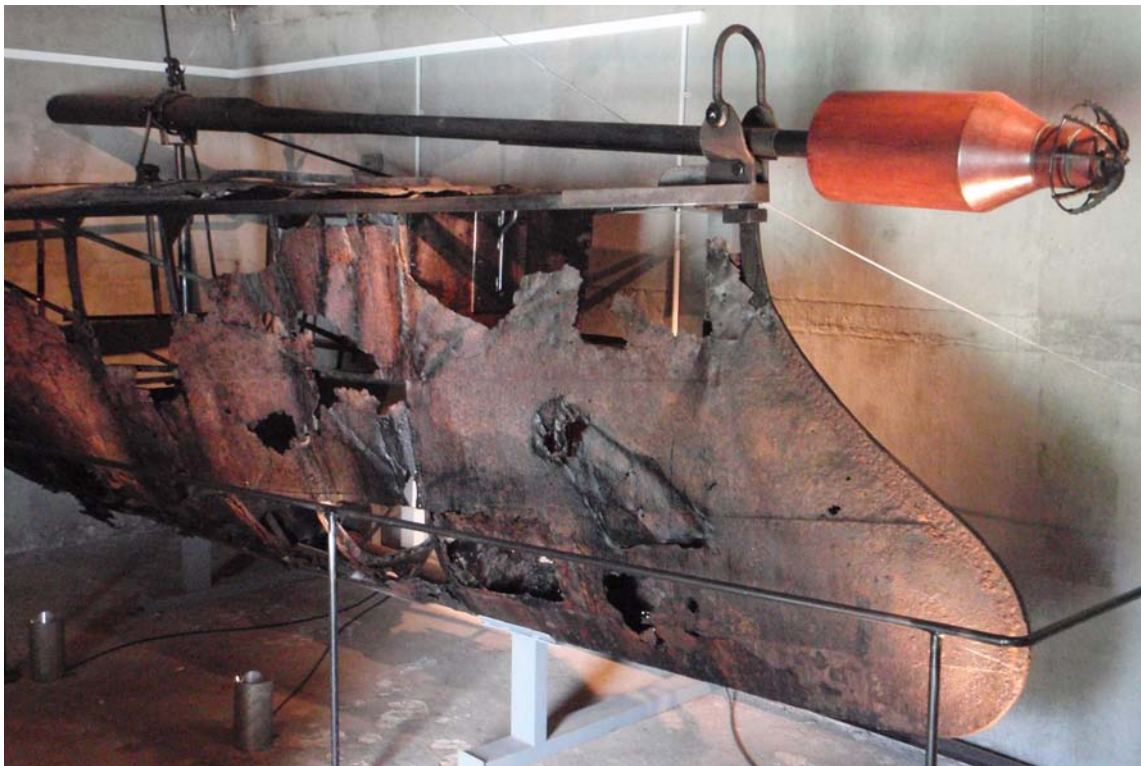
**Figure 74.** The bow section of the torpedo boat *Defender*, as reconstructed and exhibited at the Thornycroft Torpedo Boat Museum, Lyttelton.

Examination of the torpedo boat's recovered architectural elements has confirmed a significant portion of the discarded hull still existed up to its burial in 1959. This is particularly true of the bow and stern sections, which in their reconstructed form are approximately 65 to 75 percent intact (Figure 74). Hull elements visible in historic renderings of *Defender's* abandoned remnants—particularly articulated sections of deck and hull

plating—have survived to the present day, as have internal components such as the vessel's framing and bulkheads. Even the bow deck plating notably absent in the 1941 photograph was located, recovered, and ultimately reinstated to its original position on the hull during reconstruction efforts. Areas devoid of structure are evident throughout all recovered hull sections, but appear to have resulted primarily from corrosion, or damage associated with the County Council's efforts to remove the last vestiges of *Defender's* remnants from Purau Beach.

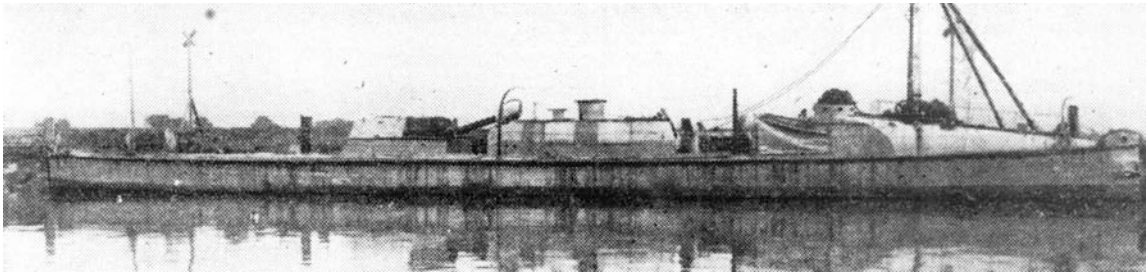
**Figure 76.** *Countess of Hopetoun's* stripped hull at Coode Island in 1924. Image courtesy of Heritage Victoria's Maritime Heritage Unit (Archaeological Site File No. 154).

and fittings from the recently decommissioned WWI-era submarine *J3* for a combined total of £1,500 (*The Argus*, 5 April 1924; *The Argus*, 28 January 1926). Hill moved *Countess of Hopetoun* to Coode Island shortly thereafter and commenced removing fittings and machinery, as well as dismantling elements of the hull (Figure 76). These items were put up for sale at public auction on 5 November 1924; the stripped hull and its remaining equipment followed suit at Melbourne's South Wharf 11 days later (*The Argus*, 16 October 1924; *The Age*, 1 November 1924). Archival sources do not reveal whether what remained of *Countess of Hopetoun* found a new owner, nor do they explain how or why the vessel was ultimately discarded in Port Phillip Bay a short distance from its former duty station at Swan Island.

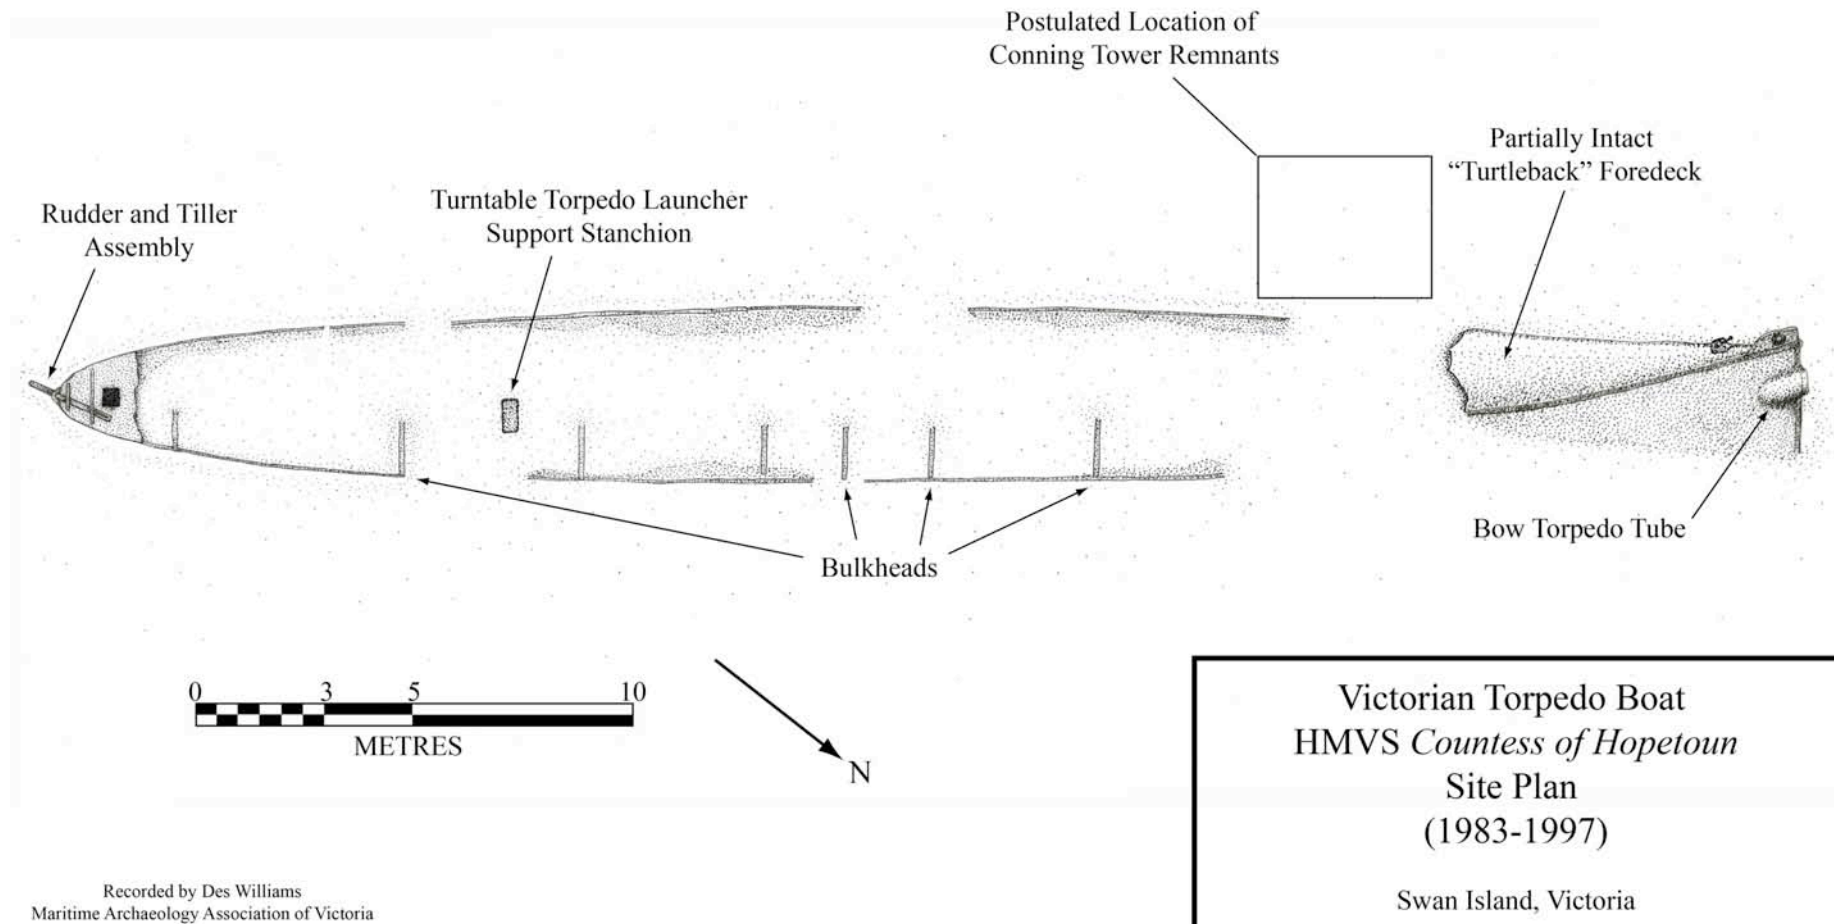
Recorded by Des Williams  
Maritime Archaeology Association of Victoria

Figure 77. Site plan of *Countess of Hopetoun*, generated from archaeological data collected between 1983 and 1997.

and featured enough original deck plating that the outline of a hatch leading to one of the aft compartments was still easily identifiable (see Figure 77). Although *Countess of Hopetoun's* engines and boilers were removed prior to the vessel's abandonment, the steel propeller and propeller shaft that comprised the remainder of the propulsion system clearly did not share the same fate (Figure 80). Curiously, neither exhibited outward signs of wear or damage that would have precluded their removal and reuse.

In stark contrast to the surviving bow and stern sections, most of *Countess of Hopetoun's* midships deck structure and upperworks were reportedly either disarticulated or missing altogether. The deck plates, in particular, were absent or cut open to such an extent that the hull appeared 'wide open, like a sardine tin' for the majority of its exposed length (Des Williams, pers. comm., 24 January 2011). Such alteration almost certainly constitutes the results of Hill's efforts to salvage the torpedo boat's engine, boiler, and other internal machinery at Coode Island in 1924. Whereas the deck plates have clearly been altered or removed, underlying hull structure comprising several lateral bulheads, deck beams or framing stations, does not appear to have been affected by salvage activities (see Figure 77).
