## CHAPTER SIX

### TORPEDO BOATS AND TORPEDO BOAT DISCARD AND ABANDONMENT IN AUSTRALASIA, 1884-1924

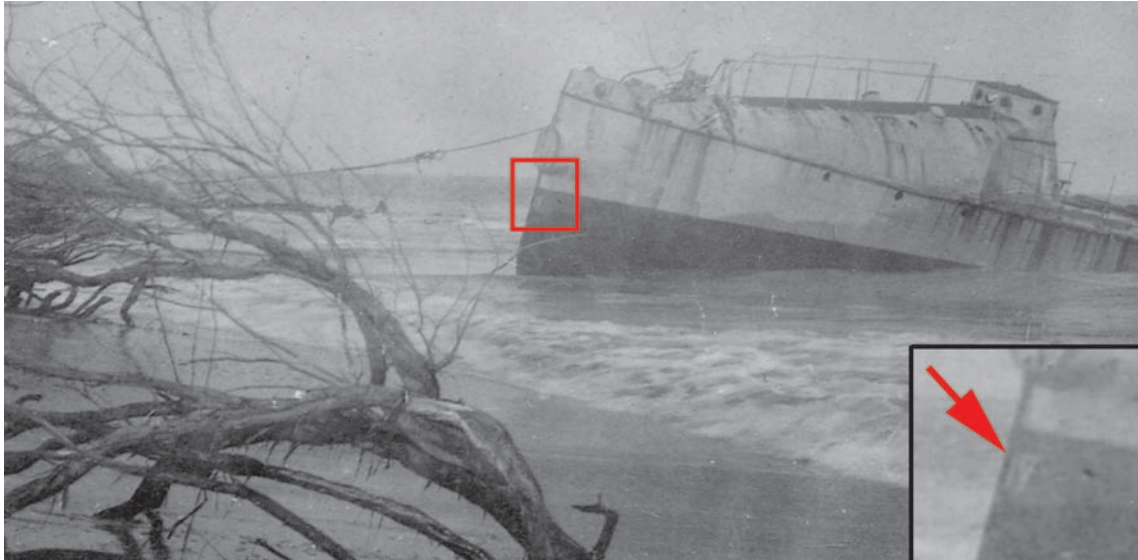
**Figure 78.** *Countess of Hopetoun*'s abandoned hull at Swan Island, ca. 1925. *Inset*, painted Roman Numeral "V" (highlighted by arrow) denoting the bow load line. Image courtesy of the Queenscliff Historical Museum (Accession No. DOC 2367/13917).

Bloomfield was the daughter of Swan Island's Naval Depot commander and lived on the island with her family between 1922 and 1932. Her photograph of *Countess of Hopetoun* constitutes the only known historical evidence of its abandonment. Although but one image, it contains a vast amount of detail and is a useful tool in interpreting the discard site. For example, it shows that approximately the first one-third of the torpedo boat's hull was originally above water, from the forward end of the bow torpedo tube to a point just off camera abaft the conning tower. Like *Lonsdale*, *Countess of Hopetoun* was oriented stern-down; consequently, most of its bow structure was visible above water, including the entire stem to the curve immediately above its junction with the keel. The hull had evidently heeled over to port, although the degree of list is unclear from the photograph.

Based on its visible attributes, *Countess of Hopetoun* appears to have been in relatively good condition at the time of, and in the years immediately following, its abandonment. Save for isolated, streaky stains that likely resulted from flash rusting of their steel fabric, the hull's surviving architectural elements do not exhibit significant signs of corrosion or damage, and appear to have been structurally sound. Similarly, the white paint scheme applied to the hull for the Prince of Wales' 1920 visit to Melbourne, although stained or faded in some areas, is still clearly evident and appears largely unmarred where exposed above water. Indeed, the overall condition of the vessel's painted surfaces at the time of discard is perhaps best illustrated by the Roman numeral "V" that denoted the torpedo boat's maximum load line. This hand-painted feature, located immediately abaft the stem and a short distance below the bow torpedo tube, was still very much apparent when captured on film (see Figure 78, inset).

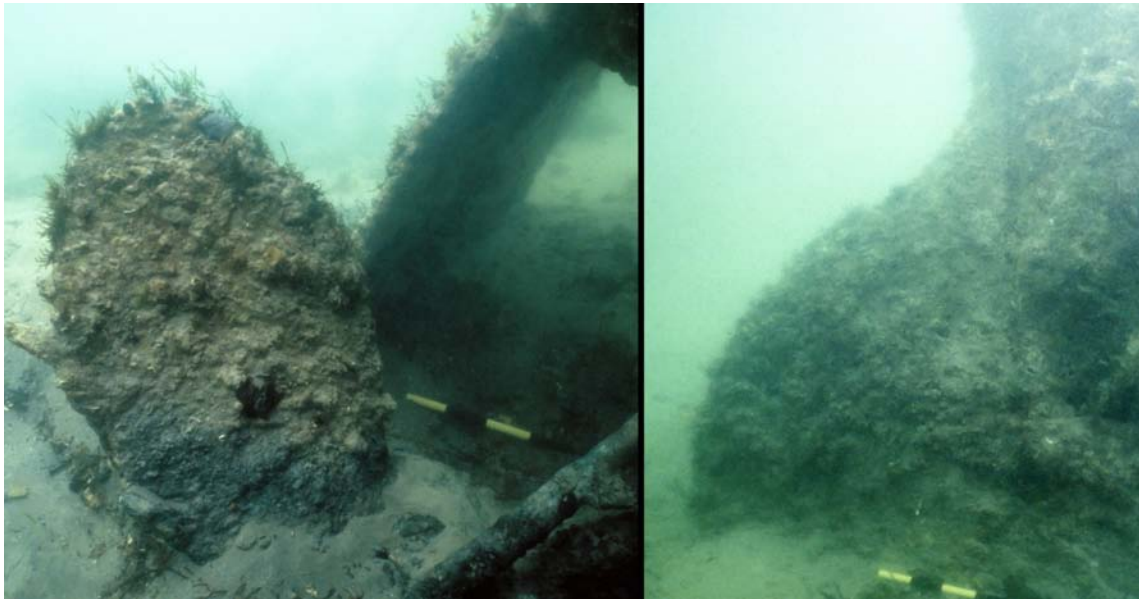
**Figure 80.** *Left*, *Countess of Hopetoun's* propeller, as it appeared in 1987. The vessel's articulated rudder is visible in the background; *right*, profile view of *Countess of Hopetoun's* rudder in 1987. Images courtesy of Heritage Victoria's Maritime Heritage Unit (Archaeological Site File No. 154).

and featured enough original deck plating that the outline of a hatch leading to one of the aft compartments was still easily identifiable (see Figure 77). Although *Countess of Hopetoun's* engines and boilers were removed prior to the vessel's abandonment, the steel propeller and propeller shaft that comprised the remainder of the propulsion system clearly did not share the same fate (Figure 80). Curiously, neither exhibited outward signs of wear or damage that would have precluded their removal and reuse.

Perhaps the most unexpected architectural feature discovered in association with *Countess of Hopetoun* was its balanced rudder and associated tiller assembly (see Figure 80). As noted with the torpedo boat's propeller and propeller shaft, the rudder and the tiller assembly were in their original positions and appeared largely intact and undamaged, save for degradation resulting from the site's surrounding marine environment. Richards (2008: 149) observes that the rudder is the structural element most frequently missing from beached and abandoned watercraft, not only because of the ease with which it can be unshipped and

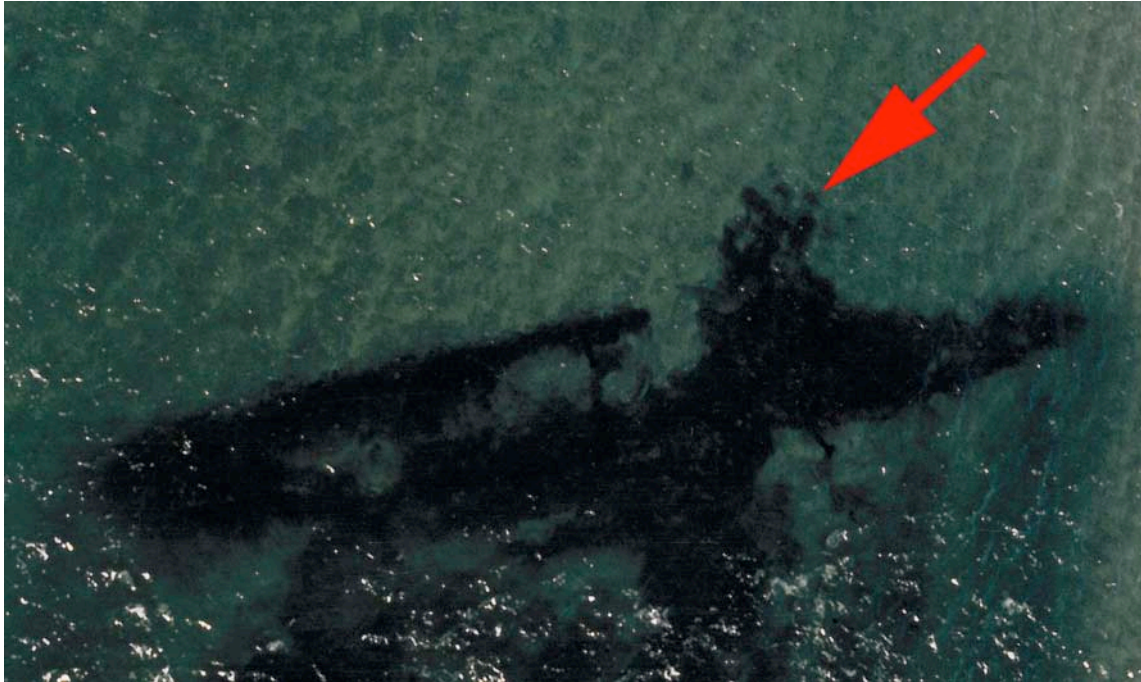
**Figure 81.** 1992 aerial photograph of *Countess of Hopetoun's* abandonment site. Arrow indicates location of possible conning tower remnants. Image courtesy of Heritage Victoria's Maritime Heritage Unit (Archaeological Site File No. 154).

One possible explanation for the damage could be a combination of the conning tower's robust construction and the hull's structurally compromised condition and list to port. As *Countess of Hopetoun's* hull gradually weakened and disintegrated due to corrosion and other environmental factors, the conning tower's sheer weight may have caused it to catastrophically disarticulate from the rest of the vessel, collapse to port, and fall into the sea. Assuming the conning tower was still relatively well attached to the turtleback and/or other structural elements of the foreship, it could have pulled the bow over as it collapsed, thereby resulting in an accentuated list. An aerial photograph of the site taken in 1992 (Figure 81) shows what appears to be substantial hull structure protruding from the vessel's side in the approximate location of the conning tower. Williams (pers. comm., 24 January 2011) has noted no evidence of the conning tower was visible during subsequent MAAV site inspections, but added that sand had filled in several exposed hull sections visible in the image, including the area referred to above.

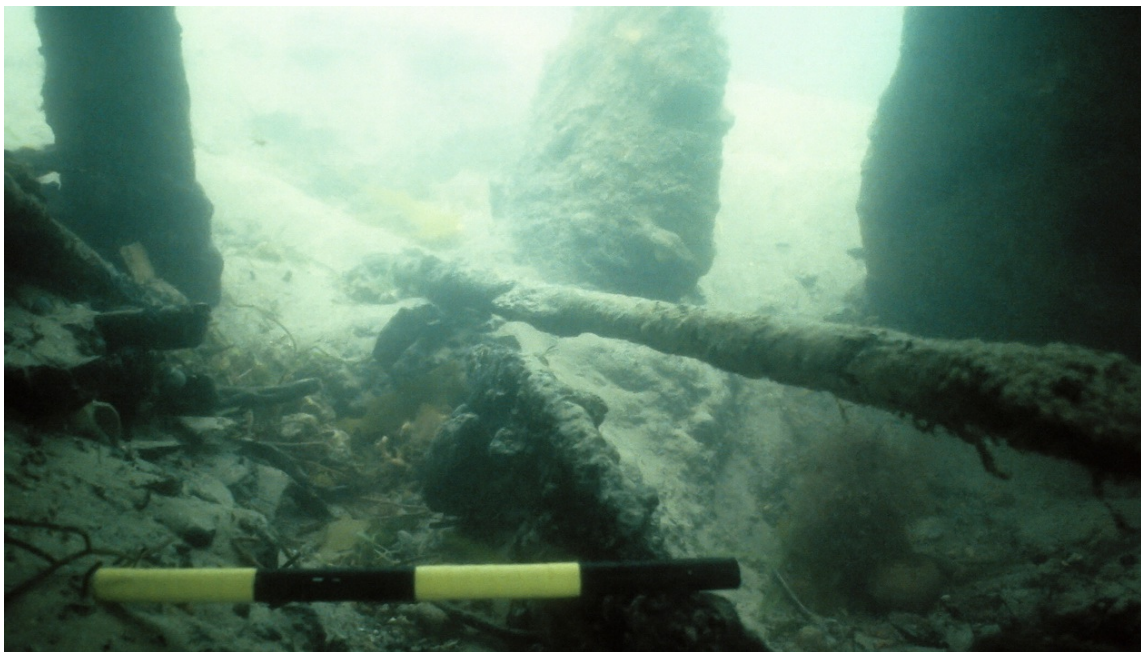
**Figure 82.** Steel cable discovered in association with *Countess of Hopetoun's* propeller. Image courtesy of Heritage Victoria's Maritime Heritage Unit (Archaeological Site File No. 154).

During the 1987 and 1992 site inspections, a length of steel cable was photographed in association with *Countess of Hopetoun's* stern structure (Figure 82). It was discovered draped over exposed portions of the propeller, from which point one end extended towards the bow before being buried in sand. The other end snaked away towards the port side of the rudder where it too disappeared into the seabed. Williams tentatively identified this feature as the remnants of a towline; however, its diameter appears to approximate that of the mooring cable visible in Bloomfield's photograph, suggesting it may represent a tangible remnant of *Countess of Hopetoun's* single documented form of placement assurance. Other methods of anchoring the discarded hull in place, such as an attempt to breach it below the waterline or
