How and to what extent can Historical Ship Structural Components be Observed in a Shallow Dynamic Environment?

The Case Study of SS *Admella*

A thesis submitted in fulfilment of the requirements for the degree of: Masters of
Maritime Archaeology.

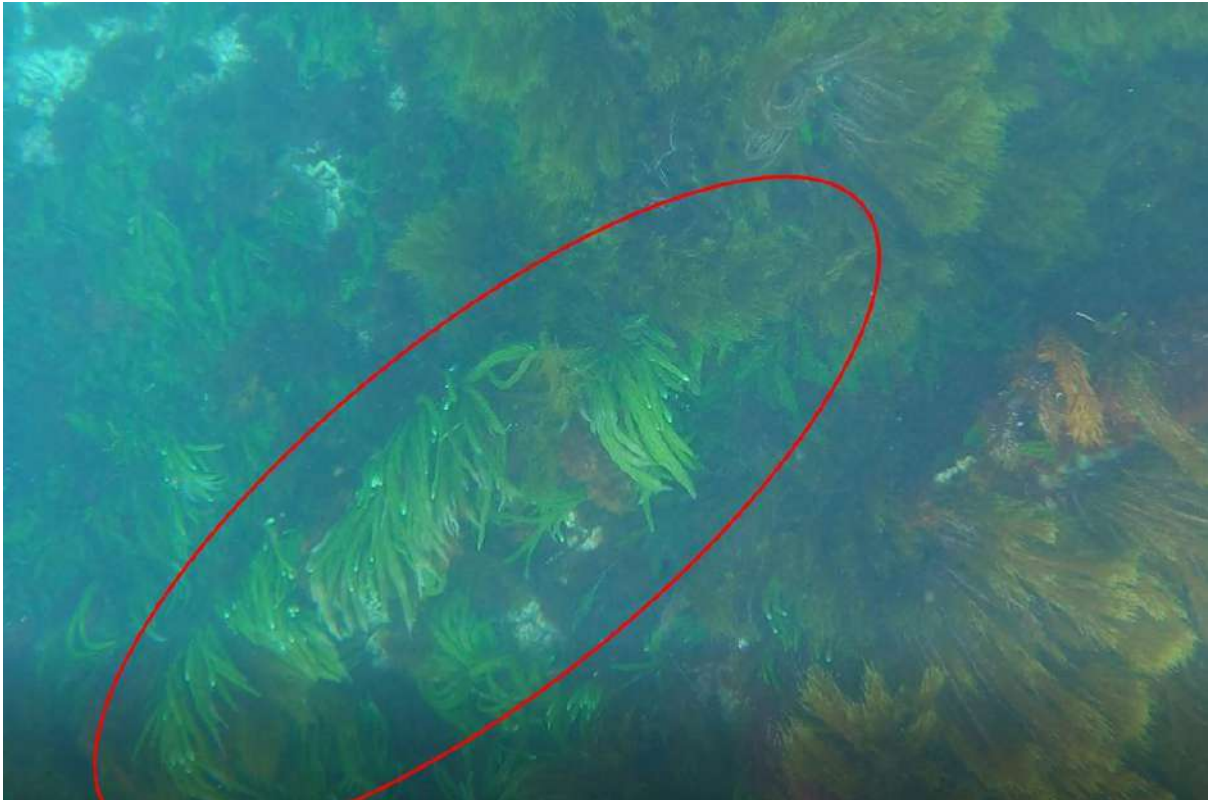
1G.10. ADM1-008 U-shaped structure resembling a semi-box beam (2022-01-12, P. Kermeen)

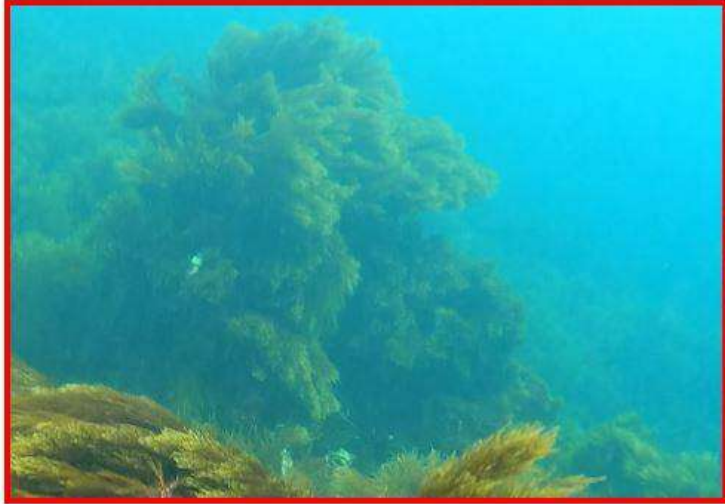
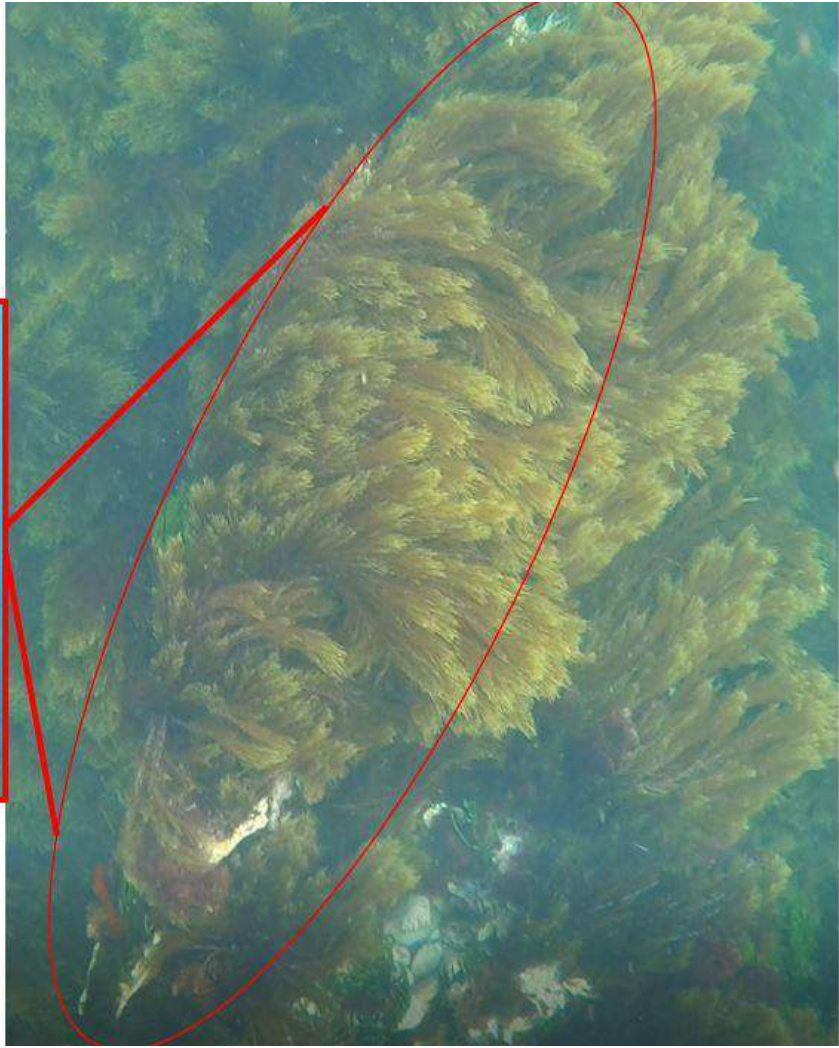
1G.15. ADM1-014 potential anchor stock and head (2022-01-13, P. Kermeen)
